BAT AND BIRD PRELIMINARY ROOST ASSESSMENT

**Walmer
Trenisson
Portloe
TR2 5PL**

Client	Becky Orchard
Project reference	498/24
Surveyor and licence numbers	Samantha Smith BSc MRSB Registered Consultant RC101 2018-35700-CLS-CLS Level 3 2019-42249-CLS-CLS-1 Level 4 Barn owl: CL29/00030
Date of survey	18 January 2024
Author	Samantha Smith MRSB
Issue date	25 January 2024

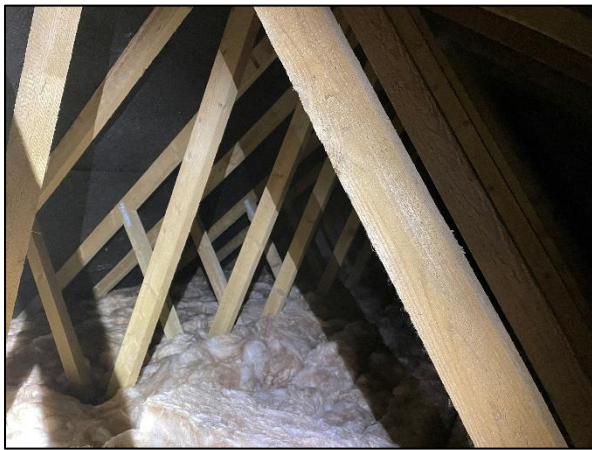
The bungalow is constructed from block work and has external stone cladding and render. The roof is covered with concrete tiles and underlined with bitumen felt. The interior of the roof void is trussed with fibreglass insulation on the floor (Figure 3) There was free access into all aspects of the void and other than an old water tank the void is empty of stored items. There was no evidence of use by bats within the void and no access points were noted internally.

Figure 3 Interior of roof void

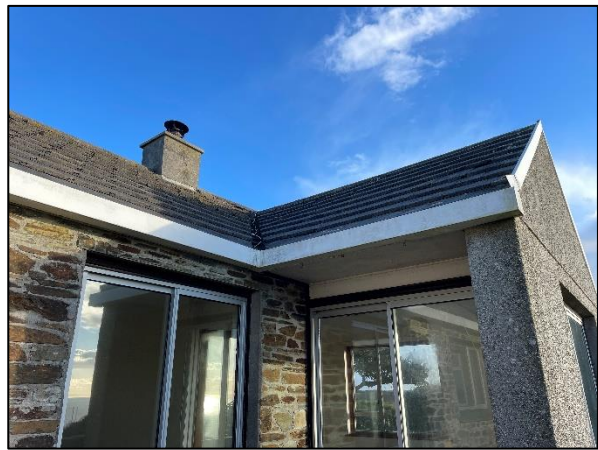
Externally the bungalow is well sealed with the plastic UPVC soffits and fascia boards flush against the wall, in addition there is a plastic covering on ends of the concrete tile roof (Figure 4).

Figure Soffits and gables well sealed

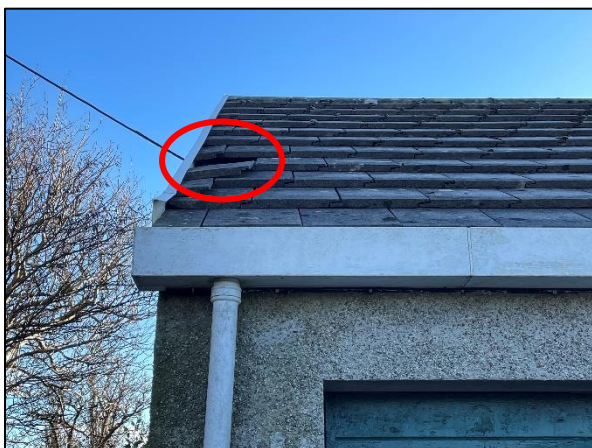
Attached to the bungalow via a small flat roofed entrance area is the garage. This is single storey stone built garage with a pitched roof. Externally there is some damage to a concrete tile on the roof however this is believed to have happened in a recent storm (Figure 5). Other than this the garage is well sealed externally with soffit boards flush against the wall and the edge of the tile roof covered with a plastic guard. Internally the garage is used for storage and does have an access hatch into the roof void. This void is also trussed and lined with a bitumen felt, there is no insulation present (Figure 6). No evidence of bats or use by bats was noted within the garage.

Figure 5 Damaged tile on garage

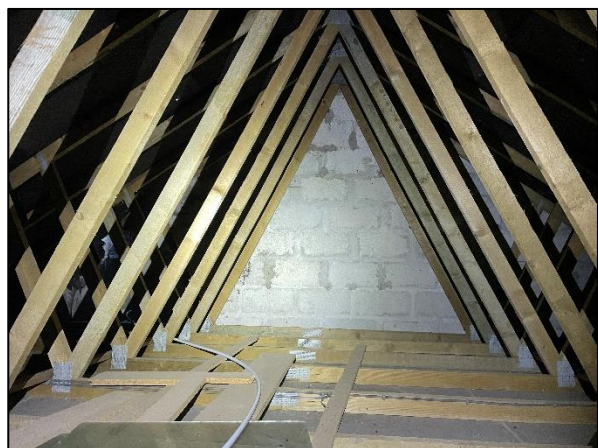
Figure 6 Roof void over garage
