Preliminary Bat & Bird Assessment

Hendravossen, Black Rock, Praze-an-Beeble, Cornwall

23rd January 2024

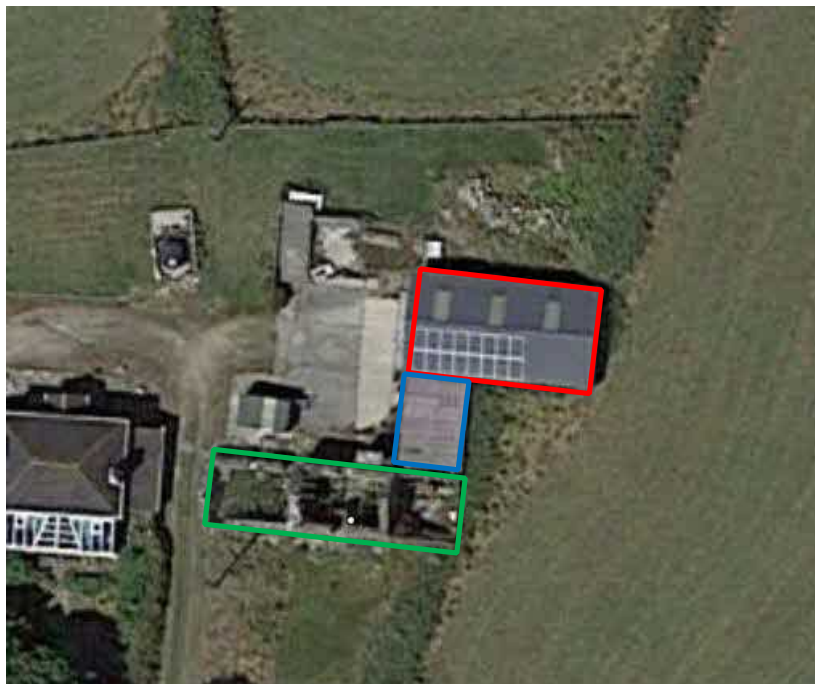
Figure 1: Aerial view of the three barns surveyed at Hendravossen. Barn 1 (red outline); Barn 2 (blue outline); and Barn 3 (green outline).

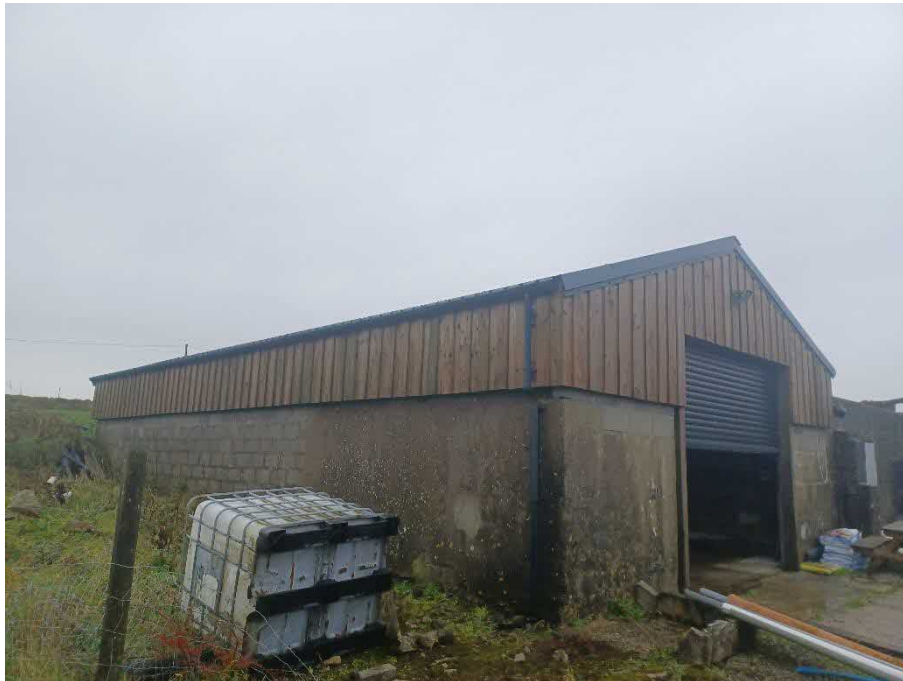
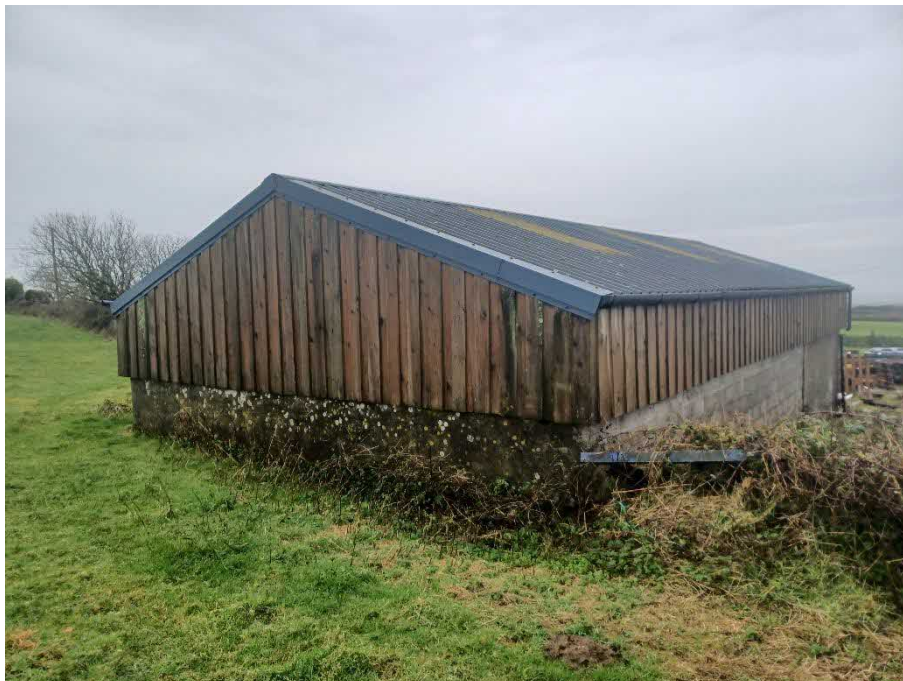
Barn 1 is of part block/ part wood panel construction with a pitched corrugated fibre roof (Figs. 2-3). The roof supports three roof lights at the north elevation and a metal ridge and fascias. A roller door is located at the west elevation.

Figure 2: View of the north and west elevations of Barn 1.

Figure 3: View of the north and east elevations of Barn 1.

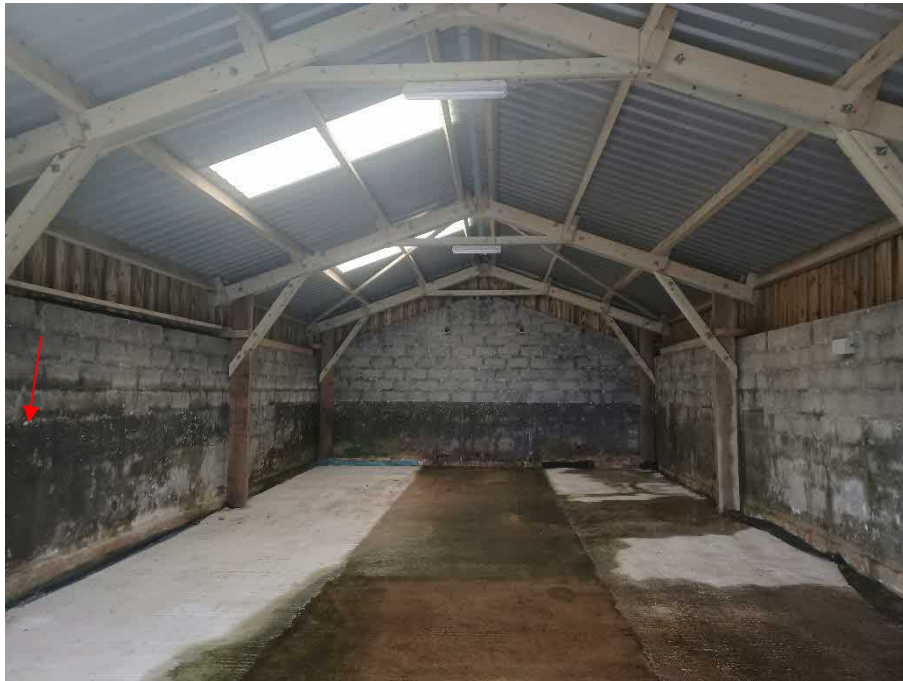
Internally, Barn 1 has a timber A-frame and the roof is unlined. The floor is concrete, and the barn is currently empty. The barn supports gaps at the internal wall tops, between the block wall and the wood panelling that could not be visually inspected for roosting bats (Fig. 4). These features have potential to permit bats into the barn interior.

Although no evidence of bats was found within the interior, Barn 1 supports potential gaps between the internal block wall tops and the wood panelling which provides access to the barn interior. Previous evidence of bats within the barn was also observed in 2014 (CEC, 2014).

Overall, Barn 1 was currently assessed as being of 'moderate suitability' for roosting bats.

Figure 4: View of interior of Barn 1. Red arrow shows gaps between the block wall top and the wood panels providing potential bat access to the barn interior.

In accordance with the Bat Surveys for Professional Ecologists: Good Practice Guidelines (Collins, 2023), works to Barn 1 must be informed with at least two bat emergence surveys undertaken between May and September; surveys must be spaced at least three weeks apart and one of the surveys must be carried out between May and August. A static monitoring survey of the barn interior is also required.

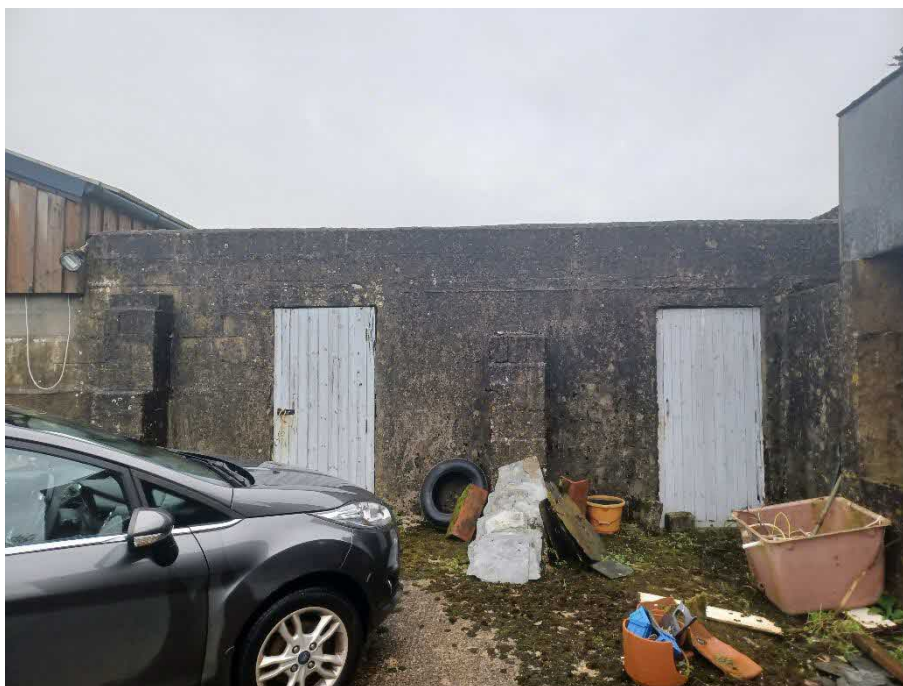
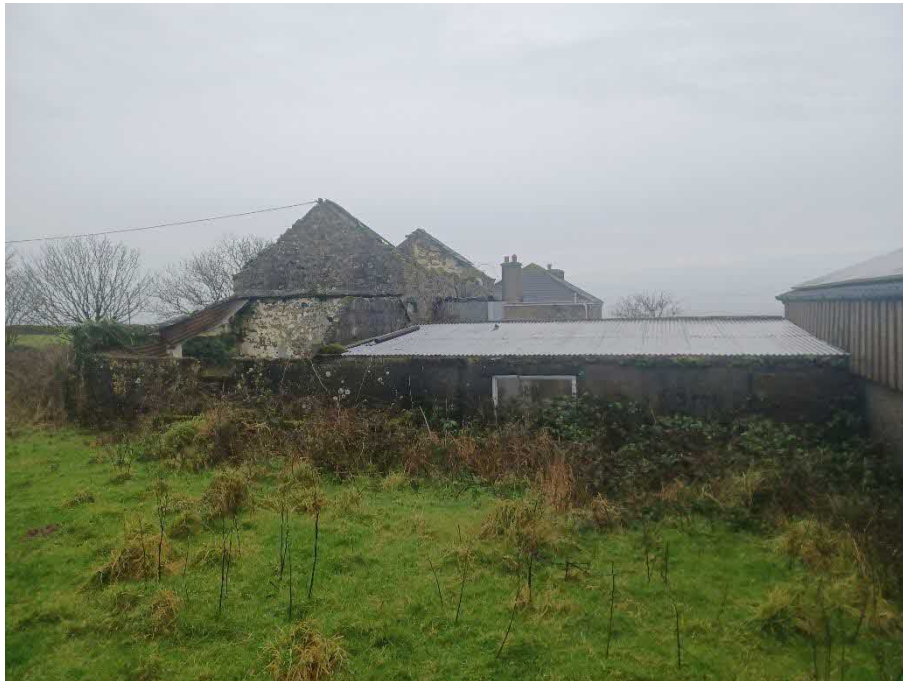
Barn 2 is a single-storey building of block construction with a clear corrugated plastic flat roof (Figs. 5-6). The barn supports two windows at the east elevation and two wooden doors at the west elevation. Externally, the building is well sealed with no obvious gaps.

Overall, barn 2 was assessed as being of 'negligible suitability' for roosting bats.

Figure 5: View of the west elevation of Barn 2.

Figure 6: View of the east elevation of Barn 2.

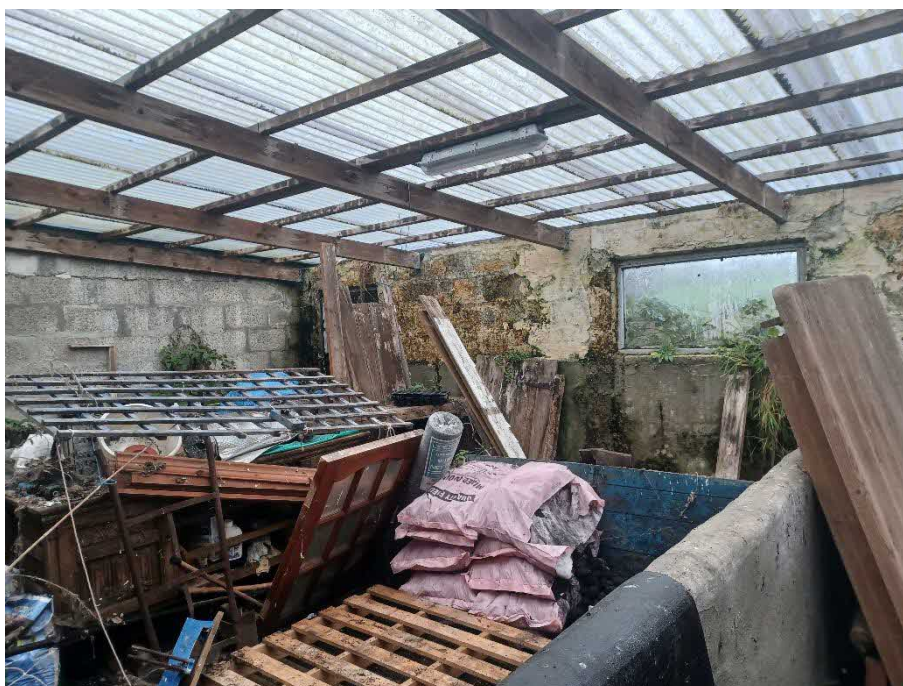
Internally, the building is used for storage and has a concrete floor (Fig. 7). The roof is unlined and heavily cobwebbed. The interior is well lit from the clear roof and two windows. No evidence of bats was observed within the interior.

Figure 7: View of interior of Barn 2.

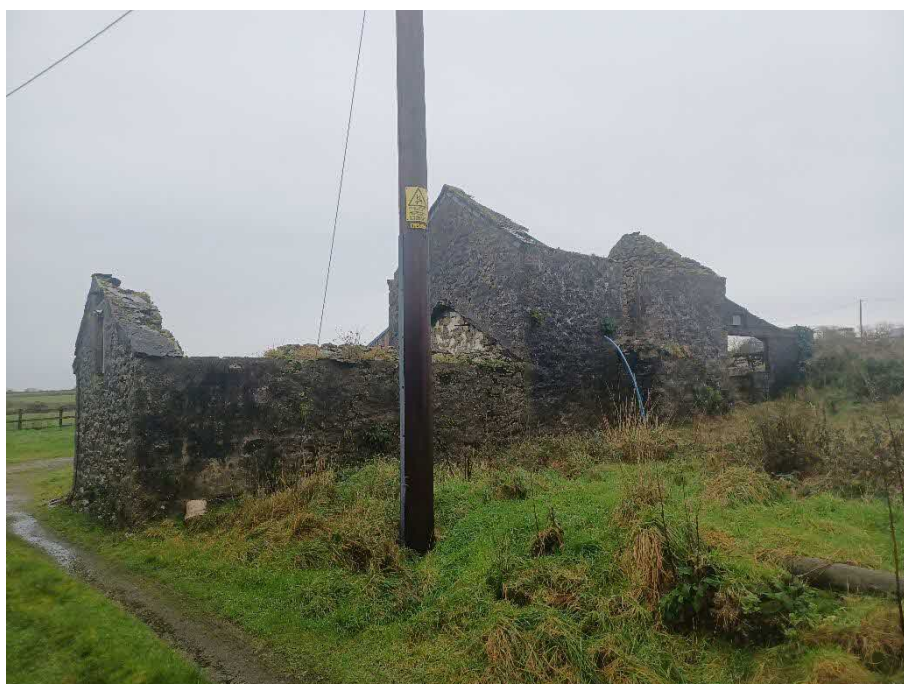
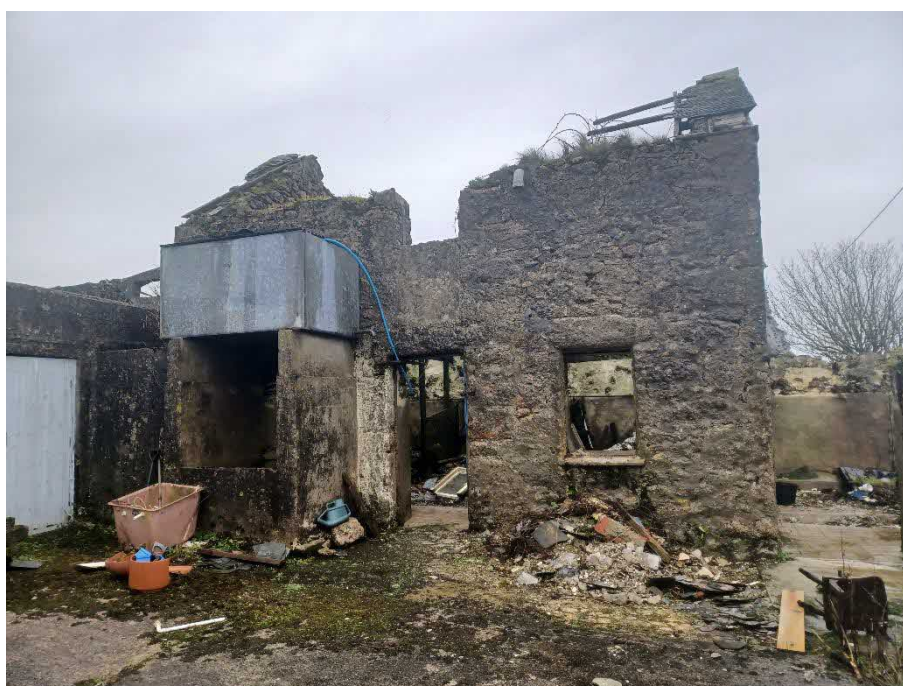
Barn 3 is a dilapidated barn of stone construction. The barn has lost most of its roof, with only the walls remaining (Figs. 8-9). The barn is open to the elements and offers very few potential roosting areas suitable for use by bats.

Overall, barn 3 was assessed as being of 'negligible suitability' for roosting bats.

Figure 8: View of the south and west elevations of Barn 3.

Figure 9: View of the north elevation of Barn 3.

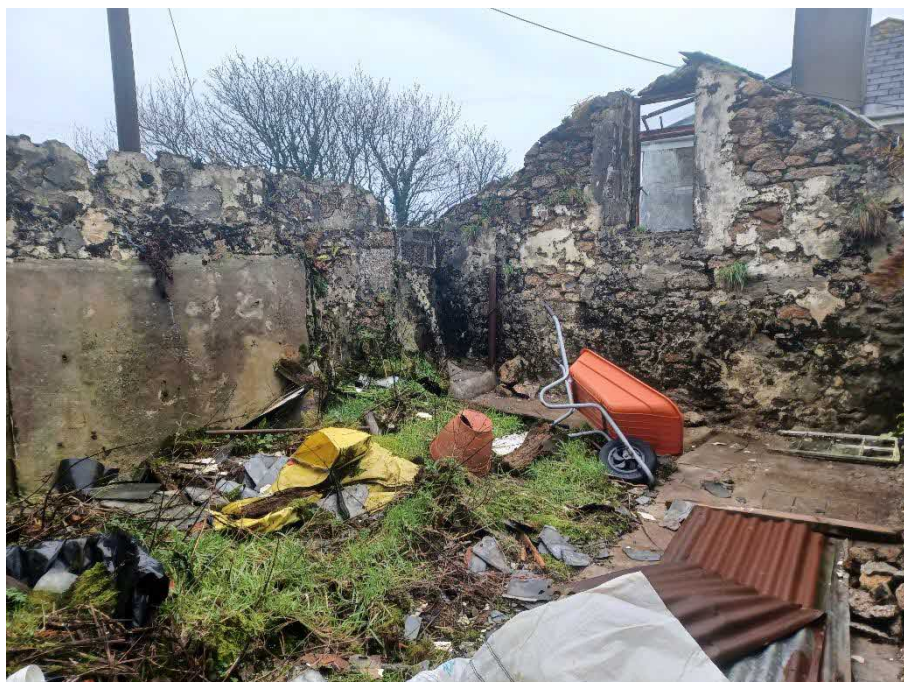
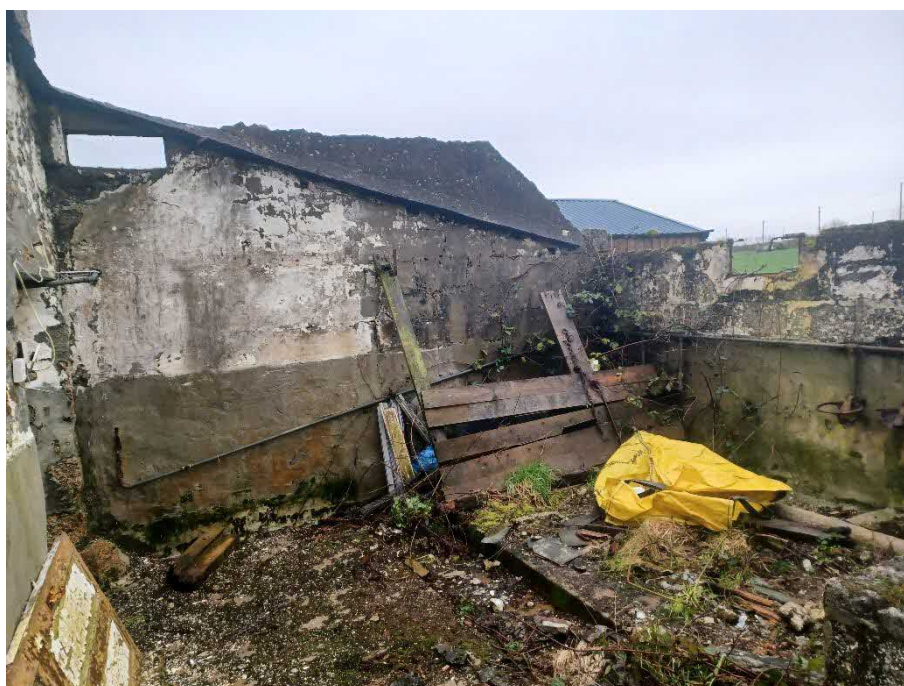
Internally, the barn has a concrete floor and is divided into three sections (Figs. 10-11). The barn interior was very damp due to the missing roof. No evidence of bats was observed within the interior.

Figure 10: View of the western interior of Barn 3.

Figure 11: View of the eastern interior of Barn 3.
