**RE: 22, Alexander Road, Frampton Cotteril, South Gloucestershire, BS36 2PZ –  
Phase II Geoenvironmental Assessment – Shallow Mining Investigation – Permit 27136**

Obsidian Environmental Ltd  
Figure:OE/1702/1057/R3/F01  
Date January 2024  
Phase II Geoenv. Assessment

Project		22, Alexander Road, Frampton Cotteril, South Gloucestershire, BS36 2PZ			Borehole No
Job No	OE/1702/1057	Date	11/01/2024	Ground Level m	19.5m AOD
				Coordinates E	N
Contractor					Sheet
Apex Drilling Services					1 of 3

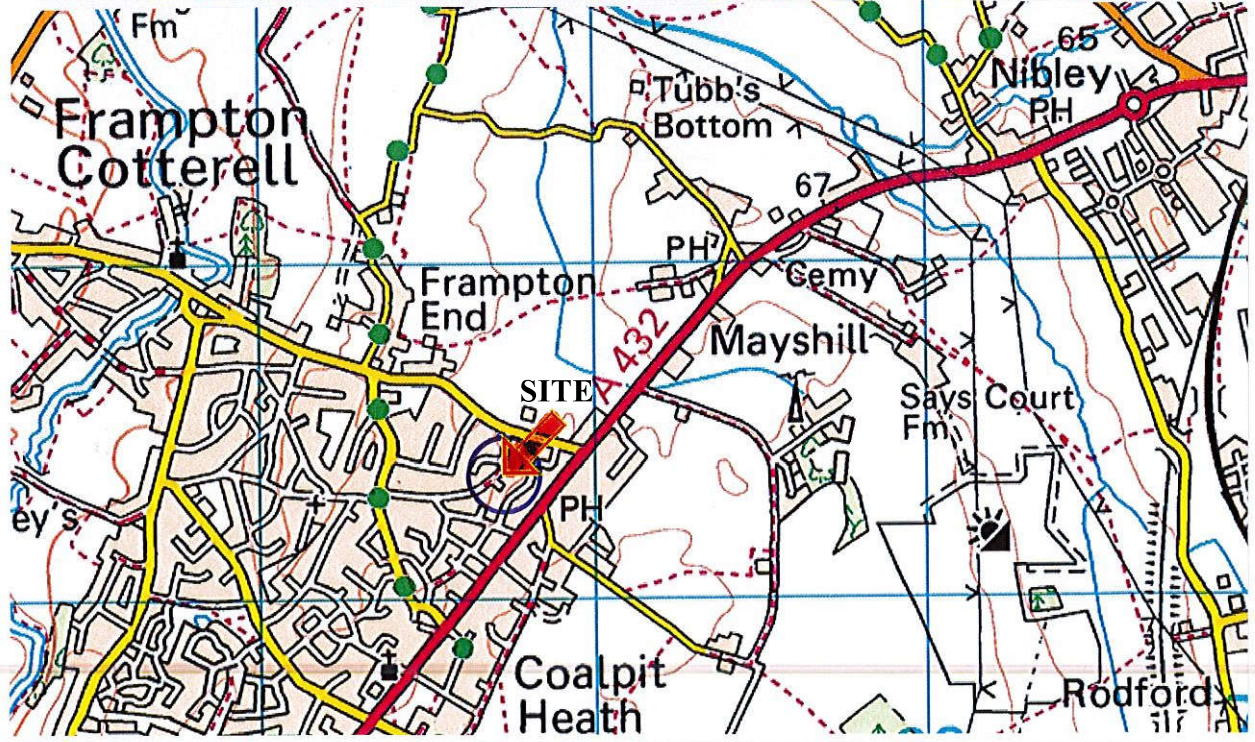
On 19 December 2023 a preliminary Phase II intrusive site investigation, by the use of a window sampler rig, was used to assess the Superficial deposits at the site and to establish rock head levels if shallow. Following this, over the 11/12 January 2024 a rotary rig was mobilised at the site to allow a shallow mining investigation to be completed. See Figure OE/1702/1057/R1/F01 – Site Location Plan. In compliance with the Planning Consent P23/00067/F.
