Red House Farm  
Lavenham Road  
Great Waldingfield  
Sudbury  
Suffolk  
CO10 0TQ

## Structural Survey of Existing Agricultural Building for Proposed Conversion to Residential Use

EPA Job Reference: 14750

Date: 9<sup>th</sup> February 2024

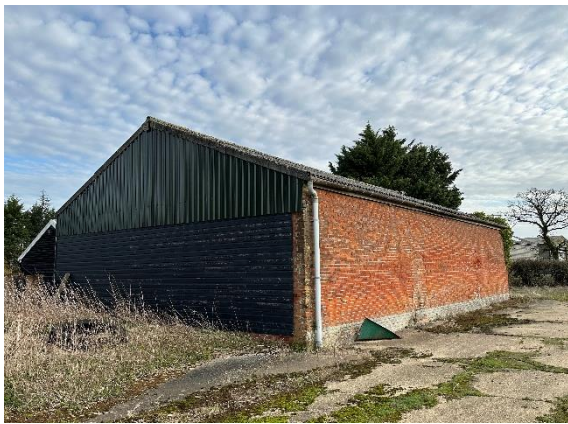
Image 3: External View of Southwest corner

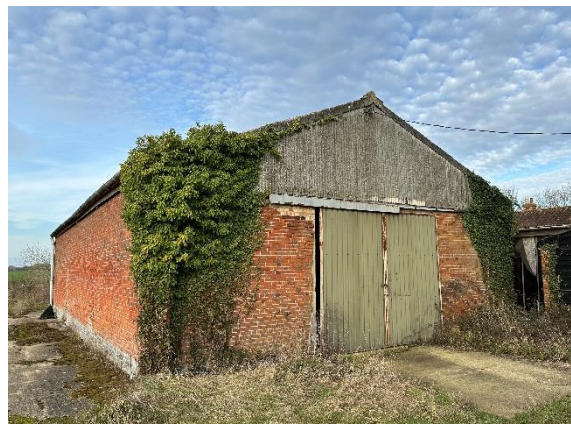
Image 4: External View of Southeast corner

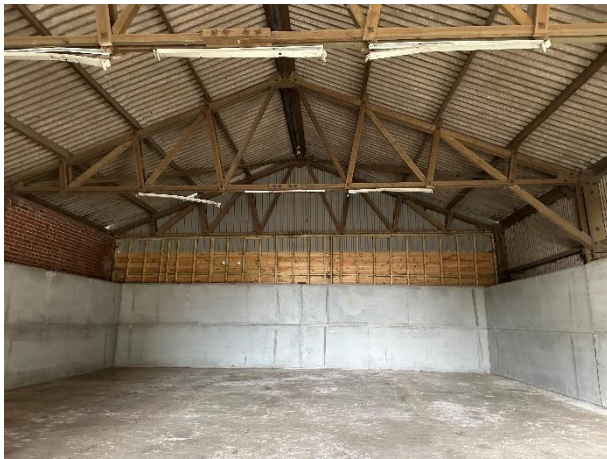
3.12 - The existing roof purlins are supported by timber trusses spaced equally throughout the building. The trusses comprise a girder configuration, consisting of internal strut & hanger members between the rafter and bottom chord members. Strut and hanger members are sandwiched and fixed through all rafter and bottom chord members. Rafter members are made up of a double 50 X 100mm spanning eaves to ridge, bottom chord members are made up of double 50 X 75mm members, with struts and hanger members sandwiched between. All members are fixed via single bolt and washer connections. All members and fixings appear to be acting adequately under current loading conditions and show no sign of stress or distortion.

Image 5: View of Existing Timber Roof Trusses

3.13 - It is to be noted that the assumed weight of the existing corrugated sheeting will be approximately 20-25Kg/m<sup>2</sup> and that as part of the residential conversion, it will be proposed to install internal finishings, i.e. plasterboard & insulation. An internal light-weight load-bearing system can be introduced to withstand any additional loadings from proposed finishings because of the proposed conversion works. Alternatively, the corrugated sheets can be analysed to determine their capability to withstand any additional loadings. It is likely, as part of the proposed conversion works, that a new modern external sheet finish will be proposed to be installed. This will likely be less than that of the original corrugated sheet finish. This offset in weight may allocate for the above noted finishings and prevent additional weight being exerted when compared to its current condition.

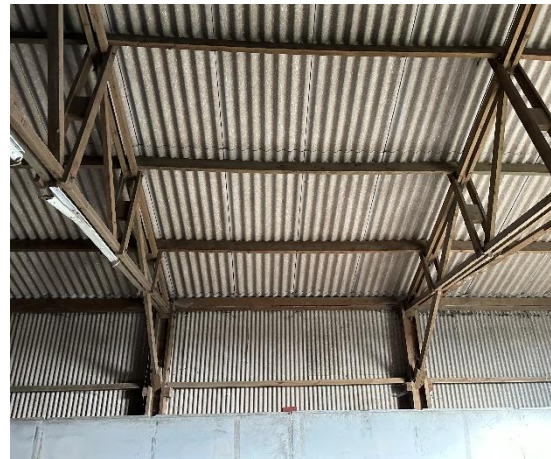
3.11 - The existing roof finish to the structure is a corrugated sheeting. The sheeting is supported internally by timber purlins each side of ridge line, spanning between existing timber truss sections. The purlins are consistent in size and spacing and show no signs of notable deflection or stress and appear to be working adequately under current and historic loading conditions.

Image 6: Internal view of timber roof purlins

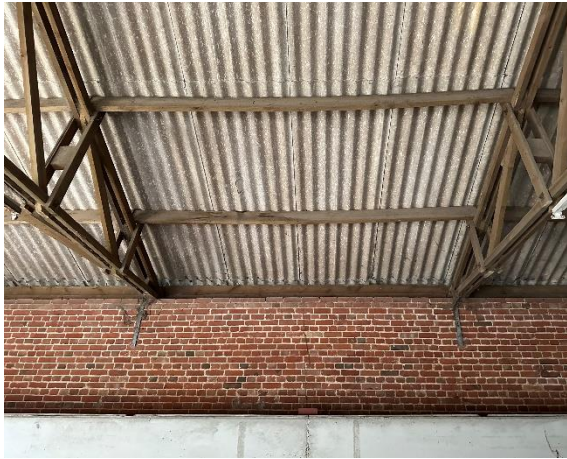
3.22 – Wall Type 1 consists of a full height solid masonry brickwork wall construction from ground slab to eaves level and occurs along the entire length of the southern wall elevation as well as intermediate sections between a large sliding door opening to the eastern wall elevation. All areas of brickwork are in sound condition and show little signs of movement.

Image 7: Wall Type 1 @ southern elevation

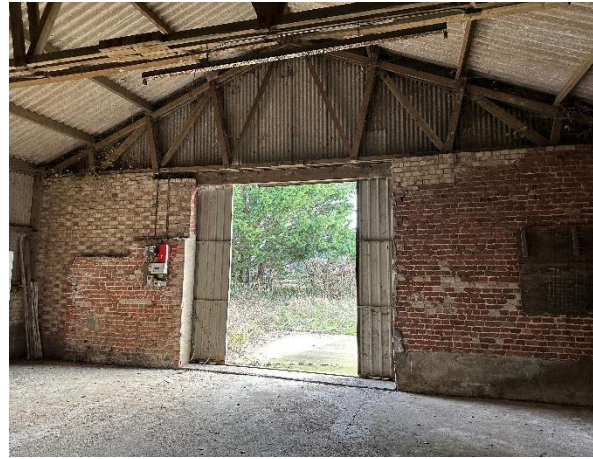
Image 8: Wall Type 1 @ eastern elevation

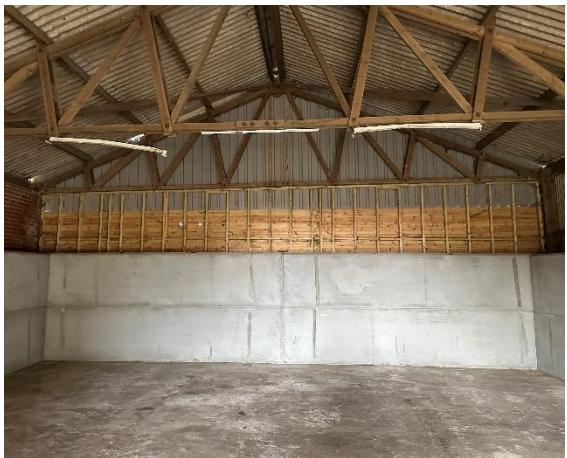
3.23 – Wall Type 2 consists of a high-level timber frame construction with a mix of weatherboarding and corrugated sheet finishing to their external face, finished by a low-level solid brickwork plinth detail at varying heights down to ground slab level. The western wall elevation consists of a mix of high level of corrugated sheeting and weatherboard as can be seen in Image 3 above, the northern wall elevation consists of corrugated sheet finish throughout.

Image 9: Wall Type 2 @ western elevation

3.24 - As part of the proposed conversion works, it will be necessary for insulation and finishes to be added to the internal face of all external wall areas. This will involve the removal of the existing boarding, introduction of insulation material between existing stud members, with the potential addition of timber batten members internally to achieve required U-Values and a modern plasterboard finish to Wall Type 2. Wall Type 1 will require introduction of a new light-weight timber framework internally to be insulated and finished with modern plasterboard finishings.

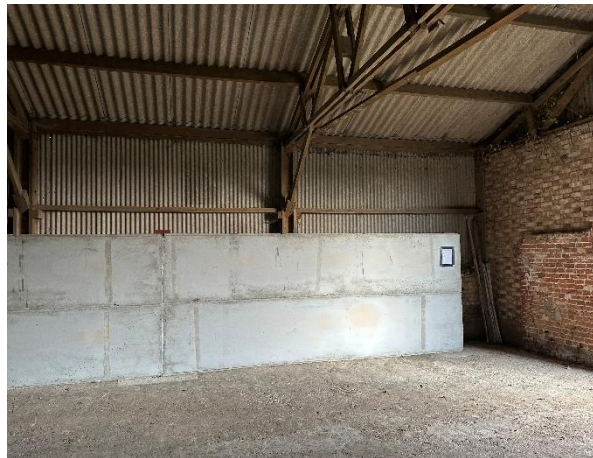
Image 10: Wall Type 2 @ northern elevation

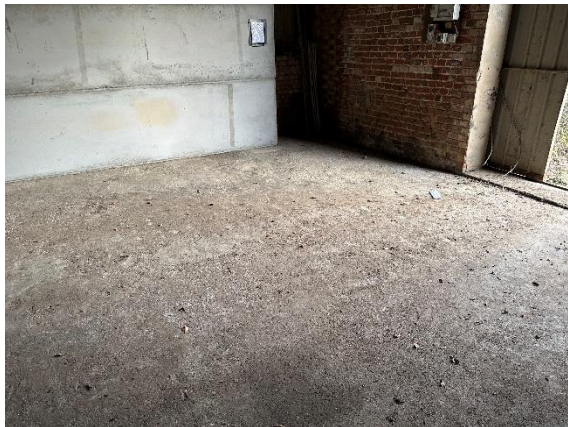
3.31 - At the time of our survey, EPA were not aware of any trial pits having been excavated to expose existing foundation conditions below ground level, however based on the age and nature of the building, it is assumed that the footing conditions consist of a continuation of brickwork forming a corbelled detail to a depth of 450-600mm below ground level. The ground floor is formed by a cast in-situ concrete slab. The slab appears to have been poured in one continuous section owing to the absence of movement joints, which, given its sound condition, suggests is robust in nature. It is assumed based on the structural condition of the building that all existing foundation and ground slab elements are performing adequately in their current condition and there are no signs of stress or distortion throughout.

Image 11: Exposed concrete slab internally  
@ northeast corner

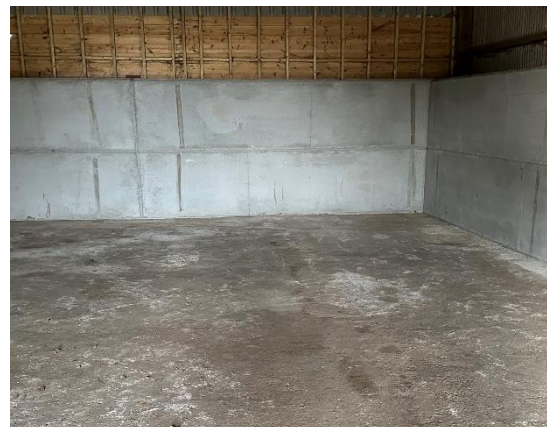
Image 12: Exposed concrete slab internally  
@ northwest corner

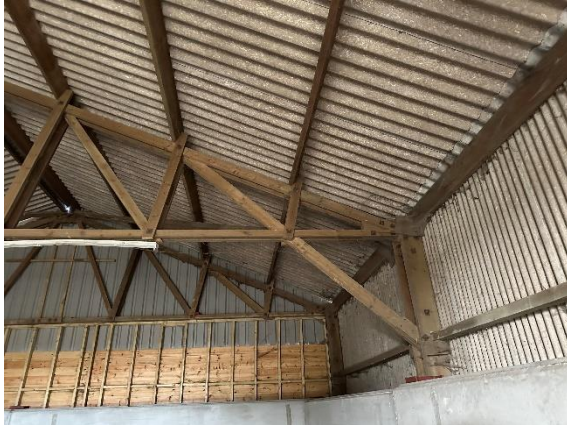
3.41 - The existing building has remained sound for the duration of its lifetime in its current bracing conditions. The external brickwork walling is providing sufficient lateral bracing along the flank walls accordingly. Timber braces are evident spanning from bottom chord of trusses to timber stud wall members. This is providing lateral bracing in opposite direction. It is to be noted that the existing roof is currently braced by diagonal timber braces to both end bays. The above bracing conditions have kept the building in sound condition under lateral stability for the duration of the building's lifetime and is working adequately.

Image 13: Timber braces at truss locations

3.42 - The conversion of the building to residential use will significantly increase the overall stability of the structure through the introduction of plasterboard internal finishings, light-weight studwork walls, as well as internal partitioning.

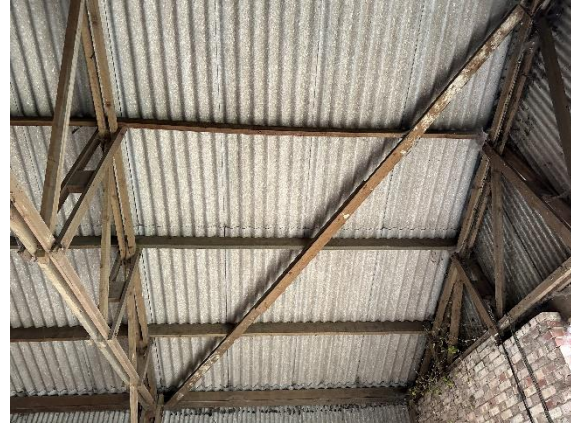
Image 14: Timber diagonal roof bracing
