Buildings off Lambert Street, West Vale

BAT SURVEY REPORT

September 2023

Report ref: 032_01

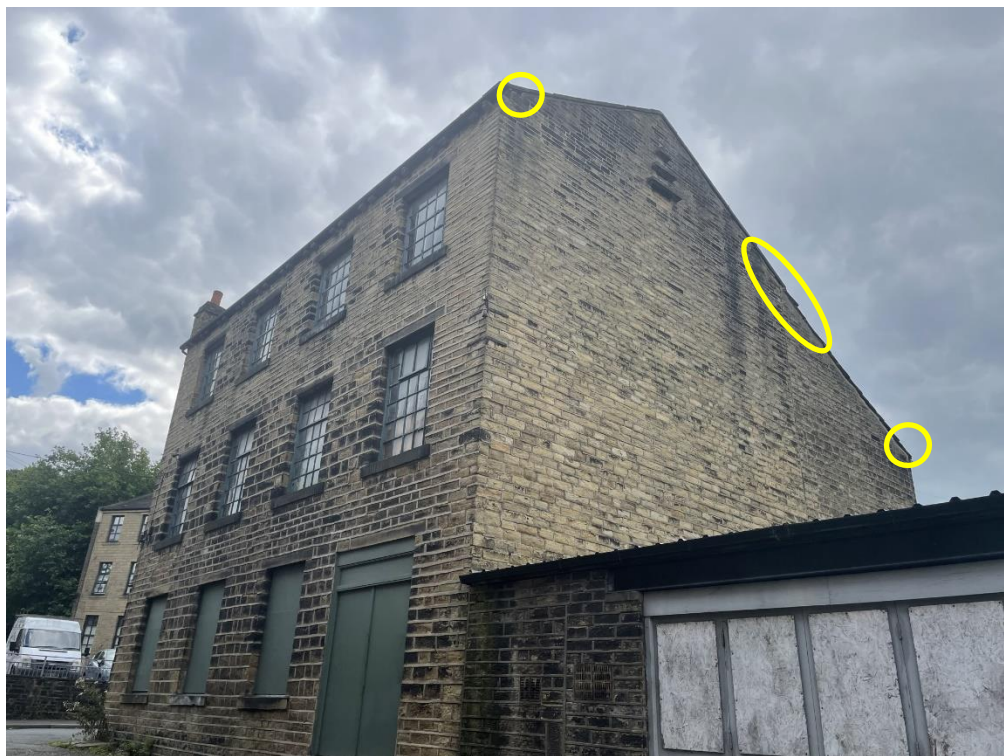
Photo 1.

Mill (north-west and north-east elevations).

Highlighted are gaps in the verge pointing / under the coping stones

The former mill is a three storey, stone building which housed a workshop on the ground floor until very recently (summer 2023). There was also disused office space on the second floor and storage on the third floor. The building has a vaulted ceiling with no loft space. The building has a gable roof structure and stone roof tiles. The stone work of the building walls appeared solid overall. However, several gaps were noted under the roof verge coping stones including a noticeable gap at the gable apex on the front; a gap on north corner; and a gap within the pointing on the north-east facing elevation. In addition, the roof has several slipped slates resulting in a number of small gaps in the roof.

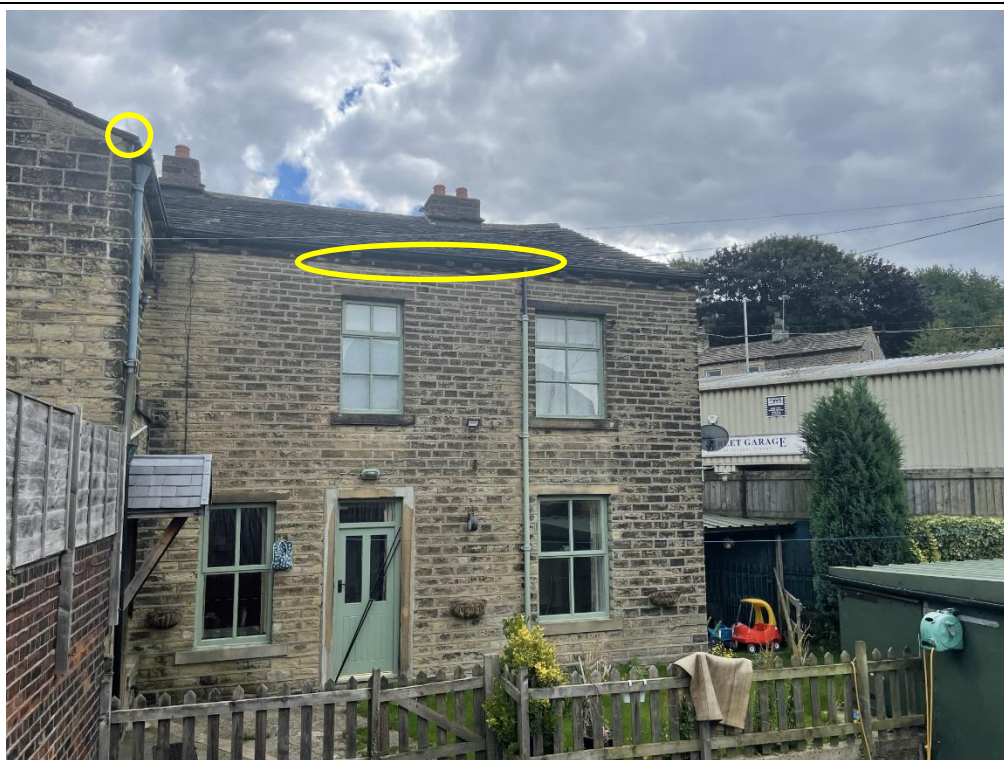
Photo 2.

Dwelling (north-west elevation).

Highlighted are gaps in the verge pointing and under the roof eaves

The dwelling is part integrated into the mill and is also stone built with a stone tile roof. The stone work of the walls and roof verge pointing appeared to be in very good repair with no gaps in the

stonework noted. There were a number of small gaps under the roof verge tiles on the south elevation (facing Lambert St) and there were some gaps under the guttering on the west elevation. As is typical of stone tiled roofs, there were a number of small gaps between slightly misshapen tiles. The loft of the dwelling was relatively sizeable and was disused. The roof did not have an underlining and several small gaps in the roof underside were observed.

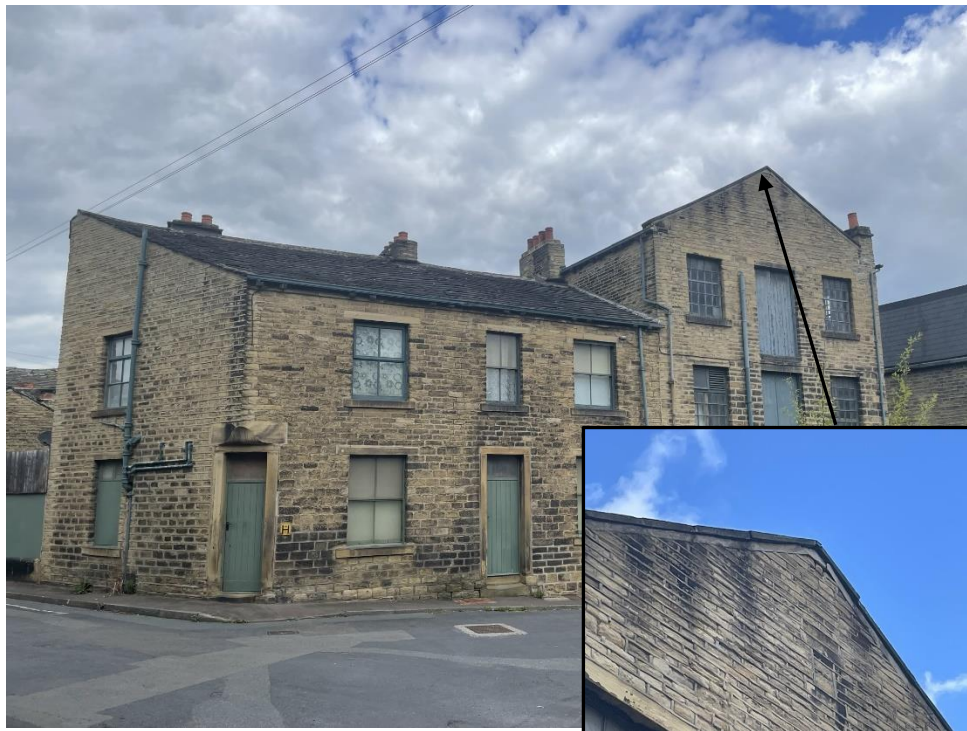
Photo 3.

Frontage of Dwelling and Mill on Lambert St.

Gaps noted in the stonework at the ridge of the mill. Also gaps in the roof verges.

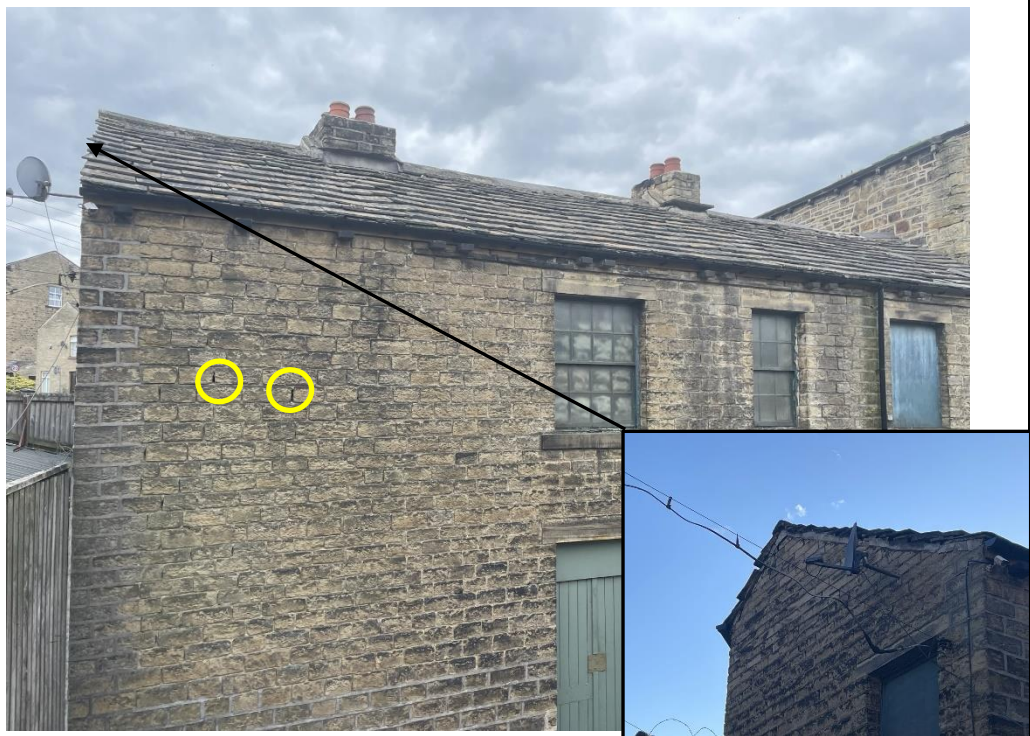
Photo 4.

Cottages (north-east elevation).

Highlighted are gaps in the stonework. Also, numerous gaps within the roof eaves, the roof slates and under verge slates.

The disused cottages are part attached to the outbuildings and the frontage of the cottages face a small cul-de-sac off Maude Street. At least two gaps potentially suitable for bats were noted in the stonework of the wall on the frontage. There were also several gaps under the timber bargeboard at the frontage. The roof verge pointing on the east elevation was cracked and several verge slates were slightly lifted. The cottages did not have any accessible lofts. However, due to rain ingress a section of the ceiling had fallen down and the roof was viewed through the gap. The roof was unlined and sizeable daylight gaps were noted in the roof slates. The cottages are adjoined by a former mill building on the north-west side which did not form part of the proposals and are not under the ownership of the landowner of the site.

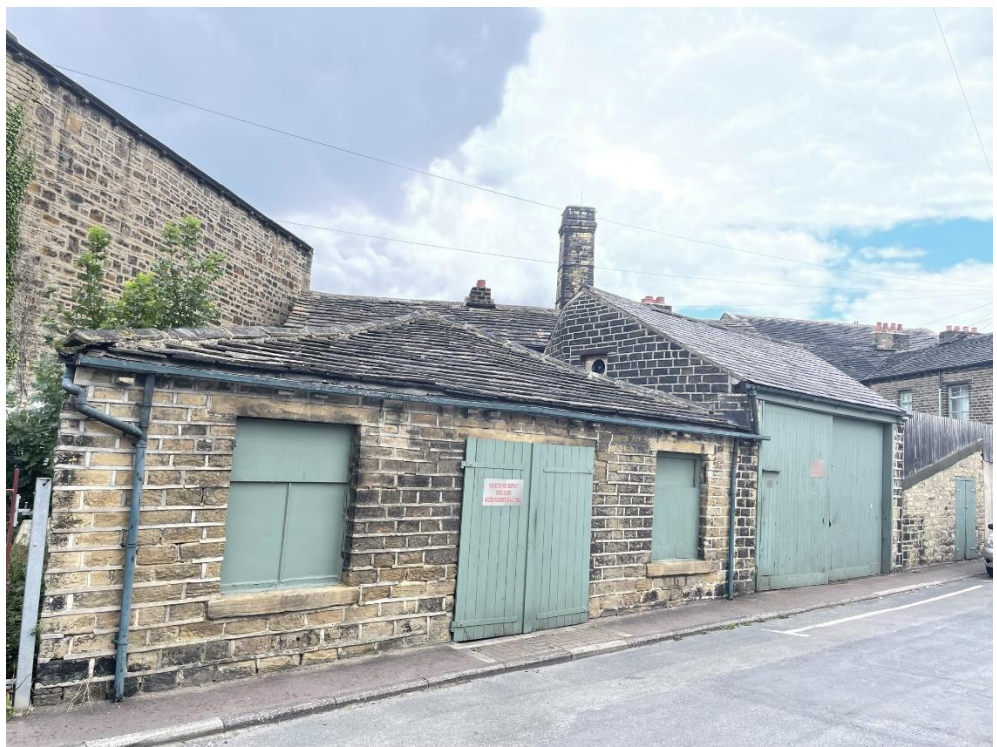
Photo 5.

Outbuildings
(south
elevation
along
Lambert St).
Gaps in the
ridge tile
pointing and
under the
roof slates.

There are two relatively small buildings to the rear of the dwelling which were used as ancillary workshop facilities. These buildings had vaulted ceilings with no loft spaces. Potential roost features were limited to the roofs of each structure via several gaps in the ridge tile pointing and the roof verge pointing on the east elevation. There were several small gaps between the stone roof tiles of the westernmost outbuilding. However, the roof pitch was shallow and the outbuilding was of limited height (approx. 3m to the ridge) which would reduce the potential suitability of the features for bats.

The main potential roost features were recorded on the east gable of the outbuilding which faces the courtyard of the dwelling. These comprised gaps between the roof verge tiles and the roof verge pointing and, gaps where the pointing mortar was missing.

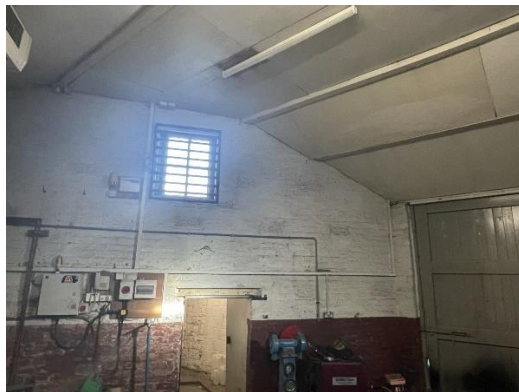
Photo 6 to 10.

Outbuilding
(top-left)

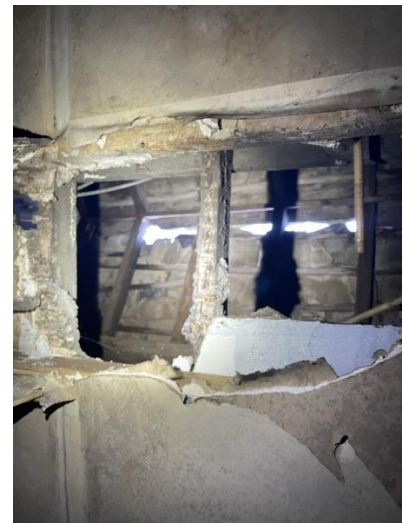
Cottages
(top-right –
showing gap
in roof)

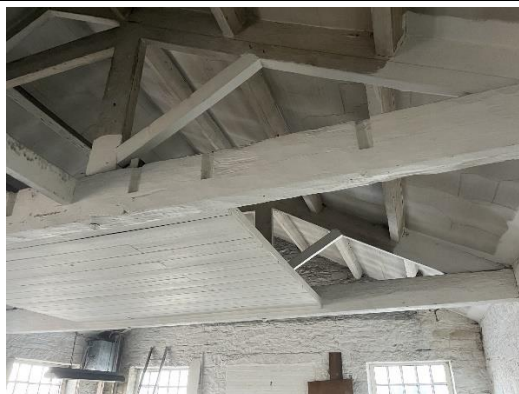
Mill (bottom-
left)

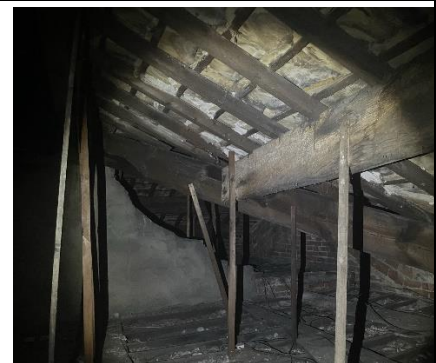
Dwelling
(bottom-
right)
