**7 Castle Close
Ventnor
Isle of Wight
PO38 1UD**

SLOPE STABILITY ASSESSMENT & DESK STUDY REPORT

**Client: Martin White
7 Castle Close
Ventnor
Isle of Wight
PO38 1UD**

February 2024

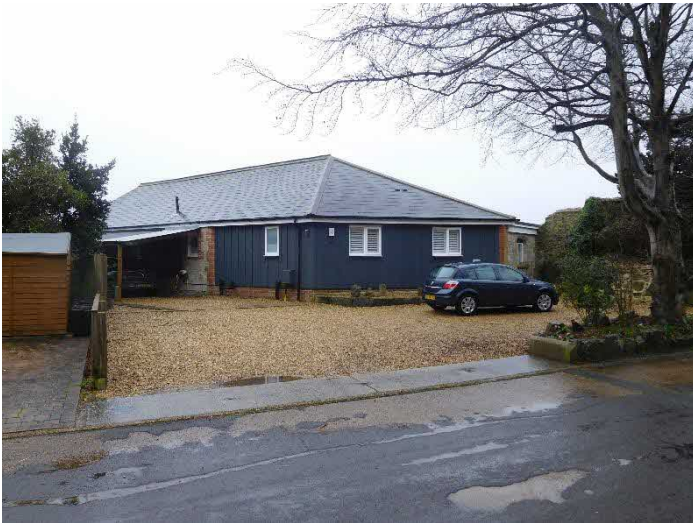
The property is a single storey dwelling with a pitched slated roof which has a hip end to the northern side facing Castle Close and a gable end facing south. The building has a distinctive angled shape which is understood to result from the available space alongside the rail line. To the west side of the site is a single storey projection constructed from stonework with a flat roof over.

7 Castle Close viewed from the road

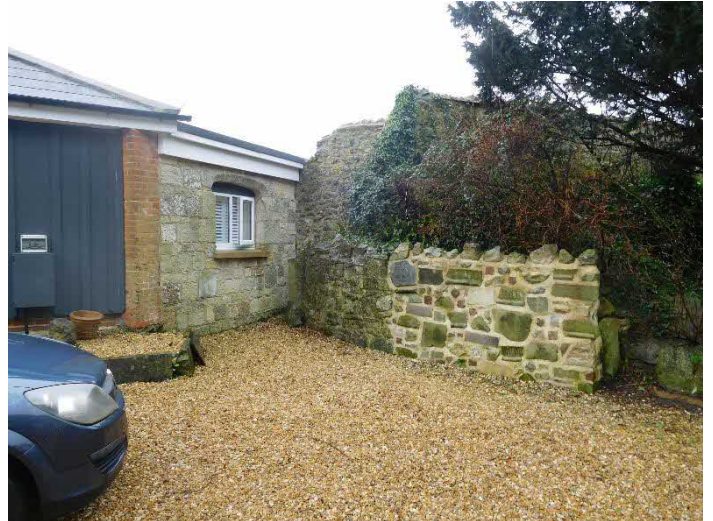
There is a section of stone wall to the front of the site at the western side of the property. Beyond the stone wall is an enclosed area of garden which forms part of the site. To the south of this area is a lightweight shed/outbuilding which abuts the side extension.

Inspection of the property did not note any evidence of recent or historic structural movements. Similarly, inspection of the external areas of the site, including the historic stone wall to the north-west corner of the site did not find evidence of ground movements.

View of western side extension and historic stonewall

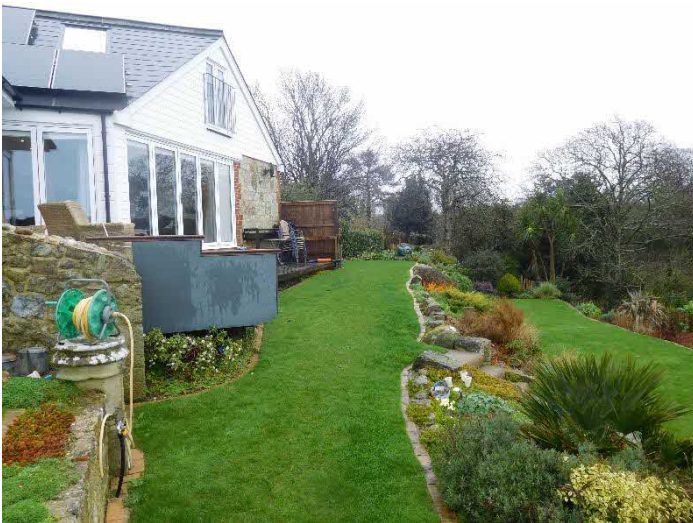
To the east side the lean-to car port leads to a timber gate which gives access to a terraced garden. The garden leads down to a gate separating the garden from the steep slope which runs alongside Undercliff Gardens.

View looking east across terraced garden

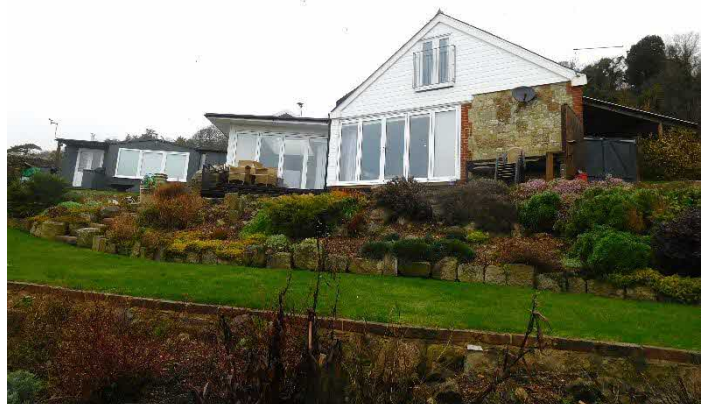
Inspection of the property did not record any signs of structural movement or distortion. The roof and ridge line were found to be true and no cracks were identified to the external walls.

View of rear elevation from lower garden terrace

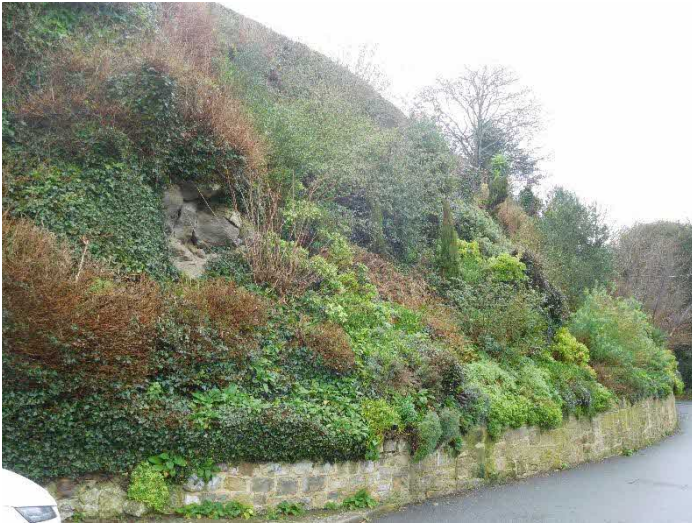
Inspection of the slope from Undercliff Gardens noted a low stone wall at the base of the slope and vegetation across the whole slope. Towards the western side of the slope an outcrop of rock was noted.

View of slope and low stone wall along southern boundary of the site with Undercliff Gardens - Note: rock outcrop

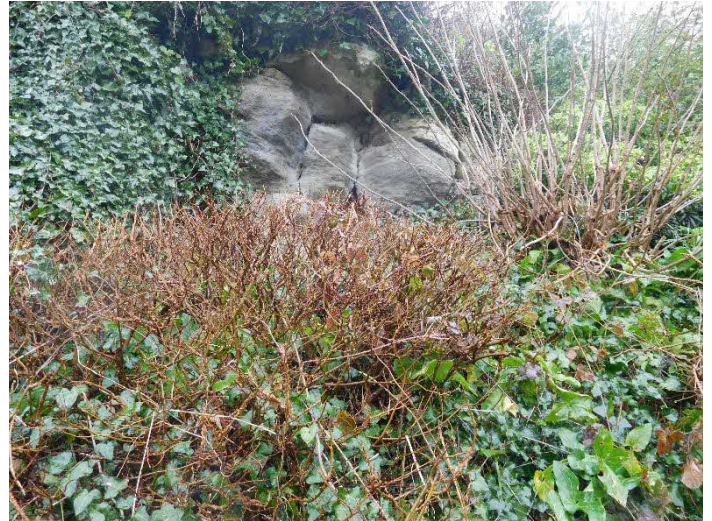
Inspection of the rock outcrop showed it is formed from large blocks of sandstone interspersed with smaller rock fragments and loose sand debris.

Interpretation of borehole logs in the area suggest the site will be underlain by Greensand debris close to the surface. This is likely to consist of large blocks of sandstone with smaller sandstone fragments and loose sand between. The blocks of greensand will increase in size with depth. The outcrop of rock noted to the scarp slope that forms the southern boundary of the site supports this interpretation of the ground make-up. In addition, anecdotal evidence and site photos from recent extension works at the property also suggest the Greensand is present below the surface of the site.

View of rock outcrop

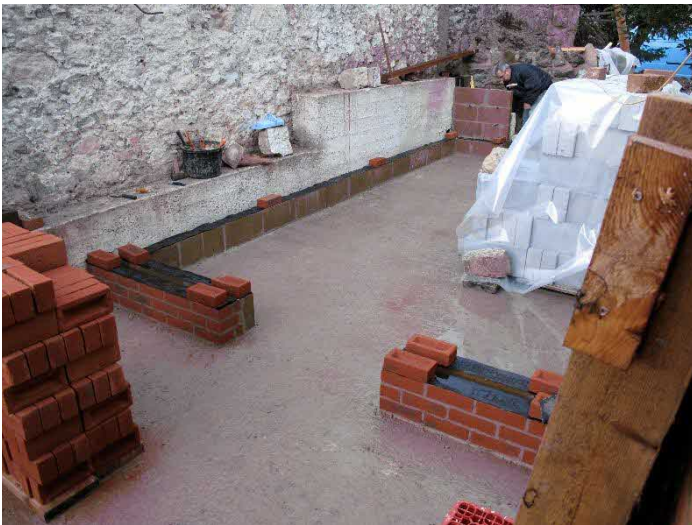
Photos taken during the 2009/17 extension and alteration works to the property were made available to us, copies are contained in the appendices. It is understood that the extensions are founded on traditional shallow foundations. Anecdotal evidence, supported by the images, suggest the surface geology across the site is formed from sandstone blocks.

View of western extension under construction

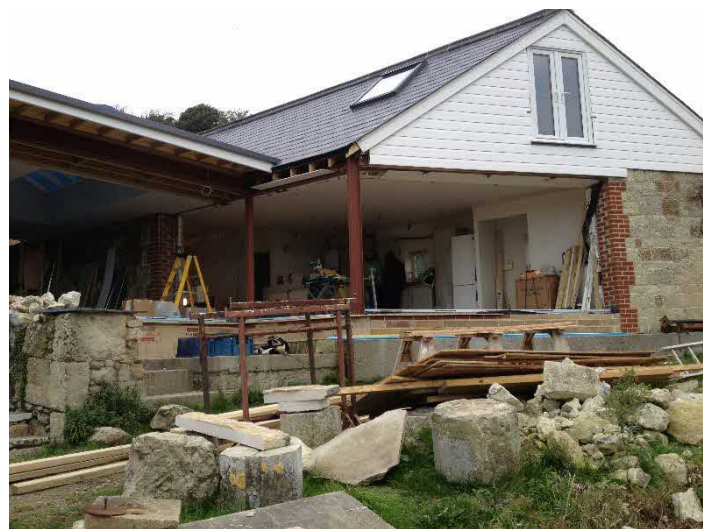
View of alterations to the rear of property in progress

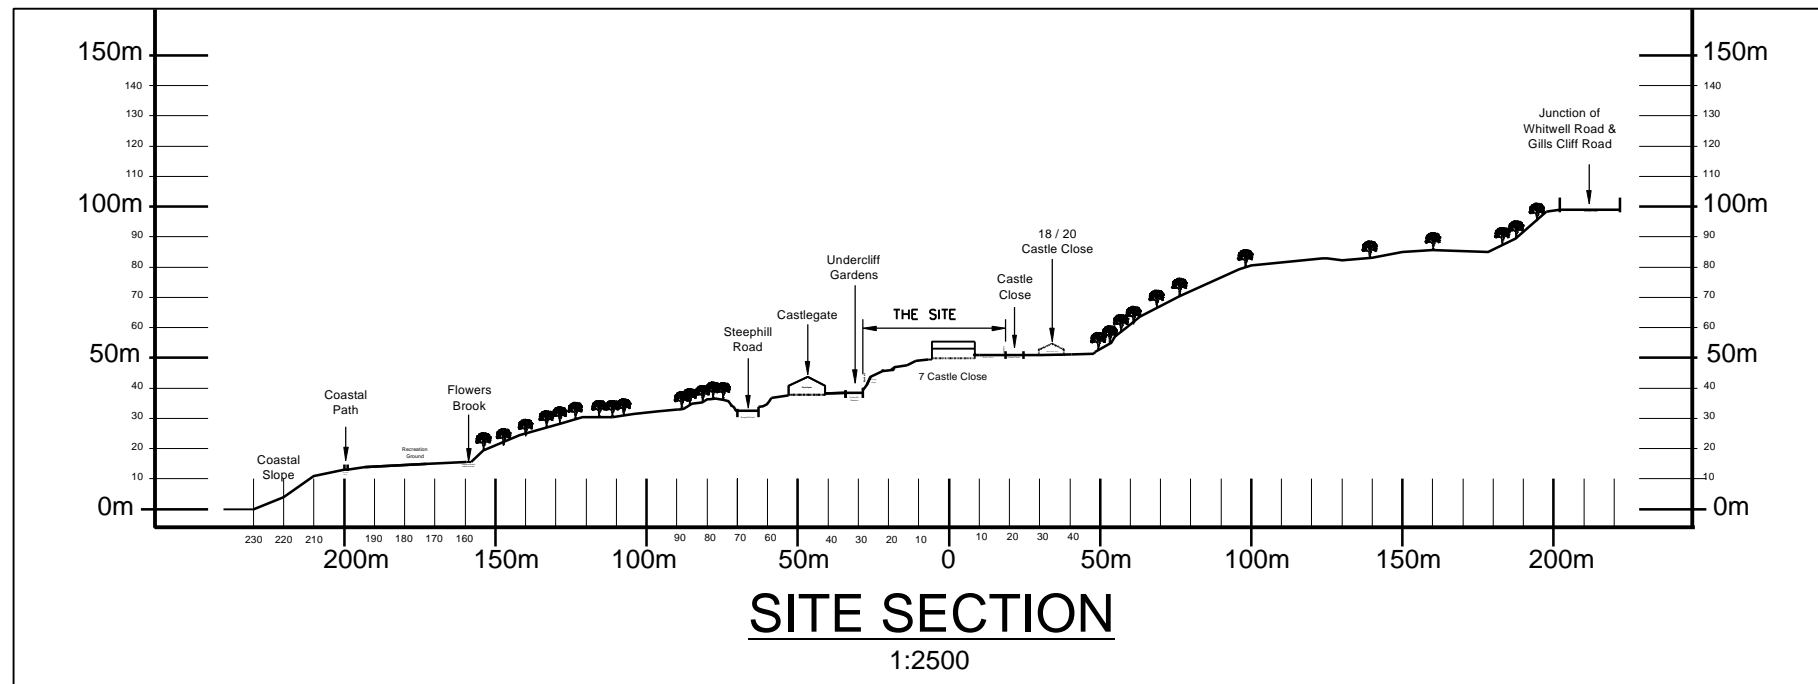
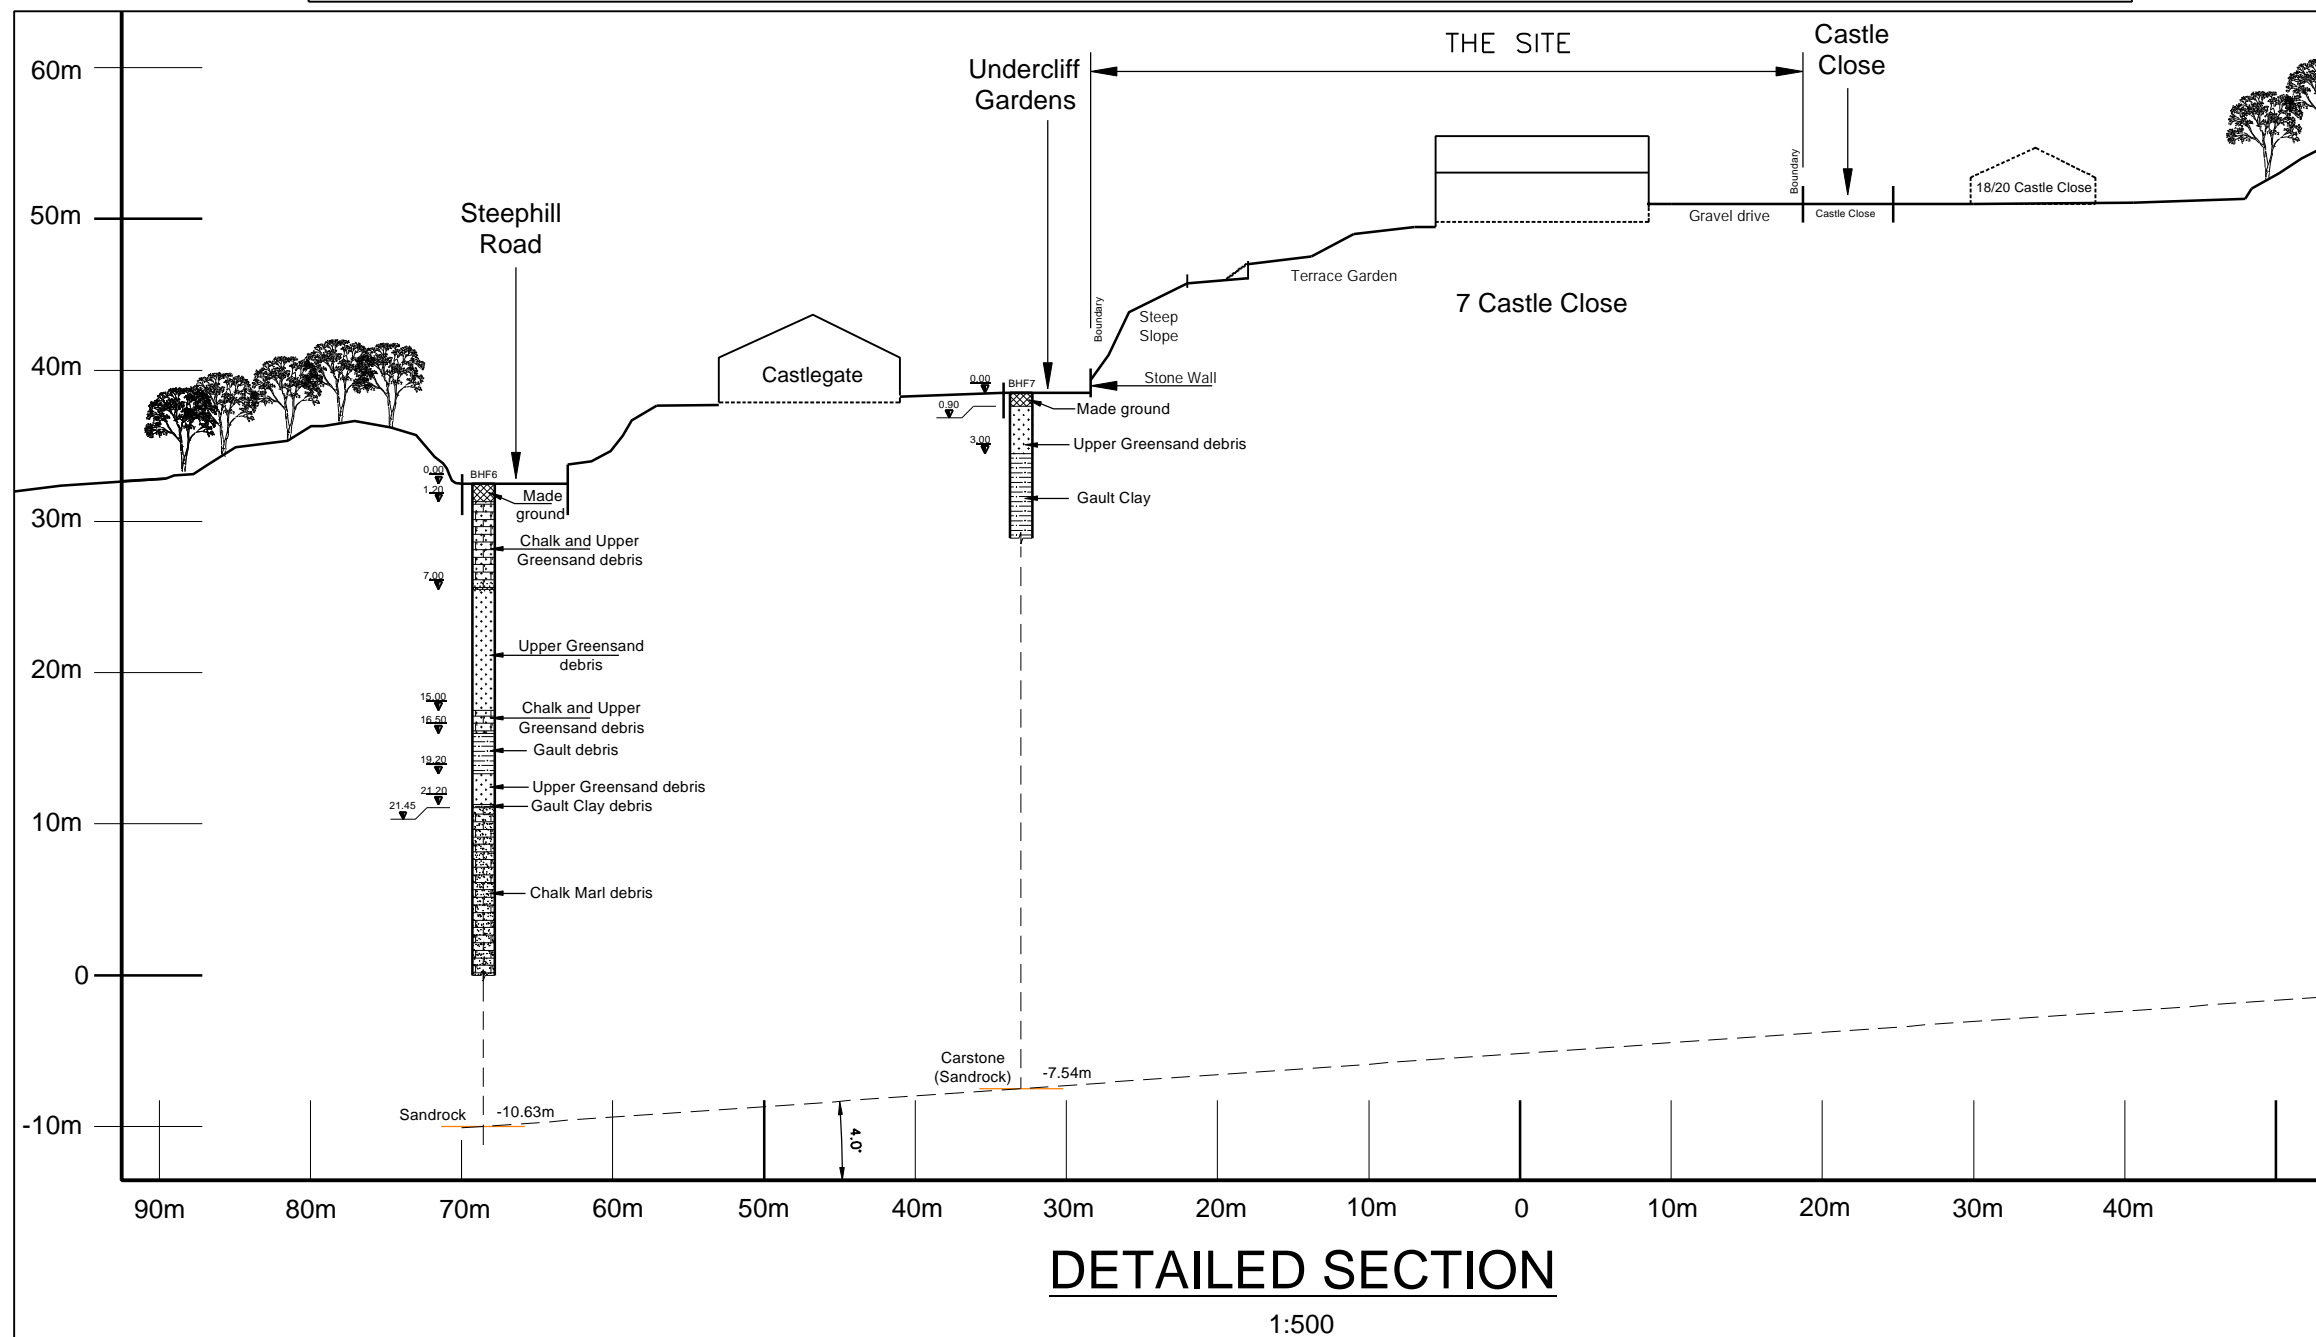
An interpretation of the borehole logs is represented on the site section contained towards the end of this report.

Both boreholes indicate the upper layers of ground close to the surface are formed from Upper Greensand debris. Borehole F7, along Undercliff Gardens encountered Gault Clay relatively close to the ground surface, at a depth of 4m (BGL). This description of Gault Clay continues to around 46m below the ground surface, at which point Carstone, part of the Sandrock formation, was encountered.

By contrast, the log F6 encountered a far greater depth of Greensand debris interspersed with bands of chalk and Gault Clay, down to around 40m below surface level. At this point the borehole description notes Sandrock formation was encountered.

This drawing has been compiled using the site survey, Ordnance Survey maps and aerial photographs.

Borehole logs have been obtained from the BGS website.

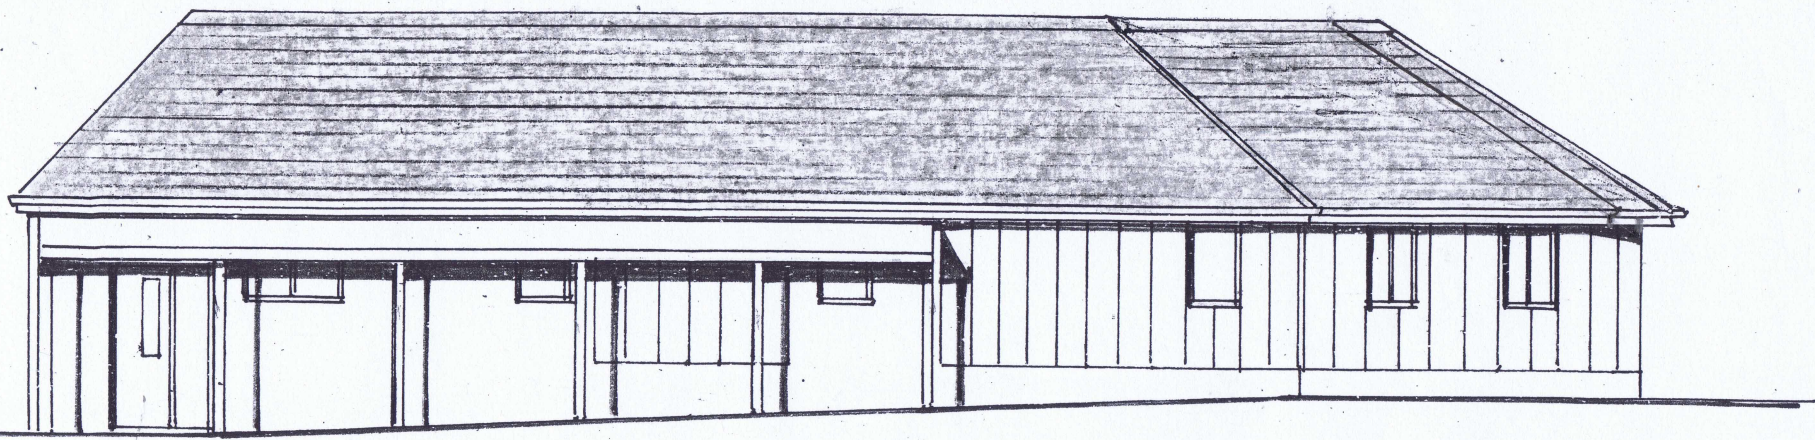
EAST ELEVATION

The extension will measure approximately 4.5m wide by 8m deep on plan and will be accessed via a new staircase from the ground floor. The extension will have a mansard style roof structure with a slate covered sloping roof to the front elevation and a flat roof over the new bedroom. The southern elevation will have a glazed façade with door to access the existing flat roof, which will be utilised as a balcony. Drawings indicating the proposals are contained in the appendices of this report.

First Floor Extension

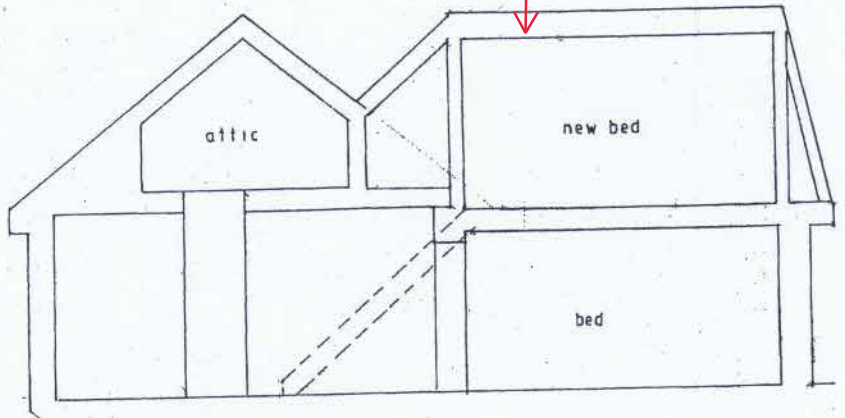
SECTION A-A

It is assumed the existing foundation building foundations will be suitable to support the roof extension but the roof joists may need upgrading to act as a floor structure for the new bedroom and for the balcony area. The new wall panels and roof structure will result in additional load on the site, as will the potential imposed floor loading. Taking into account the size of the extension, maximum additional unfactored site loadings are estimated to be in the order of 100kN permanent dead load and 50kN imposed loading. This loading will be distributed through the existing masonry walls to the foundations and into the ground.

First Floor Extension

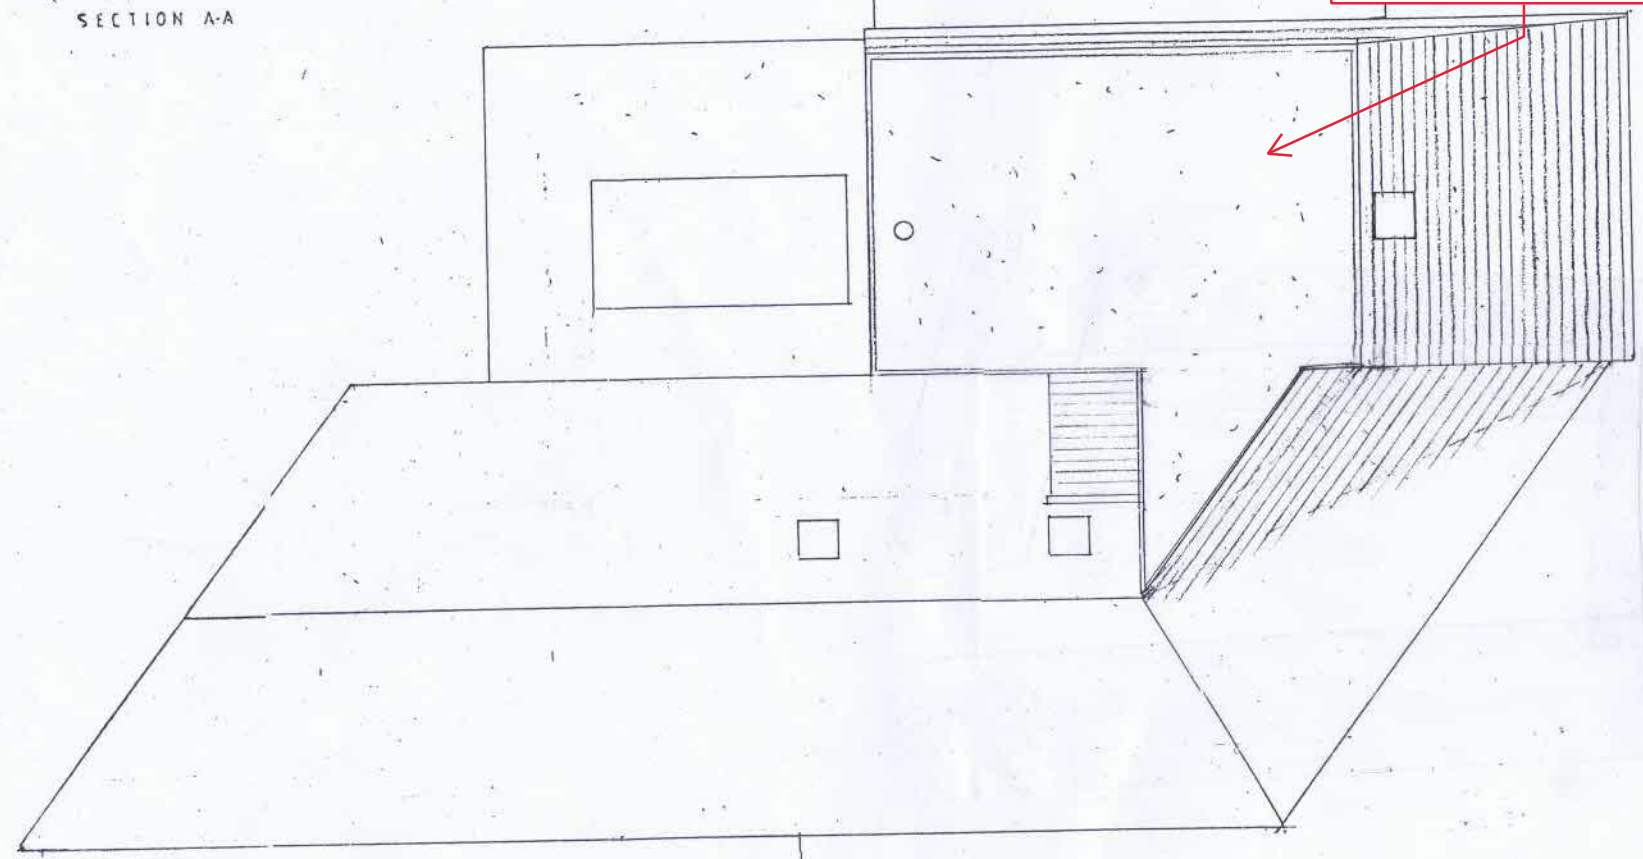
ROOF PLAN

First Floor Extension
