Access Proposals at Maker Heights Maker-with-Rame, Cornwall

Heritage Statement

Client	The Rame Conservation Trust
Report Number	2022R018
Date	20th April 2022
Status	Final
Report author(s)	Charlie Johns BA (Hons), MCIfA
Checked by	Jo Sturgess
Approved by	Andy Jones
Project number	147196
Data location	\\CAU\Live Projects\Maker Heights carpark extension HIA 2022
Planning reference	N/A

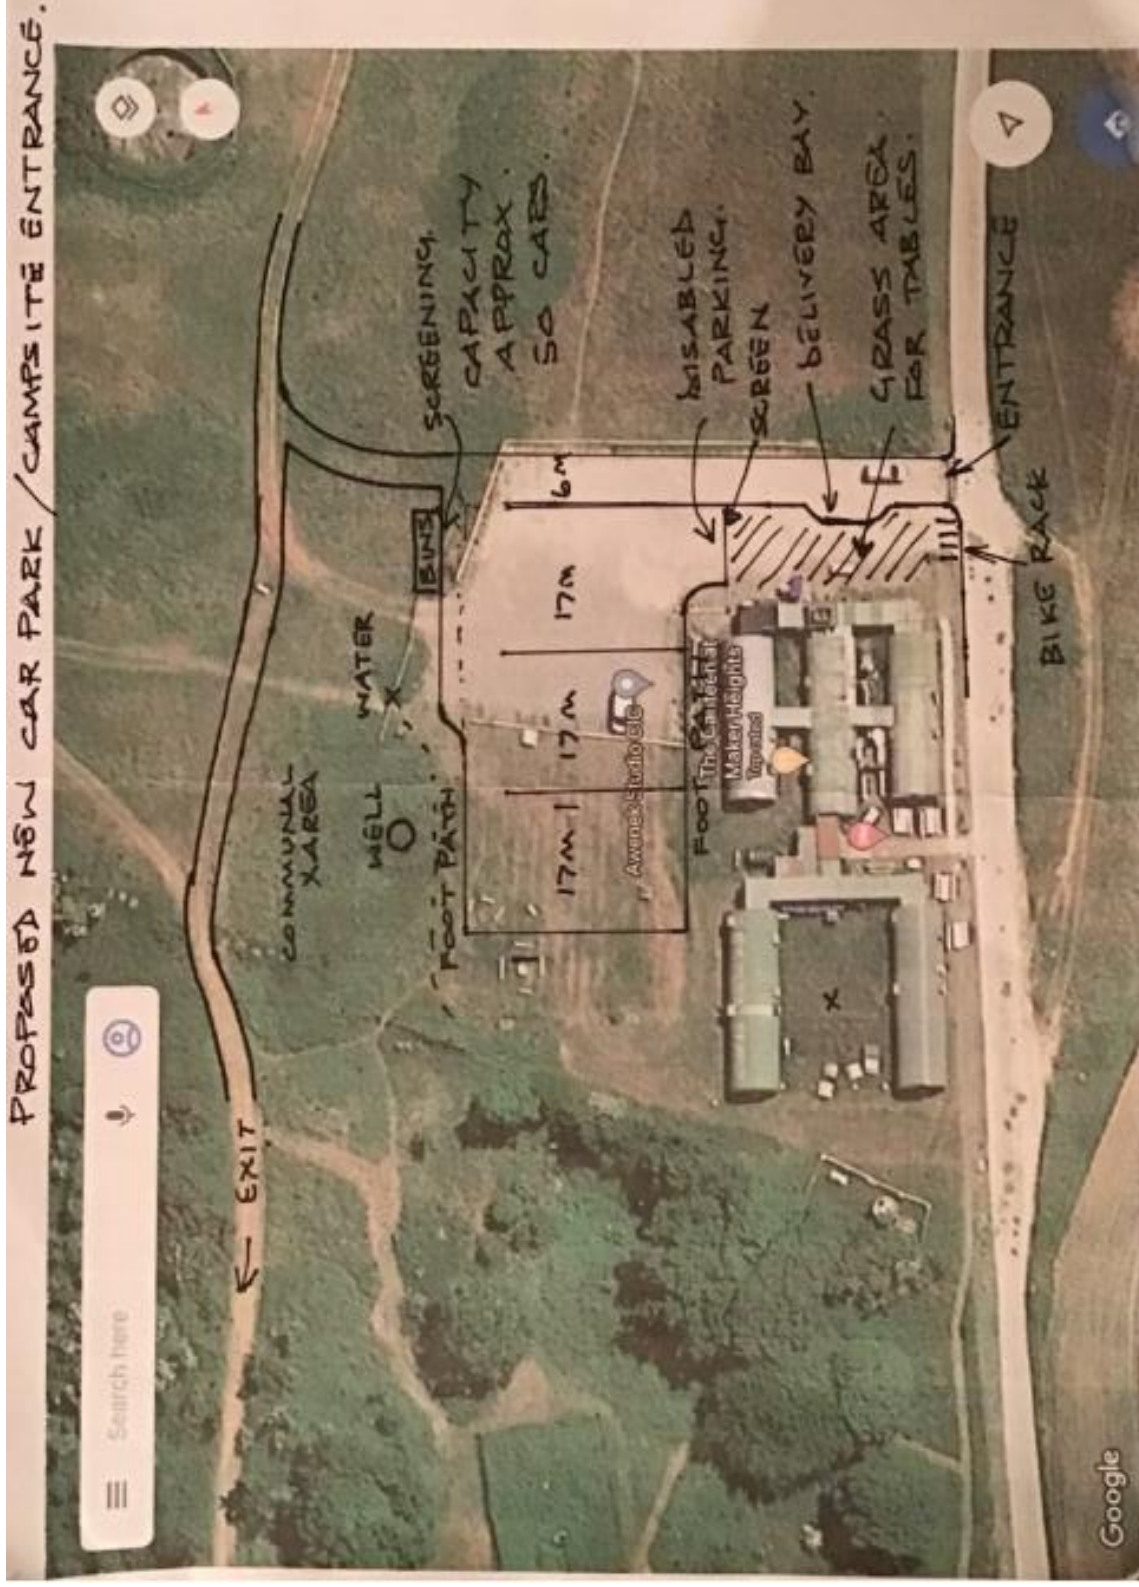
Fig 4 Sketch map of site 1: proposed carpark extension/reconfiguration (RCT).

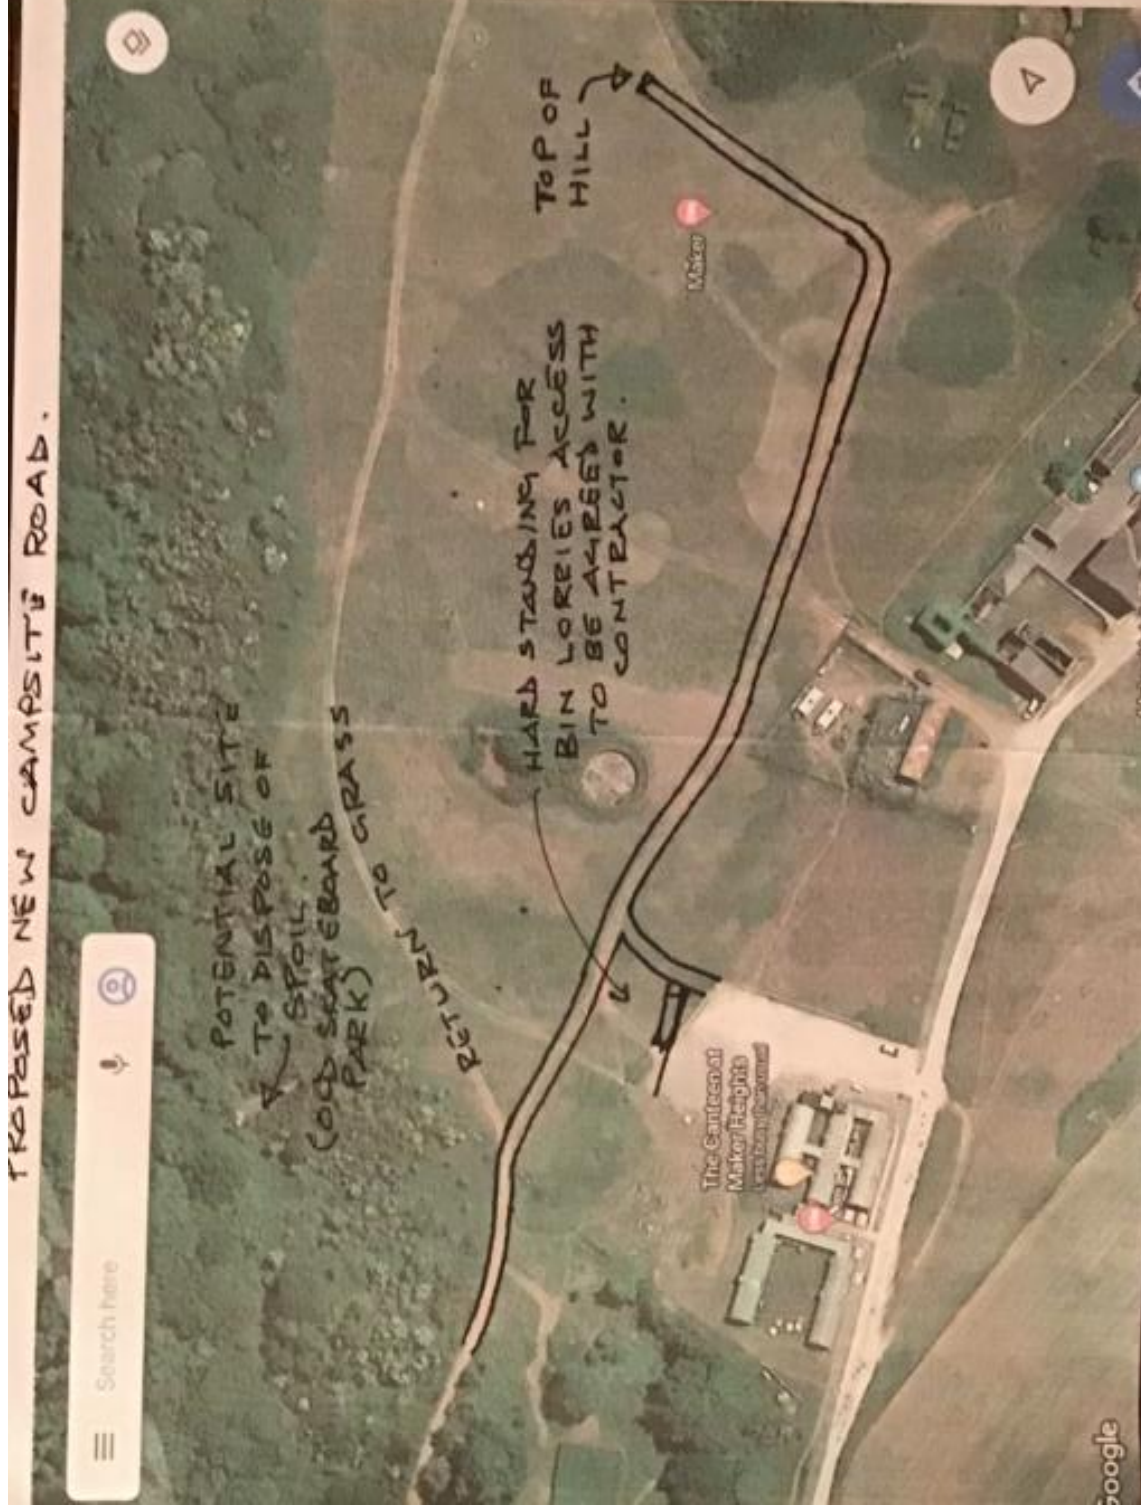
Fig 5 Sketch map of site 2: proposed new campsite road (RCT).

The RCT would like to establish a single route within the campsite for access, in addition to providing an appropriate surface to minimise damage caused by vehicles. This will utilise an existing route, apart from an end section approximately 20m long (Fig 13). It is proposed to place the surfacing for the campsite access directly on to the existing ground surface.

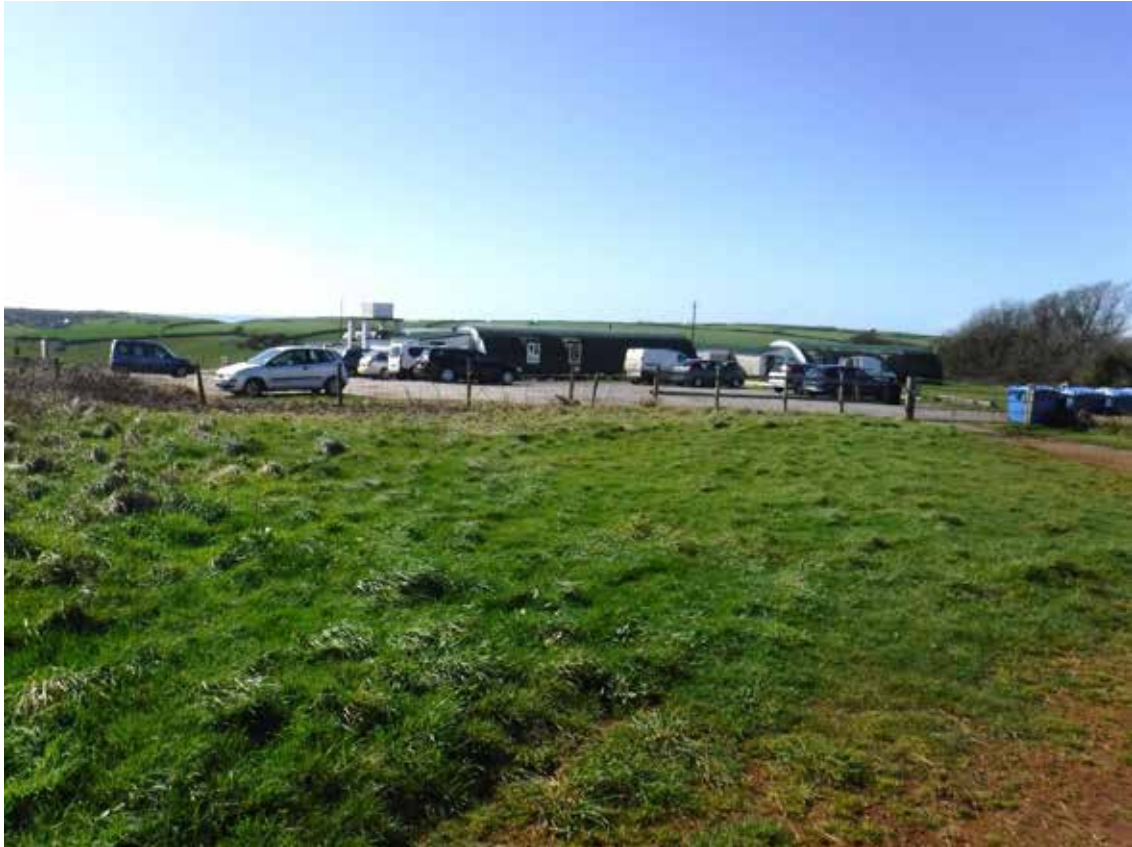
Fig 6 The car park and proposed campsite access route.

The current proposals will contribute to the delivery of the CMP vision by improving the appearance of the car park and campsite access (Fig 6) and thereby enhancing the setting of heritage assets on the site, in particular Redoubt No 1, the WWII anti-aircraft battery and the reconstructed Nissen huts. The proposals will also improve the setting of heritage assets by reducing erosion of vegetation and landscape caused by *ad hoc* parking.

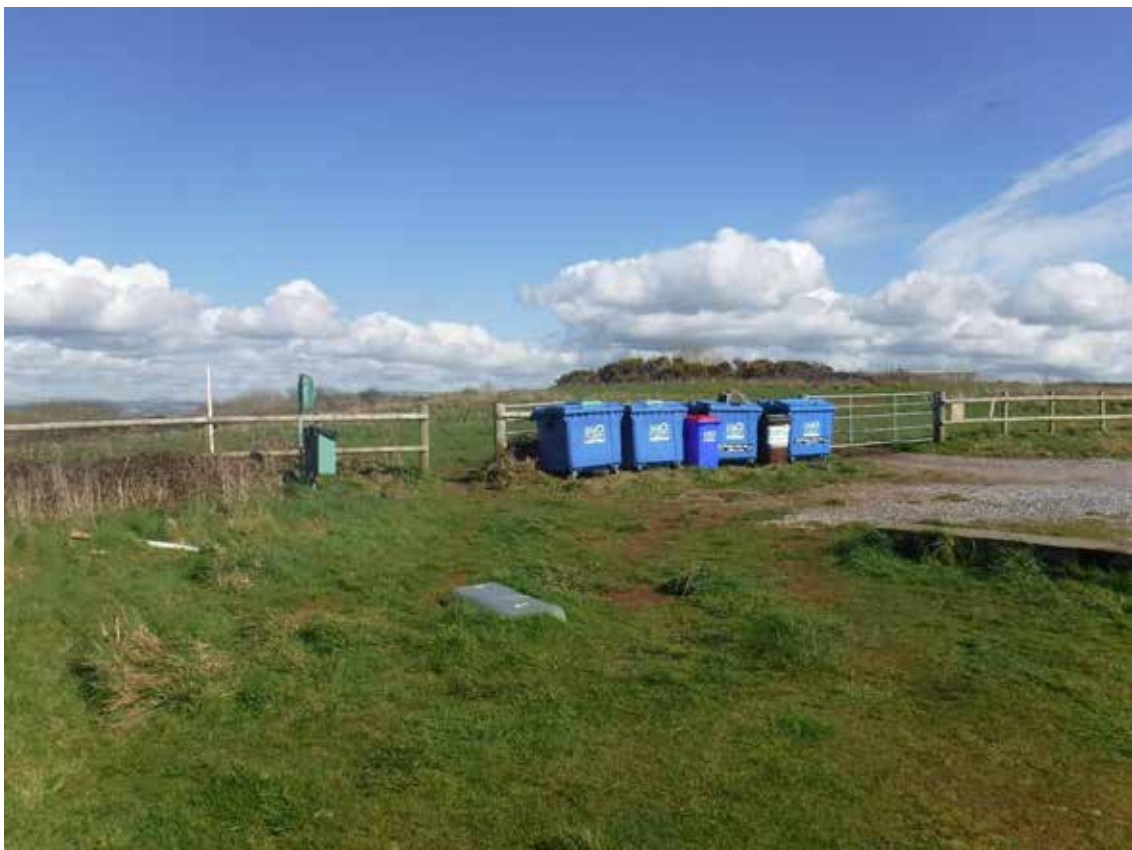
Fig 7 The waste bins at the north edge of the car park.

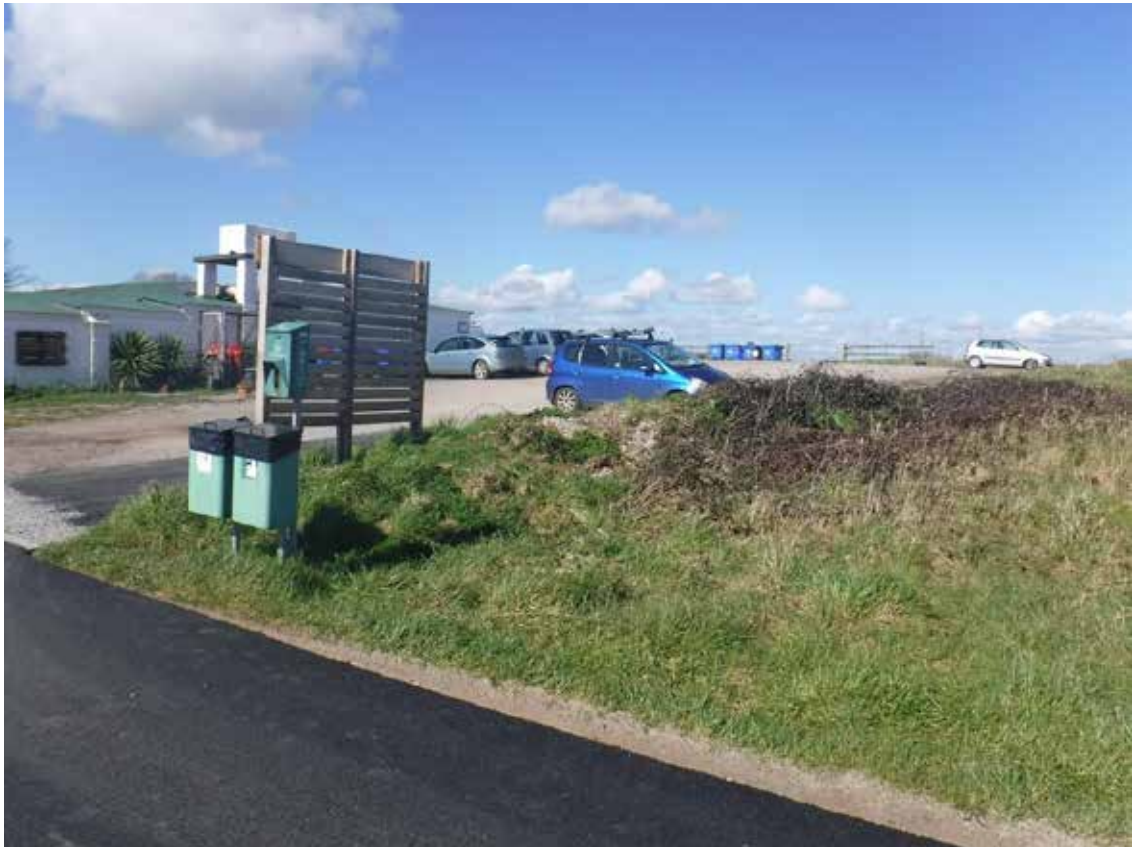
Fig 9 The grassy bund which could be extended along the eastern side of the car park.

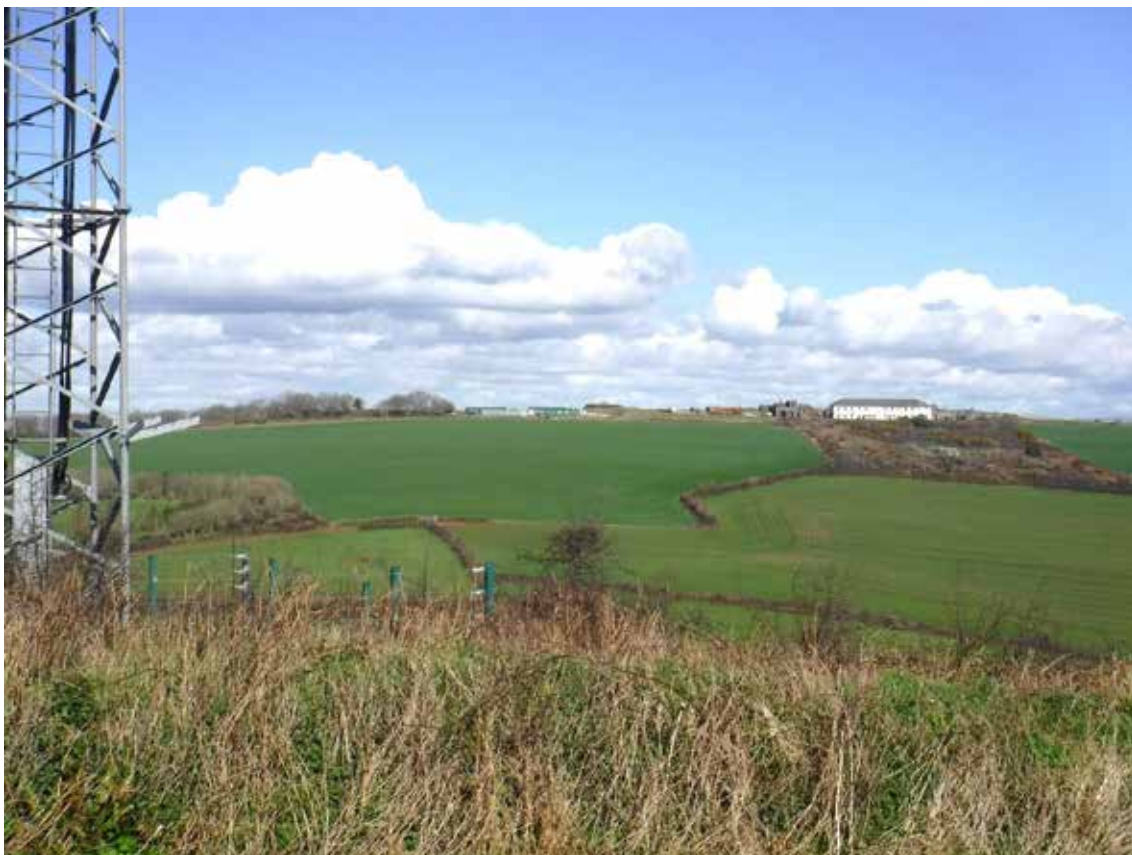
Fig 10 Redoubt No 1 from the western edge of the existing car park.

The eastern side of Redoubt No 1, closest to the car park, is quite overgrown (Fig 10). If this could be cleared and tidied as part of RCT's volunteer programme co it would be a heritage gain which would enhance the appearance and setting of the Redoubt.

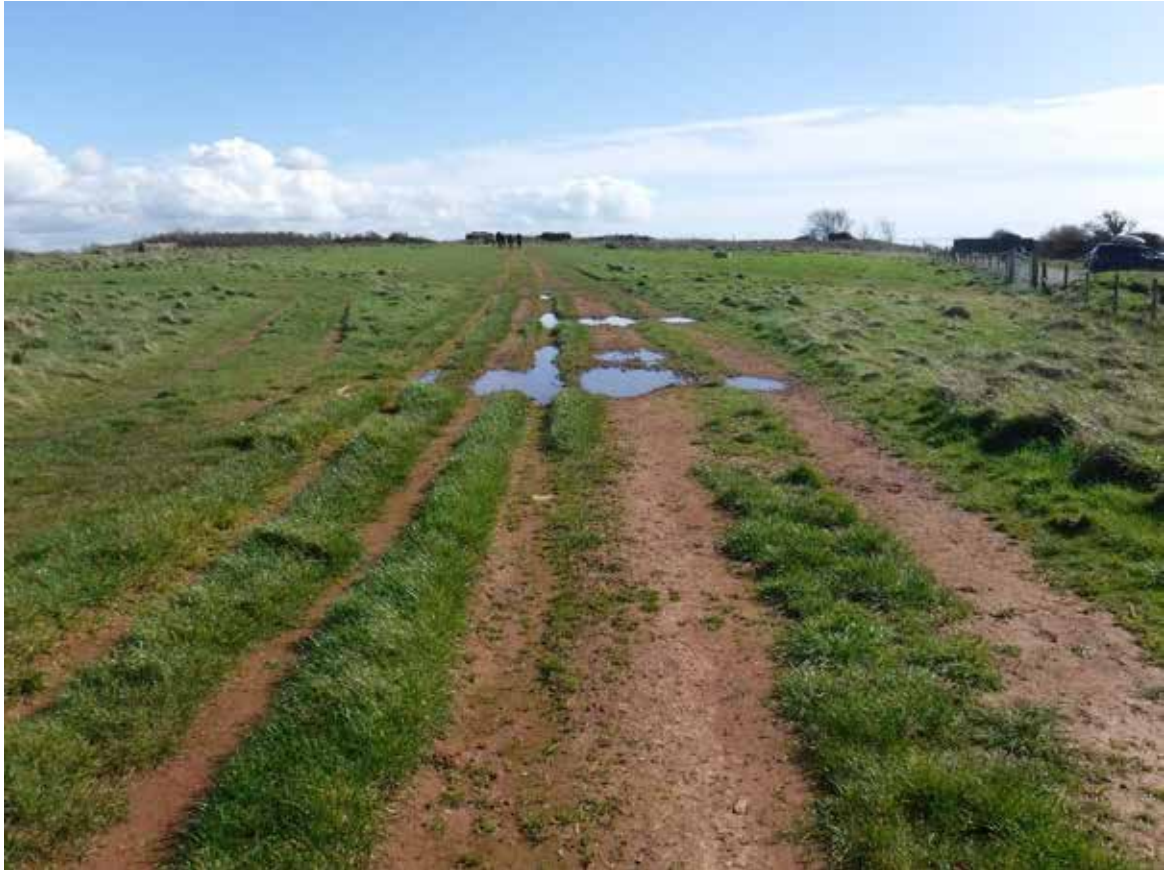
Fig 12 Campsite access route.

Maker Camp uses a circular route for access. During periods of bad weather, it is subject to rutting and erosion, which damages the land and vegetation (Fig 12).

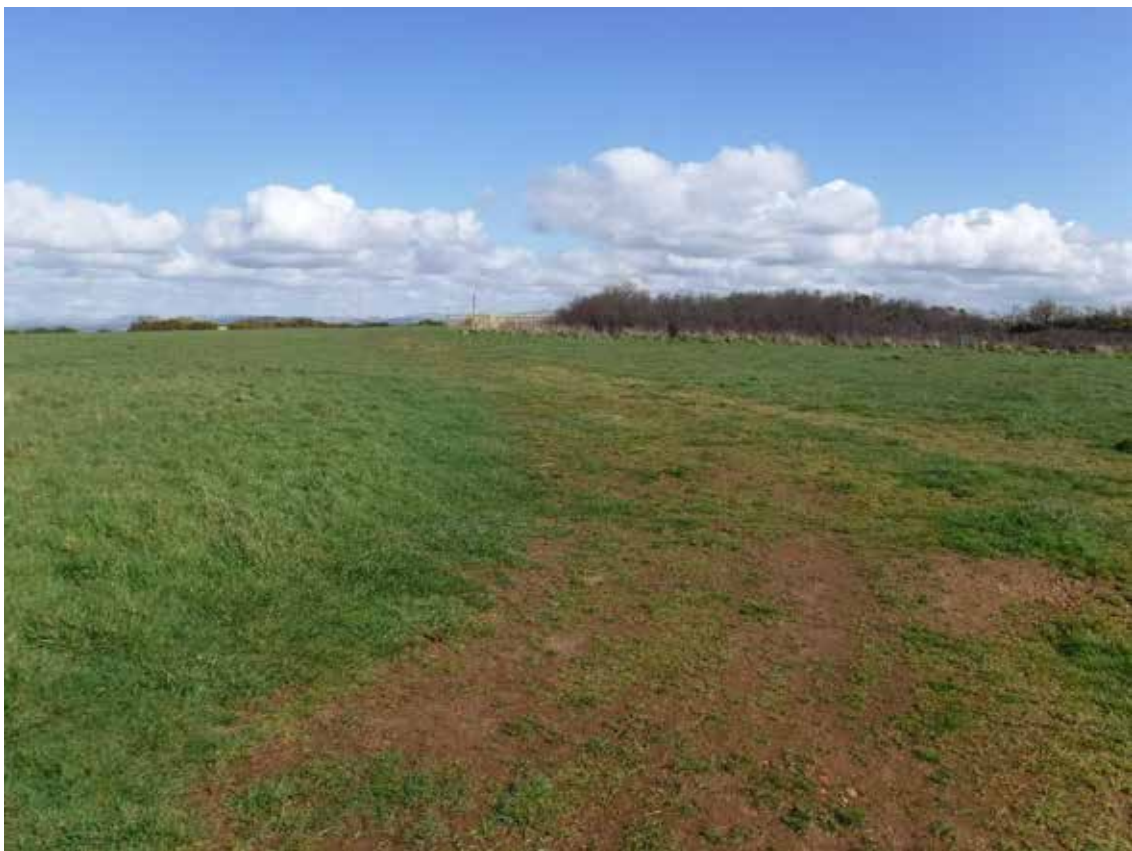
Fig 13 Final 'new' section of the campsite access route.

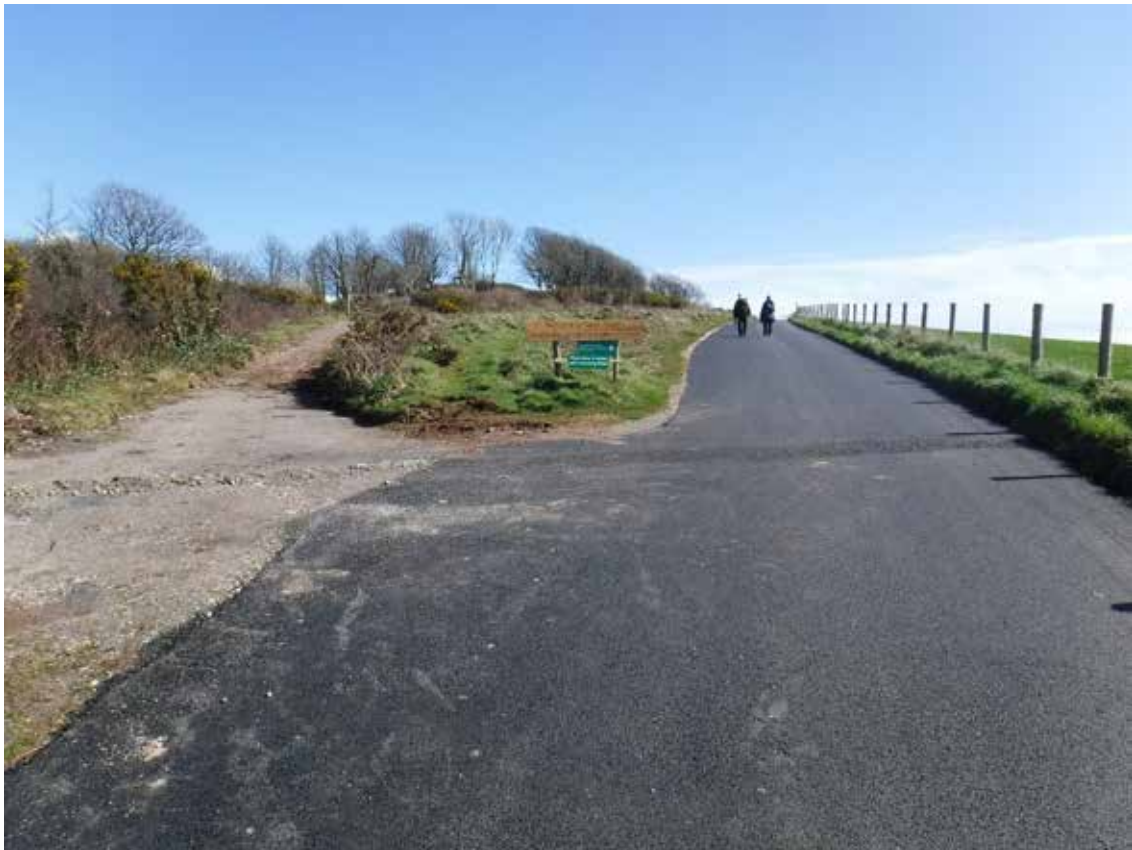
Fig 14 The entrance to Maker Heights. The recently resurfaced Tarmac road on the right will be the route in and the hardcore track on the left the exit.

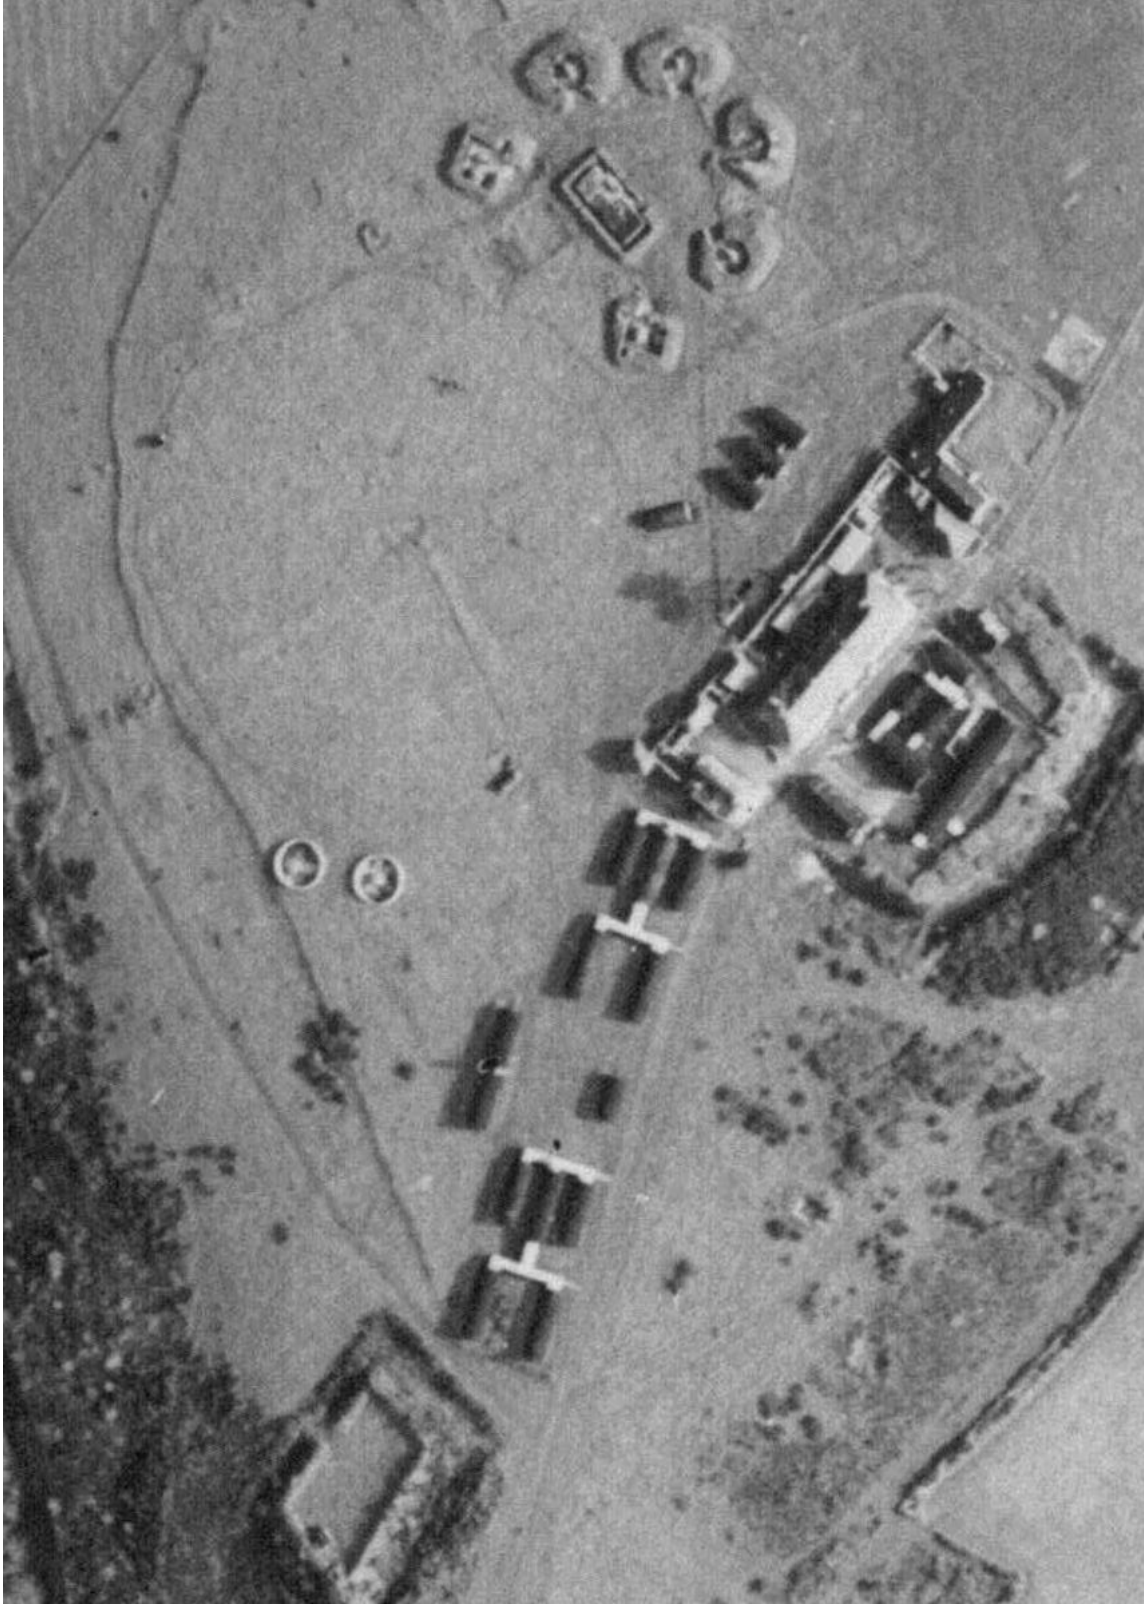
Fig 16 RAF aerial photograph taken in 1946.

The sites of two former Nissen huts lie within the existing car park to the east of the reconstructed huts (Gaz 3a). Within the north west part of the proposed car park extension (site 1) a former defensive bank (Gaz 46) is shown on the 1946 RAF aerial photograph (Fig 16). The date of the former earthwork is uncertain, but it is possibly part of what was called 'The Old Fort' in early references.

The HER records the remains of possible early medieval field systems (Gaz 40) to the north-west and north-east of the heavy anti-aircraft battery; these are visible on 1946 RAF air photos (see Fig 16) and were plotted by the National Mapping Programme (NMP).

octagonal outline on an 1946 aerial photograph (Fig 16). The standard design for the system was an octagonal mat of wire spread over the ground or raised on stilts with a diameter of 65 yards. CAU measured the feature on GIS and it almost exactly fits the measurements, and it was added it as a new gazetteer entry in the CMP.

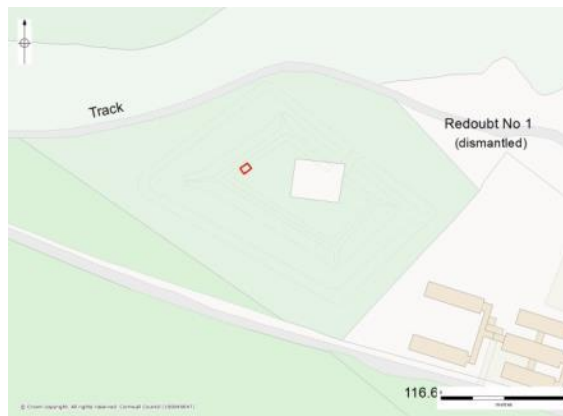
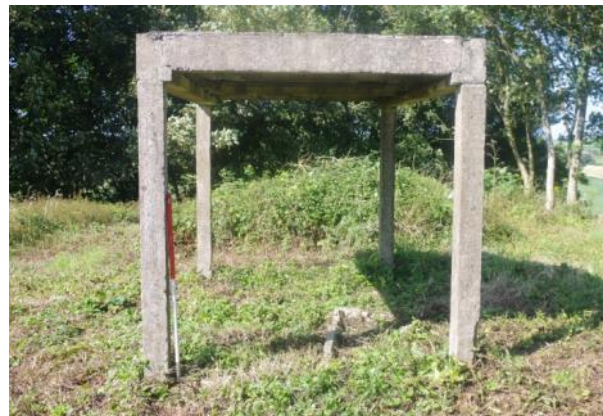
Grid Ref: SX 43262 51530

The elevated concrete platform with four legs survives from the Orlit 'B' post but the pre-fabricated building which would have sat on the platform has been lost as has the ladder which provided access to the building (Oxford Archaeology 2016). The building is constructed of reinforced concrete. The iron rebars within the concrete have begun to decay causing areas of concrete to have been blown from the structure revealing the

Criteria	Value	Notes
Rarity	Moderate	
Period	Cold War c1951-2	
Survival/Condition	Moderate	
Fragility/Vulnerability	High	
Group Value	High	
Amenity Value	Low

Keep clear of vegetation and monitor condition of fabric, including fragments lying on the ground.

If any future repairs are proposed it would be prudent to undertake a historic building record to ensure that the building is fully understood and documented prior to alterations. These works would also inform future interpretation of the site.

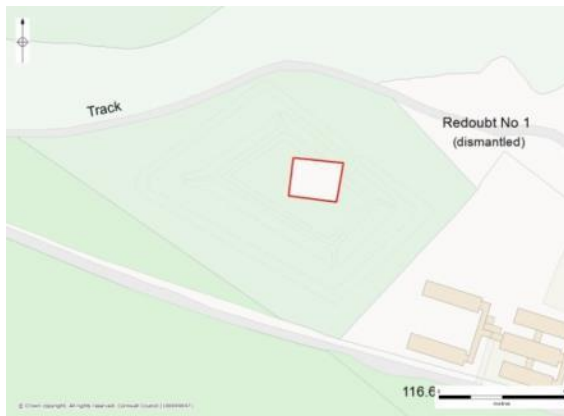
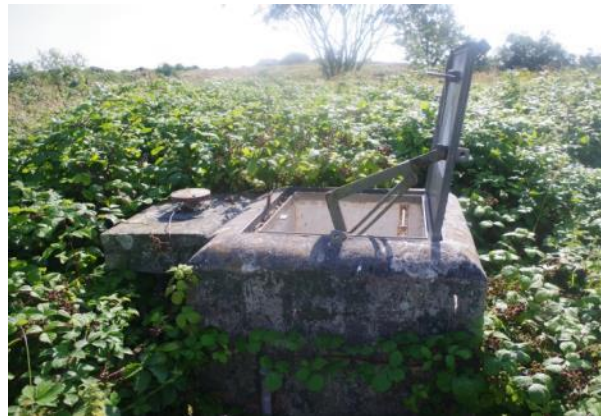
Site Name: Millbrook Post - Cold War Royal Observer Corps Bunker**Gazetteer Number: 1b****Land Parcel: A****Grid Ref: SX 43284 51526**

Period	Cold War c1950s	
Survival/Condition	High	
Fragility/Vulnerability	Unknown	
Group Value	High	
Amenity Value	Moderate	Used for group/special interest visits.

As indicated above the condition of the sunken observation post is uncertain because access has not yet been possible, although photographs from 2000 have been seen and these suggest that the basic condition of the buried shelter is relatively good. The overall structure is relatively robust and protected by the earth covering. The fact that this shelter is buried and locked means that it is no longer threatened by vandalism although internal features have been damaged in the past. The surface features including the vents, access hatch and fence are more vulnerable (Oxford Archaeology 2016). During the present survey it was noted that within the fenced area the site was heavily overgrown with brambles and the access hatch was left open. To limit any further water ingress efforts should be made to keep the access hatch closed.

An assessment of the condition of the site would be beneficial to identify and any repair work.

At the time of visit the access hatch had been left open – shutting this would prevent rain from causing internal damage and prevent people from entering the bunker.

If any future repairs are proposed it would be prudent to undertake a historic building record to ensure that the building is fully understood and documented prior to alterations. These works would also inform future interpretation of the site.

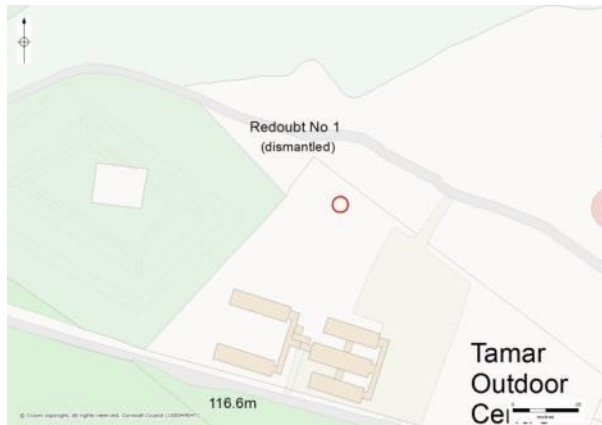
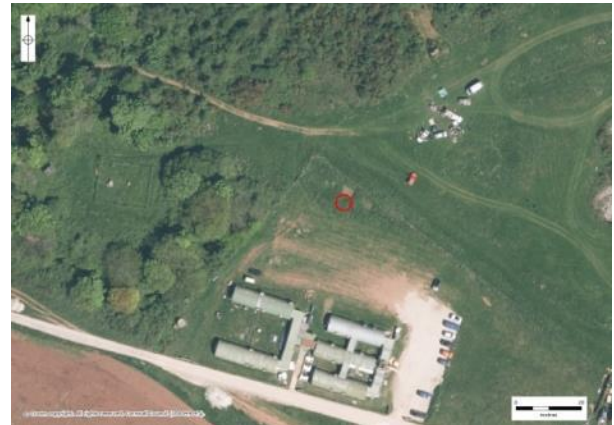
Site Name: Well to the East of Redoubt No 1**Gazetteer Number: 2****Grid Ref: SX 43351 51520**

A well is marked on an OS 6 Inch map published in 1867/9 (maps.nls.uk). The well had a large capstone with a late 18th century inscription. It was used as a fireplace during the last ten years and split. More recently it was damaged by a tractor and is now difficult to find because of overgrown vegetation.

Maintain in current condition.

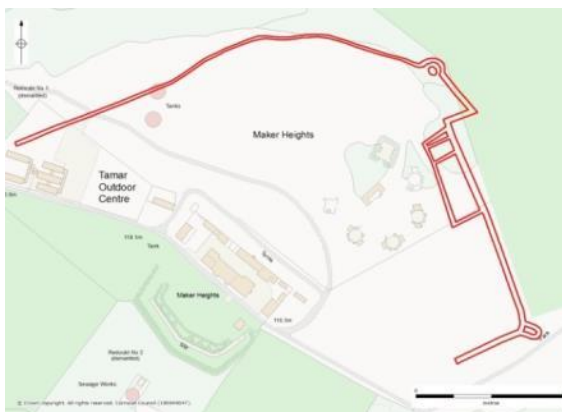
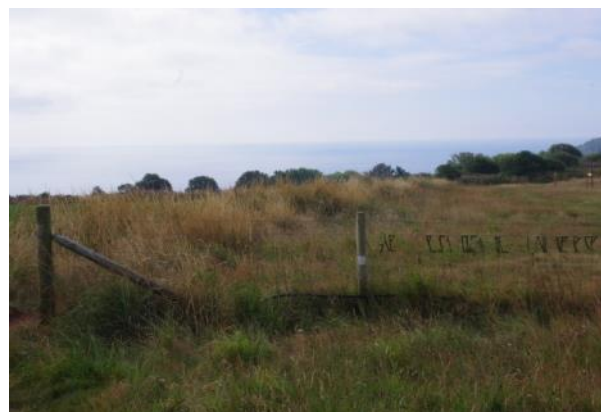
Gazetteer Number: 46

Criteria	Value	Notes
Rarity	Low	
Period	Unknown	
Survival/Condition	Moderate	
Fragility/Vulnerability	Low	
Group Value	Moderate	
Amenity Value	Low

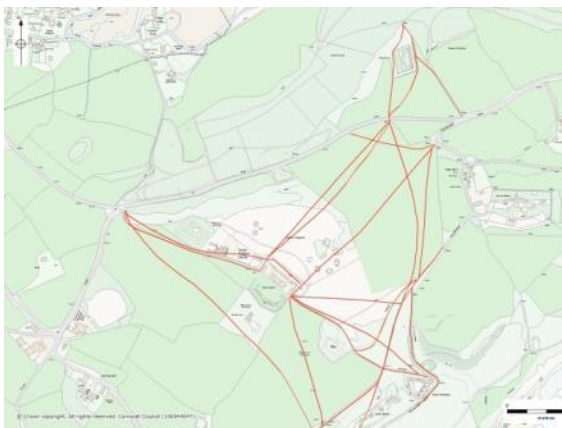
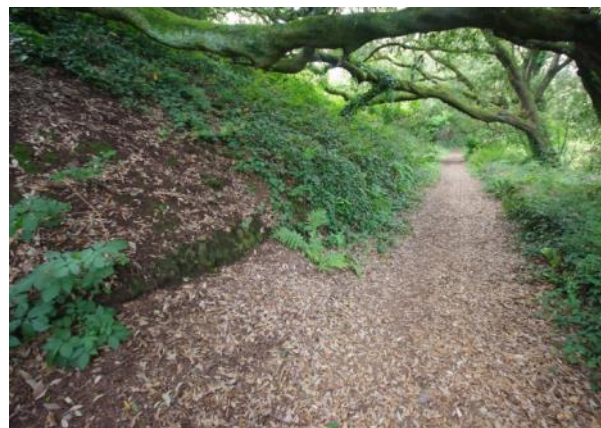
Site Name: Historic Paths and Tracks**Gazetteer Number: 58****Grid Ref: SX 43526 51355**

Criteria	Value	Notes
Rarity	Low	
Period	Multi-period	
Survival/Condition	Good	
Fragility/Vulnerability	Low	
Group Value	High	
Amenity Value	High	The paths are used by walkers.

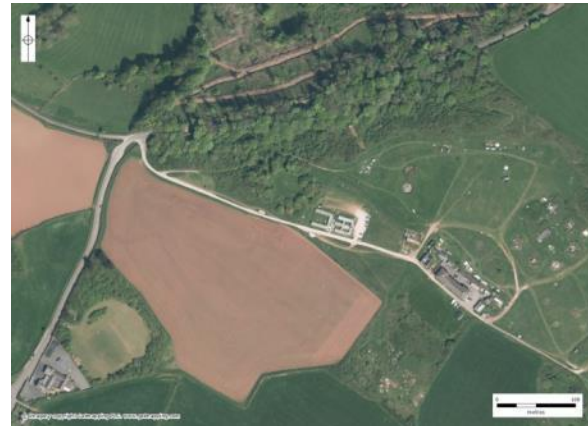
Site Name: Entrance Road**Gazetteer Number: 58a****Grid Ref: SX 43526 51355**

The road is in a poor state of repair and appears to be constructed from crushed stone hard core and has some concrete, gravel/tarmac additions. It leads from the main road junction on the Millbrook side of the site to the west, up to the barracks block and beyond.

Criteria	Value	Notes
Rarity	Low	
Period	Mid-19th century	
Survival/Condition	Moderate	
Fragility/Vulnerability	Moderate	
Group Value	High	
Amenity Value	High	The paths are used by walkers.

The condition of the road surface is poor and there is a danger of it encroaching onto Redoubt No 1.

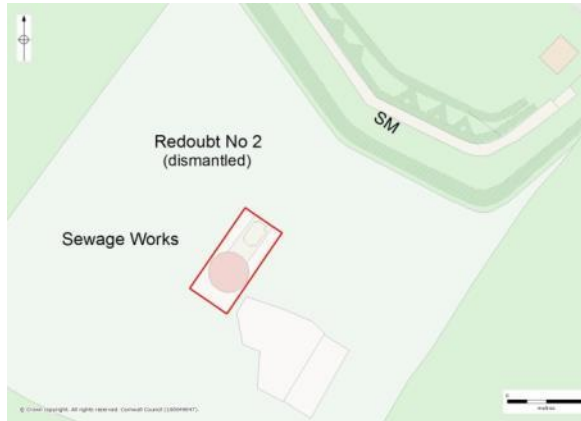
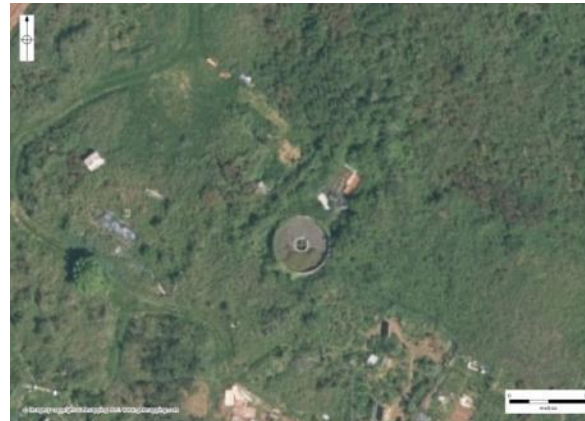
Gazetteer Number: 59

Criteria	Value	Notes
Rarity	Moderate	
Period	WWII	
Survival/Condition	Unknown	The site was not accessed.
Fragility/Vulnerability	Moderate	
Group Value	Moderate	
Amenity Value	High	The works are still in use so provide a fundamental amenity to Maker Heights.

Repairs are required to update the sewerage works.

Repair and retain the structure as far as possible.

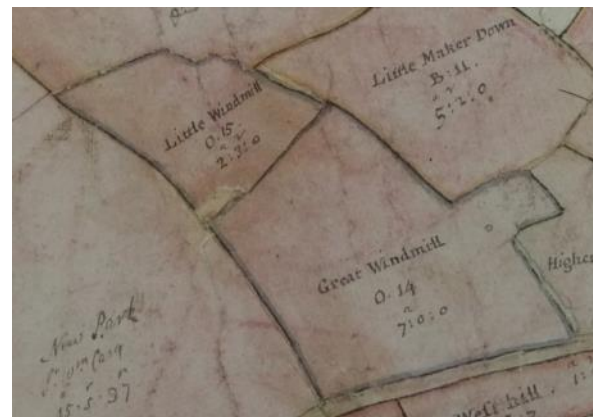
Gazetteer Number: 60

Criteria	Value	Notes
Rarity	Moderate	
Period	Post-medieval	
Survival/Condition	Unknown	The site is not visible on the surface.
Fragility/Vulnerability	Low	
Group Value	Moderate	
Amenity Value	Low
