Client Conrad Energy Limited				
Project Synchronous Condenser, Yaxley S73 Application (Single Condenser)				
Drawing Title Landscape Mitigation - Soft Works				
Created by CL	Reviewer NR	Sheet Size A3	Scale 1:1000	Date Created 30.01.24
Drawing Nr. 059-12-01(S73)				Revision C
DRaW (UK) Ltd Morwick Hall York Road Leeds LS15 4TA t: 0113 8232871 www.draw-ltd.com

Project
**Synchronous Condensers, Yaxley
Application DC/22/04021 - Condition 12**

Drawing Title
Reinstatement of Temporary Access Track

Drawing Nr.
059-12-05

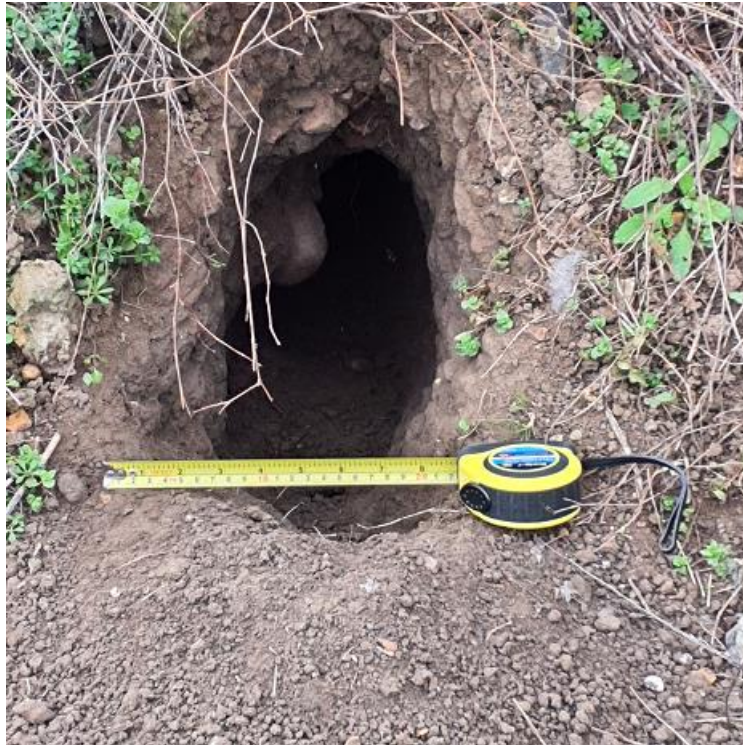
Photo 23. Burrow entrance in the east side of a soil bund beside the access road NW of the area of allotments.

A large burrow in the side of a soil bund to the east of the access road is characteristic of Fox (Photo 23), and Fox scats were also observed near the junction of the road with the loop hardstanding. Mammal trails consistent with Fox were also seen in long grass entering hedge-lined ditches just north of pond F (Photo 24) and along the west boundary of the main development area, and a single footprint was observed in the cleared area south of the access road. No evidence of the presence of Badger was observed at any point during either survey.

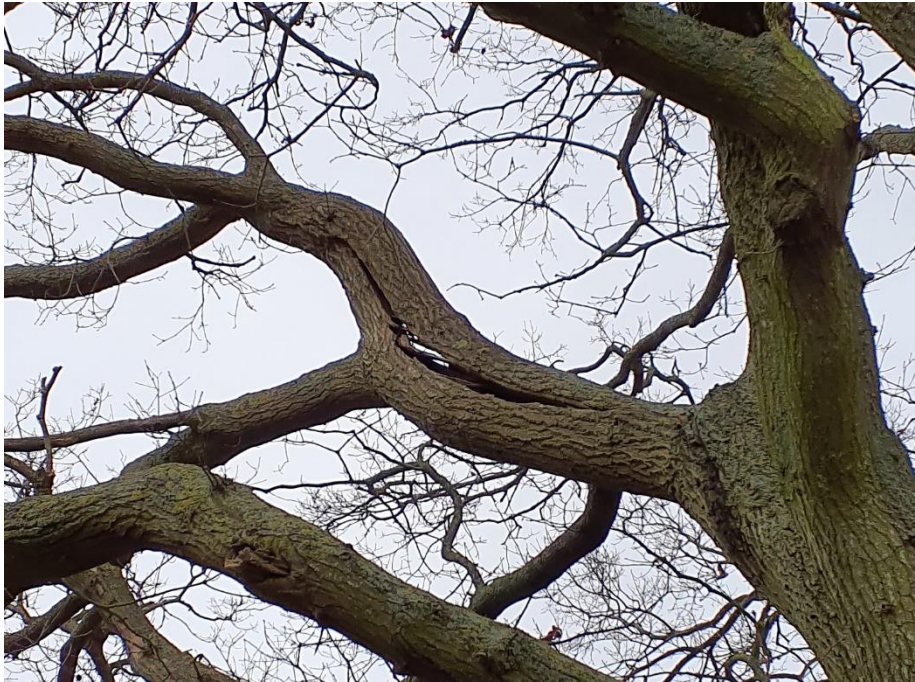
Photo 25. Hazard beam in hedgerow Oak along southern boundary of main development site, February 2023.

Hedgerow trees surrounding the main development plot were inspected for potential bat roost features during the February 2023 survey, but the only features observed were in two mature oaks near the SW corner of the main development site, one of which featured a hazard beam (Photo 25) and the other a major branch pull-out (Photo 26).

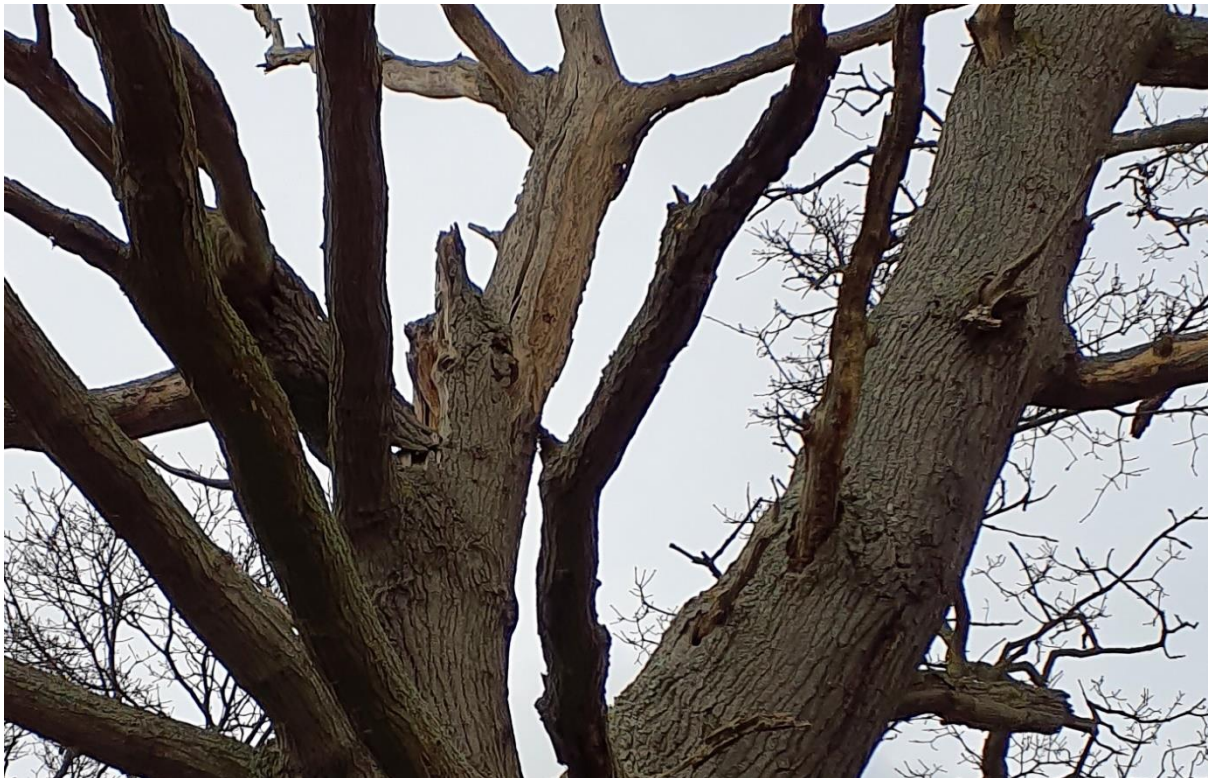
Photo 26. Branch pull-out, hedgerow Oak along southern boundary of main development site, February 2023.
