# **UPDATED BAT SURVEY REPORT**

**Old School House, The Street, Ash, Sandwich, Kent**

**4<sup>th</sup> August 2023**

Updated survey to inform licensing.

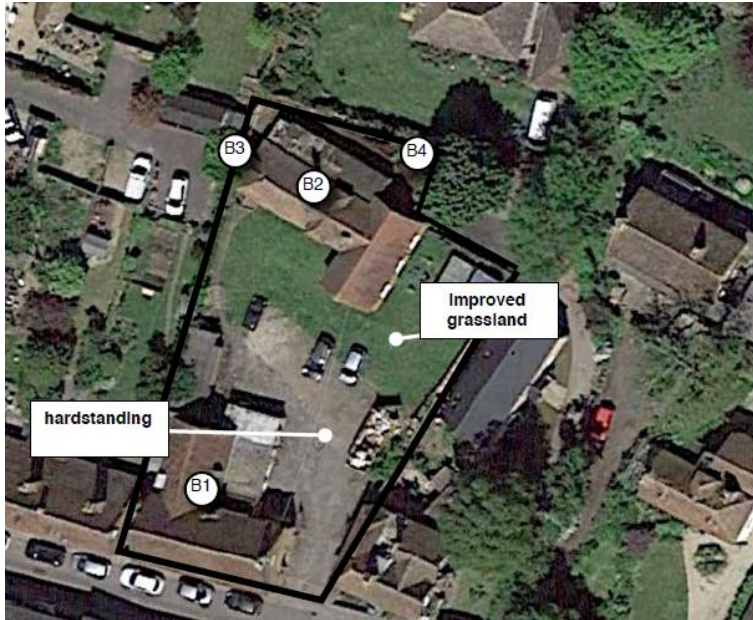
Figure 1 – Site plan, showing the buildings referred to in the text (Taken from Calumma, 2020).

Building 1 at the south/roadside of the site is of brick construction with a clay tile roof. There are no roof voids present, and the roof is lined with timber sarking. The building has potential for crevice dwelling bat species such as pipistrelles. There is limited potential for hibernating bats.

Building 2 at the north of the site is of brick construction with a clay tile roof. A small inaccessible roof void is present on the eastern section, and the western section is open to the roof with no void. The building has potential for crevice dwelling bat species such as pipistrelles. There is limited potential for hibernating bats.

Buildings 3 and 4, small brick outbuildings, were assessed to be of negligible suitability for roosting bats.

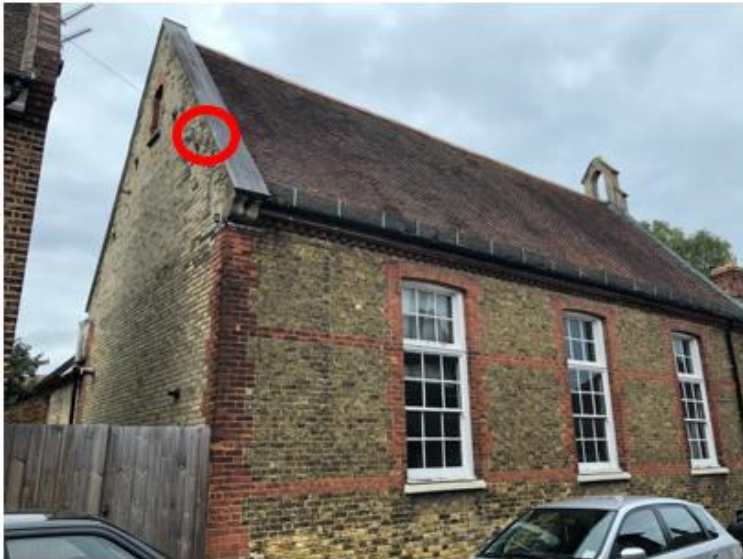
At 21:35 a single common pipistrelle was recorded emerging from a gap in the masonry in the south western gable end of Building 1. A moderate level of activity was recorded throughout the survey. Activity was dominated by a single foraging common pipistrelle within the site, with occasional serotine, noctule and a single myotis sp. passes.

- 1 x common pipistrelle day roost in a gap in the mortar at the south western gable end. **This feature will be retained. There will be limited disturbance to a single bat.**
- 1 x common pipistrelle day roost under the fascia at the apex of the northern gable end. **This is likely to be destroyed during re-roofing work.**

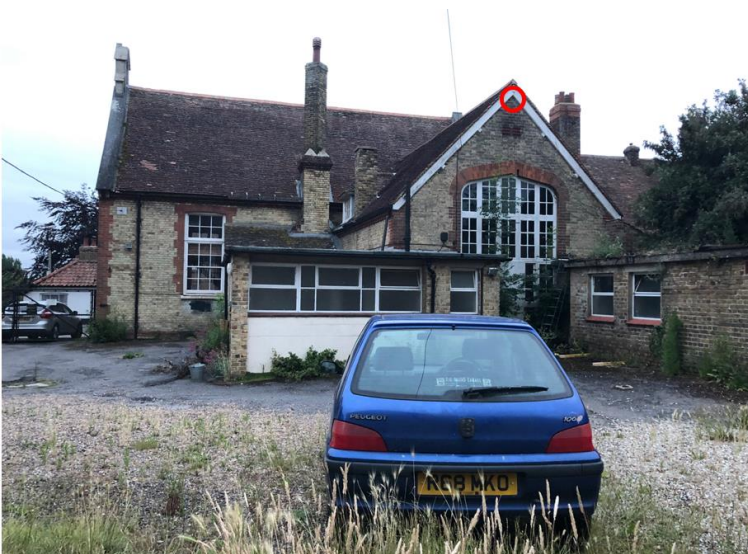
At 21:05, a single common pipistrelle was recorded emerging from the apex of the north facing gable end of Building 1. A moderate level of activity was recorded throughout the survey. Activity was dominated by a single foraging common pipistrelle within the site, with a single brown long eared bat pass.

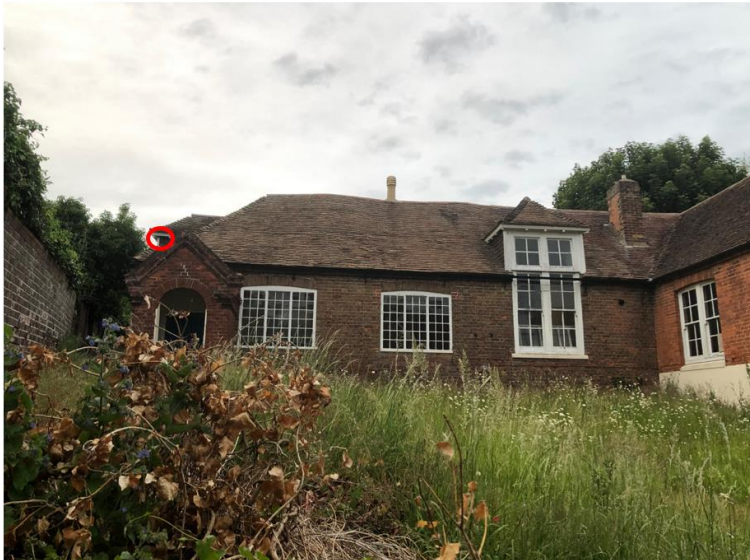
At 21:11 a single common pipistrelle emerged from the south western porch area of B2.

- 1 x common pipistrelle day roost in the south western porch area. **This feature will be destroyed during re-roofing work.**
