Design and Access Statement

Replacement roof coverings at

24 Middle Street

Listed Building Consent for replacement of the existing
roof coverings

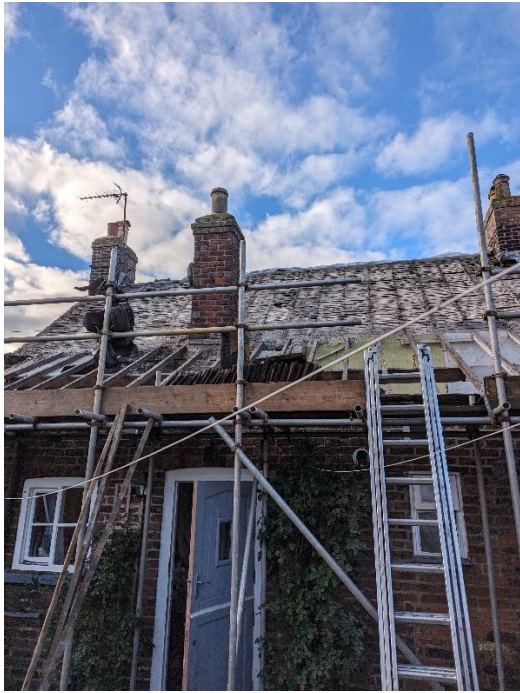
External appearance of the rear roof slope after stripping off roof tiles and roofing felt, to expose the existing pargetting and original tiling lathes, all of which have been retained during the course of the works.

4.6 All of the defective roof coverings have been removed and also the underlying rotten roofing felt. The existing roof structure was thereby exposed and found to be in good order whereby new tiling lathes were secured through breathable waterproof sarking felt onto the existing rafters beneath. The whole of the roof surfaces to the front and rear elevations were then finished with red clay pantiles to achieve the desired external appearance pertinent to the area and to render the dwelling waterproof.

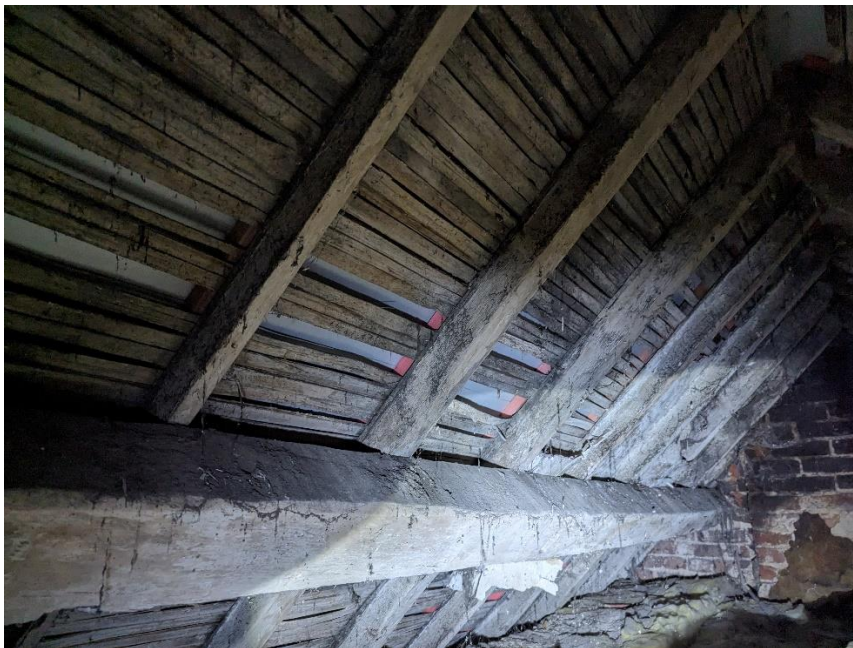
Internal photo of the front roof slope which shows the retention of the existing tiling lathes and original roof construction.

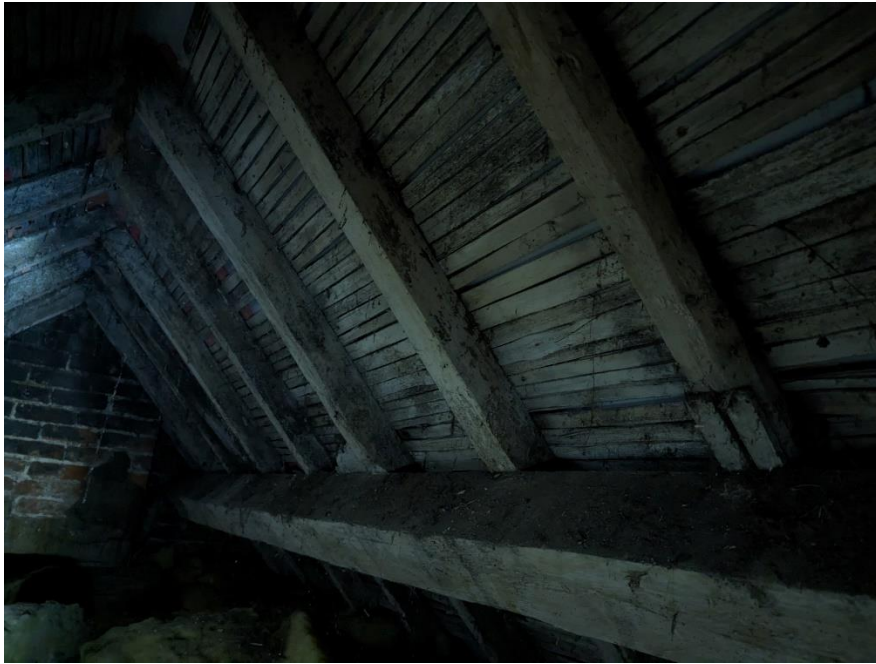
Internal photo of the rear roof slope which shows the retention of the existing tiling lathes and original roof construction.
