Client: Commercial Development Projects Ltd	Project No: CD/30	Sheet 1 of 2
Project: Wiko Ridge Farm, Leeds	Calc By: JP	Date: 23/10/23
Element: Foundation Excavation Pit	Chkd By:	Date:

METHOD STATEMENT FOR ASSESSMENT OF IMPORTED SOILS

AT
WIKE RIDGE FARM
LEEDS

CLIENT: COMMERCIAL DEVELOPMENT PROJECTS LTD
 JOB NUMBER: CDP/30
 PROJECT: WIKE RIDGE FARM, LEEDS
 REPORT TYPE: METHOD STATEMENT FOR ASSESSMENT OF IMPORTED SOILS
 REPORT REFERENCE: CDP/30imple

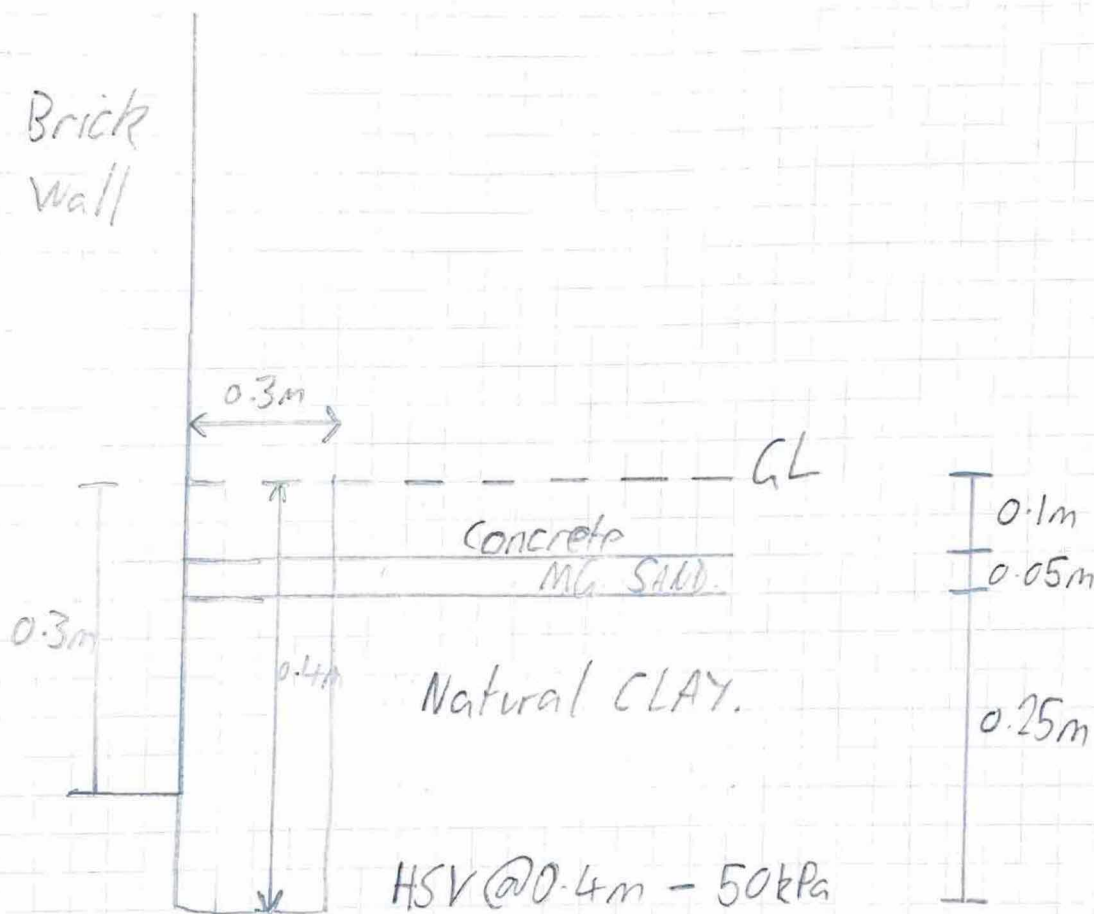
HP01

GL - 0.1m - Concrete

0.1m - 0.15m - Bedding SAND - Orangish brown, fine to coarse SAND.

0.15m - 0.4m - Firm, slightly gravelly, slightly sandy CLAY. Gravel is subangular to subrounded, fine to coarse, of sandstone.

- Base of foundation reached at 0.3m, with natural clay moved beneath.

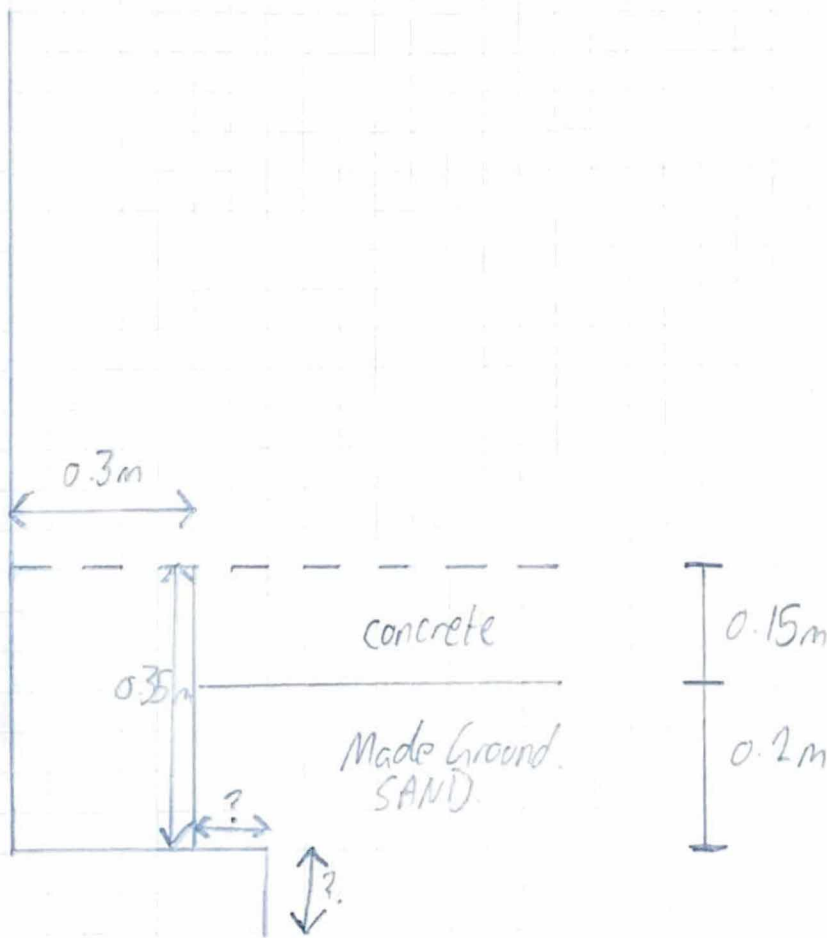
HPO2

GL - 0.15m - Concrete

0.15m - 0.35m - MADE GROUND: Light brown gravelly, silt to coarse sand. Gravel is subangular to subrounded, silt to coarse, org sandstone and concrete.
Hand Vines not possible.

0.35m - Concrete - Foundation Steps out.
