STAGE 2 GEO-ENVIRONMENTAL REPORT

WIKE RIDGE FARM
LEEDS

COMMERCIAL
DEVELOPMENT
PROJECTS LTD

CLIENT: COMMERCIAL DEVELOPMENT PROJECTS LTD
 JOB NUMBER: CDP/30
 PROJECT: WIKE RIDGE FARM, LEEDS
 REPORT TYPE: STAGE 2 GEO-ENVIRONMENTAL REPORT
 REPORT REFERENCE: CDP/30r2le

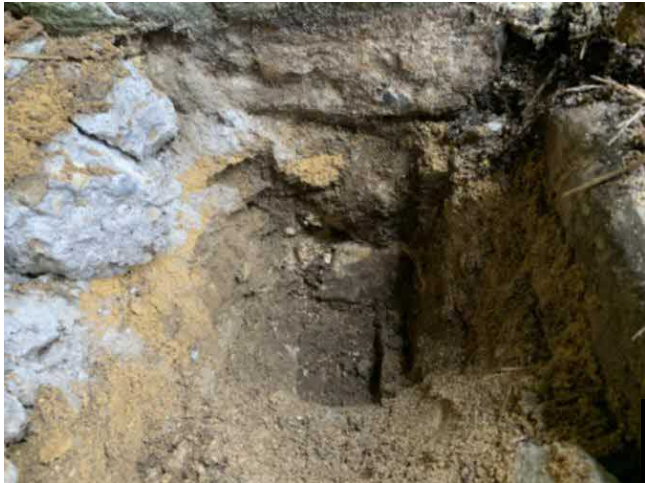
Depth (m)	Sample / Tests	Water Depth (m)	Field Records	Level (mOD)	Depth (m) (Thickness)	Description	Legend
0.20-0.40	ES1		Concrete foundations extend to 0.3m.		(0.10)	MADE GROUND: Concrete.	
					0.10	MADE GROUND: Orangish brown, fine to coarse SAND.	
0.40	HSV 50kPa				(0.25)	Firm brown, slightly gravelly, slightly sandy CLAY. Gravel is subangular to subrounded, fine to coarse, of sandstone.	
					0.40	Complete at 0.40m

Base of foundations reached.
 No groundwater ingress encountered.
 Backfilled with arisings upon completion.

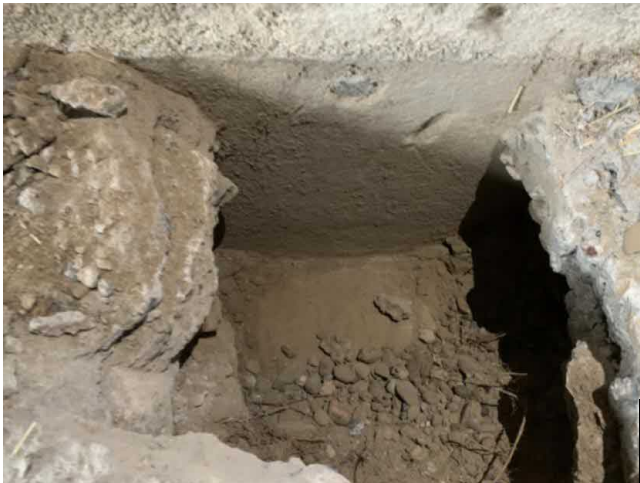
Scale (approx) 1:20	Logged By JP	Figure No. CDP/30.HP02
-------------------------------	------------------------	----------------------------------

Depth (m)	Sample / Tests	Water Depth (m)	Field Records	Level (mOD)	Depth (m) (Thickness)	Description	Legend
0.20-0.30	ES1				0.15	MADE GROUND: Concrete.	
					0.20	MADE GROUND: Light brown gravelly, fine to coarse SAND. Gravel is subangular to rounded, fine to coarse, of sandstone and concrete.	
					0.35	MADE GROUND: Concrete foundation.	
					0.35	Complete at 0.35m

Pit terminated due to concrete foundation stepping out.
 No groundwater ingress encountered.
 Backfilled with arisings upon completion.

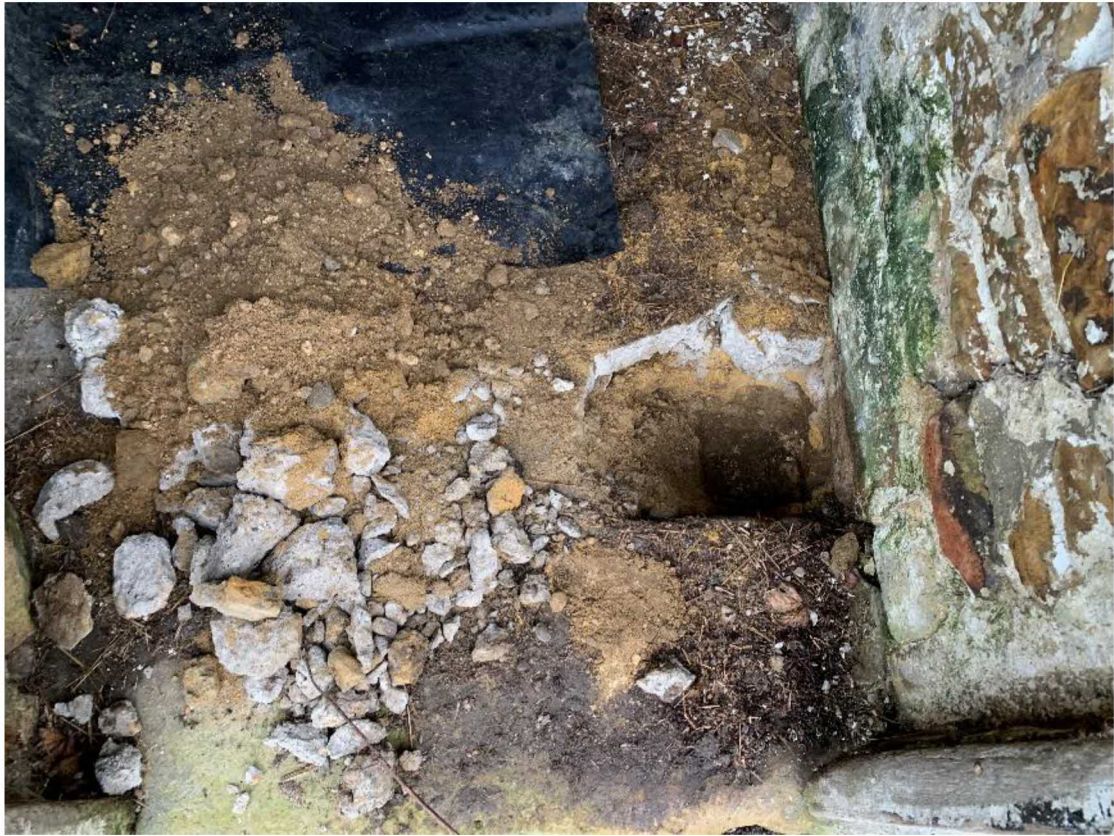
Photo 1: 23-10-2023 General view of the foundation pit in the small barn to the south west of the site (HP01).

- 6.5 The foundation of the single storey stable along the western edge of the courtyard was exposed in HP1. The foundation comprised sandstone blocks down to 0.3m depth, founded on firm

brown clay. A hand shear vane test within the clay recorded an undrained shear strength of 50kN/m² indicating firm (medium strength).

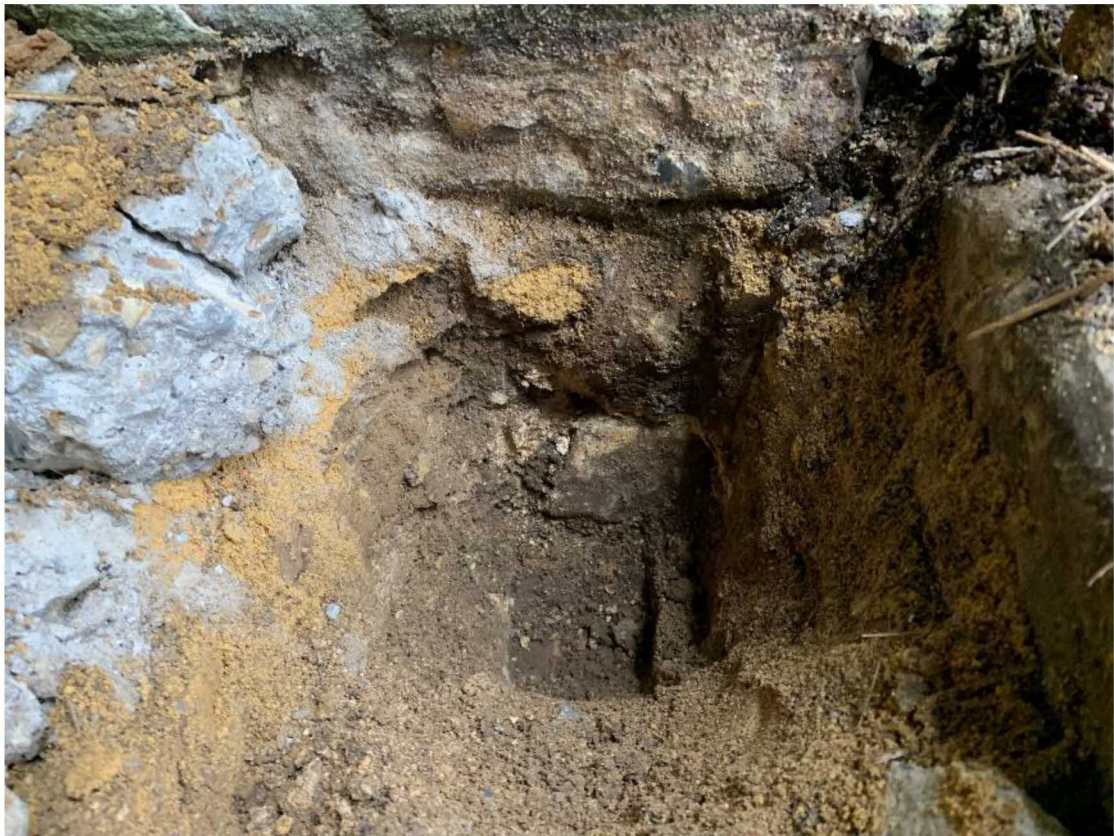
Photo 2: 23-10-2023 Closer view of HP01.

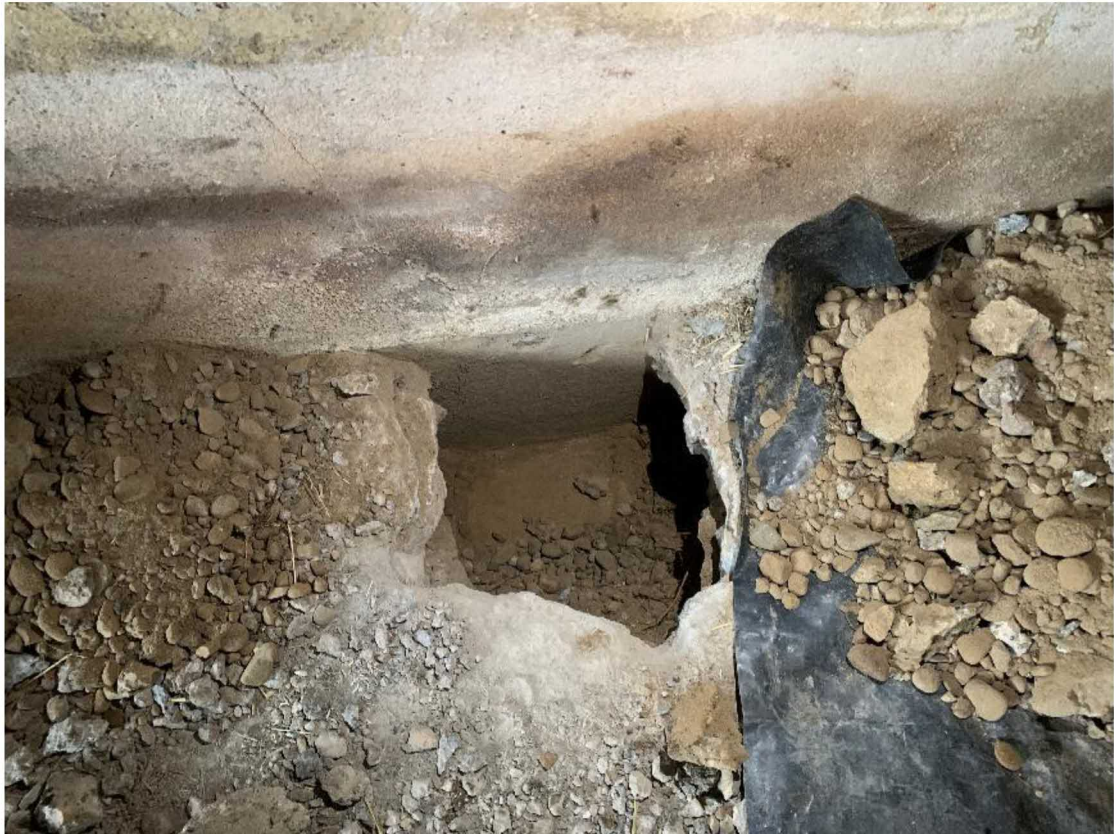
Photo 3: 23-10-2023 General view of the foundation pit in the larger building to the north east of the site (HP02).

- 6.6 The foundation of the two-storey barn along the northern edge of the courtyard was partially exposed in HP2. The surface of a concrete foundation was encountered at to 0.35m depth stepping out at least 0.5m beyond the area of floor slab that had been broken out. Due to the thickness of the floor slab, it was not possible to extend the pit further to confirm the dimensions of the foundation within the time constraints of the site works. Based on the ground conditions identified within nearby window samples, WS1 and WS7, it is likely that the foundations are seated on firm clay, with intact bedrock present at shallow depth at both locations (<1m depth).

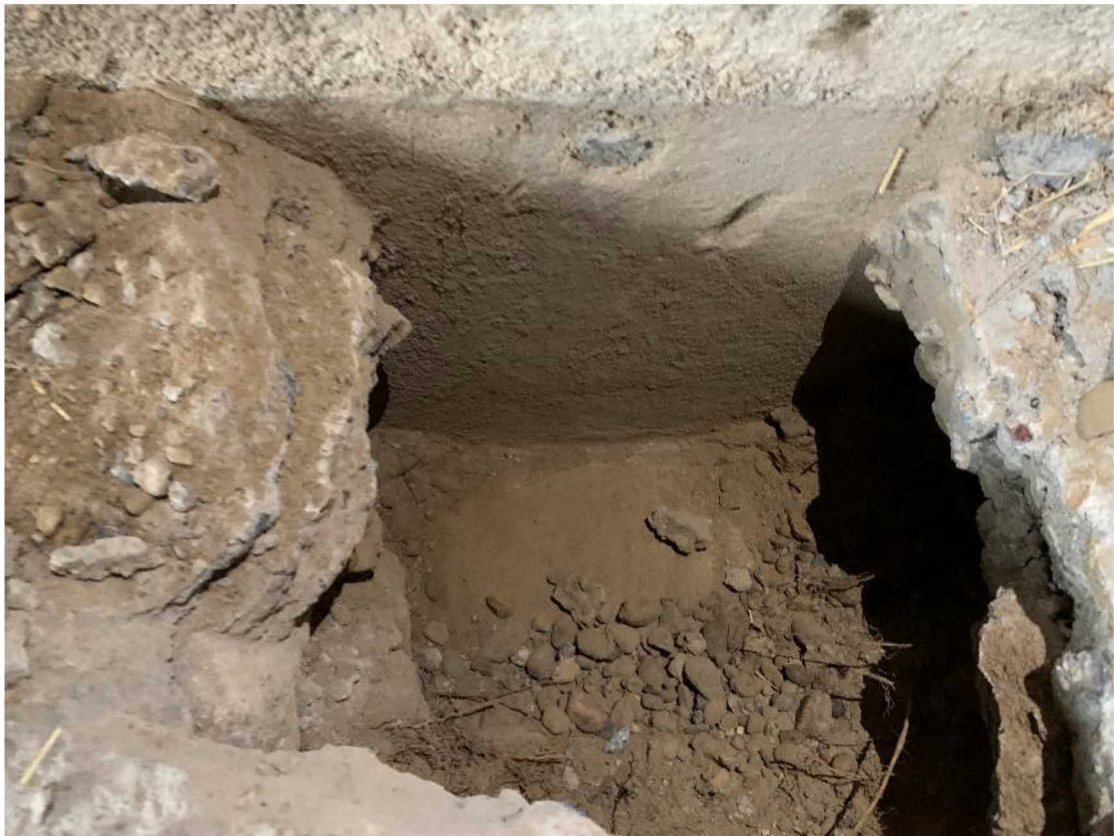
Photo 4: 23-10-2023 Closer view of HP02.
