**DESIGN AND ACCESS STATEMENT
INCLUDING
CONDITION SURVEY
(UPDATE)**

**CHANGE OF USE FROM
AGRICULTURAL BUILDINGS**

**BATTISFORD HALL BARNs
CHURCH ROAD
BATTISFORD
SUFFOLK IP14 2HG**

**BAT -DESIGN AND ACCESS
FEB 2024**

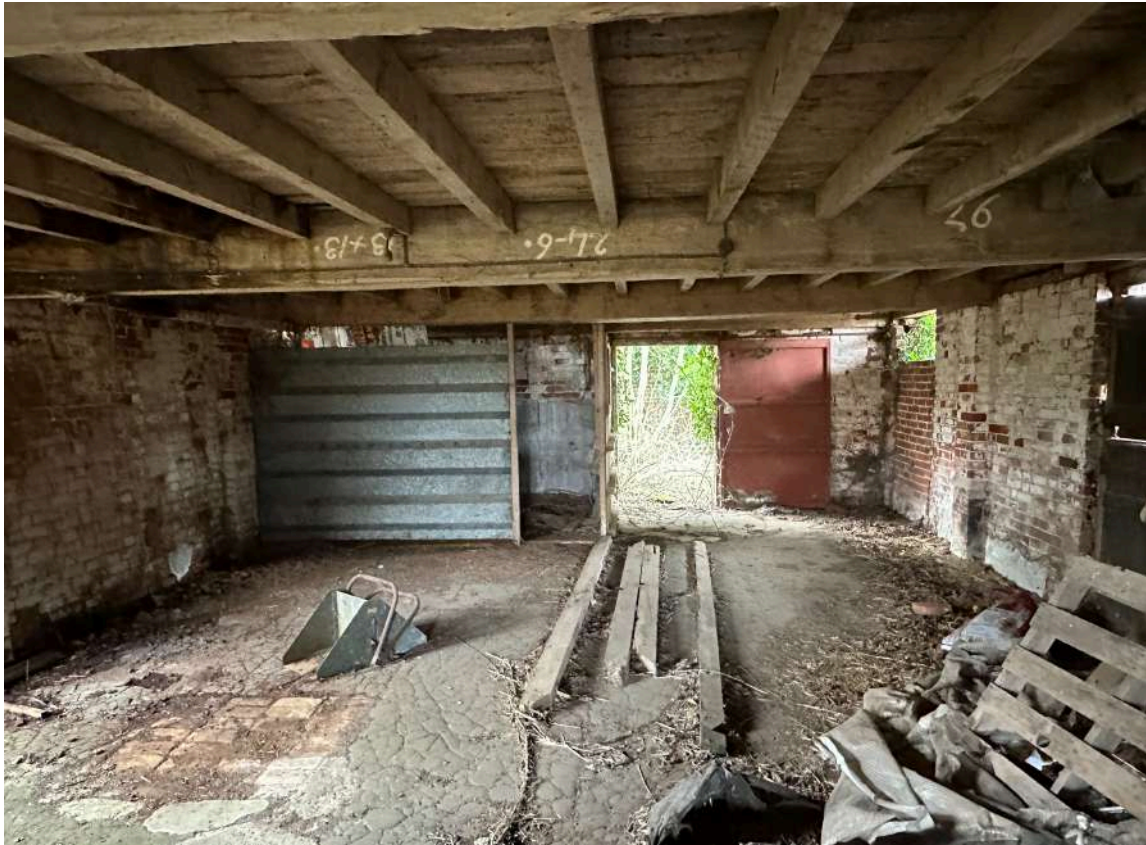
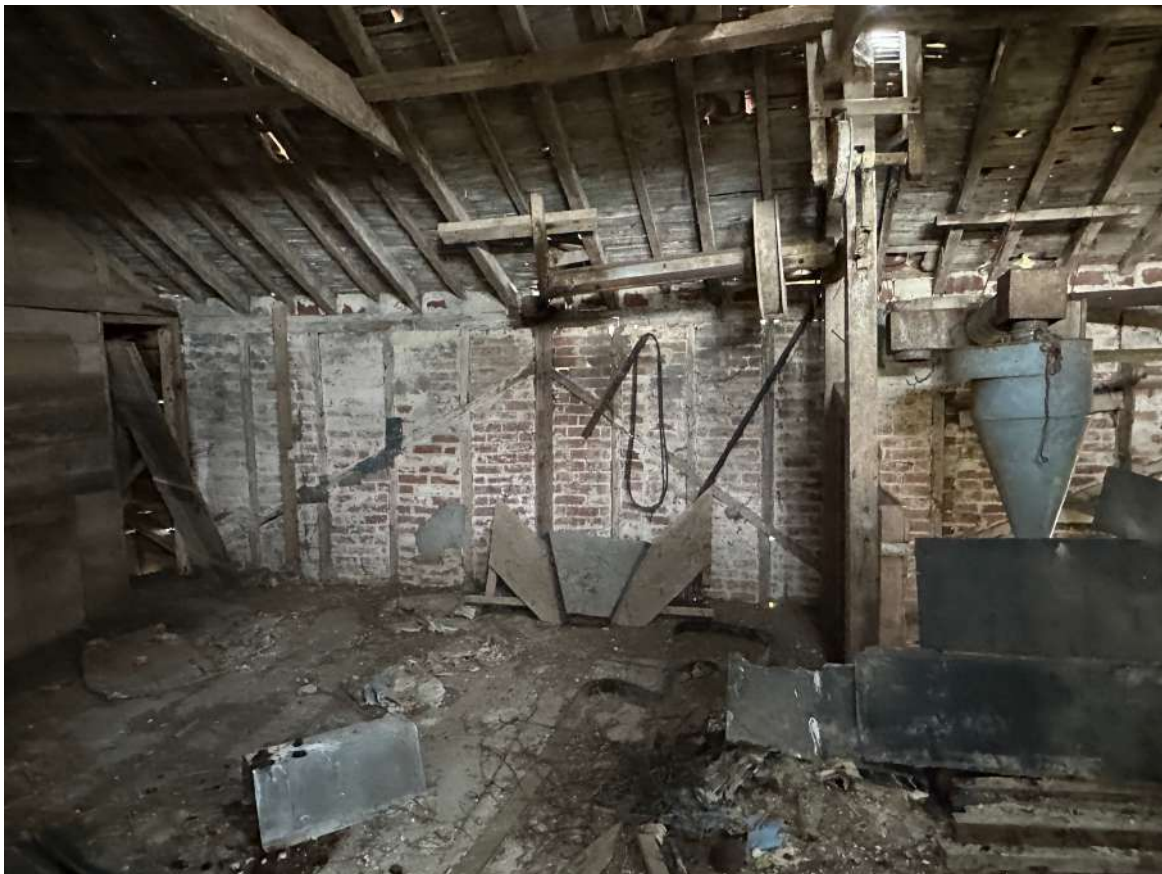
The Old Mill - The Old Mill Building is has brick ground floor base construction in good condition with timber frame at the first floor and roof which is also all in a sound condition with localised damage to a small areas of the main roof and localised damage where the wings were attached. The north and south wings on the Estern side which have both collapsed and have caused some damage to the timber frame at these junctions so some limited repairs would be necessary.

The 'Old Mill' Building with Brick Ground floor walls (Above) and timber frame with Brick infill to the first floor (below)

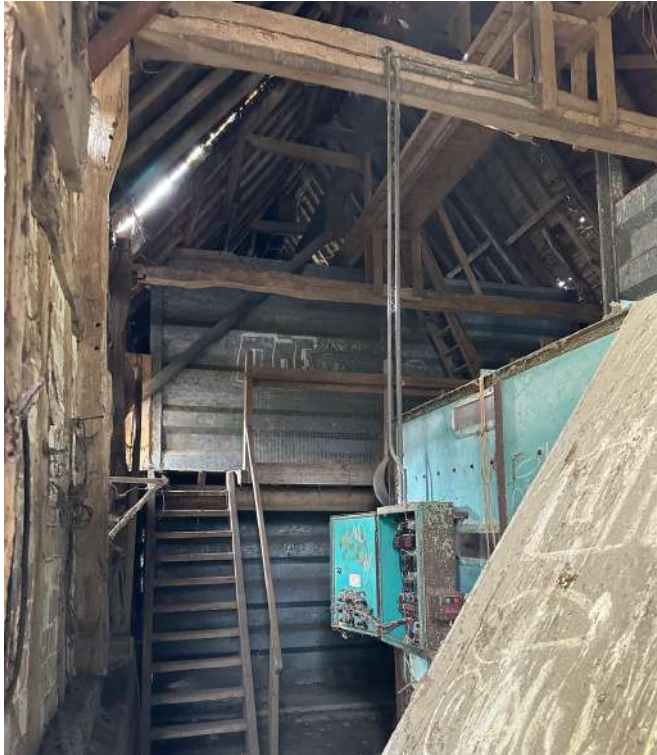
The Grain Barn - The Grain barn has a substantial Oak frame which looks to be largely in good condition on both walls and roof although this is limited to inspection due to the large, galvanised steel grain silos within the building. Where accessible the barn appears to be an early 17th century frame of an excellent quality and again the linked wings on the Eastern sides have caused localised damage when they have also collapsed.

Grain Barn - Substantial well preserved Timber frame

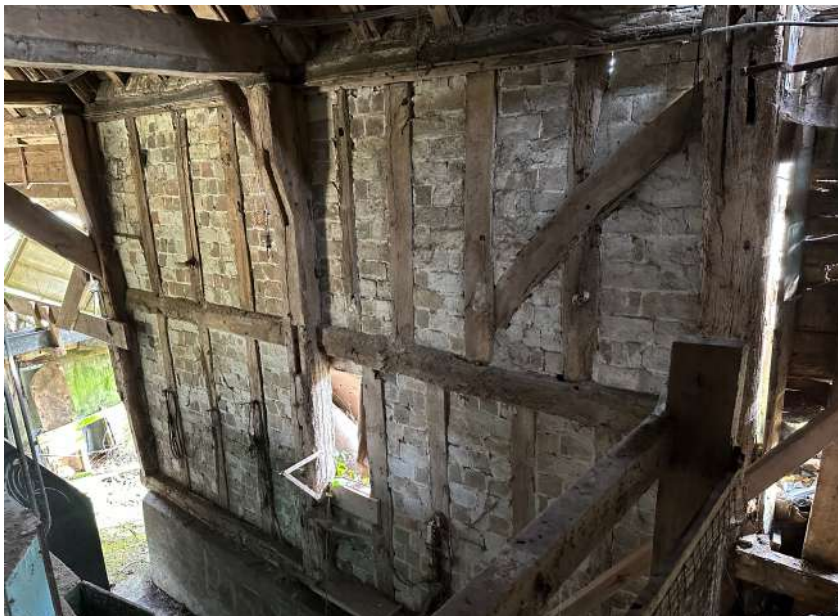
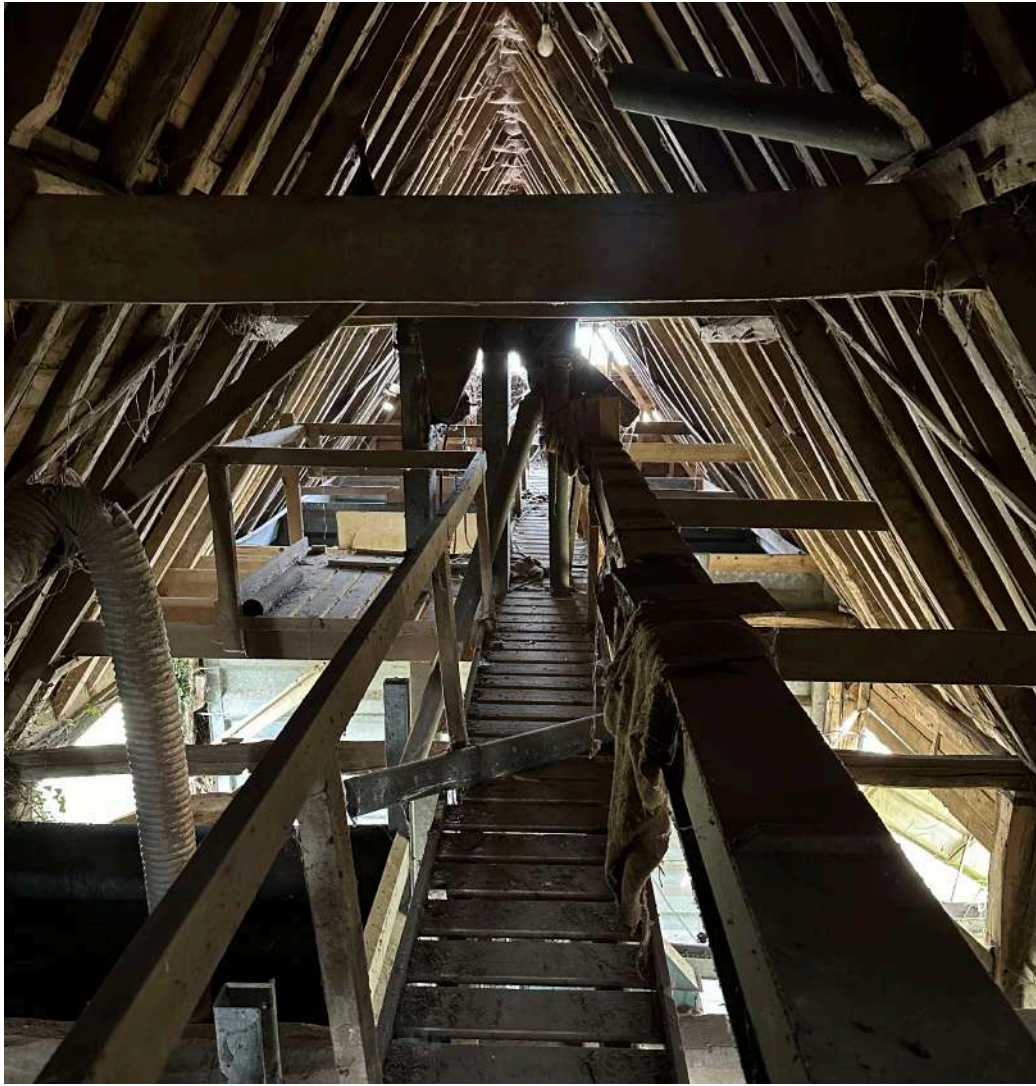
Grain Barn -Main roof high level walk-way

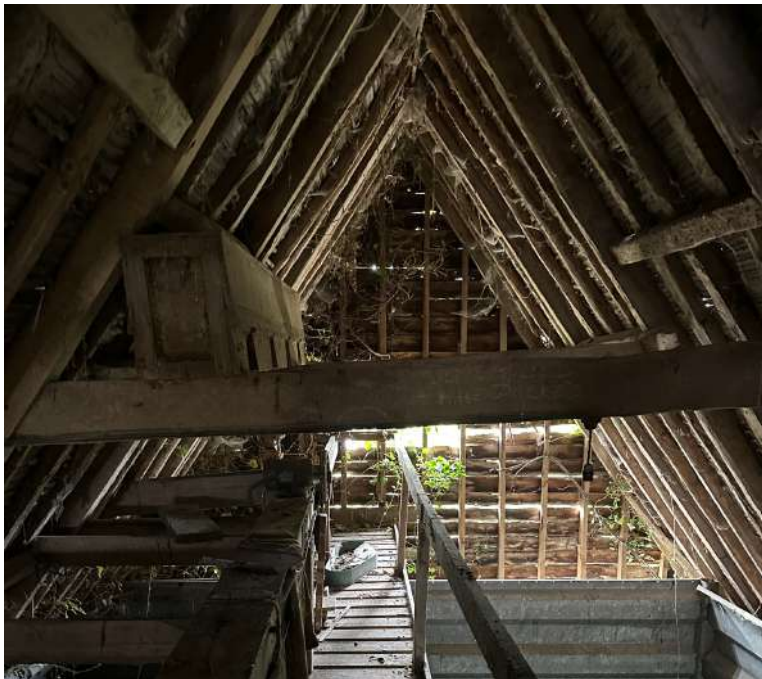
The Open Barn - The open barn consists of a substantial oak aisled barn, however it has lost its original roof, which has been replaced with a modern version with lower pitch, however this was obviously carried out many years ago and the remaining structure and roof finish remain intact and prevent any further decay to the building frame. The frame has some areas that need localised repairs but remain generally in good condition which would be easily made good during the conversion. The large associated wings to this building are in a poor state of repair and access was difficult due to the extensive vegetation, however their form and roofs are still in place in areas despite partial collapse of some areas, however from the evidence of photos for the original survey they have not deteriorated significantly since then and would be capable of restoring back to their original as indicated by some of the historical photos contained in the Whitworth D&A.

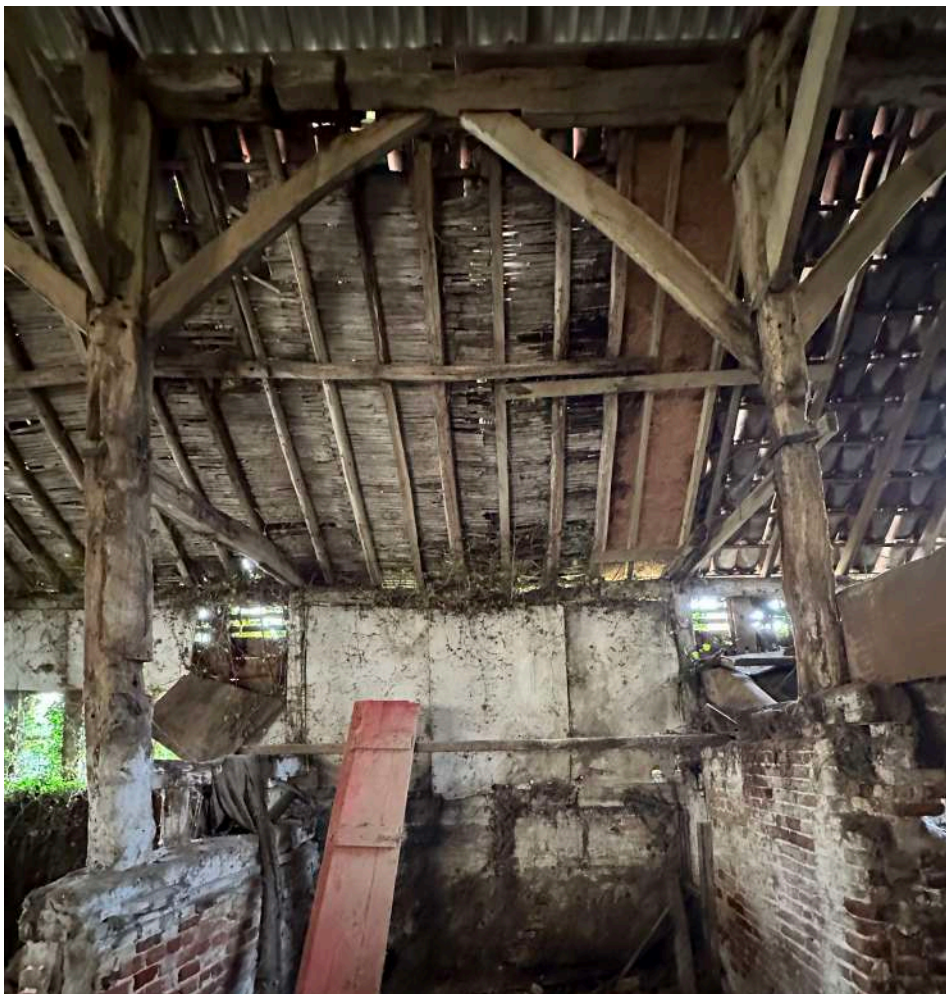
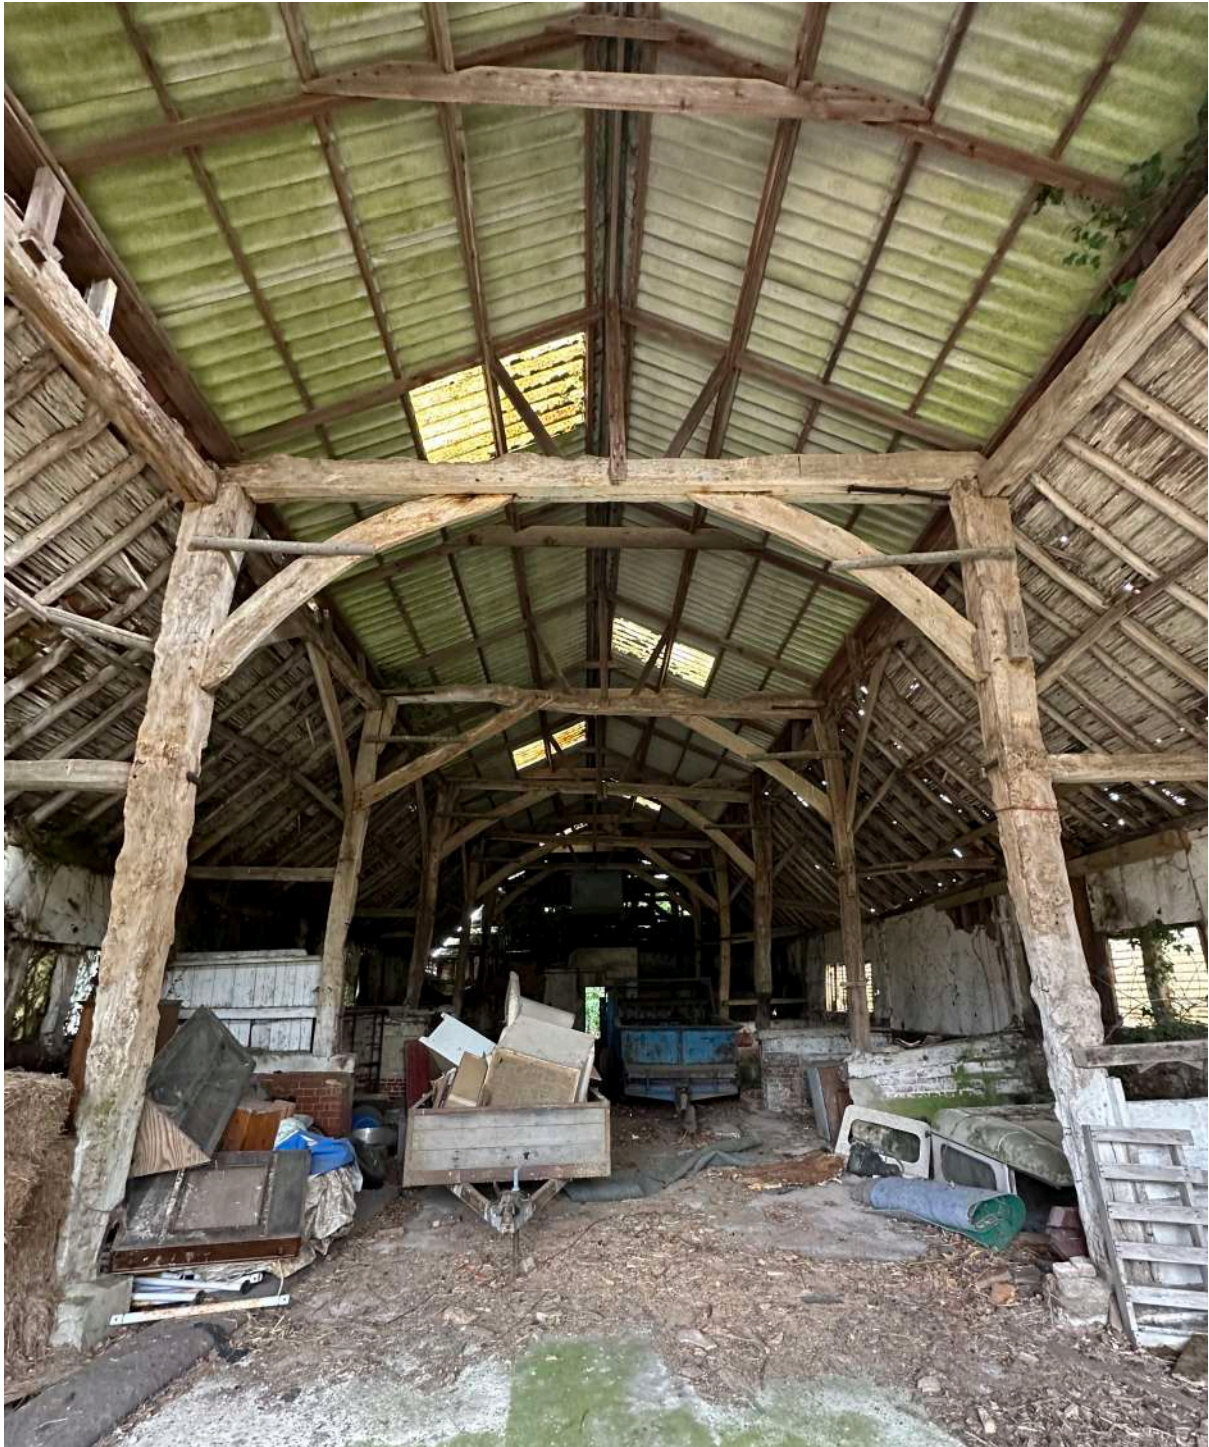
Open Barn - Showing Aisled Oak frame and replacement roof

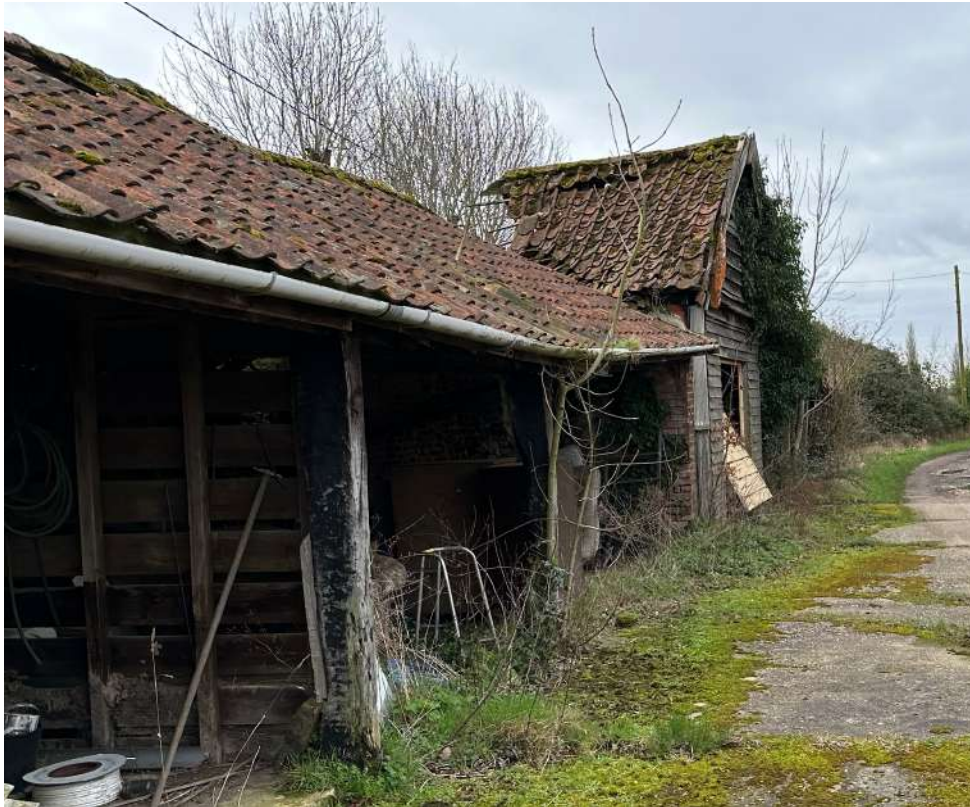
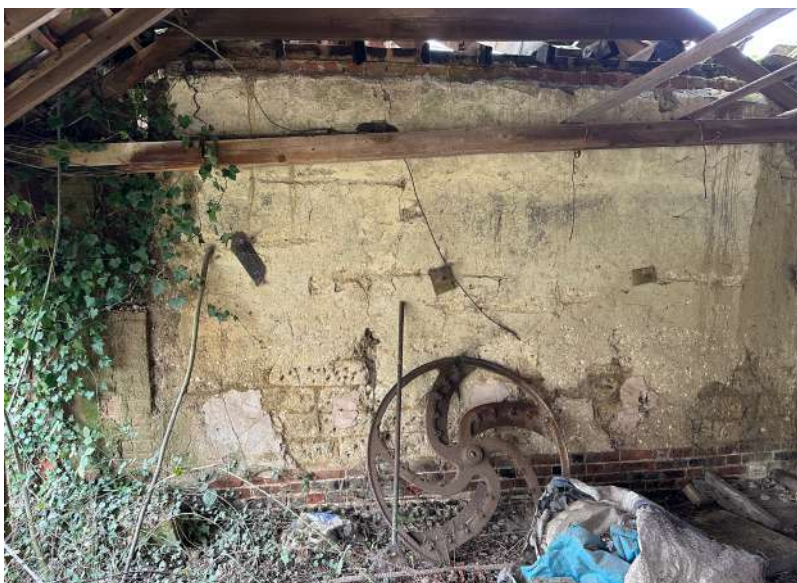
The Cartlodge - The Cartlodge Building is a combination of brick and timber frame, consisting of several elements which are largely intact however the central 'garage' section has deteriorated and its roof has now collapsed since the last survey. The associated side walls of brick, flint and clay lump have remained in place but would again need some repairs prior to their conversion.

Cartlodge - Showing the garage section roof now partially collapsed (above) and Clay lump wall still intact (Below)

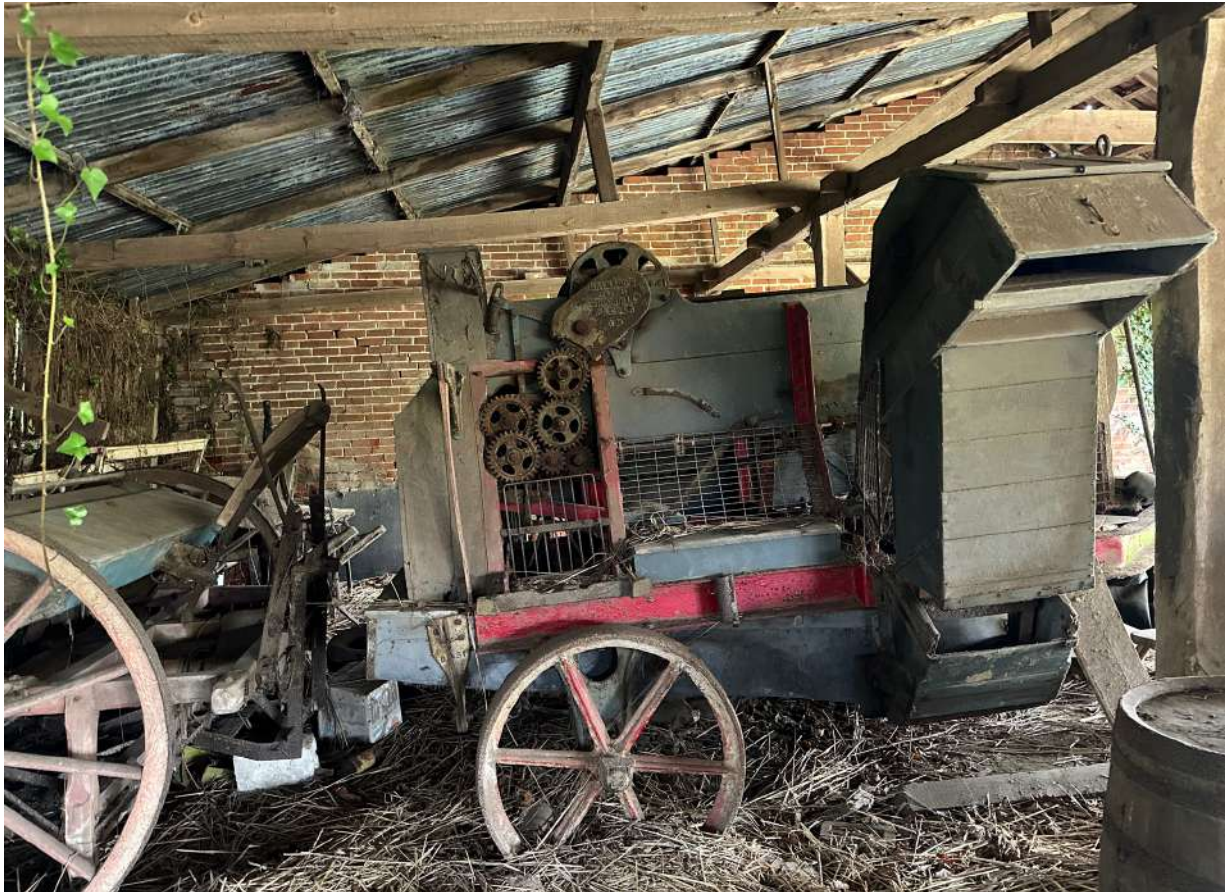
Cartlodge - Showing Southern end brick gable wall and Threshing machine storage

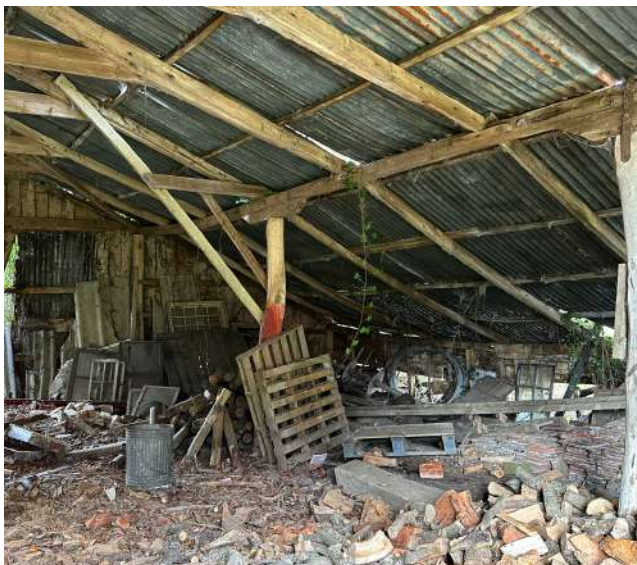
The Woodshed - The woodshed is a simple softwood post framed building with low pitched sheet roof finish, although still in use the building has not been included as part of the conversion proposals and is due to be demolished in the overall scheme.

Timber framed 'Woodshed'

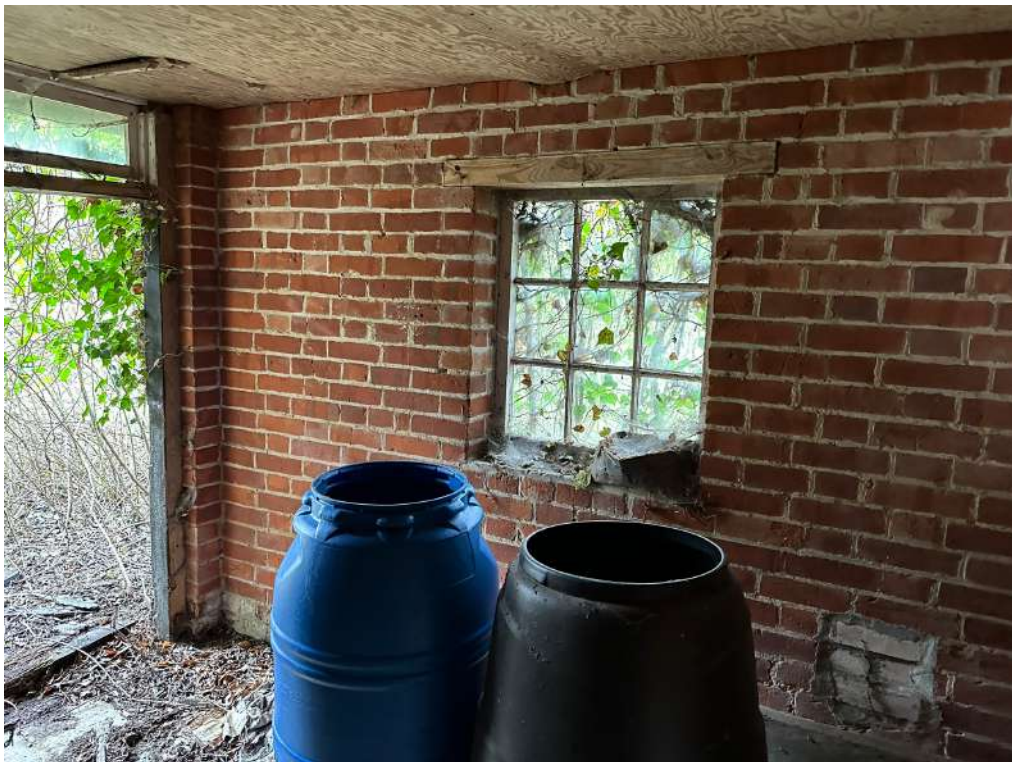
The Pig Shed - The Pig Shed is a simple single storey brick and block building with pitched tiled roof to the northern section and low-pitched steel sheet roof to the south over the blockwork and timber pig pens. Whilst the building is sound with some it capable of conversion it is, in the current scheme intended to demolish the building.

Brick walls of the Long 'Pig Shed'

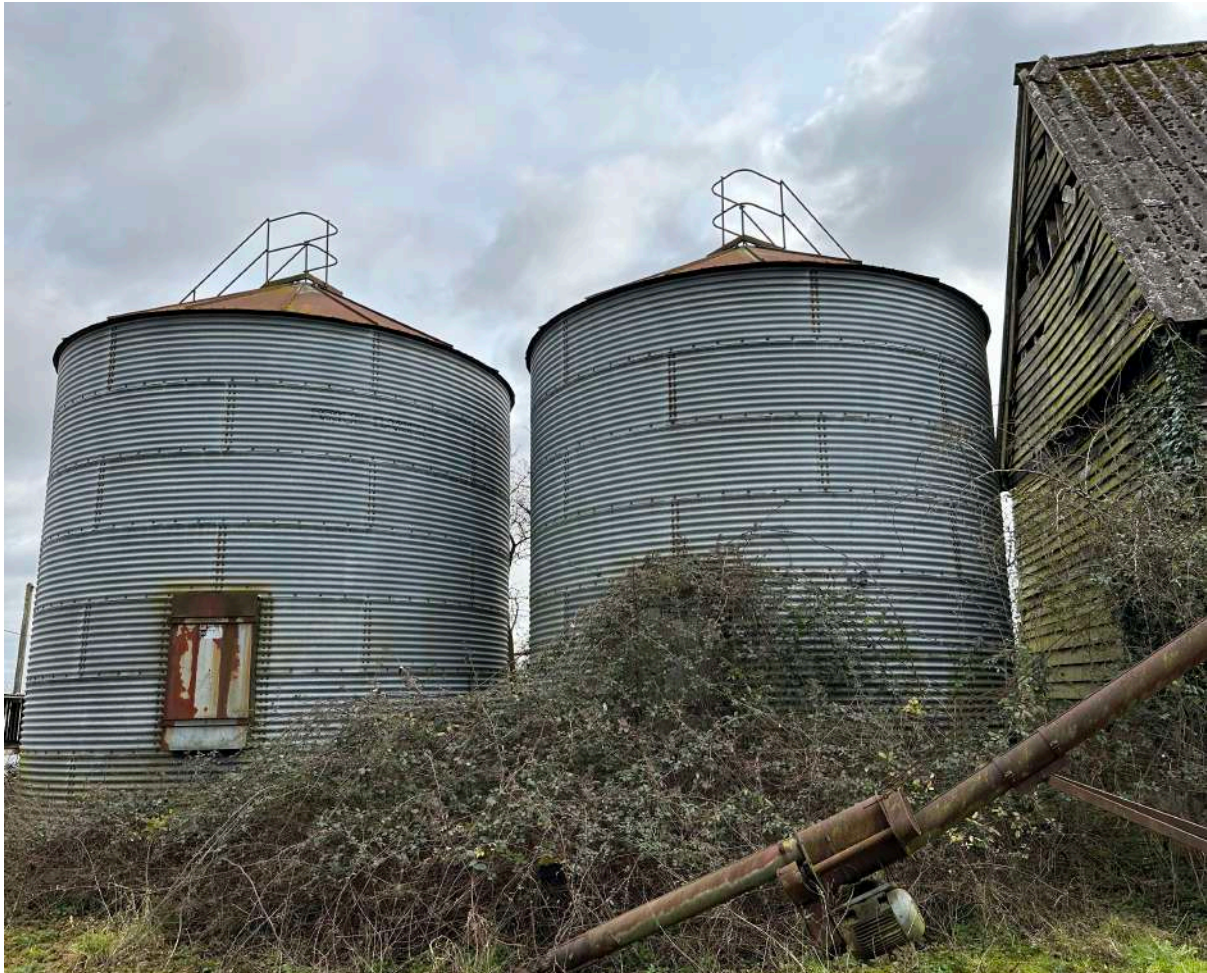
Steel Tower Grain Silos with 'Grain Store Building to the left
