Preliminary bat roost assessment

Site Location	26 North Villiers Street, Leamington Spa, CV32 5XY
Document reference	CE4466
Date of Site visit	15 th February 2024
Report by	Garry Smith – Senior Ecologist
	Signature:
	Tel: 07792064673
	Email: info@chaseecology.co.uk

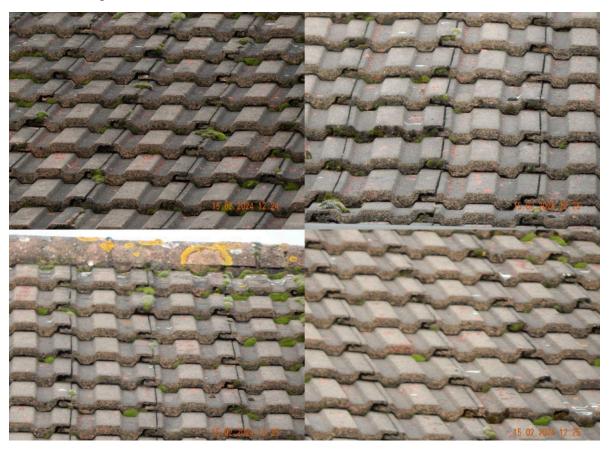
External	Features of	Notes
External Stonework/ Coverings	No	The brickworks to the structure have demonstrated a fair level of condition with no observed features of value to bats noted. The external coverings of the detached garage have demonstrated areas of deterioration, however the single skin materials have shown no likely roosting habitats of value to bats.
Window/door frames	No	No gaps or features of value to bats observed within or surrounding the door/window frames to the main dwelling or detached garage.
Eaves coverings	No	No gaps of adequate proportion to offer access or roosting value was observed throughout the main dwelling. There were a number of gaps between the fabricated roof coverings and vertical section below, however there are no enclosed habitats of value for roosting between.
Roof coverings	No	No observed features of value to bats were observed within the roof coverings throughout the main dwelling or detached garage.

$\label{eq:loss_equation} \mbox{Image 3-Close view of the main roof covering to show condition and lack of value to bats throughout}$

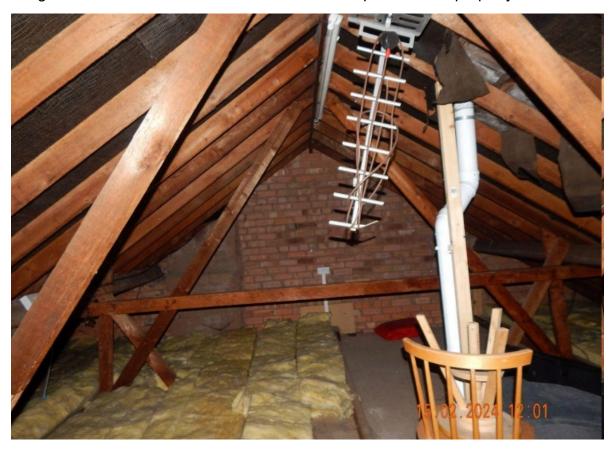
Internal	Features of value to bats	Notes
Membrane coverings	No	An intact felt membrane covering was observed throughout the roof void spaces of the main dwelling. No membrane coverings within the detached garage structure.
Floor coverings	No	Insulated coverings.
Protruding daylight	No	No areas of daylight observed within the roof void spaces.
Evidence from bats	No	No observed evidence from bats internally or externally to the main dwelling or detached garage.
Restrictions	No	Full access available during the survey.

Image 5 – Internal view from within the roof void spaces of the property

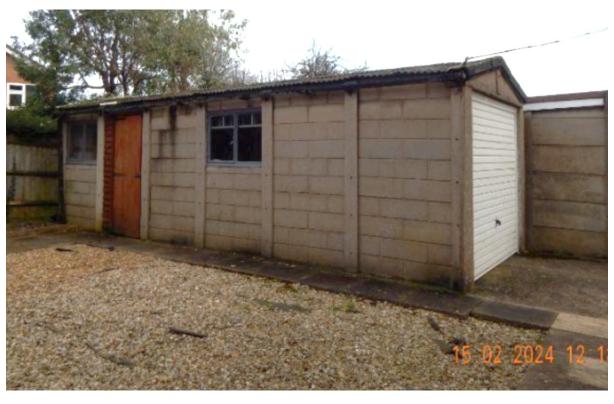
$Image\ 6-Detached\ fabricated\ garage\ structure\ to\ the\ rear\ of\ the\ property\ which\ has\ demonstrated\ no\ features\ of\ value\ to\ bats\ throughout$

- **6.4** Both the main dwelling and detached garage has evidenced no suitable features of value to bats where the proposed development works shall take place.

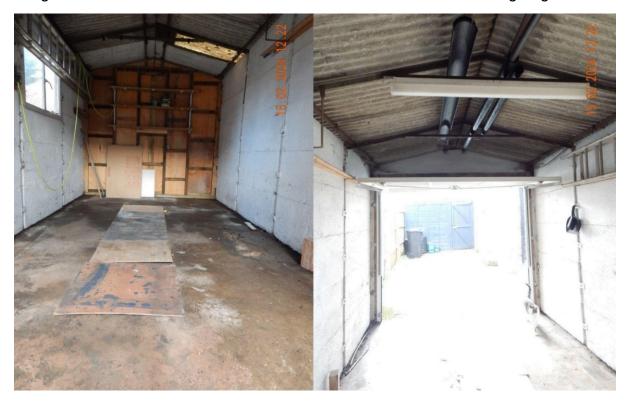
Image 7 – Internal view from within the internal areas of the detached garage
