**Woodside Training
Centre**

Bat Survey Report

Report Reference
edp7182_r004a

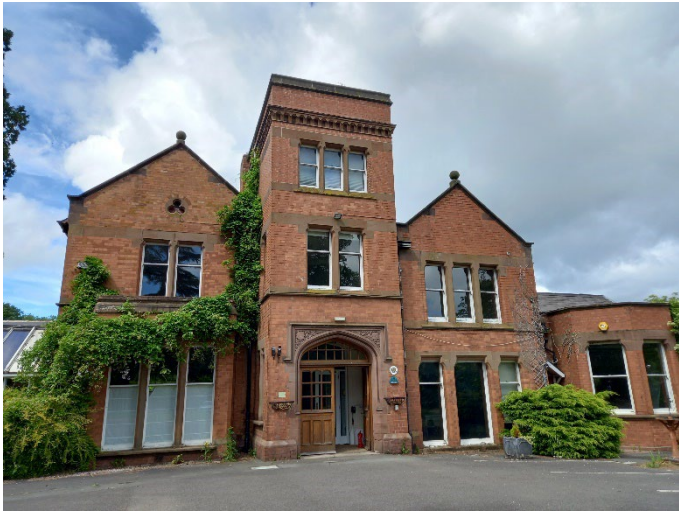
Building Ref.	Photograph	Potential Bat Features	Roosting Suitability
B1

<p>Internal (16 roof voids) - bitumen lined with timber/steel beams, rafters and truss. Wooden boarding backing bitumen present in several voids. Vaulted ceilings present in two of the voids. Newer extension had a false ceiling covered with ceiling tiles.</p> <p>External features - lifted/cracked/missing tiles, missing bricks, ornate vent, door into roof void gaps under fascia board and gaps around windows.</p> <p>Feeding remains and droppings (brown long-eared bat) present in roof void.</p>	Confirmed Roost

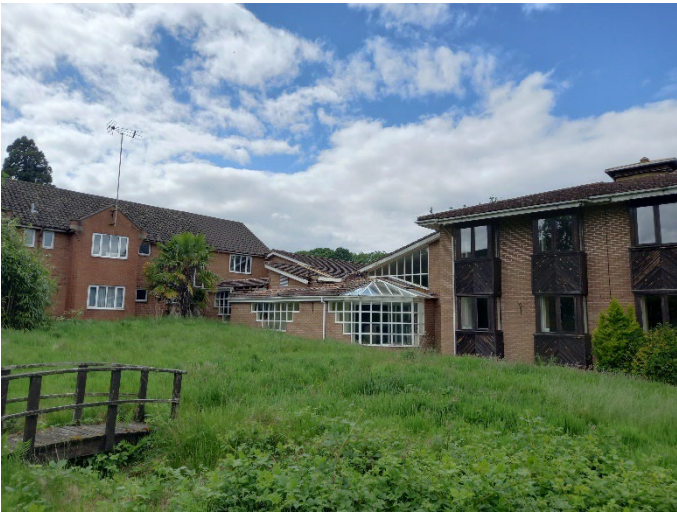
Building Ref.	Photograph	Potential Bat Features	Roosting Suitability
B2

<p>Internal (7 roof voids) – bitumen lined with wooden beams/rafters/truss. Rockwool insulation on floor.</p> <p>External features - lifted/cracked/missing tiles and hanging tiles, wooden panelling, holes into void in soffit box and collapsed roof.</p>	Moderate
B3

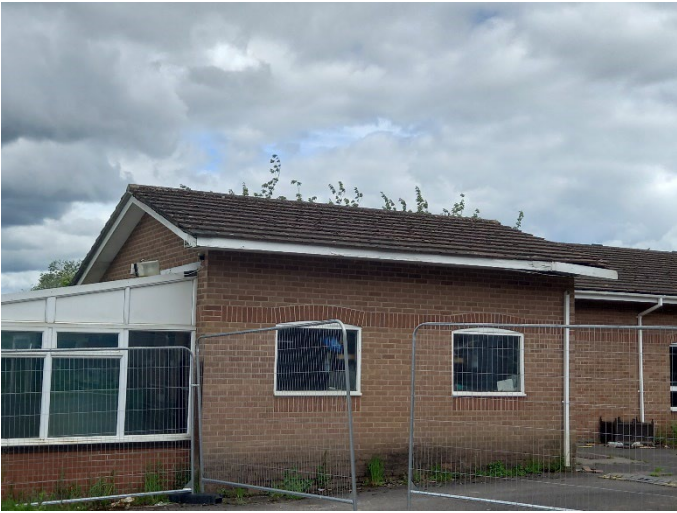
<p>Internal (1 roof void) – bitumen lined with wooden beams and rafters.</p> <p>External features - lifted/cracked/missing tiles, holes into void in soffit box and open door.</p>	Moderate

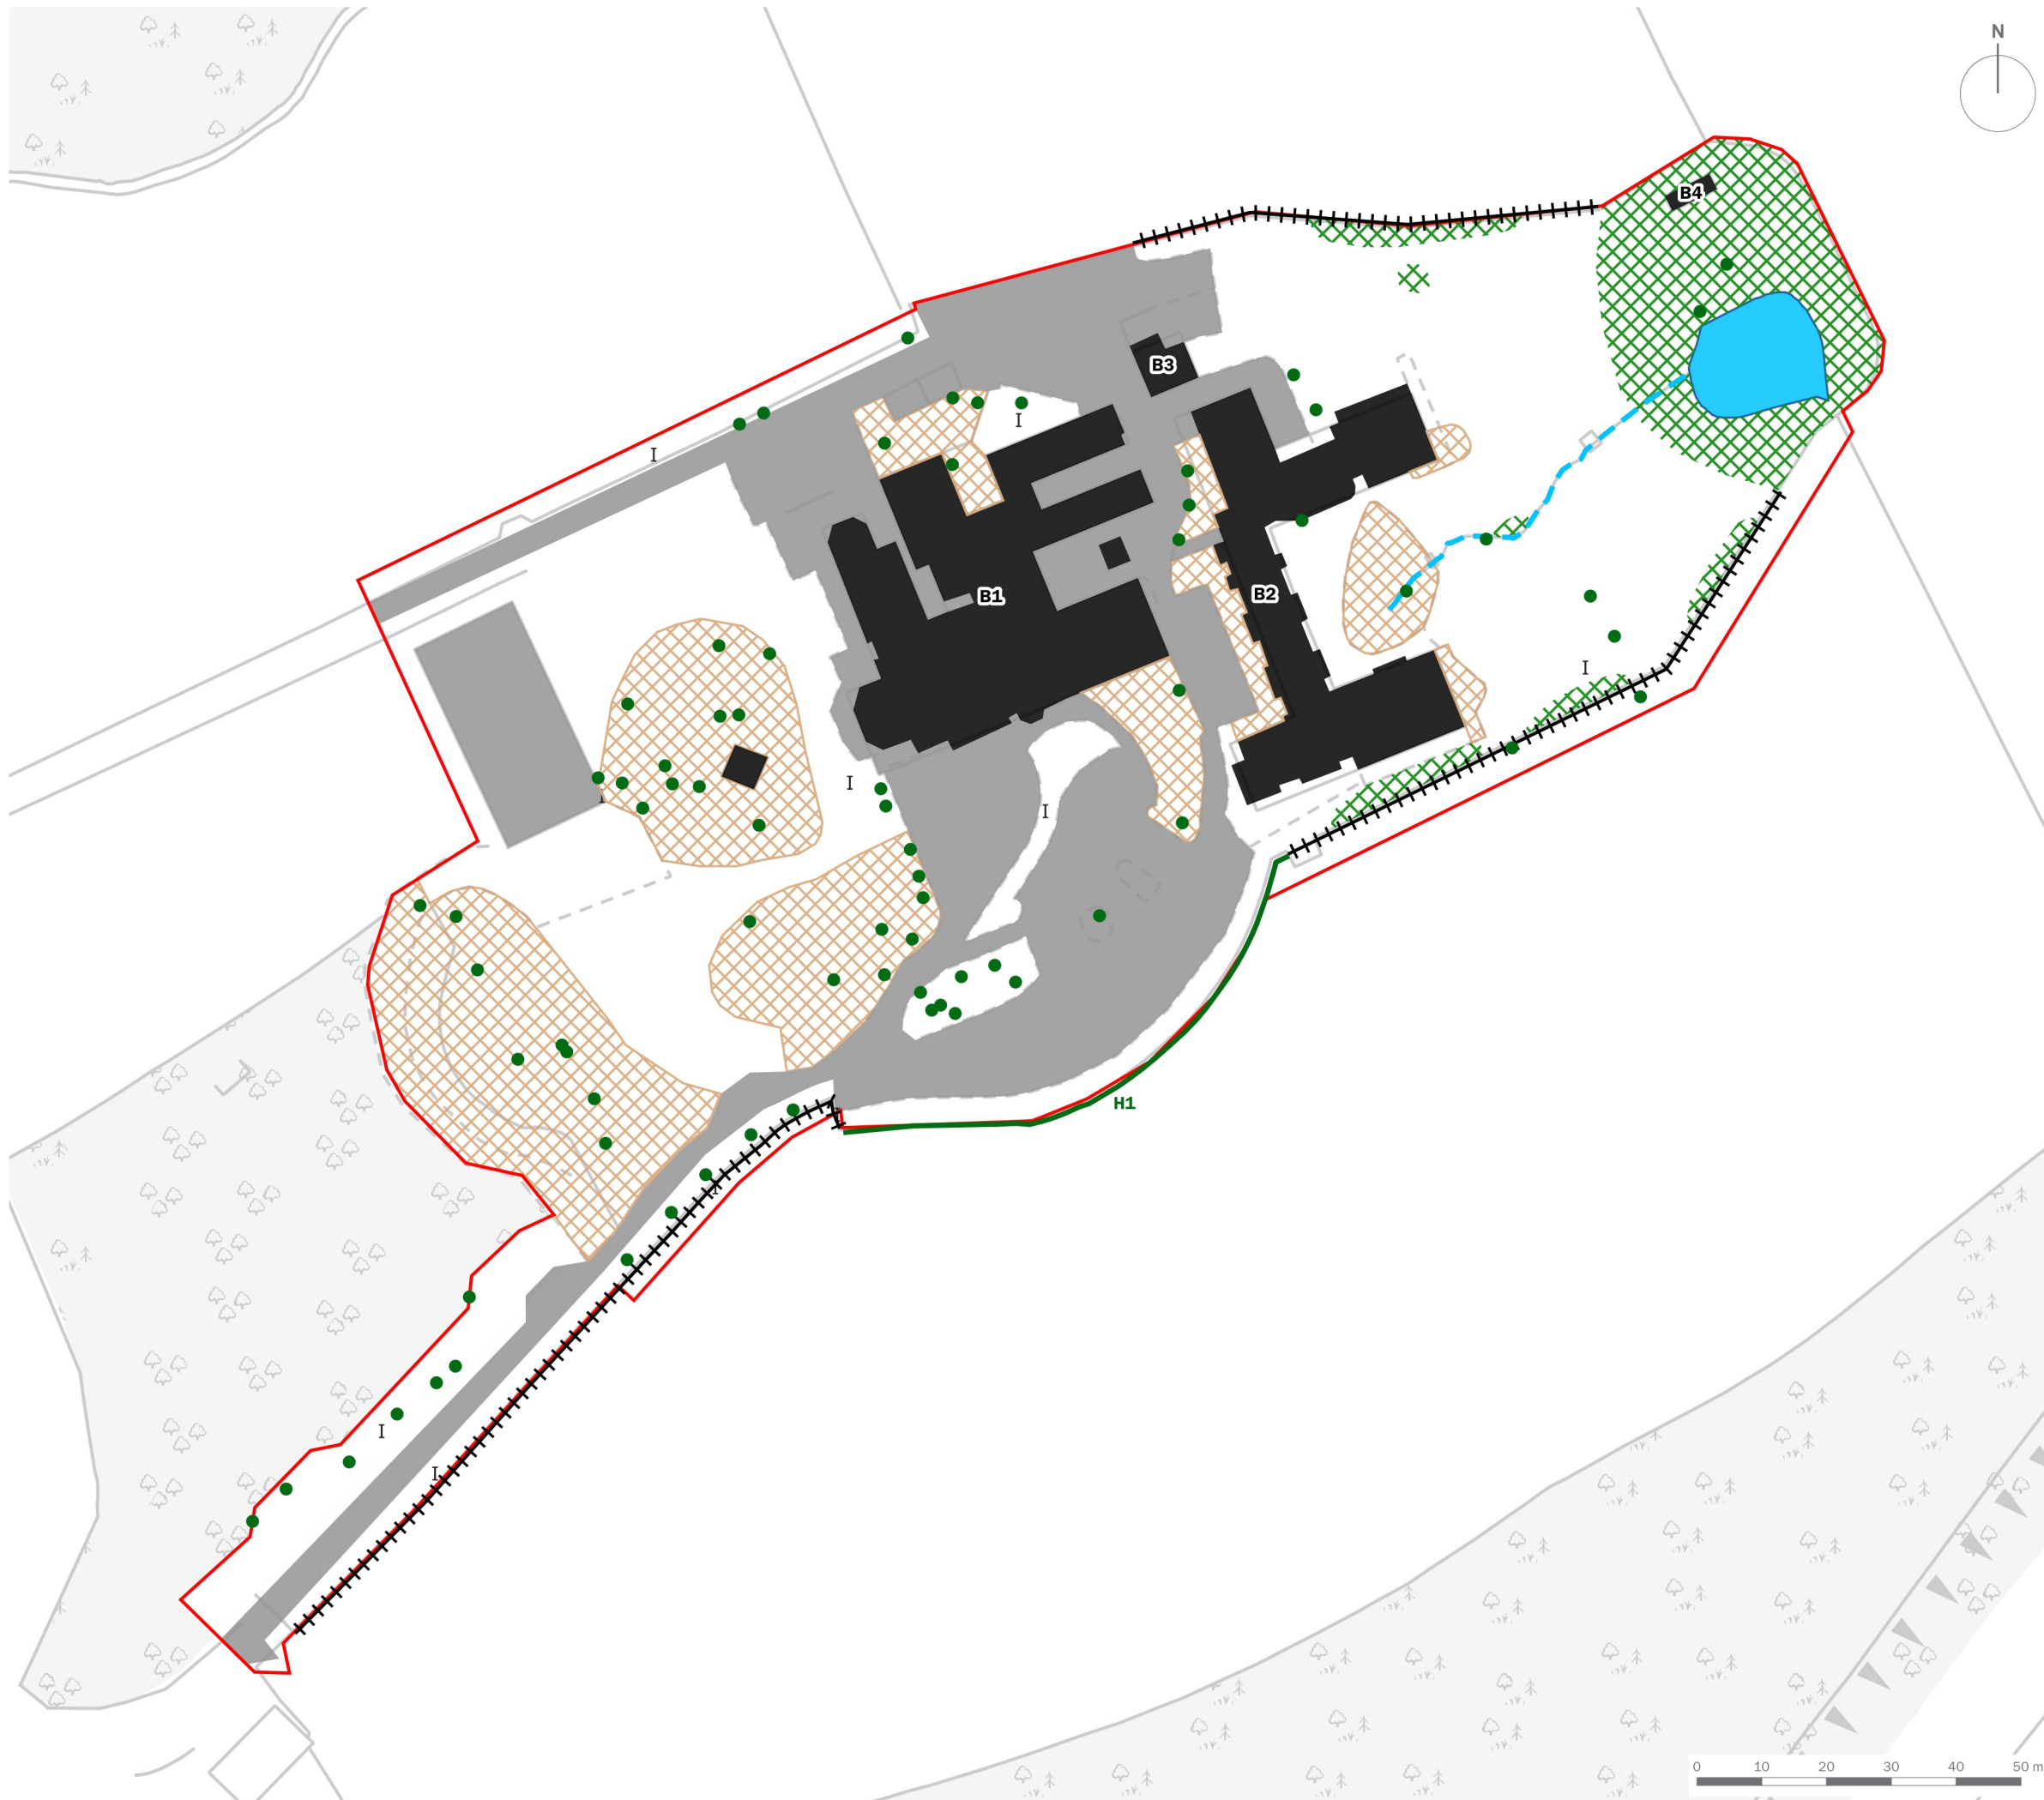
Plan EDP 1: Extended Phase 1 Habitat Survey
(edp7182_d002a 15 March 2023 GYo/CNe)

- Site Boundary
- Dense Continuous Scrub
- Introduced Shrub
- Improved Grassland
- Standing Water
- Building
- Hardstanding
- Intact Species-poor Hedgerow
- Dry Ditch
- Fence
- Scattered Trees (Broadleaved)
