GEOENVIRONMENTAL ASSESSMENT

PROPOSED RESIDENTIAL DEVELOPMENT
WOODSIDE CONFERENCE CENTRE
CREWE LANE, KENILWORTH

Report No: 20256/3
Date: June 2022

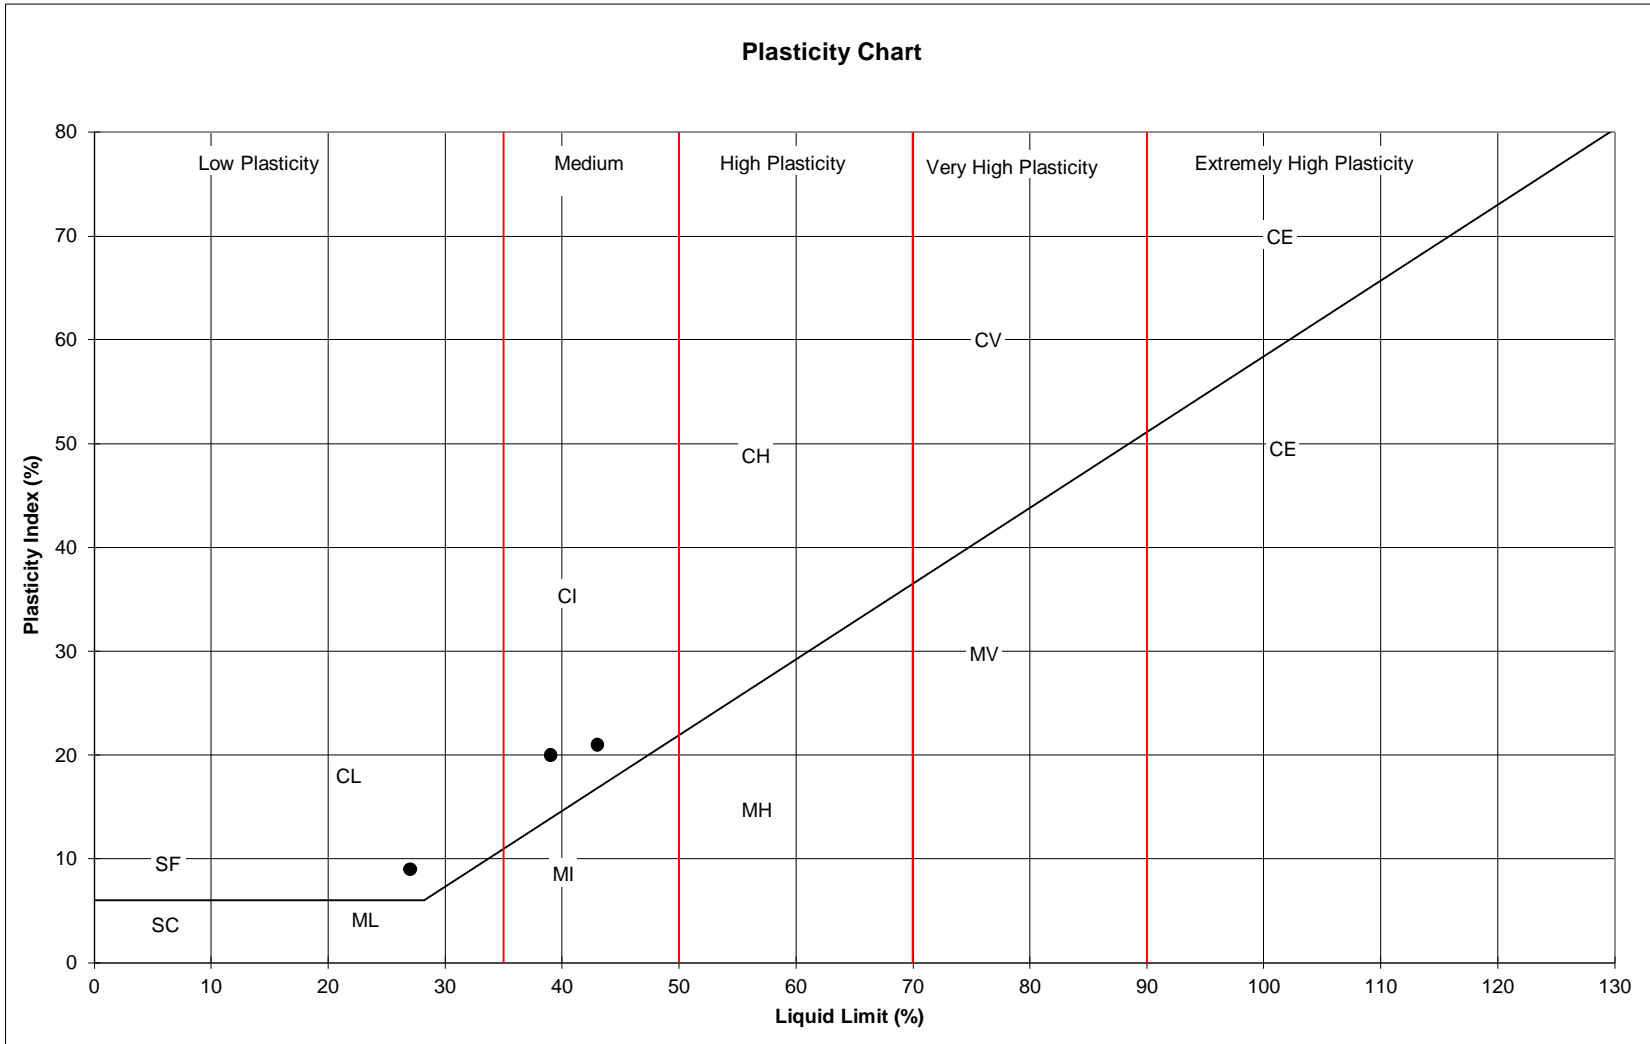
Drawing Title
Plasticity Chart - Ashow Formation

7.3.3 Four samples of Ashow Formation were scheduled for Atterberg Limit determinations and natural moisture content tests. One sample was taken from a sandy pocket in WS03 at 0.9 m and was confirmed as non-plastic. The tests on the remaining samples are summarised in Table 5. The test results are included in Appendix E together with a Plasticity Chart included as Drawing 20256/5.

Test	Minimum (%)	Maximum (%)
Liquid Limit	27	43
Plastic Limit	18	22
Plasticity Index	9	21
Moisture Content	17	20
Volume Change Potential	Low	Medium
