Design, Access and Heritage Statement for

**Whitfield Court, Surrey –
Revised Repairs and Alterations following
Opening up**

Whitfield Court,
Littlewick Road,
Knaphill,
GU21 2JU

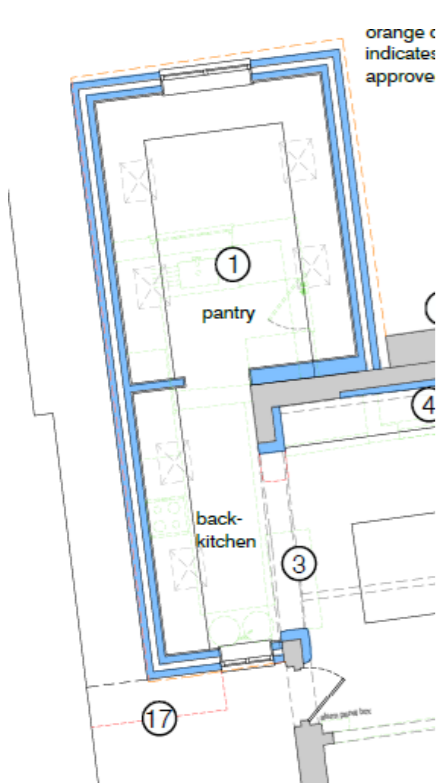
Item 1 – Adjustments to proposed single storey rear extension	
<p><u>Description</u> – Size and alignment of Pantry & Back Kitchen Extension adjusted slightly from previously approved design, 2No. additional rooflights added, window to east elevation removed. Windows to be double glazed, and have single horizontal glazing bars to match style of existing first floor windows to Master Bedroom.</p>

<p><u>Reference Image</u> – This extract of the ground floor plan shows the new proposed walls in blue, with the previously consented wall outline in dashed red beyond.</p>
<p><u>Discussion</u> – The previously submitted rear extension design had not been set out to a brick dimension which suits the brick bonding pattern proposed to the existing house. The revised extension footprint is as close as possible to the previously consented design (it is slightly shorter and narrower), but would not necessitate cutting the bonding pattern short. The rear extension is proposed to be a pantry/back kitchen, and so a further pair of 'conservation' style flush rooflights are proposed, to improve top lighting in this area, whilst a window previously proposed on the eastern elevation has been omitted to allow more space for cupboarding. The northern window is proposed to be double glazed, but to the match the astragal and detailing of the existing window joinery to this area of the house. These proposals are an evolution rather than a revolution to what was previously proposed. As with the previous assessment of the rear extension, these proposals have a positive impact upon the significance of the heritage asset, removing a poor quality flat roofed extension, and replacing it with a simple and deferential alternative.</p>

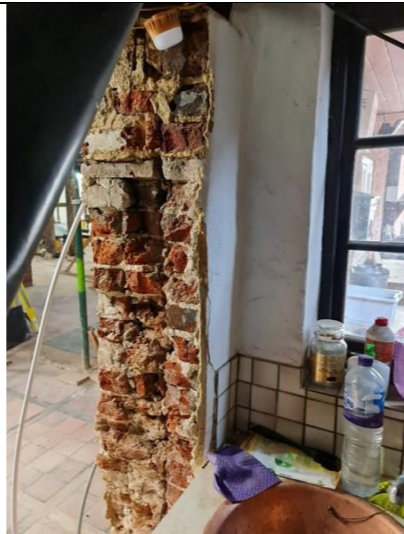
Item 3 – Brick pier repairs	
<p><u>Description</u> – Existing brickwork nibs under new oak beam cut back & repaired/rebuilt as required</p>

<p><u>Reference Image</u> – This photograph illustrates the condition of one of the wall nibs (here the southern side) supporting the existing opening between the previous single storey northern range, and the main kitchen.</p>
<p><u>Discussion</u> – Repairs to the lintel over this opening were previously proposed, however it was assumed that the masonry below was in reasonable condition. Upon opening up, it became apparent that this is not the case, and the brickwork had largely become friable, with an insufficient bearing capacity for the lintel and first floor above. New brickwork set on a new pad foundation has been spliced into the existing brickwork to either side of the opening.</p>

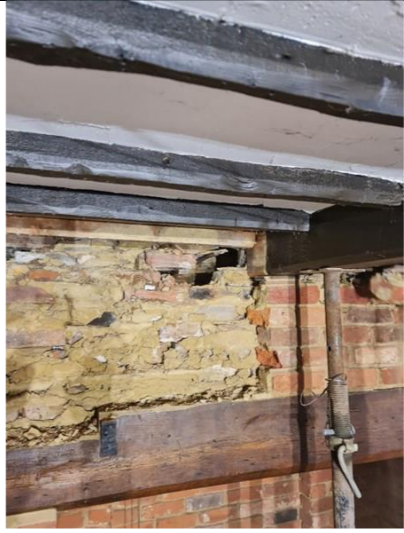
Item 4 – Brickwork over bressummer repairs	
<p><u>Description</u> – Existing brickwork repaired as required following removal of existing mock chimney breast.</p>

<p><u>Reference Image</u> – This photograph illustrates the condition of the brickwork behind the mock chimney breast to the northern wall of the kitchen range internally.</p>
<p><u>Discussion</u> – 1980's brickwork was partially removed to expose a poorly constructed core, improperly bonded to the masonry skin internally. The brickwork has been rebuilt to the Structural Engineer's details.</p>

Discussion – As noted in item 4, upon opening up the brickwork to the internal northern elevation of the north range was found to not be sufficiently tied back to the masonry beyond. This necessitated rebuilding a portion of the brickwork, tied back to the wall's core beyond to the Structural Engineer's details.

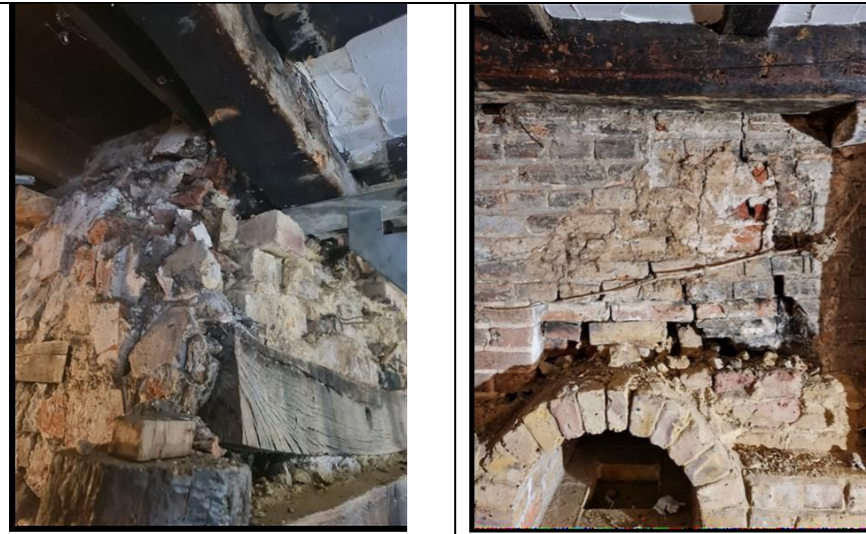
Item 7 – Chimney repairs
<u>Description</u> – Due to partial collapse of existing brickwork chimney during removal of late 20C. timber framing and brick infill, chimney partially taken down to underside of ceiling level and reconstructed in brickwork. Existing bressummer beam re-installed in original location.

Reference Images – This is a portion of the brickwork core to the chimney breast located centrally to the middle of the western range. More extensive photographic records of this and other defects found, can be reviewed in Appendix C – Contractor’s Record Photographs.

Discussion – It was clear during the development of the previous application that questionable works had been carried out to the central chimneybreast of Whitfield Court – evidenced particularly by the faux bread ovens, stretcher bond brickwork and decorative timberwork. Upon opening up, removing these detrimental features, the core of the chimney breast was found to be in a poor state of repair, and consequentially was propped and the brickwork consolidated by the Contractor. Historic timbers, including the bressummers, have been reinstated in their original locations.

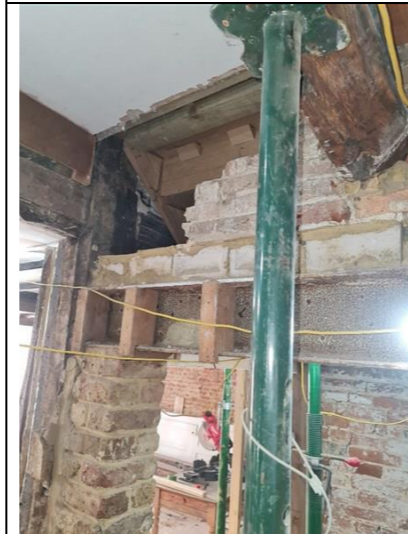
Item 8 – Structural repairs to opening into entrance hall
<u>Description</u> – Late 20C. fake brickwork infills removed. New oak post installed, and adjacent opening retained.

Reference Image – The existing lintel was exposed, revealing poor quality masonry above it, and no pad stones where bearing on piers below.

Discussion – As elsewhere, these alterations were carried out in the 1980’s, and are of a poor quality. Replacement lintels and piers were installed to the Conservation Accredited Structural Engineer’s details.

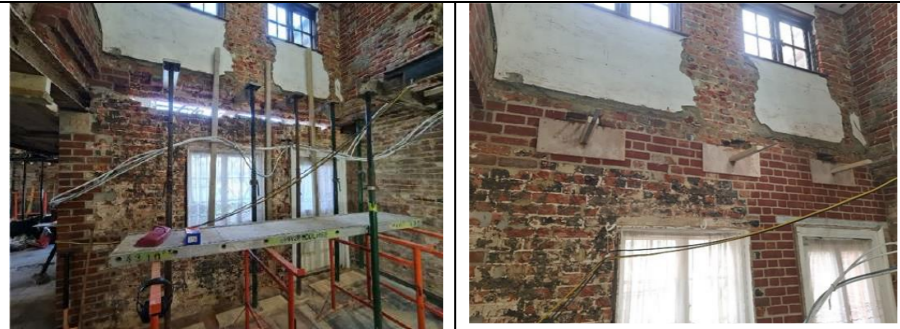
Item 12 – Lintel replacement
<u>Description</u> – Existing modern window and door lintels replaced with new concrete lintels more compatible with the existing fabric of the building.

<u>Reference Image</u> – The existing wall was pinned and the lintel removed, with brickwork repair being carried out with integrated restraining straps to the Structural Engineer's detail.
<u>Discussion</u> – The internal lintel above the door and window adjacent to the proposed new staircase were assessed by the Structural Engineer, and found to be inappropriate and insufficiently sized. It is proposed to introduce new correctly sized lintels, to be concealed beneath new lime plaster internally.

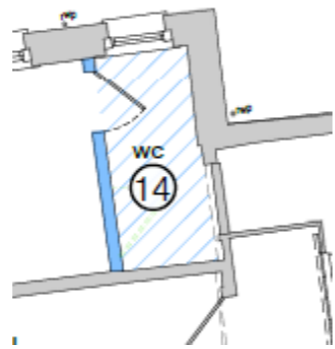
Item 14 – Removal of concrete slab and associated works	
<u>Description</u> – Remove existing concrete slab and poor condition brickwork separating wall. Reinstall vented timber joist floor and construct new timber wall to WC.

<u>Reference Image</u> – This extract of the ground floor plan shows the area of W.C which is proposed to have its floor replaced and wall/doorway reconfigured.
<u>Discussion</u> – The utility room, which leads through to the W.C., has a timber ventilated floor. The W.C. however has a cast concrete slab which is cracking in places and is driving moisture into the solid masonry construction of the adjacent walls, which has led to damage to the brickwork externally to this portion of the building. It is proposed to break out this slab and replace it with a ventilated timber joisted floor, replacing the poor quality separating wall at the same time.

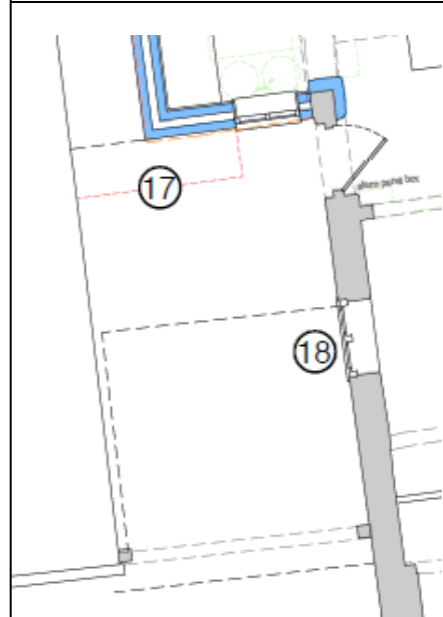
Item 17 – Extending existing flat canopy	
<u>Description</u> – Existing late 20C. external canopy adjusted to fully cover pathway to Kitchen external door.

<u>Reference Image</u> – This extract of the ground floor plan shows the area of flat canopy (dashed in red) proposed to be extended, with the current extent of the canopy shown to the dashed line at the base of the drawing extract.
<u>Discussion</u> – There is an existing flat roofed canopy between the western wall of the house, and an adjacent built range. To the northern end of the canopy there is a small area of side passage not covered by the canopy, and this is proposed to be filled in.

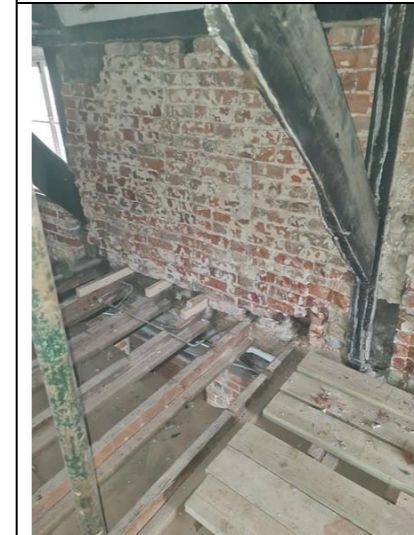
Description – New joists and floorboards to achieve level floor throughout within Master Suite (joists to be under-boarded within Kitchen with new plasterboard and acoustic insulation fitted between).

Reference Image – Here a portion of the undersized joisting sitting into voids in the brickwork can be seen, following opening up.

Discussion – The first floor to this portion of the building was known to be quite 'live', and the previous proposals noted that following opening up, strengthening of the existing structure was proposed to ameliorate this issue. However, it was found that the existing joists were not historic and were undersized compared to their span, and in places were unsupported at their junction with supporting walls. It is proposed to enlarge the common joists, retaining existing floor structure where possible, and adding acoustic insulation between the joists.

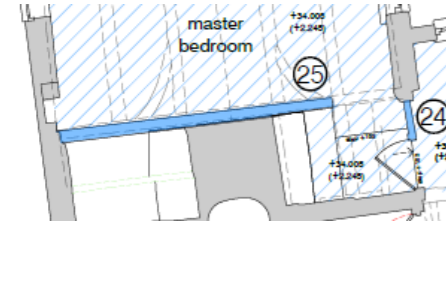
Item 25 – Adjustments to proposed single storey rear extension	
<u>Description</u> – New timber stud wall and door constructed under existing frame, and infill sections of frame over.

<u>Reference Image</u> – This extract of the first floor plan shows the proposed location of a new stud wall to the southern side of the master bedroom suite.
<u>Discussion</u> – The southern wall of the master bedroom is formed of an opening to the eastern side (leading to the stair hall and landing) and a cupboarding nook to the western side. It is proposed to form a new stud partition against the central chimney breast, to create a flat wall (for siting a bed against), and allowing for running electrical conduit without surface mounting the conduit or chasing into the fabric of the chimney. The partition would be lightweight and fully reversible.
