Monitoring visit **4** of **7**

**Monitoring Plus Report**

Owners name	<input type="text" value="Miss Jo Chimes"/>	Suspected cause	<input type="text" value="to be advised"/>	Monitoring type	<input type="text" value="levels"/>
Address	<input type="text" value="Penbryn, Green Street Eye Hoxne IP21 5AX"/>	Principal area of damage	<input type="text" value="to be advised"/>	Installed	<input type="text" value="21/04/2023"/>
		Damage category	<input type="text" value="to be advised"/>	Frequency (weeks)	<input type="text" value="8.7"/>
		Surface geology	<input type="text" value="to be advised"/>	Completion date	<input type="text"/>

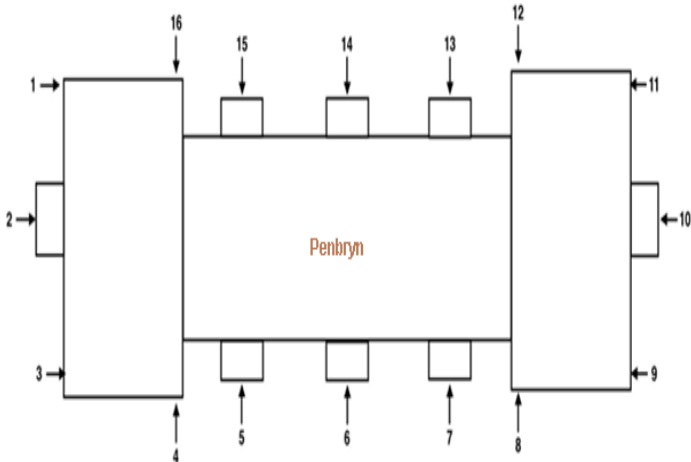
<p style="text-align: center;">Front Elevation</p>

Comment				Status	<input type="text" value="open"/>
Max movement	<input type="text" value="2.7 mm"/>	Feedback from last visit	<input type="text" value="no feedback for this visit"/>		
Focal area	<input type="text" value="Pts 9, 10, 11,"/>				
<input type="text" value="no comment for this visit"/>		Sketch showing location of monitoring points

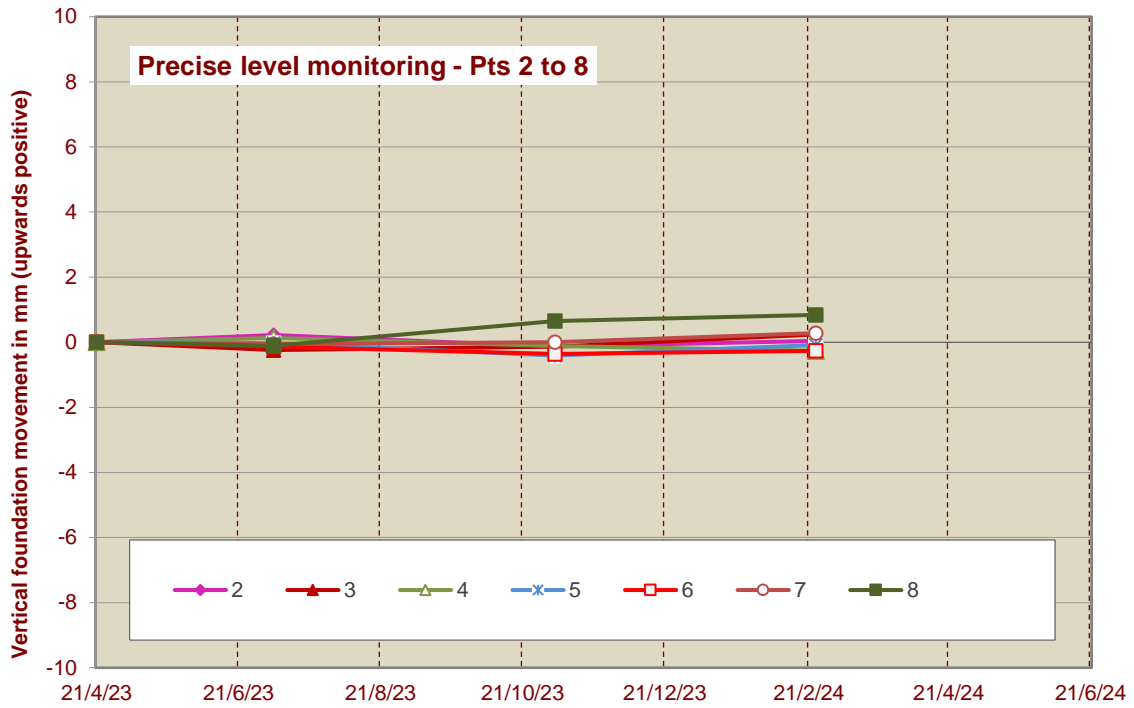
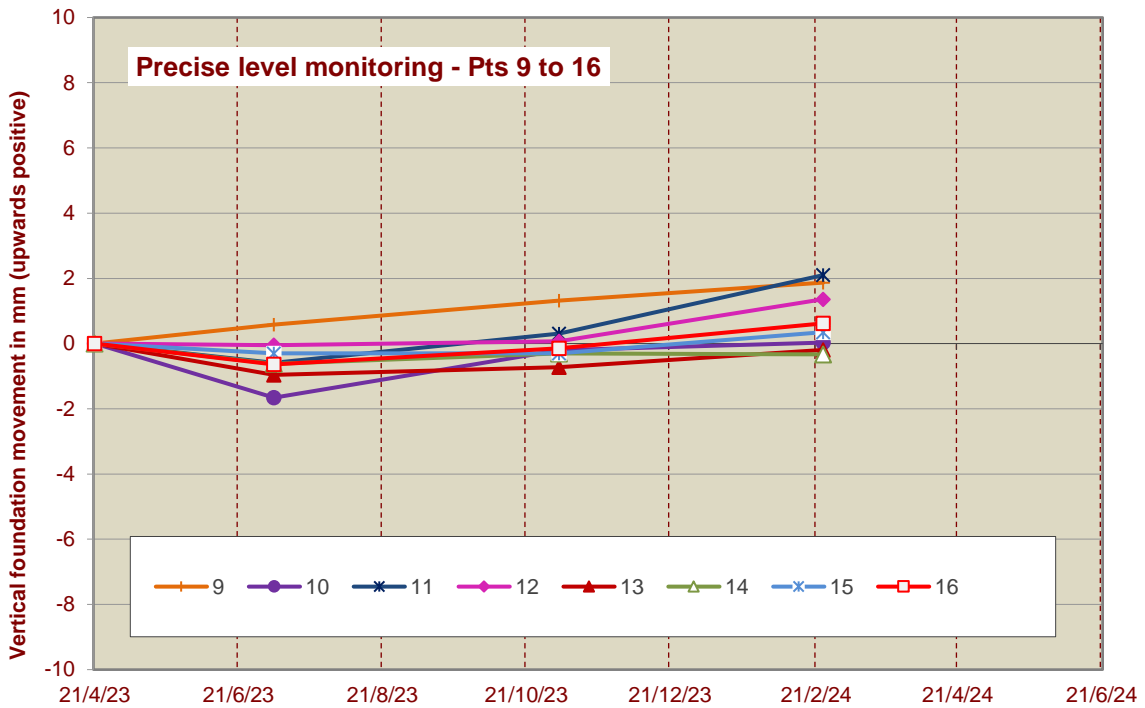
## Precise level monitoring related to Point 1

Survey:	1		2		3		4		5	
By:	CV		CV		CV		CV			
Date:	21/04/2023		06/07/2023		04/11/2023		24/02/2024		#N/A	
Point ID	levels mm	chngs mm	levels mm	chngs mm	levels mm	chngs mm	levels mm	chngs mm	levels mm	chngs mm
1	1000.00	0.0	1000.00	0.0	1000.00	0.0	1000.00	0.0		#N/A
2	1029.04	0.0	1029.26	0.2	1028.91	-0.1	1029.08	0.0		#N/A
3	825.74	0.0	825.50	-0.2	825.60	-0.1	825.98	0.2		#N/A
4	828.24	0.0	828.37	0.1	828.12	-0.1	827.98	-0.3		#N/A
5	922.53	0.0	922.50	0.0	922.12	-0.4	922.44	-0.1		#N/A
6	1004.24	0.0	1004.10	-0.1	1003.88	-0.4	1003.98	-0.3		#N/A
7	1136.82	0.0	1136.76	-0.1	1136.82	0.0	1137.10	0.3		#N/A
8	886.50	0.0	886.39	-0.1	887.15	0.6	887.34	0.8		#N/A
9	934.85	0.0	935.43	0.6	936.17	1.3	936.72	1.9		#N/A
10	1000.69	0.0	999.03	-1.7	1000.49	-0.2	1000.72	0.0		#N/A
11	870.36	0.0	869.77	-0.6	870.67	0.3	872.46	2.1		#N/A
12	1005.92	0.0	1005.87	-0.1	1005.99	0.1	1007.28	1.4		#N/A
13	1120.29	0.0	1119.33	-1.0	1119.57	-0.7	1120.10	-0.2		#N/A

14	1136.45	0.0	1135.83	-0.6	1136.15	-0.3	1136.12	-0.3		#N/A
15	1127.97	0.0	1127.67	-0.3	1127.67	-0.3	1128.32	0.3		#N/A
16	1106.87	0.0	1106.23	-0.6	1106.72	-0.2	1107.49	0.6		#N/A
