PHASE 1 PRELIMINARY RISK ASSESSMENT (PRA)

Wainies Brook, Higher Crackington, Bude
EX23 0LD

Our Ref: 23329

Phase 1 Preliminary Risk Assessment (PRA)

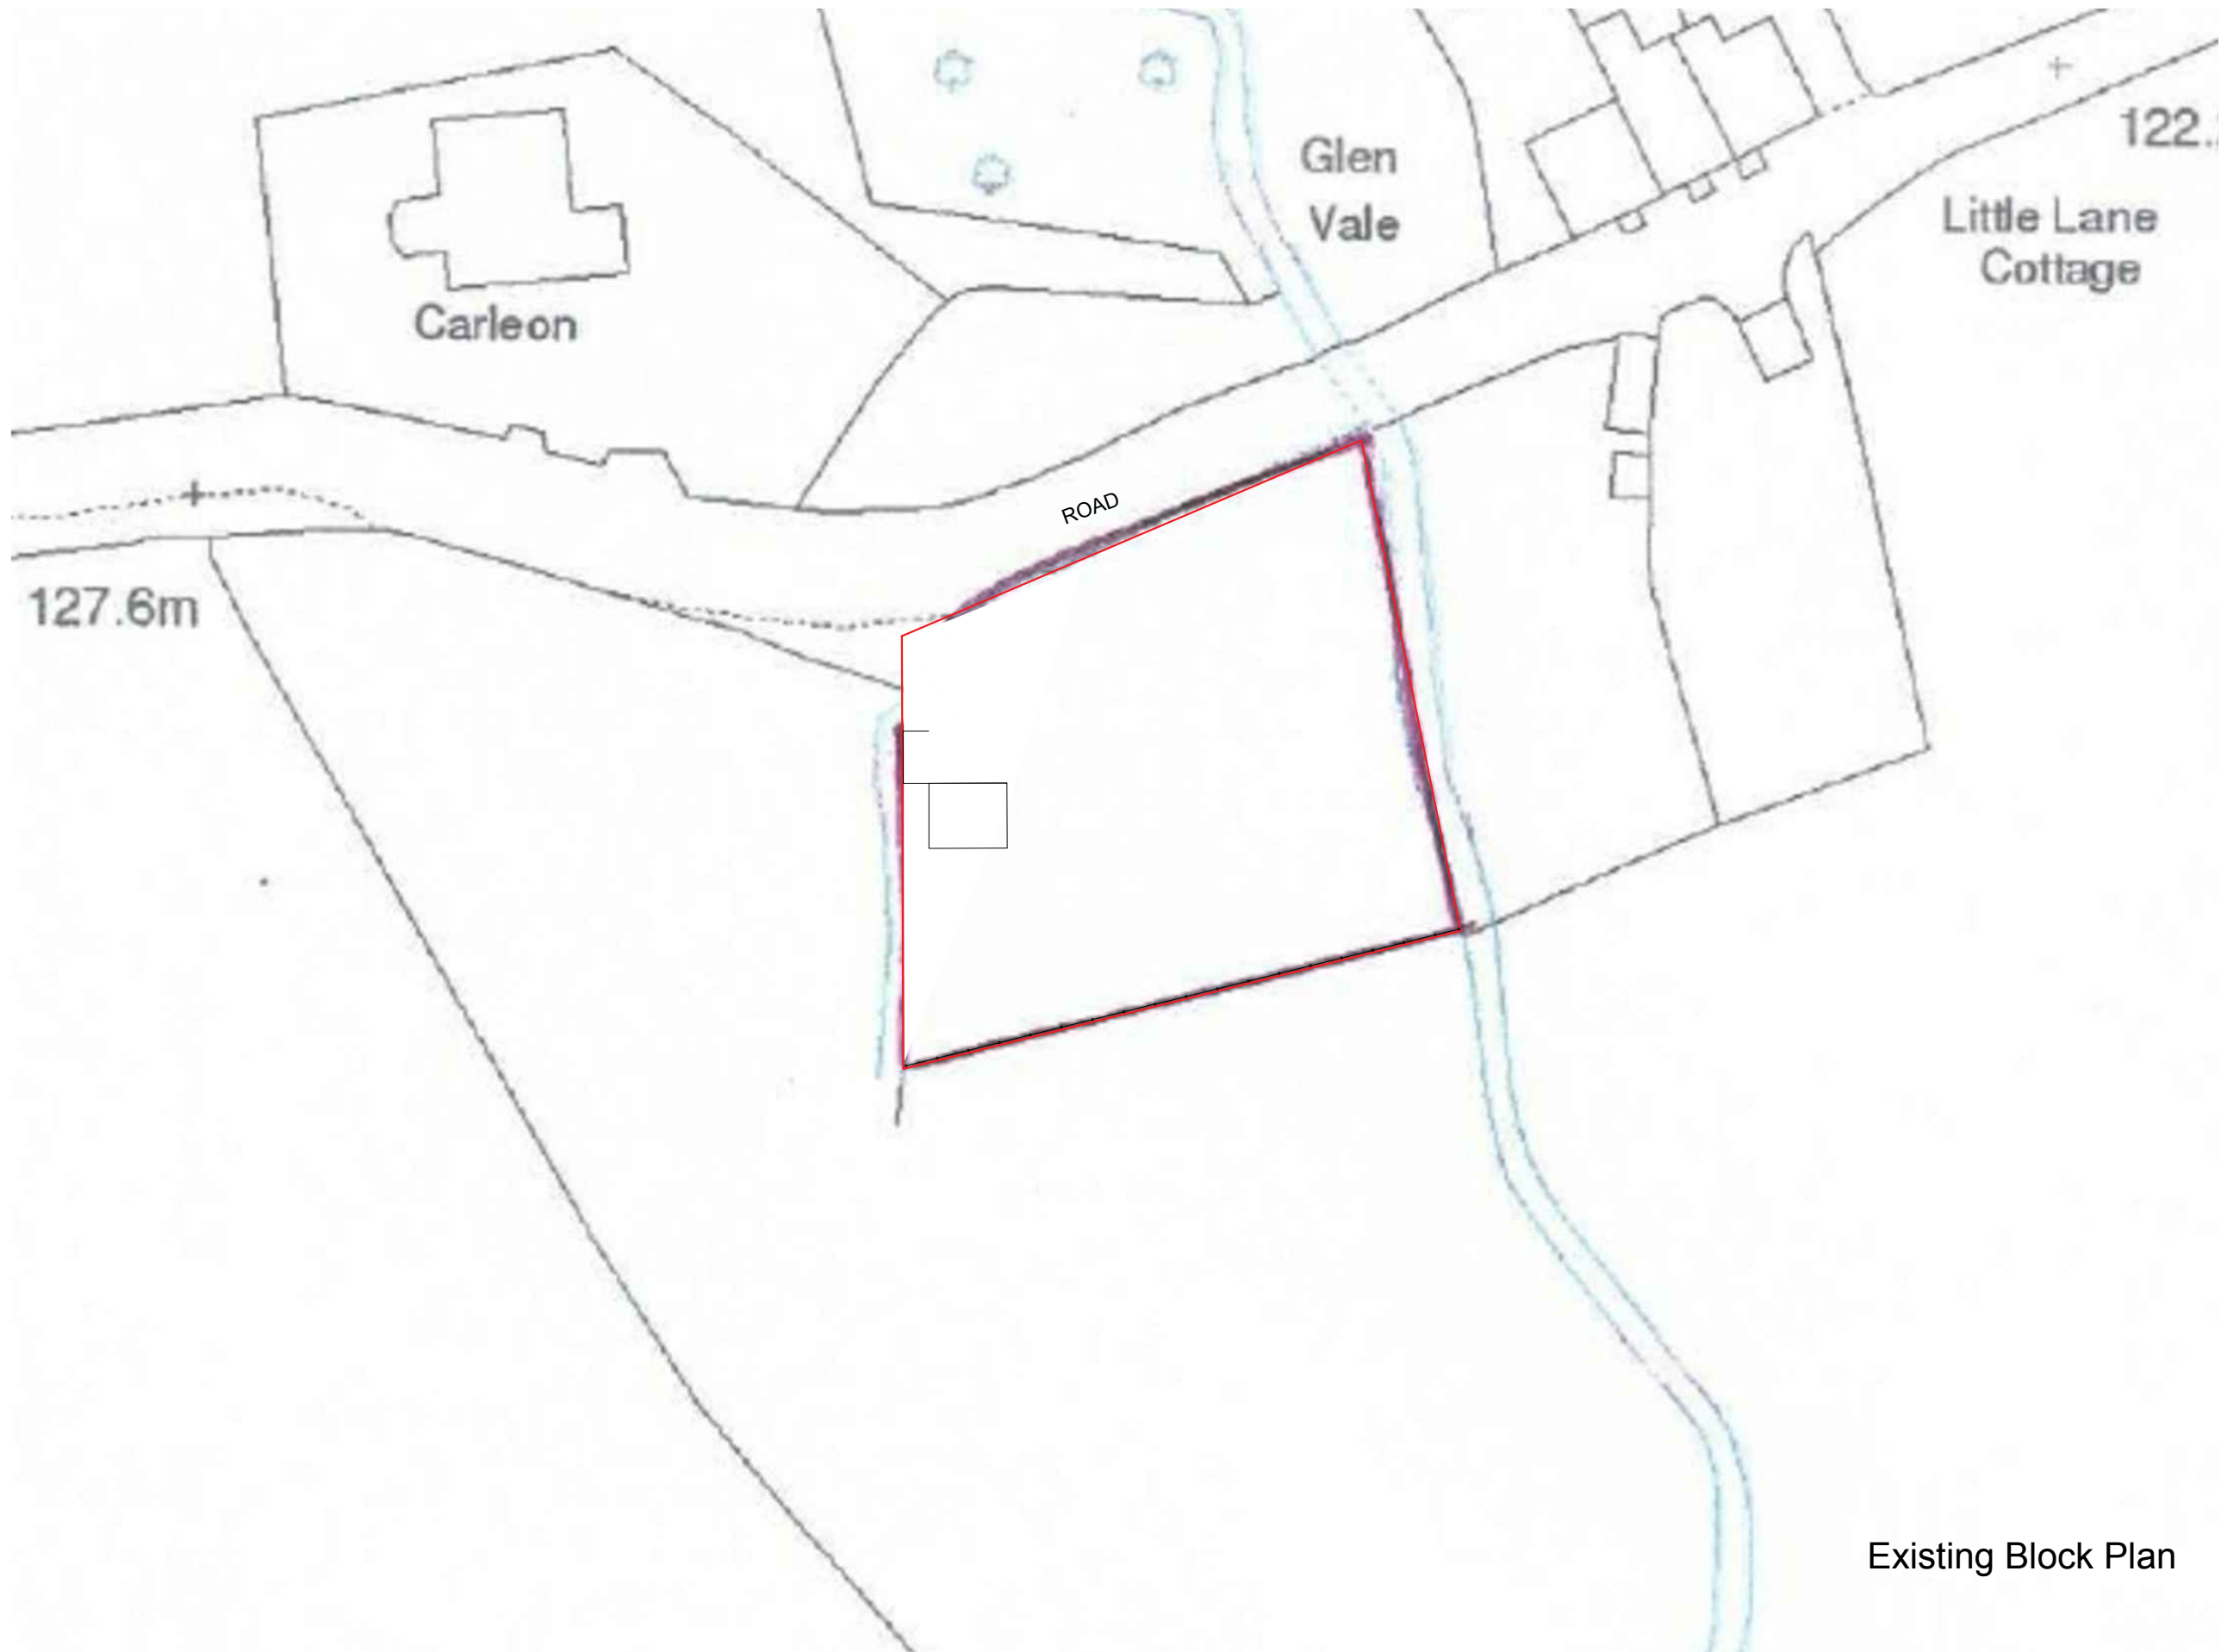
Figure 2.2

The current site plan is contained in Figure 2.2, to the rear of the report.

The site is accessed on its northern edge [Plate 1]. The site is currently a small field, with a small single storey block walled, steel sheet roofed, concrete floored building on its western side (Plates 2, 3). The remainder of the site is laid to rough pasture (Plates 4, 5), sloping steeply down to a brook on its eastern edge (Plates 6, 7), and wet underfoot close to the brook.

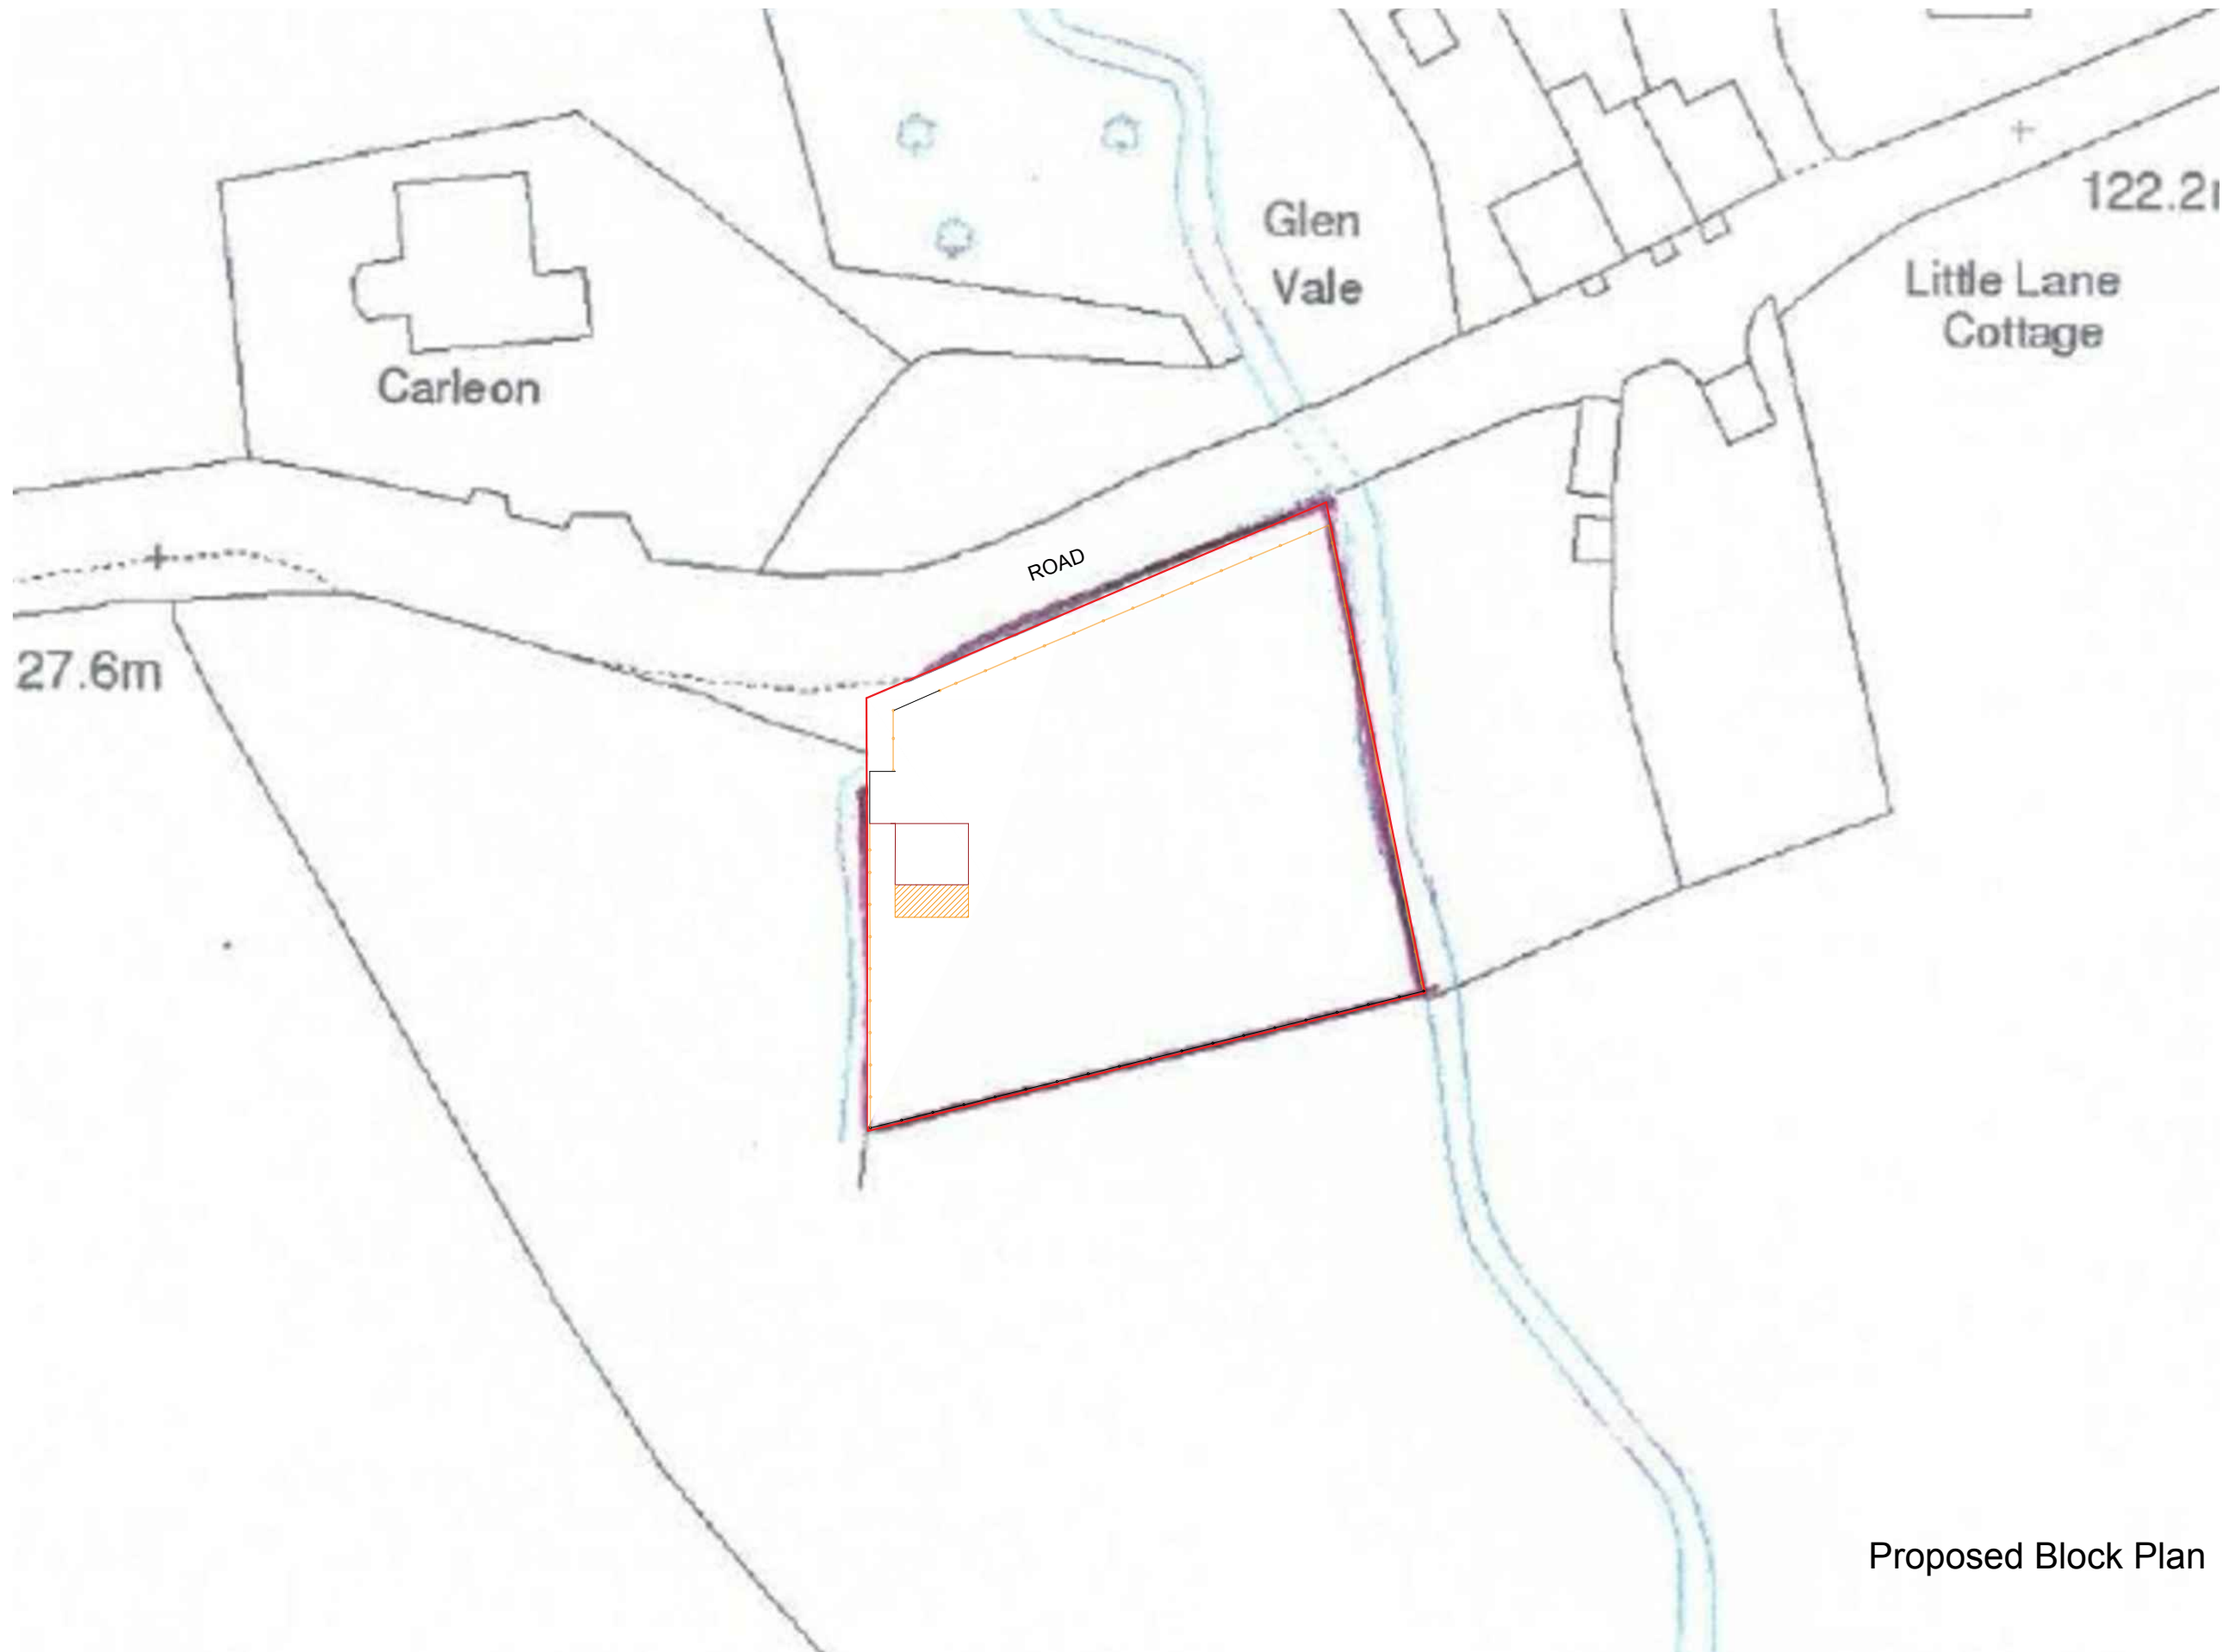
Figure 2.3

It is proposed to develop the site by conversion and extension of a small storage building as a single guest house property.

The proposed site plan is contained in Figure 2.3, to the rear of the report.

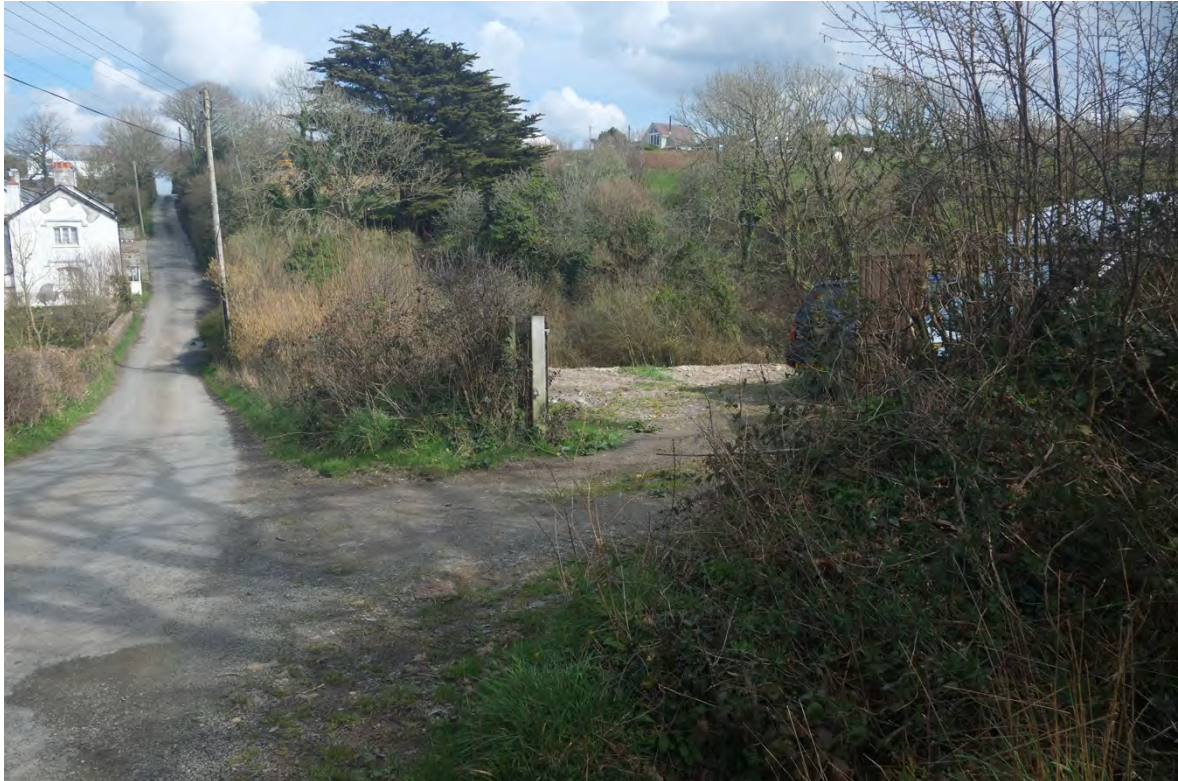
PLATE 1

Mature trees bound the site to the east and west [plates 3, 6]. A hedge borders the lane to the north [plate 1]. To the south, the boundary is delineated by a fence and recent hedge planting [Plates 5, 7].

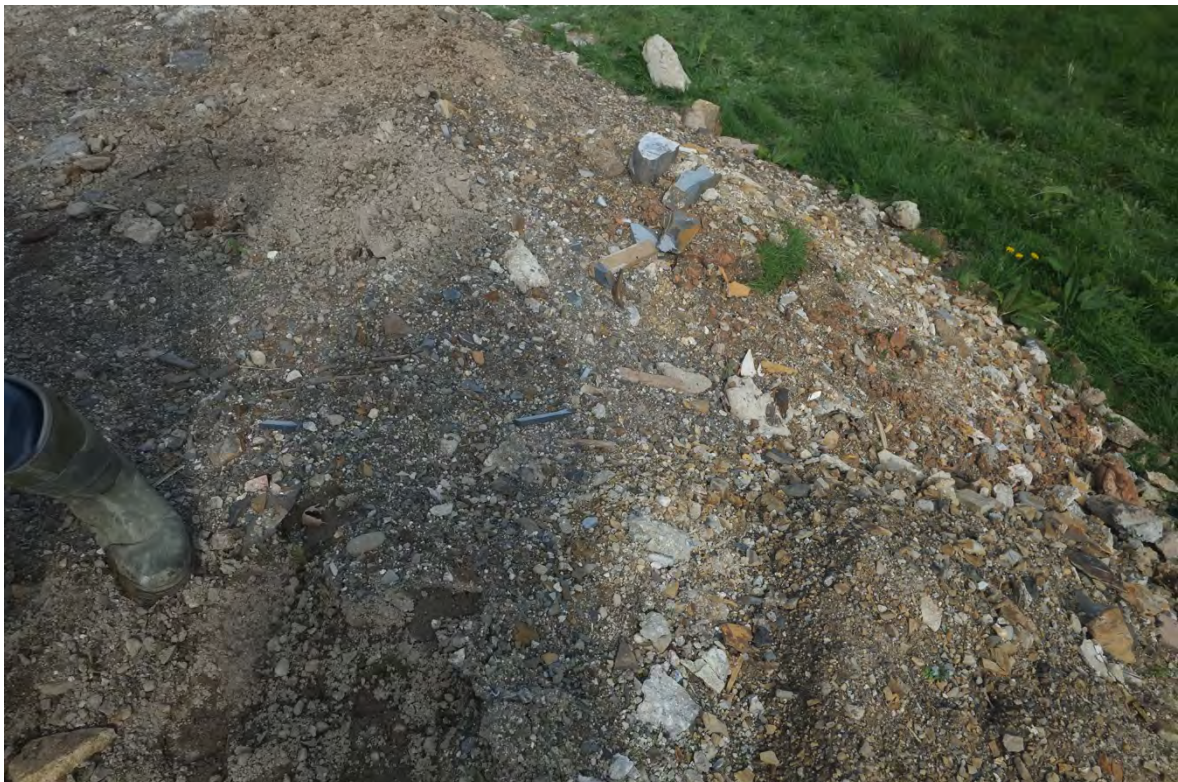
PLATE 8

The access to the site has recently been surfaced with locally sourced imported material comprising mainly natural gravel derived from local strata ("Shillet"). Some pieces of brick and concrete were visible but no tarmacadam or asbestos containing material was visible [Plate 8].
