PRELIMINARY ROOST
APPRAISAL

10 BINSWOOD AVENUE
LEAMINGTON SPA CV32 5SQ

Date: 28th February 2024

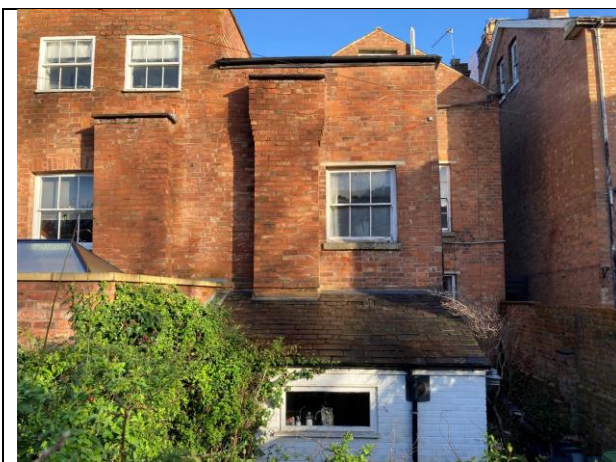
3.1.1 The building was a stucco brick, three storey Regency villa. The main roof was pitched and clad with natural slate tiles and included a parapet at the north elevation. The roof appeared in reasonable condition, although the flashing in the valley between the roof and neighbouring roof was in poor condition but no PRFs or ingress points were observed in association with it.

Photo 1 South elevation

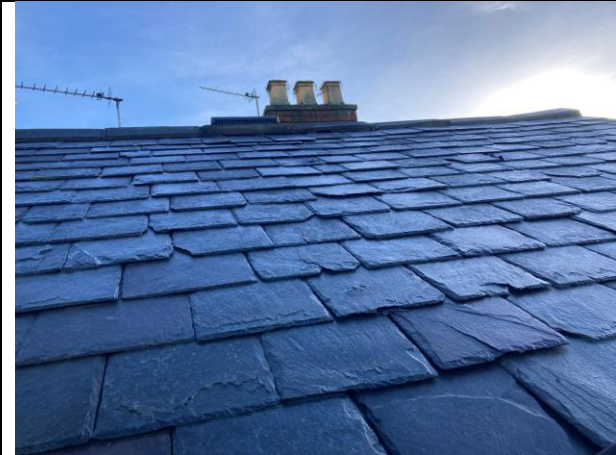
3.1.3 The ridge supported significant cobwebbing which was considered to provide evidenced that the ridge had not been disturbed by bats or other animals in recent years. The main roof was considered as having no bat suitability.

Photo 2 Main roof west pitch

Photo 3 Main roof west pitch

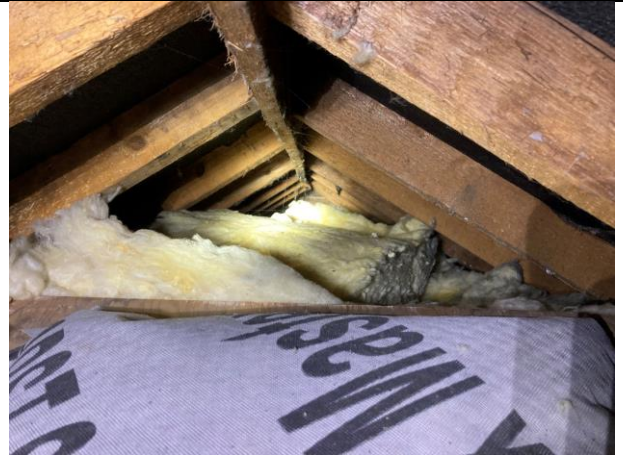
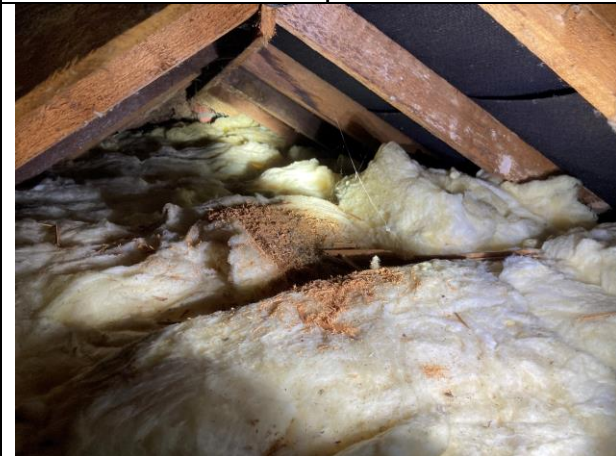
3.1.2 The roof void was taken up mostly by living space, although a small void was accessed. Inside the void it could be seen that the roof was supported by relatively new timbers and bitumen lining and the small area was stuffed with fibreglass insulation. No evidence of bats was encountered on the upper surface of the insulation or areas beneath which were inspected by lifting the insulation.

Photo 4 Small void above main roof

Photo 5 Small void above main roof

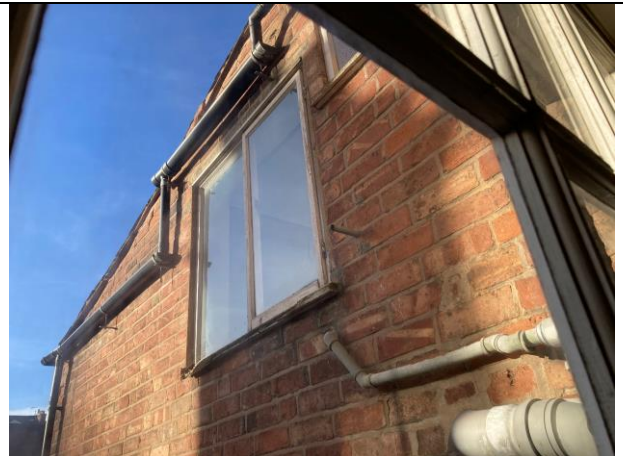
3.1.4 Adjoining the main structure was a two storey section that had a single pitched roof. This was covered with natural slates and was in reasonable condition, although some areas of the east verge appeared to show gaps where mortar had fallen away. On closer inspection from an adjacent gable window it could be seen that the damage was superficial and that no access points / PRFs had arisen from it. The structure was considered as having no bat suitability.

Photo 6 East verge rear (south) two storey section

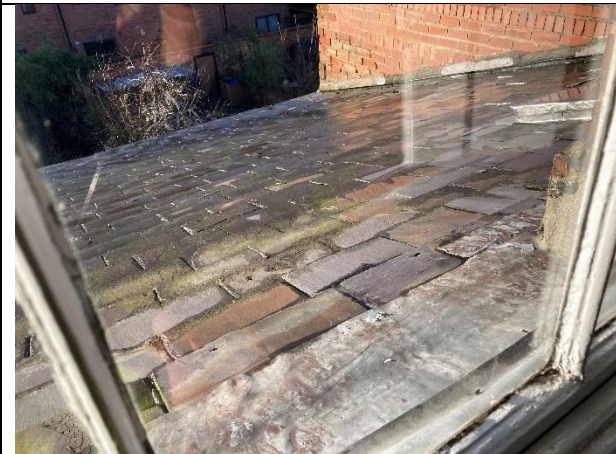
Photo 7 Single pitch over two storey section to rear

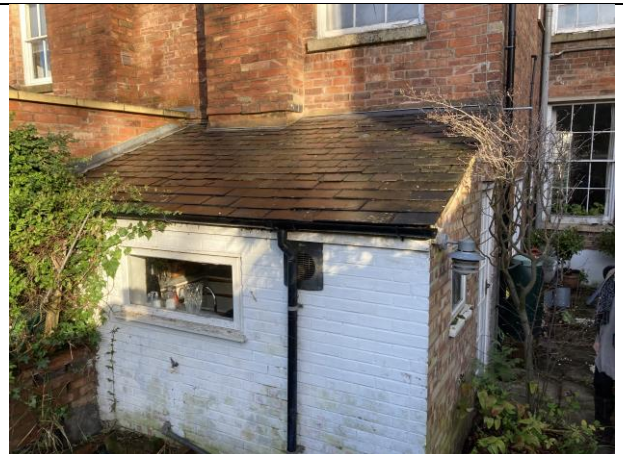
3.1.4 To the rear of the double storey brick section was a small, single storey brick outbuilding that appeared to have been converted to kitchen space. This had a single pitched roof clad with natural slate tiles which appeared to be in reasonable condition showing no PRFs. The structure was considered as having no bat suitability.

Photo 8 Rear outbuilding
