Sauchiehall Street, Glasgow

Desk Study and Preliminary Risk Assessment

Project No: 541974

Client: Fusion Glasgow Devco Ltd.

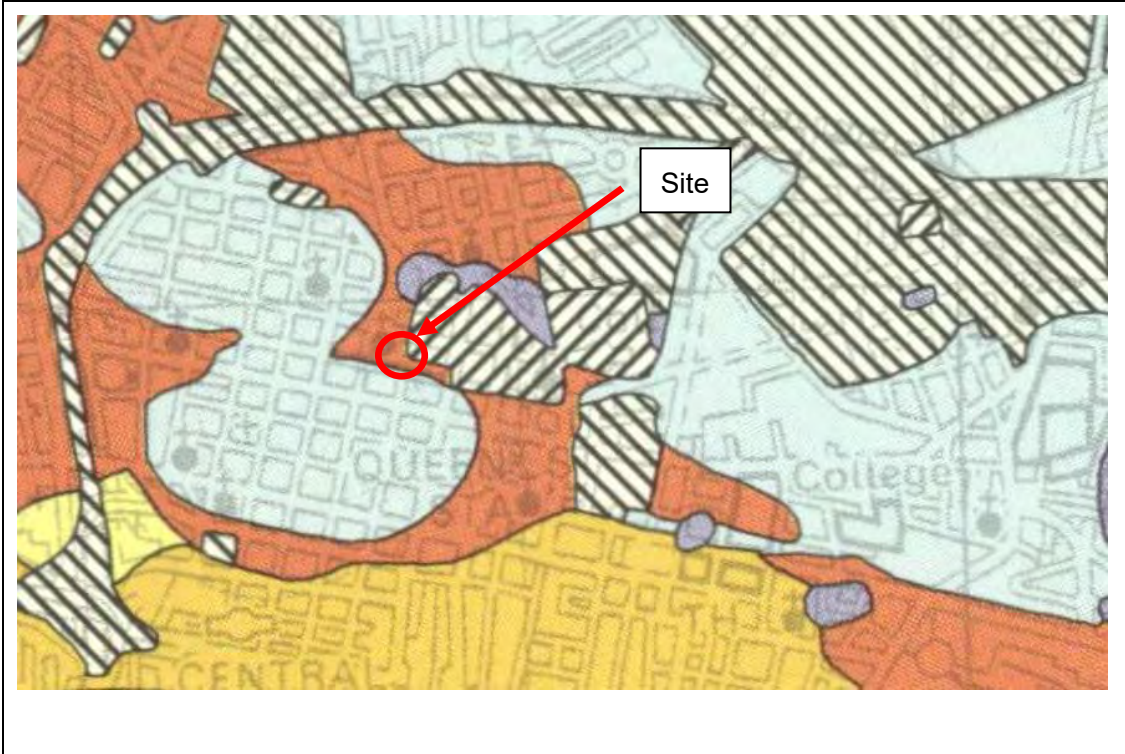
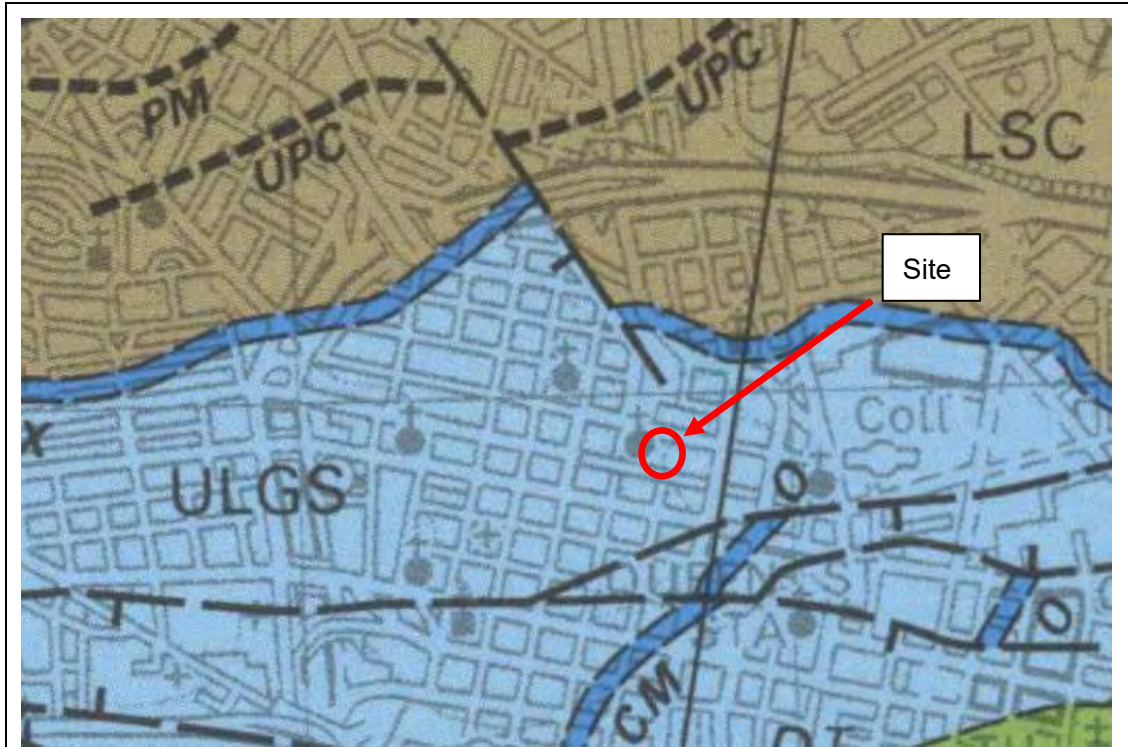
Superficial Geology

The BGS online maps portal provides access to scans of almost all maps produced by the BGS since 1932. An extract of the most recent available scanned maps for the site are included below:

Made Ground: man-made and natural materials on original ground surface

Made Ground: Fill of man-made and natural materials in excavations

Glaciomarine Deposits: intertidal and subtidal clay and silt

Glacial Diamictons: till of lodgement or deformation type, boulders and stones in a hard to stiff sandy silty clay matrix.

The geological maps show the north-eastern corner of the site to be underlain by made ground; whilst glaciomarine sediments comprising silt and clays and glacial diamicton deposits comprising boulders and gravels in a sandy silty clay matrix outcrop across the remainder of the site. BGS borehole records for the nearby Royal Conservatoire of Scotland building located 30 m to the north-east of the site indicate made ground in the area to extend to an approximate depth of 11 m. Boreholes situated around Bath Street approximately 90 m south of the site show boulder clay deposits extend to a similar depth of approximately 10 m. It is likely that the glacial diamicton underlies the glaciomarine deposits.

The BGS superficial map sheet records the made ground as an area of fill or man-made and natural material in excavations. Any prior excavations pre-date the historic maps procured as a part of this study. Inspection of the BGS historic borehole records from within the area of made ground indicate that it is generally granular in the near surface, and generally fine grained soils at depth with fragment of brick. Locally coarse sandstone gravel is reported at the base as possible or presumed made ground.
