Preliminary Roost Assessment and Ecological Walkover

Great Underbank, Stockport

Reference: 81-352-R1-1

Prepared for:
Kion Developments

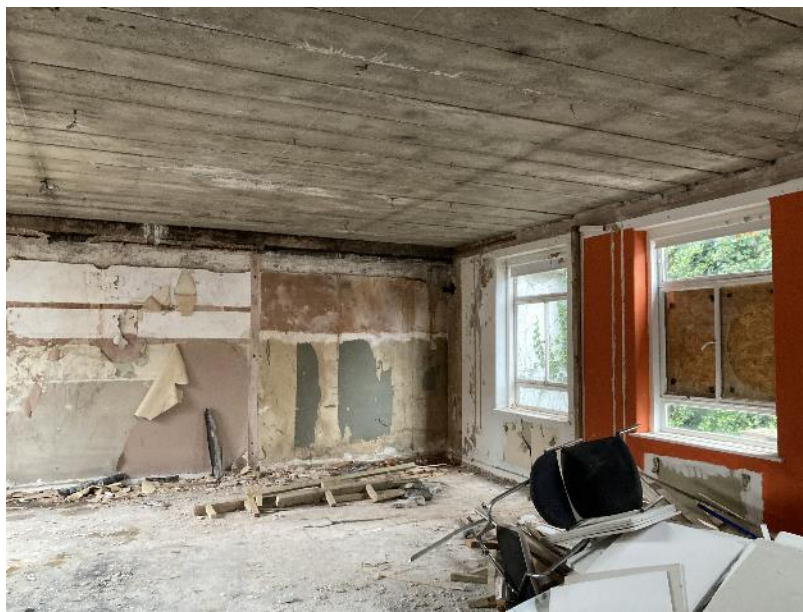
PLATE 1 SHOWING FIRST FLOOR

The building comprised a commercial unit on the ground floor, comprising Old Town General Store. The first and second floor had also previously been used for commercial purposes but were vacant at the time of the survey. Internally, on the ground floor the building was in good condition. However, it was evident that the upper two floors had been subject to partial renovation works. Crevices in brickwork and areas of peeling paint and wallpaper were noted across the first and second floor. These features may provide suitable roosting opportunities for opportunistic bats. Windows were smashed on both the first and second floor, though these had been adequately boarded. Thereby, preventing bats from accessing the internal roost features within the building.

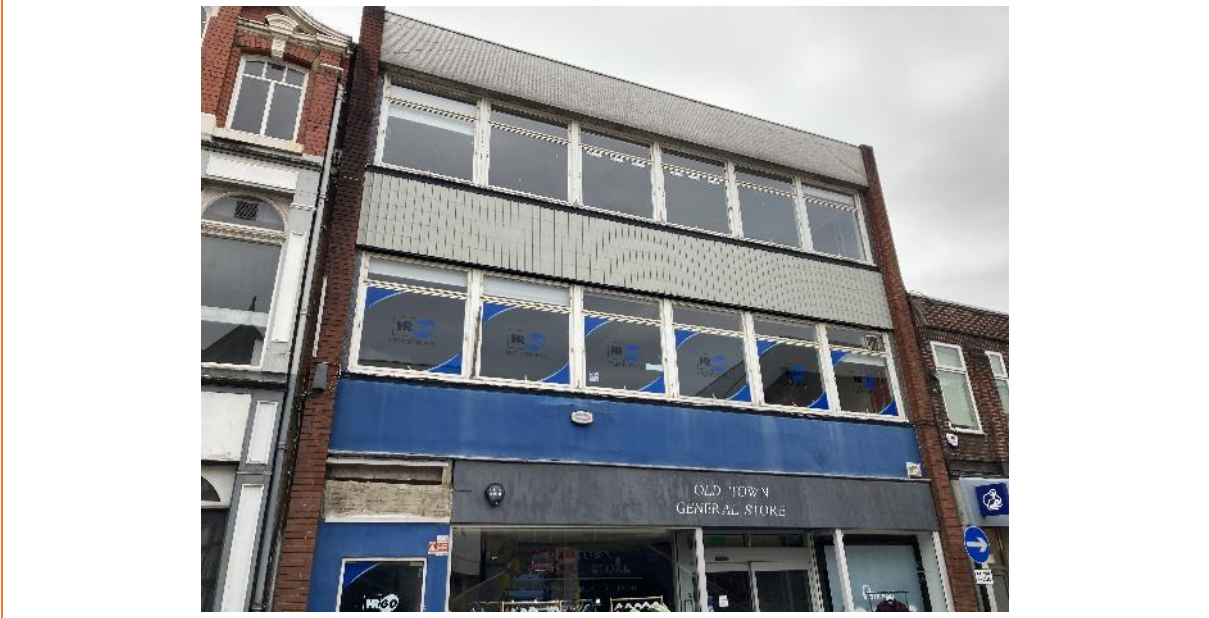
PLATE 2 SHOWING MAIN ENTRANCE ON NORTHERN ASPECT

Externally, the building comprised red brick and plastic clad walls, with a flat roof formed of concrete. On the northern aspect of the building the brickwork was largely well sealed, providing no potential roosting opportunities for local bats. Missing cladding was noted above the main door on the northern aspect, revealing the underlying concrete and mortar. On assessment, this feature was determined to be too exposed and liable to fluctuating temperatures. As such, bats are not anticipated to use this feature for roosting purposes. However, lifted flashing was noted above the door, running the extent of the front of the building. This could offer crevice dwelling species with roosting opportunities, however, the lifted flashing was located on the northern aspect of the building, directly above the commercial shop, facing the busy high street, thus limiting its overall value for roosting bats as it is likely subject to regular disturbance. No other potential roosting features were noted on the northern aspect of the building.

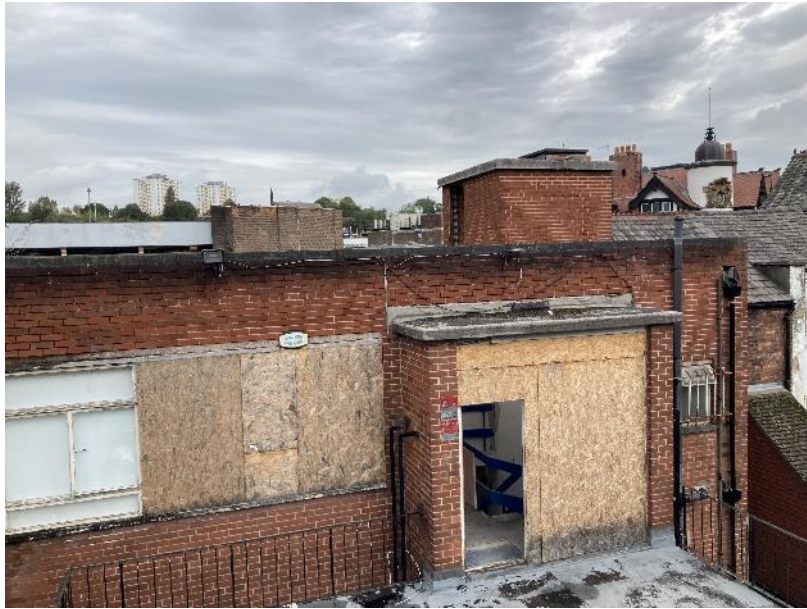
PLATE 4 SHOWING DAMAGED SOUTHERN ASPECT

On the southern aspect, the second floor did not extend across the entirety of the building, creating a terrace above the southern aspect of the first floor. The terrace was well sealed with no roosting features identified. However, gaps within the brickwork surrounding the pipework were noted on the external of the second floor. These features may provide opportunities for crevice dwelling bats such as pipistrelle species (*Pipistrellus sp.*) on an occasional basis. In addition, areas of missing mortar were noted above the window on the southern aspect.

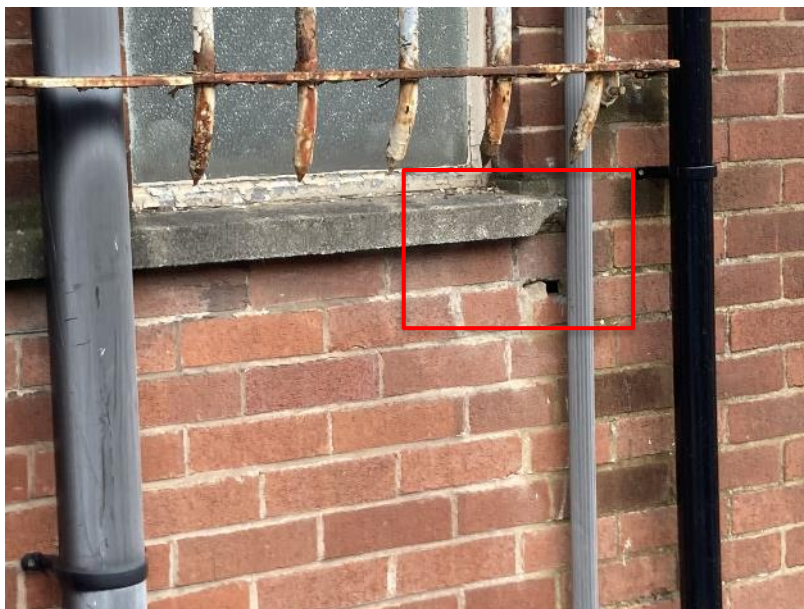
PLATE 7 SHOWING DAMAGED BRICKWORK (F4)

On the southern aspect beneath a window ledge, adjacent to pipework a crevice in the brickwork was identified. The feature was approximately 20 cm south-west of the window on the southern aspect of the building.

No other potential roost features were identified externally. The features were identified as providing roosting opportunities for crevice dwelling species on an occasional basis only. The building lacked a cellar and loft void, and no features were found to be suitable to support hibernating bats or maternity colonies. Overall, the building was assessed as having Low bat roosting potential.

- ✦ The building was assessed as having Low bat roosting potential. As such, one Nocturnal Bat Survey is required on the building between May and August (inclusive). If bats are identified roosting within the building, a further two surveys would be required to characterise the roost and a European Protected Species Licence will be required and with up-to-date surveys from the survey season prior to the application submission.

- ✦ Alternatively, due to the low suitability features and urban location of the site an ecologist will attend site during the initial phases of the works. This will avoid further delays to the planning application. If the application is submitted after May 2024, it's likely further surveys would be required. An ecologist would supervise the works affecting the sensitive areas during the initial works. This would comprise a search for bats prior to the works commencing, including the removal of the crevices and damage to the brickwork. If bats are found roosting within these features works will cease and an EPSL will be required.

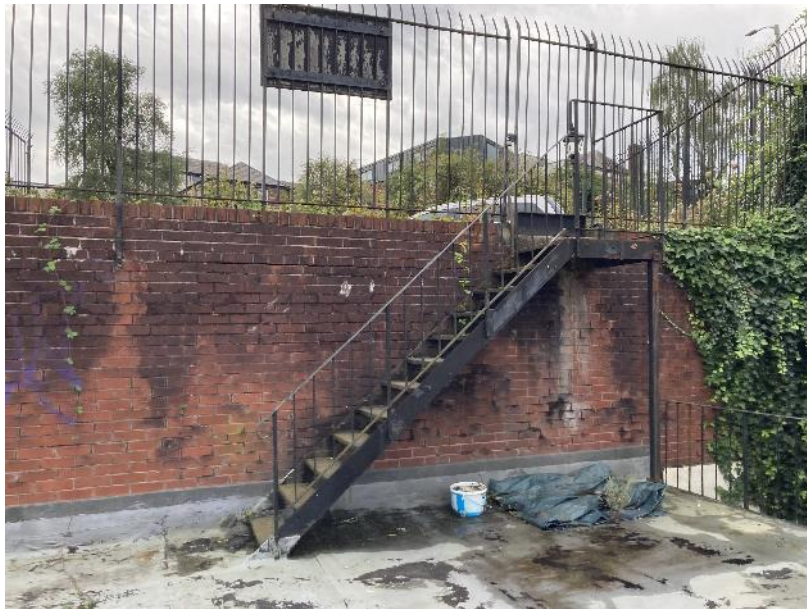
PLATE 8 SHOWING RED BRICK RETAINING WALL

A red brick retaining wall was noted south of B1, defining the hardstanding car park. The wall was approximately 2 m in height at its maximum. The western aspect was dense with ivy (*Hedera helix*) coverage and as such could not be fully inspected for potential roost features. However, due to the density of the ivy it is expected to prevent bats from roosting within any potential roost features beneath. The remainder of the wall was well sealed with no potential roost features observed. Therefore, the wall was assessed as having Negligible bat roosting potential.

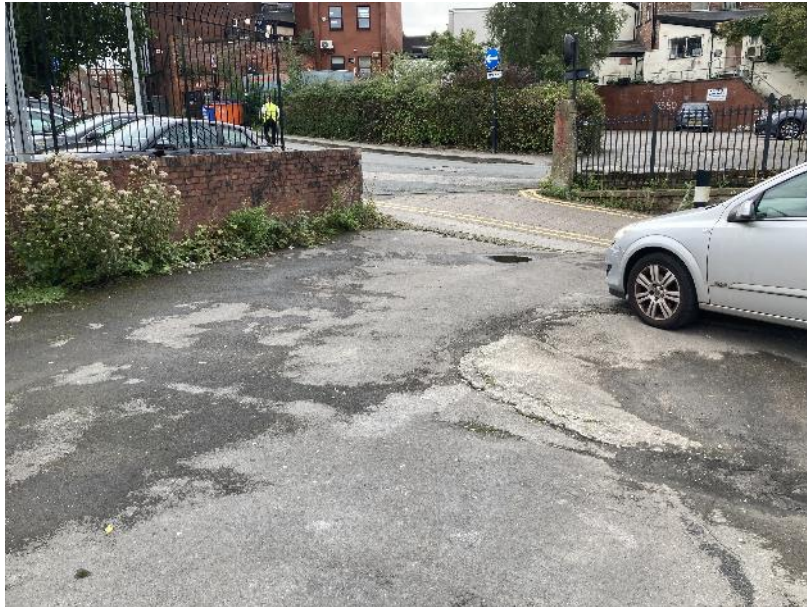
PLATE 9 SHOWING HARDSTANDING CAR PARK

The remainder of the site comprised a hardstanding car park, which was colonised in areas by spear thistle (*Cirsium vulgare*), bramble (*Rubus fruticosus agg.*), ivy, hemp agrimony (*Eupatorium cannabinum*), American willowherb (*Epilobium ciliatum*) and oxford ragwort (*Senecio squalidus*). Due to the expanse of hardstanding and sparse vegetation the site offers limited ecological value for local wildlife.

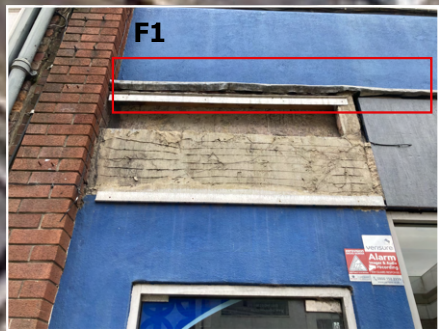
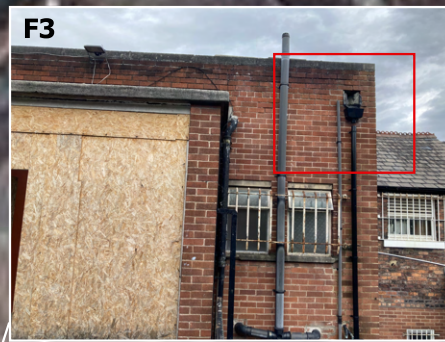
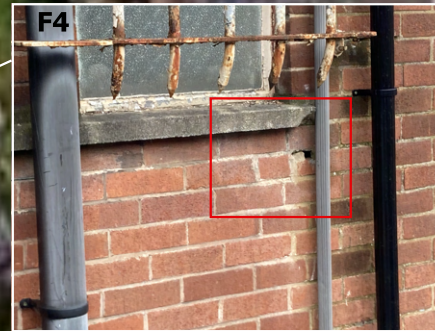
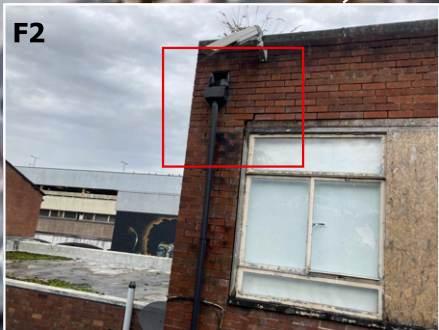
**APPENDIX I
PRELIMINARY ROOST
ASSESSMENT PLAN**

A Preliminary Roost Assessment (PRA) was undertaken on the building on-site, as well as the retaining wall to the south. No other buildings, structures or trees were present within the site boundary. Please see Appendix I for the Preliminary Roost Assessment Plan which details the location of the potential roost features.
