Dean Farm, Dean, Shepton Mallet

Bat & Bird Survey Report

Date: June 2023

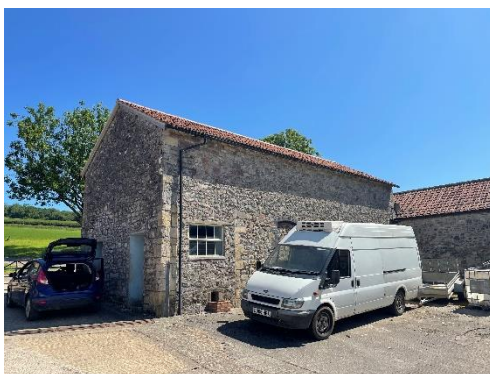
Plate 1: Barn (Southern Aspect)

The Barn was a stone building that was attached to another building in the east (Plates 1 & 2). The walls were constructed from stone and mortar and were in a good condition. A former doorway on the northern aspect had been blocked up. A small number of holes were present; these were inspected with an endoscope and no signs of bats were recorded (Plate 3). Intact doors and windows were present throughout. Open-bottomed soffit boxes were located on the northern and southern aspects. Fascia boards were present on the gable walls. Both the soffit boxes and fascia boards contained gaps that led into the roof (Plate 4). The roof was pitched and clad in double-roman tiles. The roof was in a good condition lacking any raised, slipped or missing tiles. The apex tiles were cemented in place.

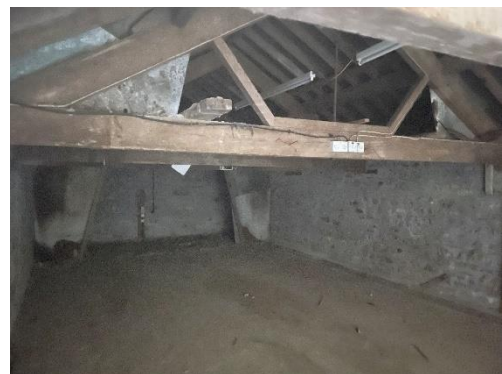
Plate 6: Barn – Interior (Upper-floor)

The upper-floor comprised an open-plan space (Plate 6). The walls comprised exposed stone and were in a good condition. The roof was lined with bitumen felt and supported by a sealed wooden frame. Cobwebs covered much of the apex. There were no obvious access points into the upper-floor and no signs of bats were recorded.

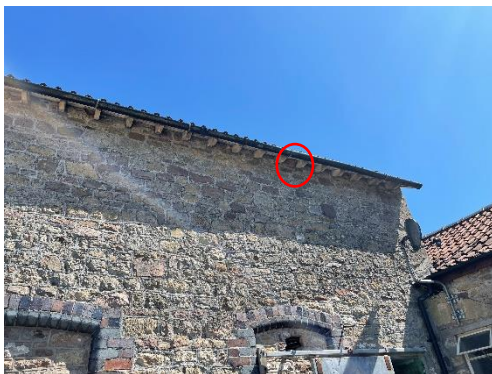
Plate 7: House Martin Nest (Circled)

An active house martin (*Delichon urbicum*) nest, along with several crumpled nest cups, was present on the Barn’s southern aspect (Plate 7). A dead swallow (*Hirundo rustica*) was found next to a window on the ground-floor (Plate 8). It is likely that the swallow accessed the Barn via the drainage hole and could not escape. A disused swallow nest cup was present in the upper-floor.

An active house martin nest was located at the eaves on the southern aspect. Effort will be made to retain this nest cup and avoid disturbance to the birds. Works will be undertaken outside of the nesting period (i.e. between October and March), when the house martins are absent.
