## 2021 - FOLLOW-UP BAT AND PROTECTED SPECIES SURVEYS

TRADITIONAL FARM BUILDINGS  
GRANGE FARM  
WISETON  
DONCASTER  
NOTTINGHAMSHIRE

January 2022

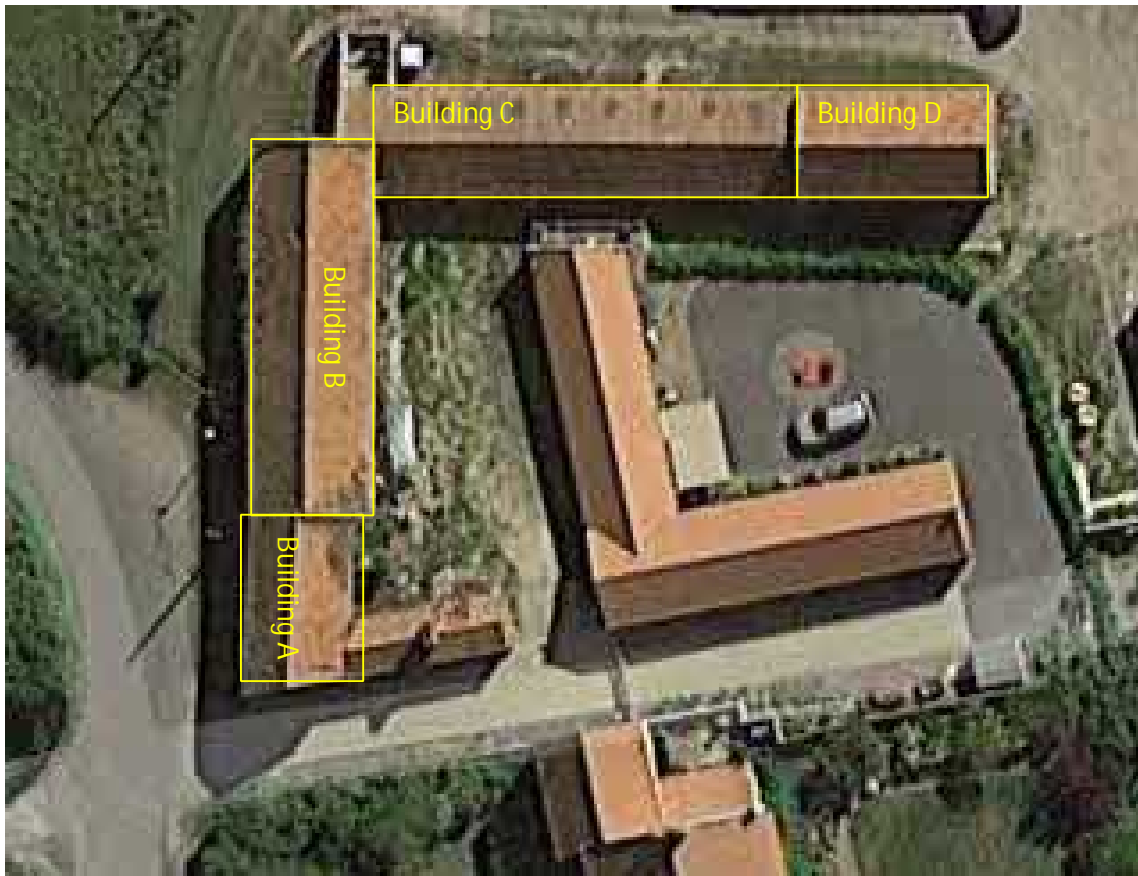
Figure 1a: The annotation of the farm buildings in this survey report, courtesy of Google Earth

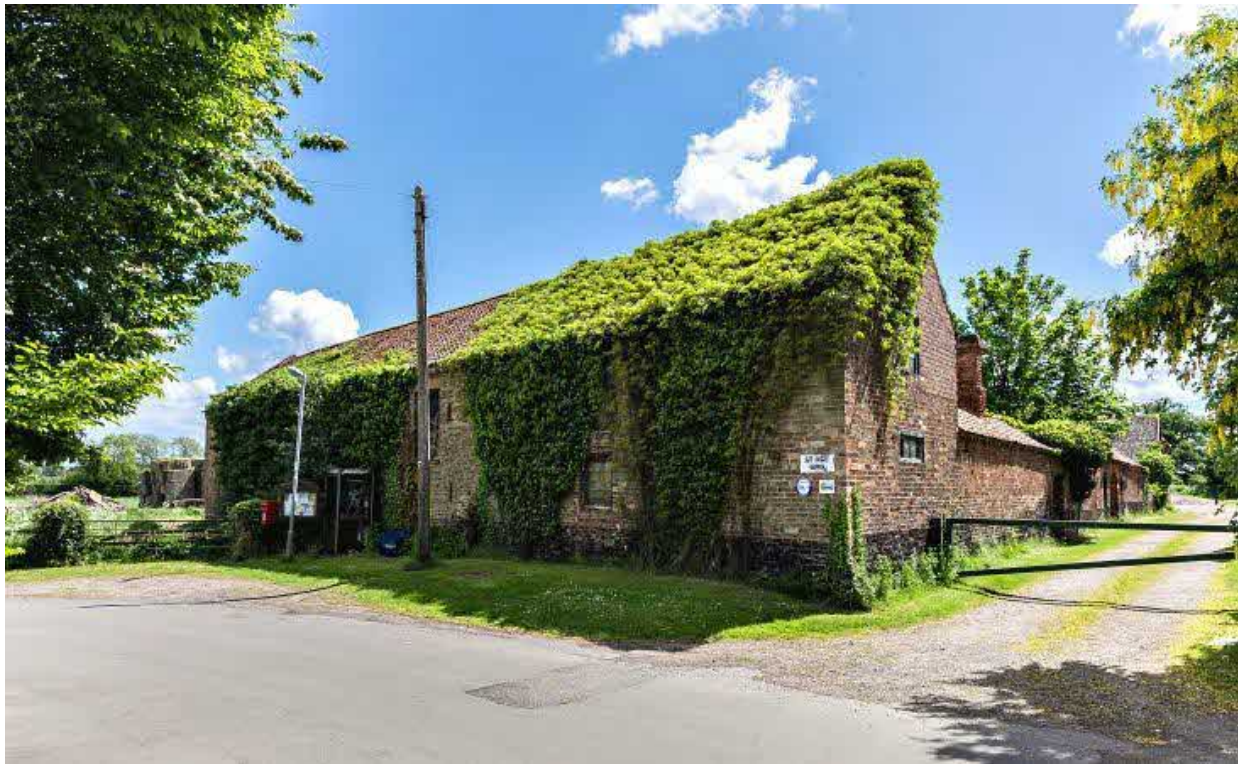
Building A is a two-storey barn in the north-west corner of the site. It is constructed from solid brick with a pantile roof covering atop a timber purlin and rafter frame. The roof covering is not underlined and is covered by a climbing plant. The building is fitted with timber windows and doors, of which the ones on the first floor are open and give access internally.

Building B is a former threshing barn of two-storey height connected on its western end to Building A where they share a gable. Building B is a single open void from floor to roof apex internally. It is constructed from solid brick with a pantile roof covering atop a timber queen post roofing frame. The

Photograph 1: Building A and Building B taken from the north-west, showing the two-storey height and the climbing plant covering parts of the roof.

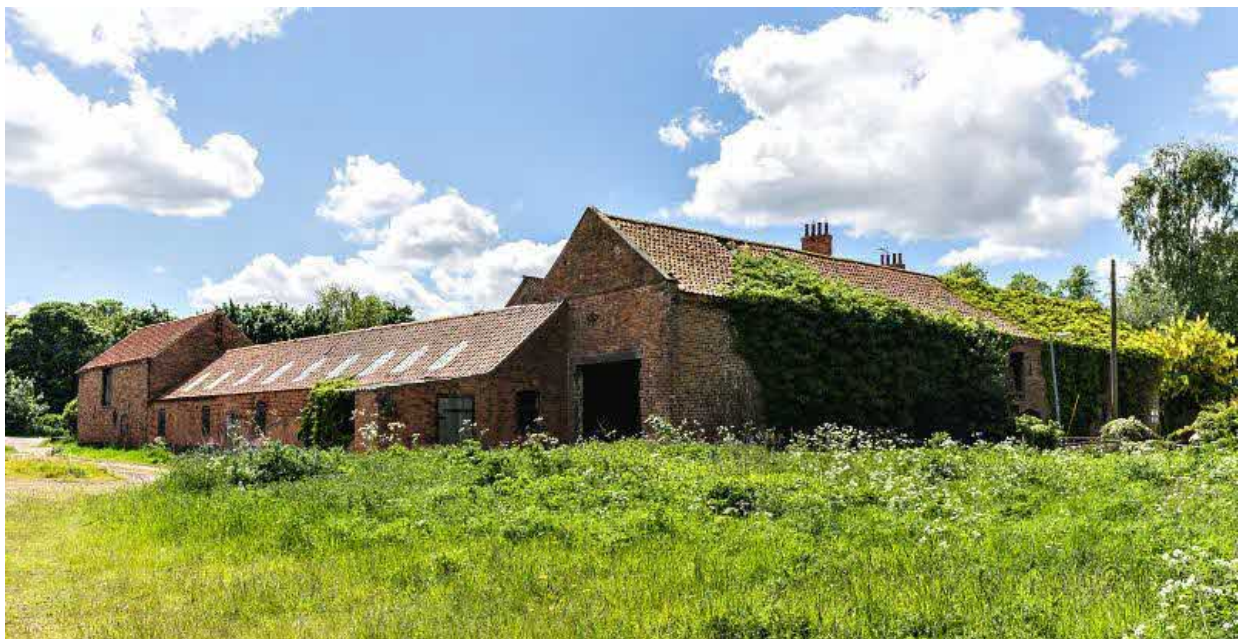
Photograph 2: Buildings A and B to the right and C and D to the left, taken from the north-east.

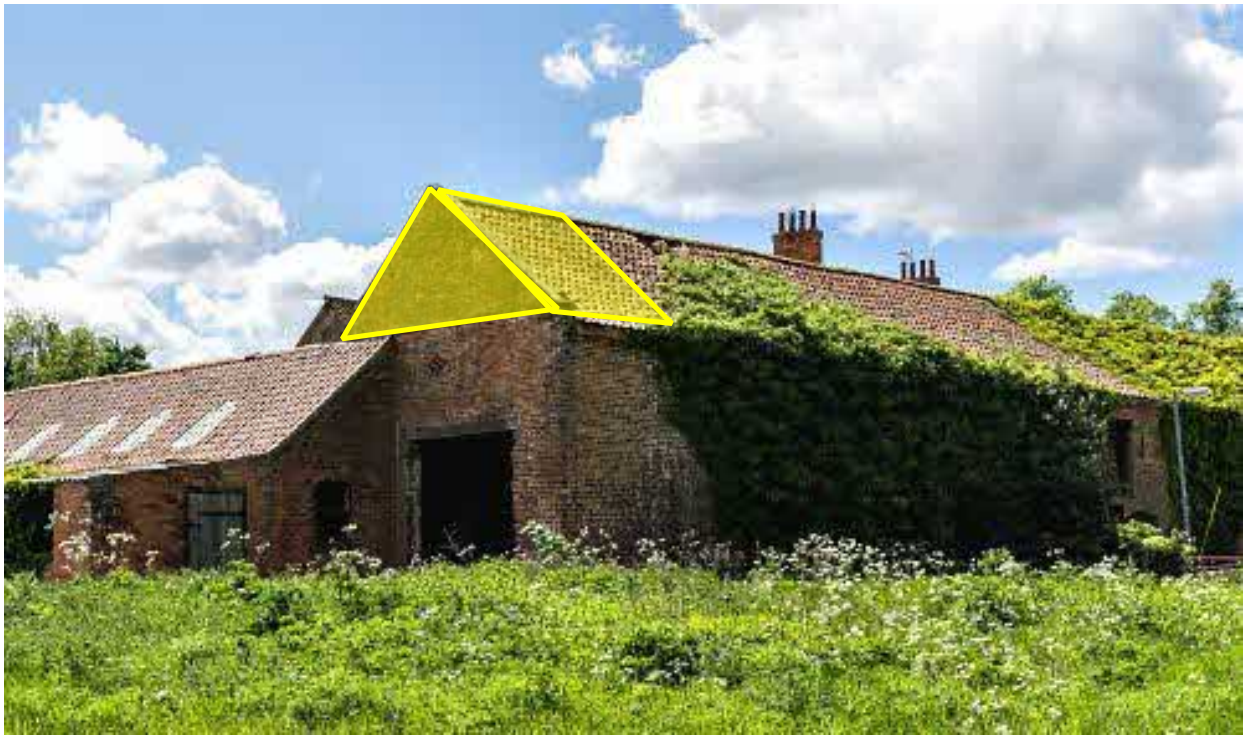
Figure 2: The position of the proposed bat attic within the roof void of the threshing barn.

It is recommended that a single bat attic be installed within the redeveloped roof void of building B. In order for this space to be sufficient for replacing the lost habitat, the dimensions must be of at least 5m in length, the width of the barn and 2.8m in height with a completely unobstructed void to allow for pre-emergence flight. The position of the bat attic is shown in the annotated image Figure 2 below.

The requirements for an unobstructed roof void should be delivered by retaining the existing purling and rafter roof frame. The proposed location for the bat attic is shown in Figure 3.

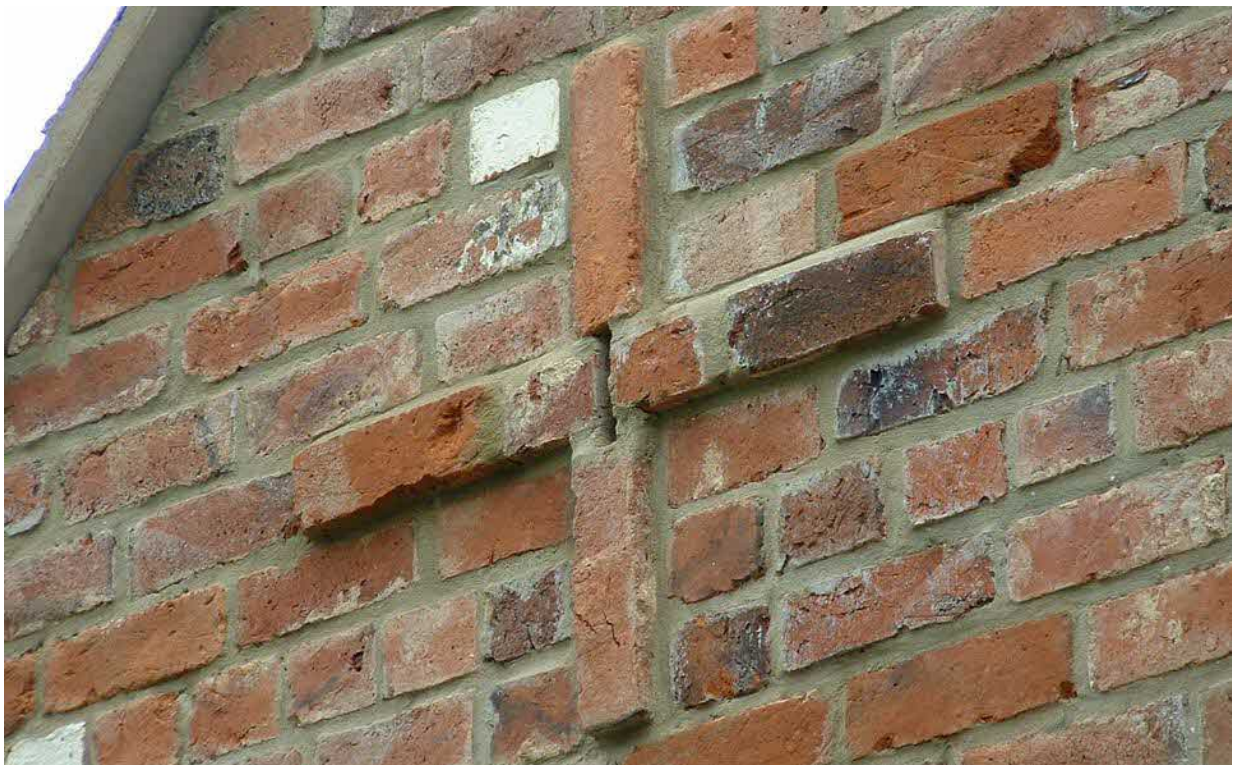
Figure 3: an example of the access slit to be installed within the eastern gable.

Access into this roof void must be in a similar area in relation to the access cart doorway on the eastern gable of building B. This access point will be achieved by installing a slot like access through the flat face of the gable, an example of this is shown in Figure 4 below.

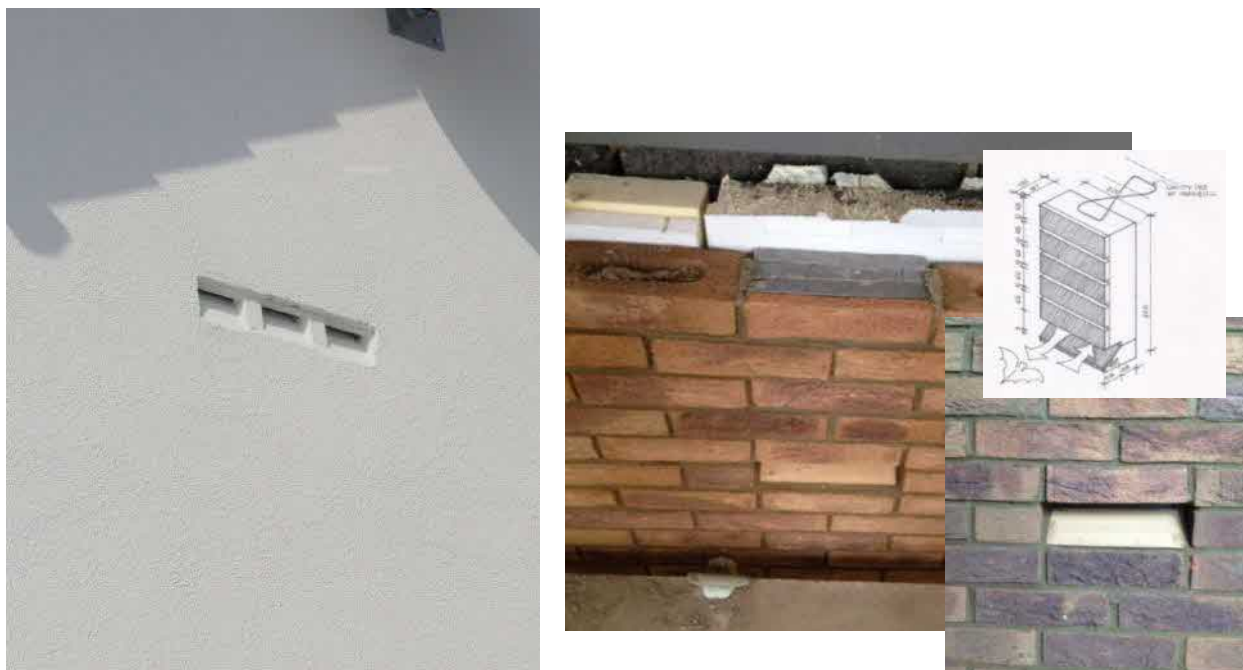
Figure 4: Examples of bat tubes fitted within the brickwork of an exterior wall

For the day roosting bats which emerged from the south facing gable of building A, an enclosed bat tube is to be installed in one of the exterior walls of the redeveloped barn.

The enclosed bat tubes are to be installed within the exterior walls as such that the access slot to the box fits flush with the wall to allow a bat to land below and crawl up into the box. An example of an installed Habitat box is provided in figure 4 below.

In order to comply with best practice mitigation a total of three of these boxes are required, to replace day roosting habitat on a like-for-like basis.
