Preliminary Roost Assessment:

Gods House Farm, Harts Lane, Ardleigh, Colchester, Essex
CO7 7QQ,

Eco-Planning UK

May 2023

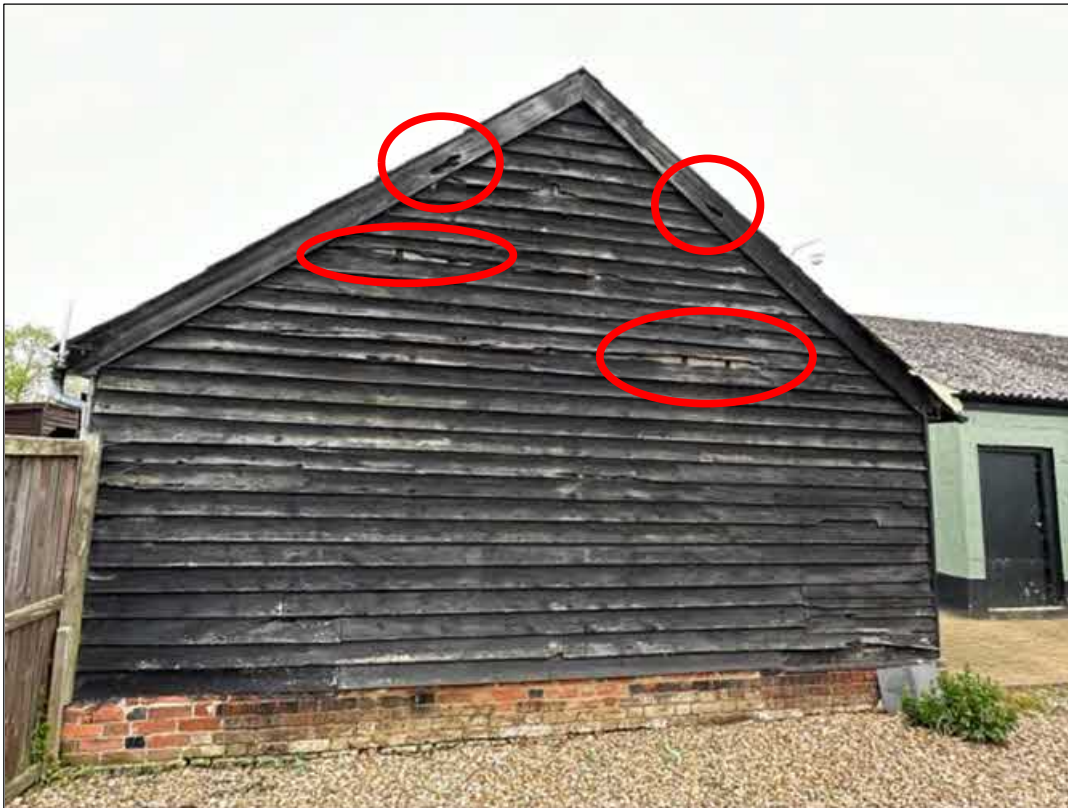
3.1 The storage barn is a small traditional building aligned east/west with a timber frame, pitched slate roof and weatherboarded walls. There are three internal stables which are in use. The following potential bat access points/roosting opportunities were noted:

- Several gaps/crevices on the eastern aspect between weatherboards and fascias
- Internal opportunities between traditional timbers
- Gaps beneath warped weatherboards on all aspects

3.1 The above features could reasonably support bat roosts/allow access into a roost – particularly for crevice dwelling species. No evidence of a larger/maternity roost was found. This building is likely to be suitable for small numbers of common, crevice dwelling species only.

This building has low roost suitability.

a) Building 1: Various crevices/ingress opportunities on eastern aspect circled.

- 6.1 During the site visit, several possible access points/crevices were noted around Building 1, notably on the eastern aspect that could reasonably support bats. Building 1 has “low” roost suitability, bat presence could not be ruled out during a daytime inspection alone.

- 6.1 Work to Building 1 could reasonably impact bats, resulting in disturbance, killing or injury. Where there is a reasonable likelihood of protected species being present and affected, Local Planning Authorities need to understand the impacts and any required mitigation in their decision making. To understand if any roosts exist, further survey is needed so that mitigation can be designed reflecting the species and status of the roost. In accordance with best practice guidelines, one dusk survey on Building 1 is initially required. Three surveys will be needed if bats are encountered during the first survey. The purpose of the dusk survey is to identify if/where bats are accessing the property, species and number. The survey will be carried out between May and August inclusive, in reliably warm settled conditions (overnight temperatures 10 degrees or above). The survey will require surveyors stationed around the building to identify any bats exiting/re-entering. To sufficiently cover the building, a team of 2 surveyors are recommended, using professional grade detectors and either thermal or Infra-red cameras as night vision aids.

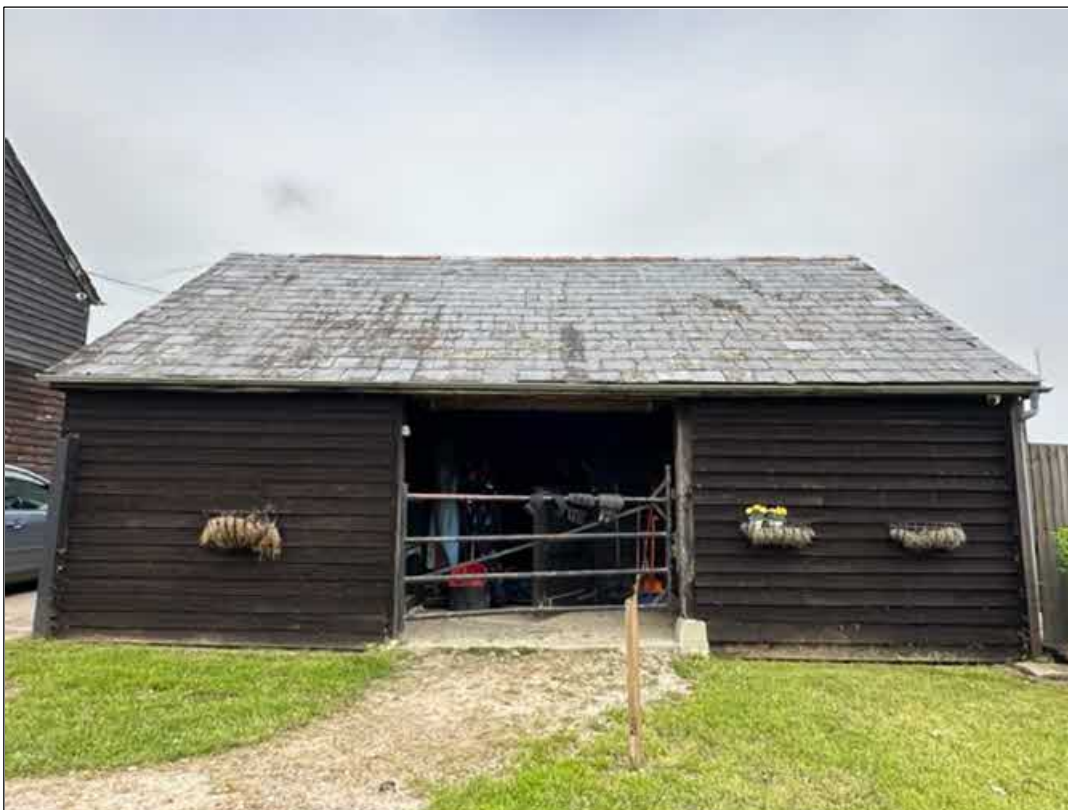
b) Building 1: Southern aspect

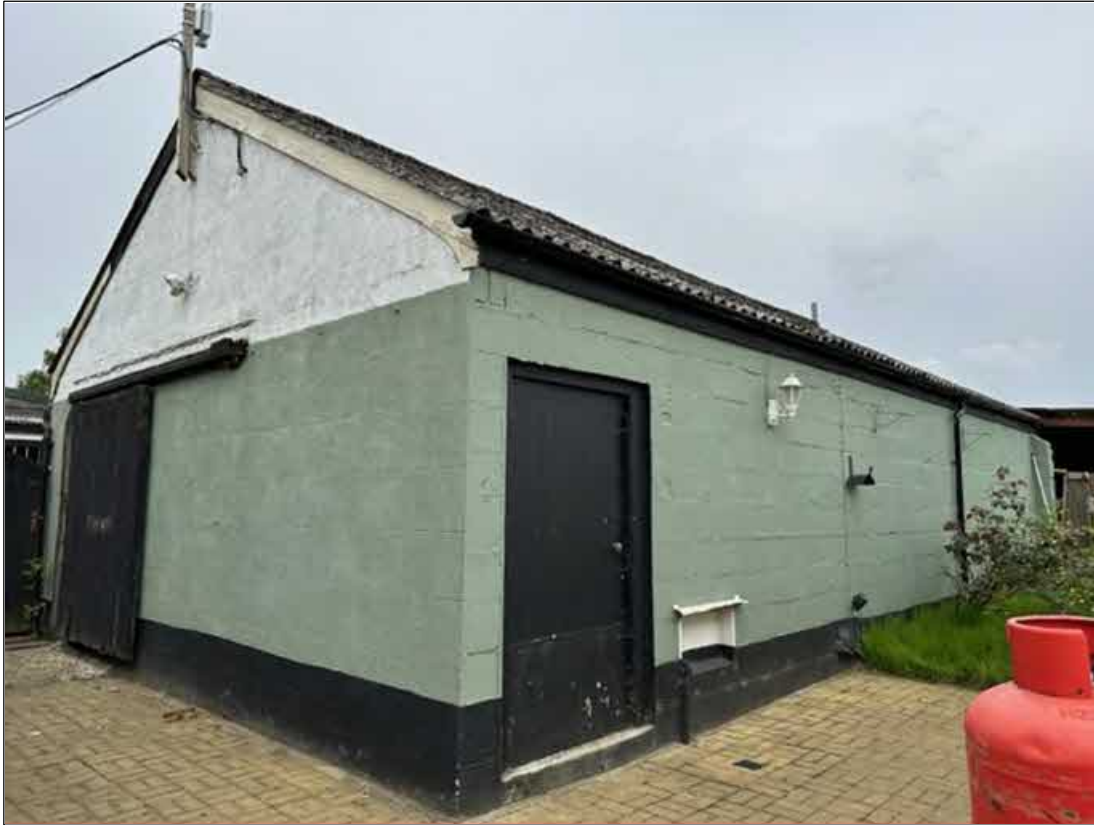
3.1 The Old Milking Parlour has a timber frame, blockwork walls and a pitched asbestos roof aligned north/south. There are large internal stables that are disused. An active blue tit nest was identified on the southern gable. Internal conditions are generally unsuitable for bats, the roof temperature will fluctuate too much to be a suitable roosting position. Externally, all cladding and pointing is well-sealed. No bat evidence was identified.

This building has negligible roost suitability.

c) Building 2: Southern/western aspect. Fascias/walls are well-sealed.

- 6.1 Building 2 and Building 3 have negligible roost suitability and currently require no further survey. In the unlikely event that bats are encountered during works to Building 2 or Building 3, work must cease and an ecologist must be immediately contacted.

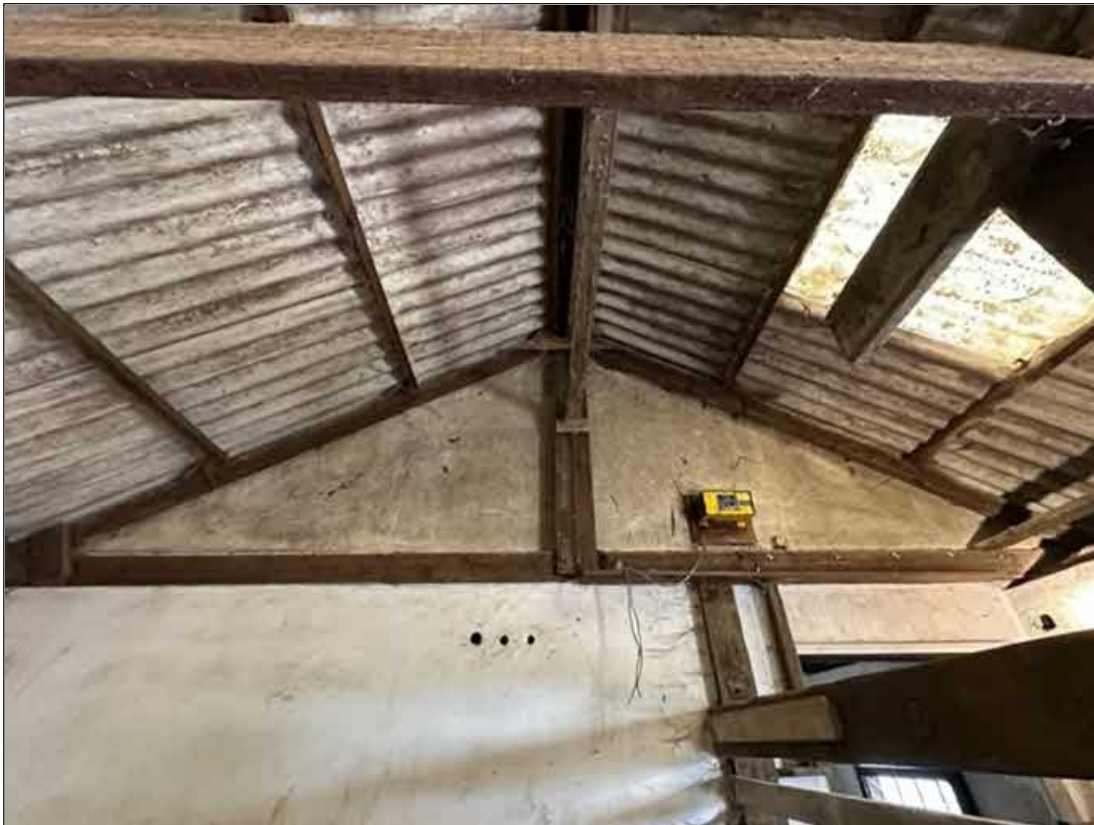
d) Building 2: Internal, roof/ridge board unsuitable for roosting bats.

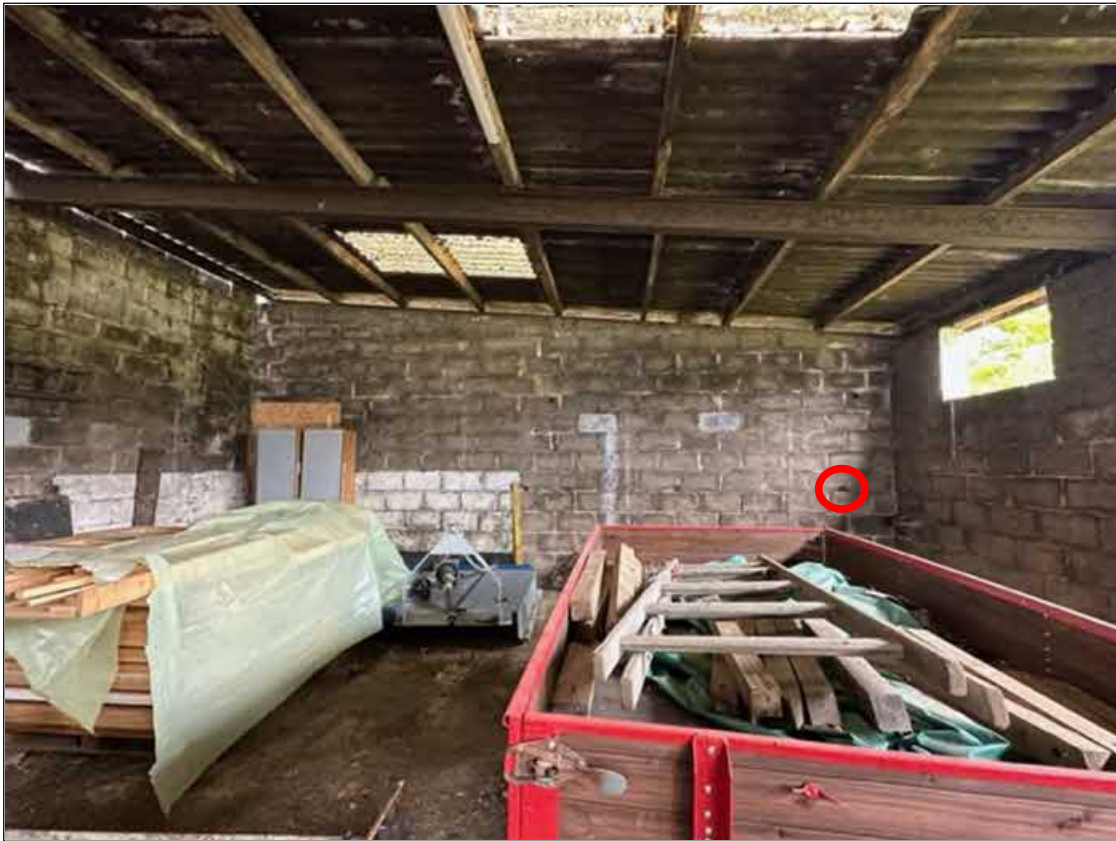
3.4 The calving building is now used for storage, it has a steel frame, blockwork walls and an asymmetric asbestos roof. A modern stable block adjoins the western aspect. The building is open to the south and there are windows to the east. There are cavity walls to the north and west. In the larger barn, an active wren nest and bumble bee nest were identified in cavity walls to the north. No bat droppings were identified within or around blockwork gaps despite a thorough inspection with an endoscope.

e) Building 3: Northern aspect, internal. The gap circled was inspected with an endoscope.

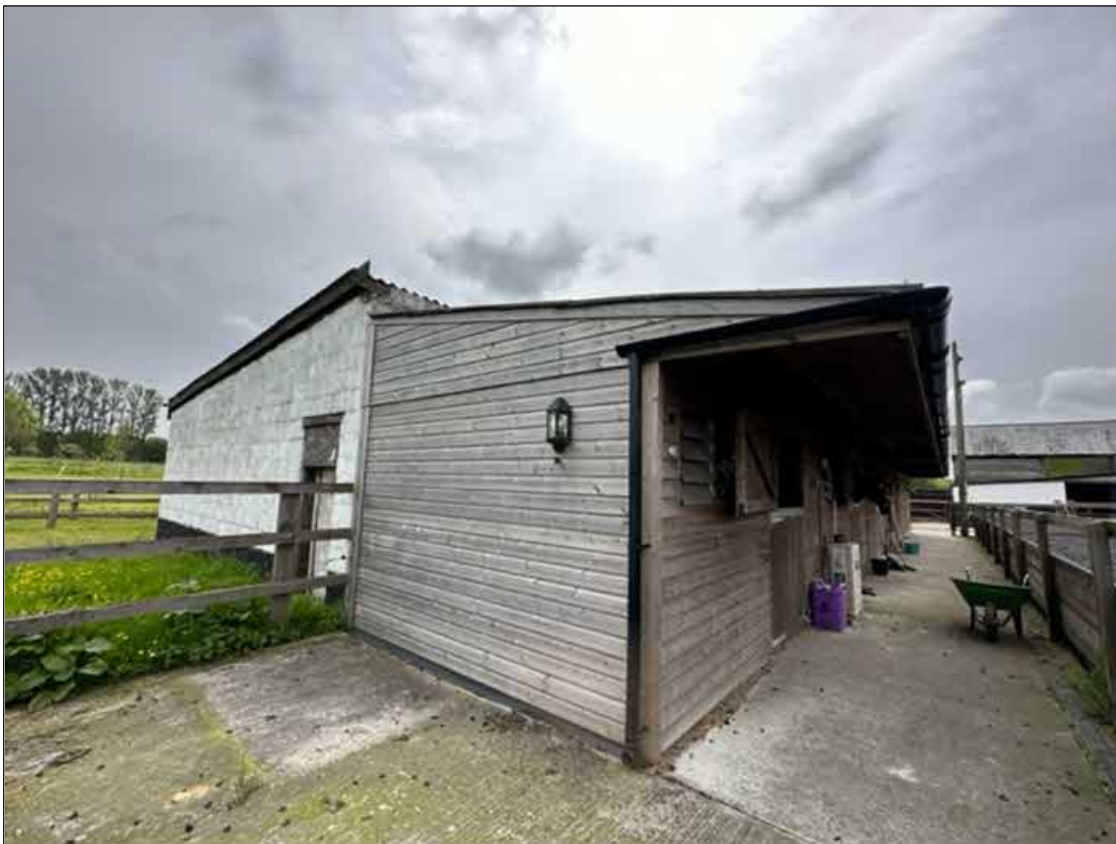
3.1 The modern stable block has tightly fit timber tongue and groove walls and overhang to the west. There are no opportunities for roosting bats.

This building has negligible roost suitability.

f) Building 3: Northern aspect and adjoining modern stable block.

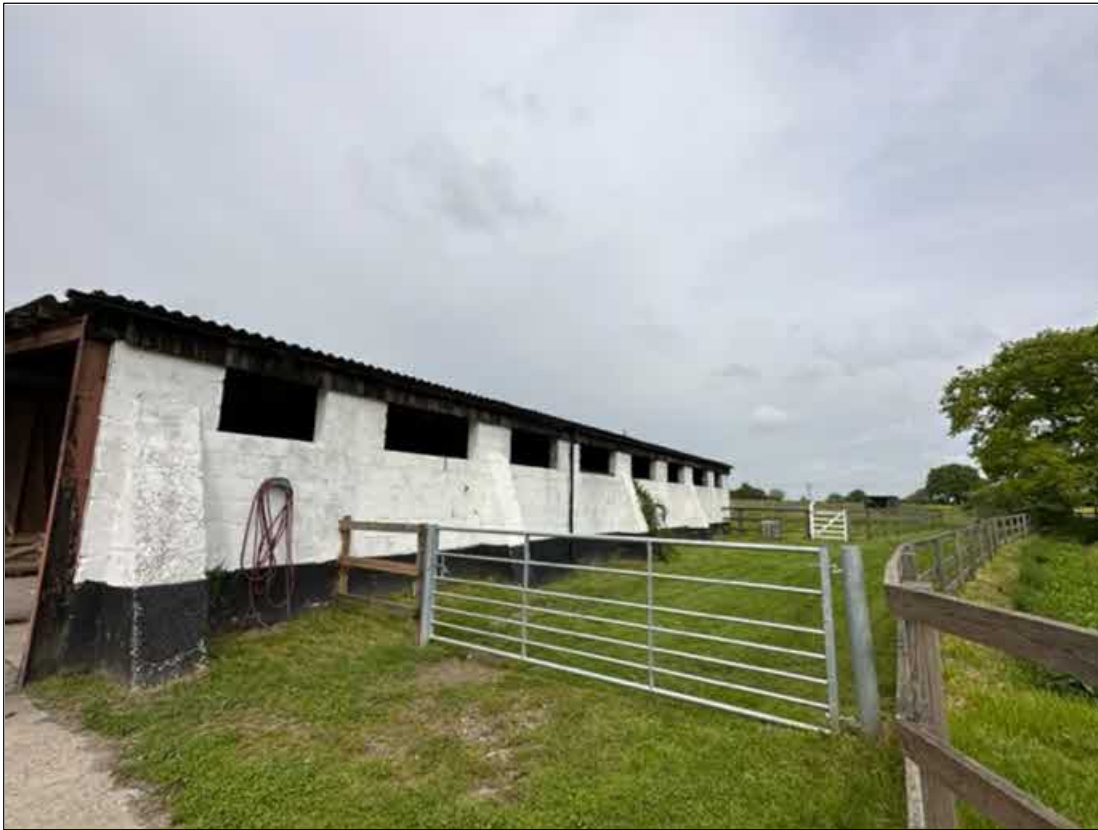
g) Building 3: Eastern aspect

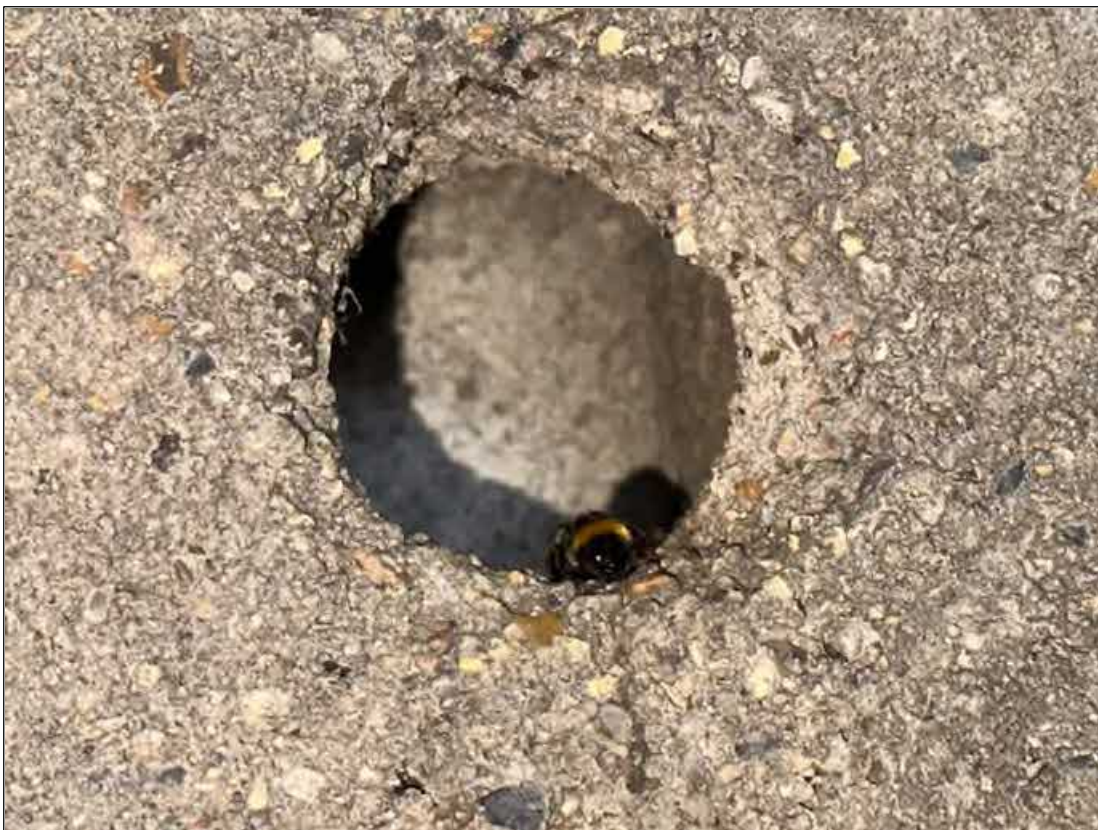
h) Bumble bee in cavity wall on northern aspect.

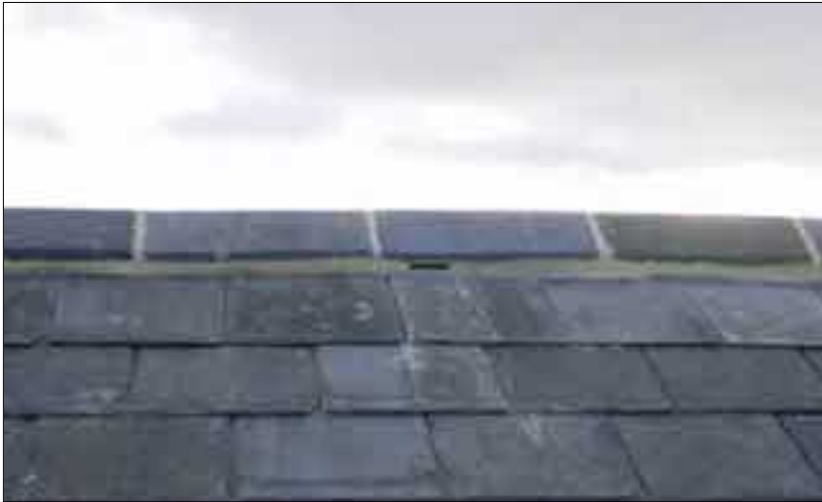
a) Gap beneath ridge tile of slate roof

- 2.4 The finished development should include compensatory roost provision, the scope of which will be determined following the dusk survey. Integrated bat roost features could be included on buildings or externally mounted boxes could be installed on trees. Artificial bat roost features are included in Appendix 1.

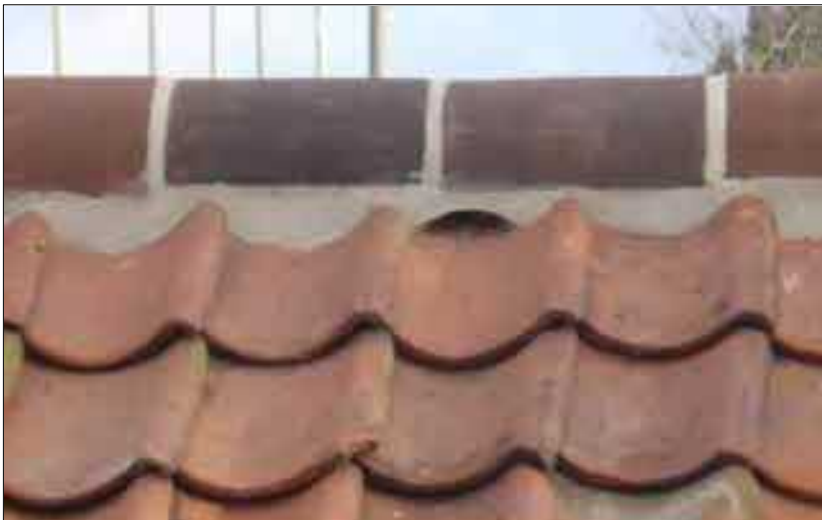
b) Gap beneath ridge tile of reclaimed clay pantile roof

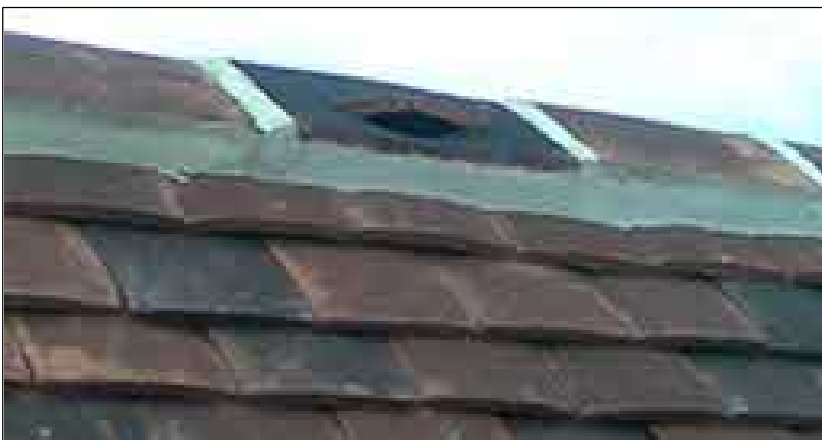
c) Made by Tudor Roof Tiles (www.tudorrooftiles.co.uk) this 'top tunnel' tile provides a tunnel to an entrance hole in the undertiles, allowing bats to crawl into a roost or along the ridge beam where a cavity has been created

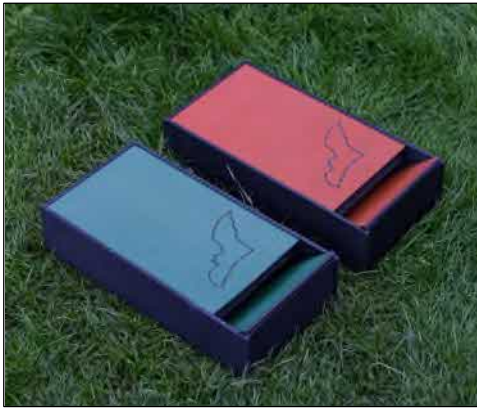
d) Integrated Eco Bat Box for buildings – [Integrated Eco Bat Box | NHBS Practical Conservation Equipment](#)

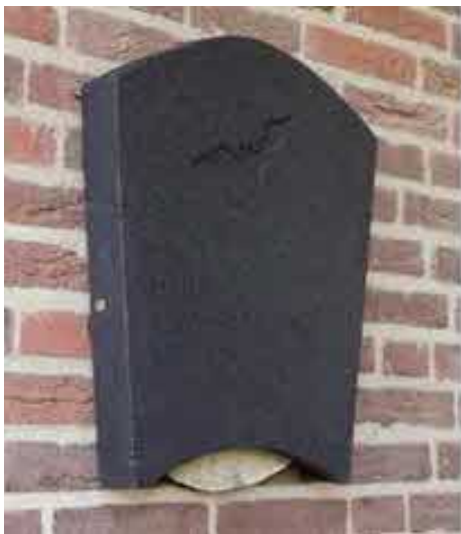
e) Beaumaris woodstone bat box for gable ends

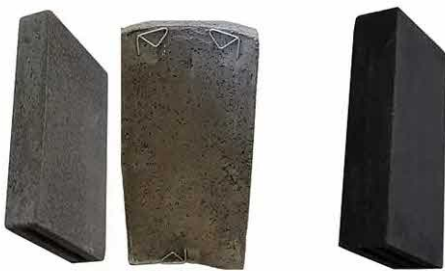
SINGLE CREVICE BAT BOX

TWO CREVICE BAT BOX

External: 43 high x 21.5 wide x 6.8 deep.

Internal: 41 x 16.5 x 1.8 crevices @ 1.

Made with small groups of crevice dwelling bat species in mind, such as pipistrelles. Approx.

Internal: 41 x 16.5 x 1.8 crevices @ 2.
