Bat Roost and Emergence Survey, Pond Assessment, and Bat Mitigation Strategy

**The Cottage, Upper Green,
Felsham, Suffolk, IP30 0PL.**

Survey Commissioned by:	Mr Joe Naughton
Project Number:	REP23033
Report issued:	13 th October 2023
Date of Surveys	3 rd and 17 th August, 3 rd September 2023
Lead Surveyor:	Odette Robson BSc (Hons) PhD MCIEEM

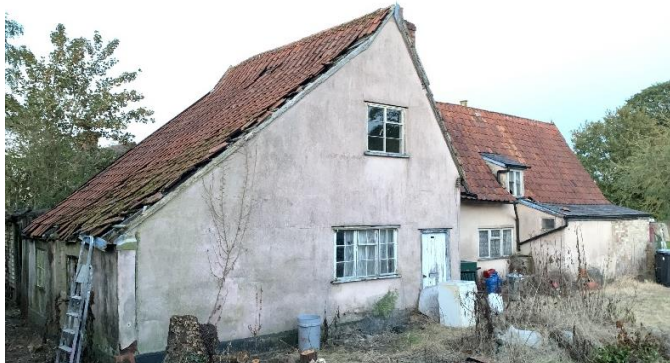
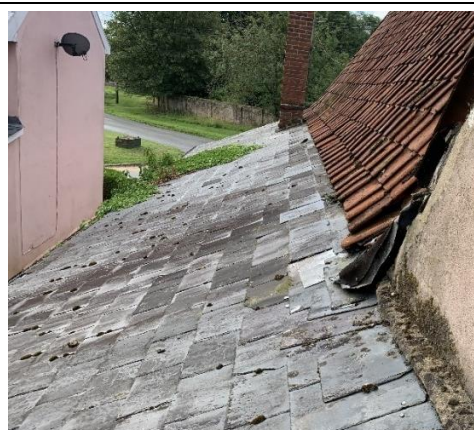
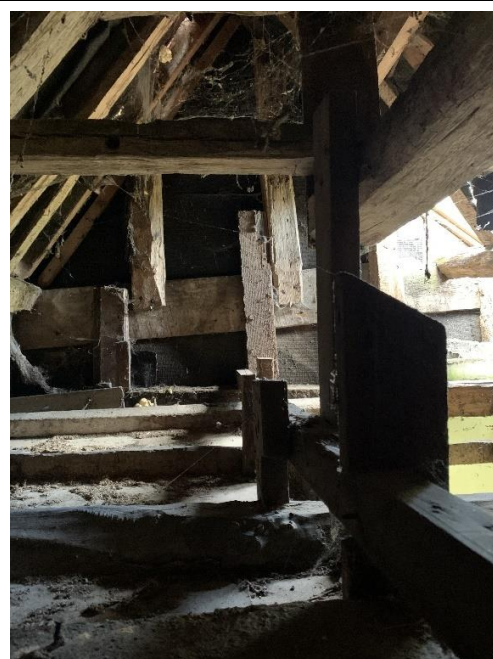
The Cottage - External.

Two-storey timber-framed gabled house, externally rendered, with a pan-tiled roof. Large number of broken, slipped, and missing roof tiles.

Slate-roofed single storey lean-to sections to the north-east and south-western elevations – well-sealed slates.

Two brickwork chimney stacks with sections of missing mortar. Glazed windows were broken/missing with rotting wooden frames and significant gaps between frames and surrounds.

Internally, only the northern end of the loft was accessible to survey: the void was heavily cobwebbed below the ridge with high light levels due to missing ceilings below. No bat droppings or other evidence of bats recorded.

The main roof void was reduced height due to being converted to living space, with no access hatch.

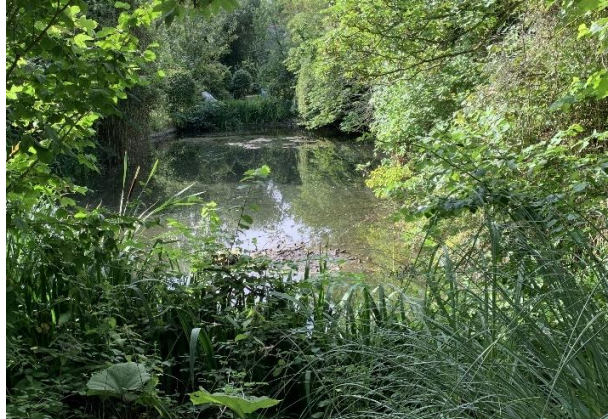
1) Pond/ Lake

Approximately area of lake: 500m²

Distance to The Cottage: 20m

No access for survey – separated from the site by a high brick wall and mown grass verge and road, which would obstruct movement of amphibians between the water body and site.

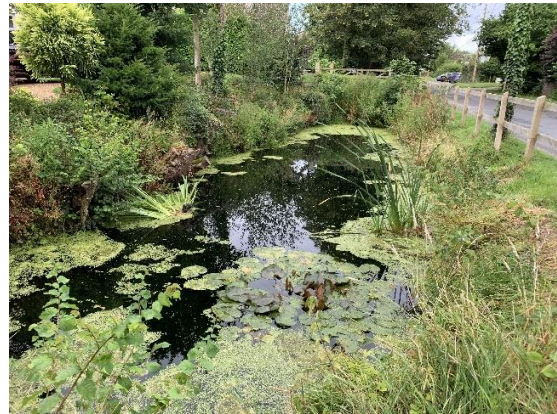
2) Pond

Approximately area of pond: 80m²

Distance to The Cottage: 23m

Well vegetated pond/ditch with good water quality. Moderate quantities of Duckweed *Lemna* spp., Reedmace *Typha latifolia*, and Water Lilies *Nymphaeales*. No shading and no evidence of fish or water fowl. Bank-sides well vegetated.

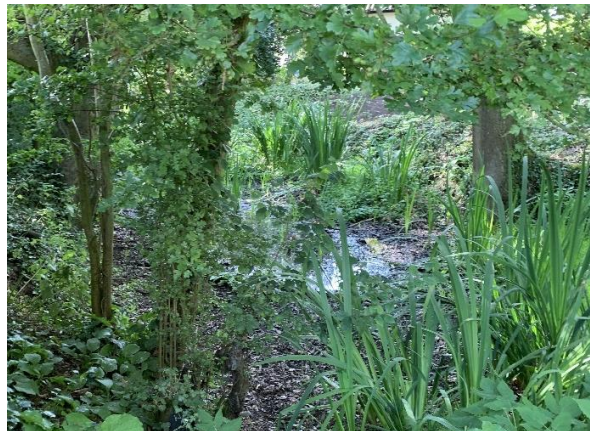
3) Pond/Ditch

Approximately area of pond/ditch: 250m²

Distance to The Cottage: 55m

Two separate ditch sections adjacent to the brick wall/road. Holding shallow water in places, but mainly dry at the time of the survey. Depressions overgrown with Iris and Woody Nightshade *Solanum dulcamara*. Heavily shaded by Yew *Taxus baccata*, Sycamore *Acer pseudoplatanus*, Elm *Ulmus* spp., Hawthorn *Crataegus monogyna*, and Elder *Sambucus nigra*.

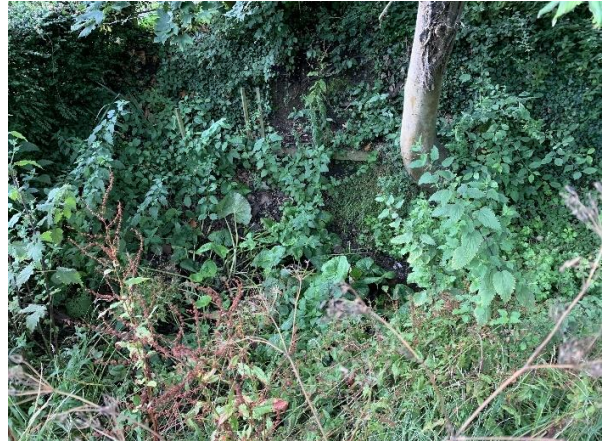
4) Ditch

Approximately area of ditch: 50m²

Distance to The Cottage: 45m

Dry ditch adjacent to road overgrown with ruderals but with vegetation suggesting regular inundation: Marsh Marigold *Caltha palustris*.

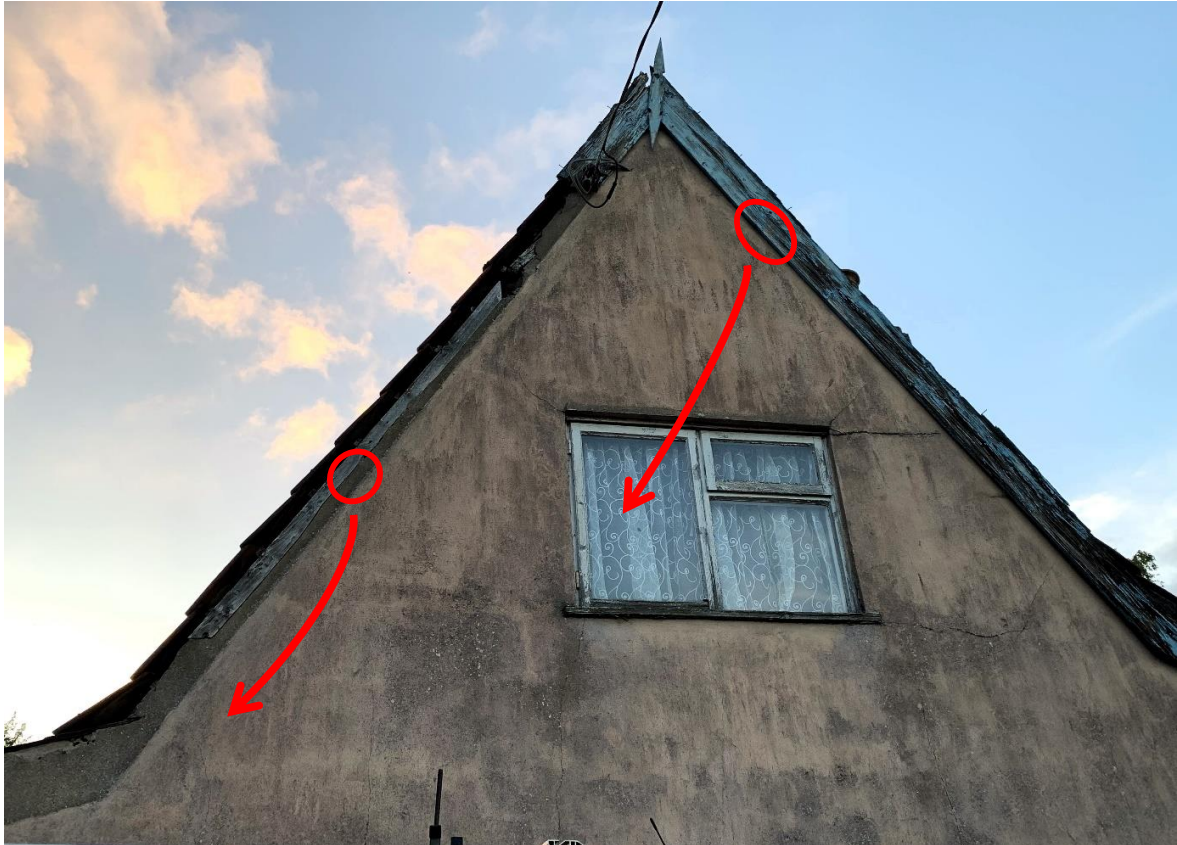
Roosting: 1x common pipistrelle emerged from the south-east facing gable end – southern slope barge-board - Plate 3.1.

Roosting: 2x common pipistrelle emerged from the south-east facing gable end (southern and northern slope barge-boards) - Plate 3.1.

Roosting: Single common pipistrelle emerged from the south-east facing gable end – southern slope barge-board (Plate 3.1).

Plate 3.1: Location of common pipistrelle emergences recorded on all surveys: South-eastern gable of Cottage (Photo: O. Robson 03.08.23)

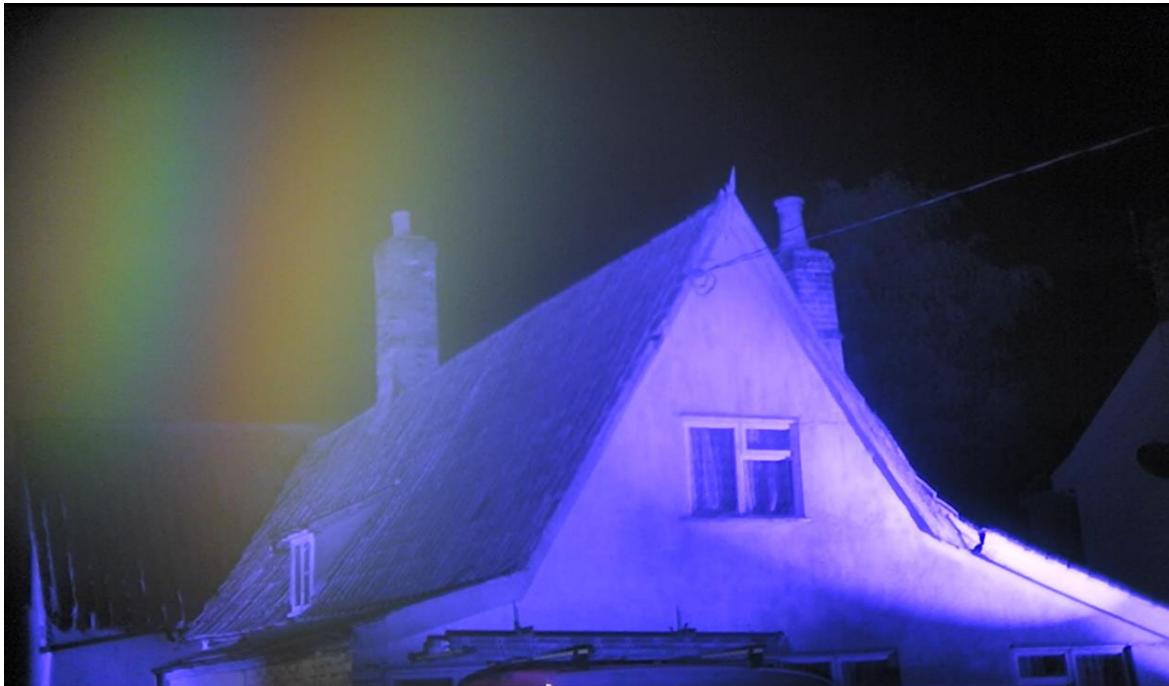
Plate 3.2: SiOnyx Aurora with Nightfox XB5 Illuminator – south-eastern gable end – 03.09.23

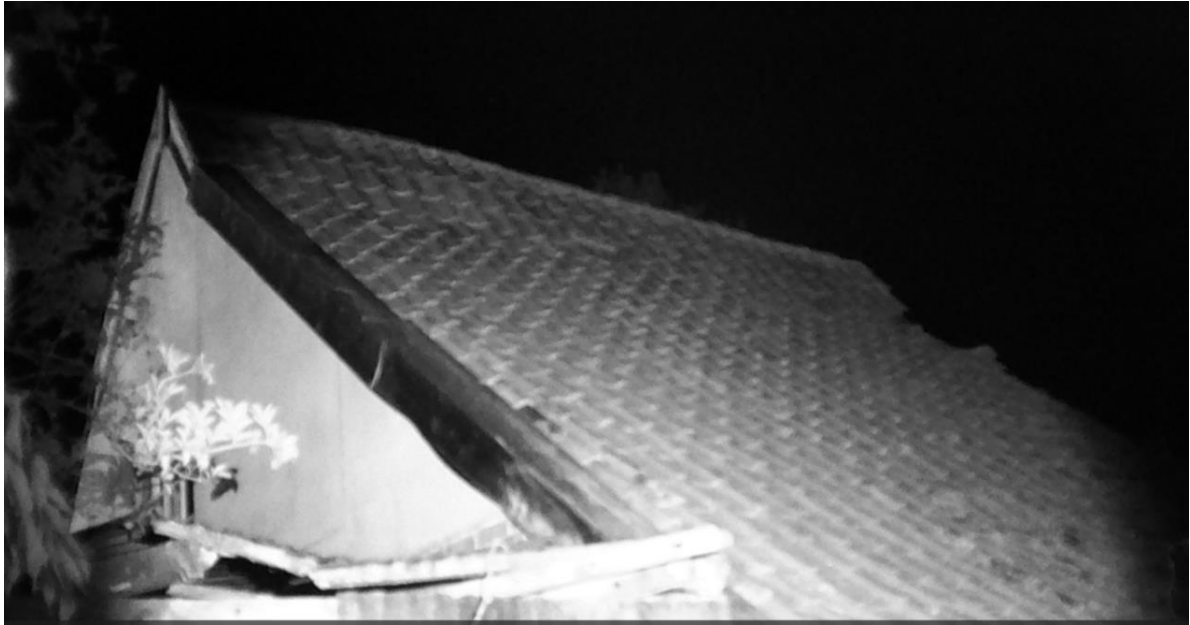
Plate 3.3: Nightfox Whisker with Nightfox XB5 Illuminator – north-western elevation – 03.09.23

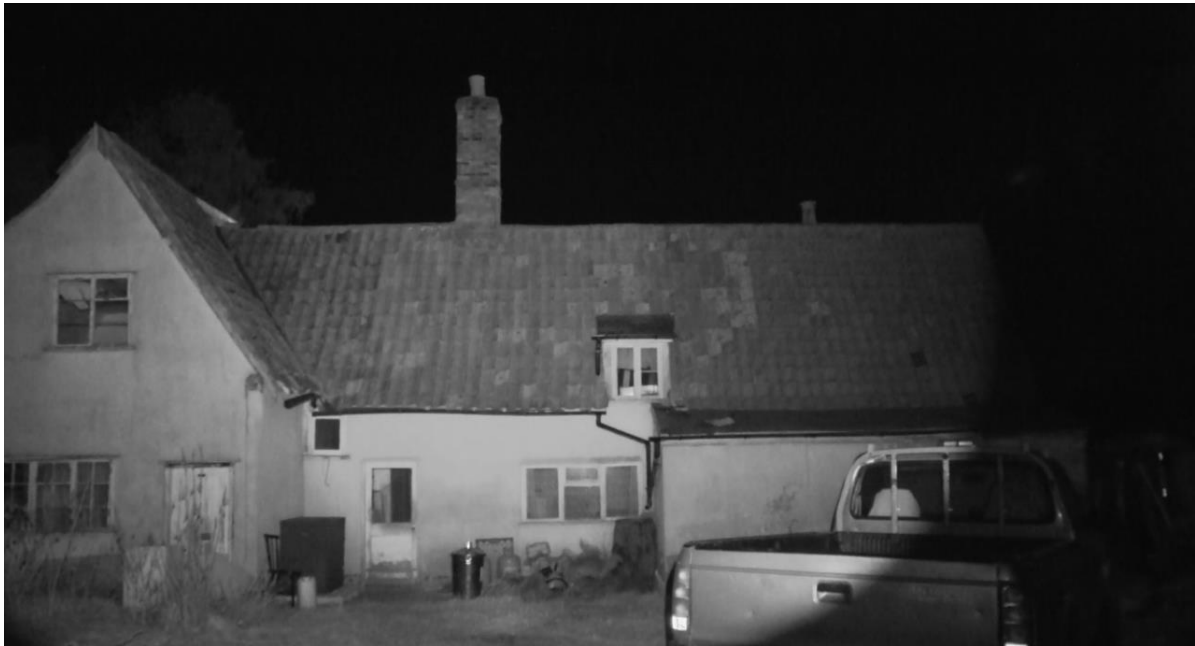
Plate 3.4: Canon XA11 with Nightfox XB5 and 12-Led 90°Wide Angle IR Illuminator – south-western elevation of Cottage – 03.09.23.

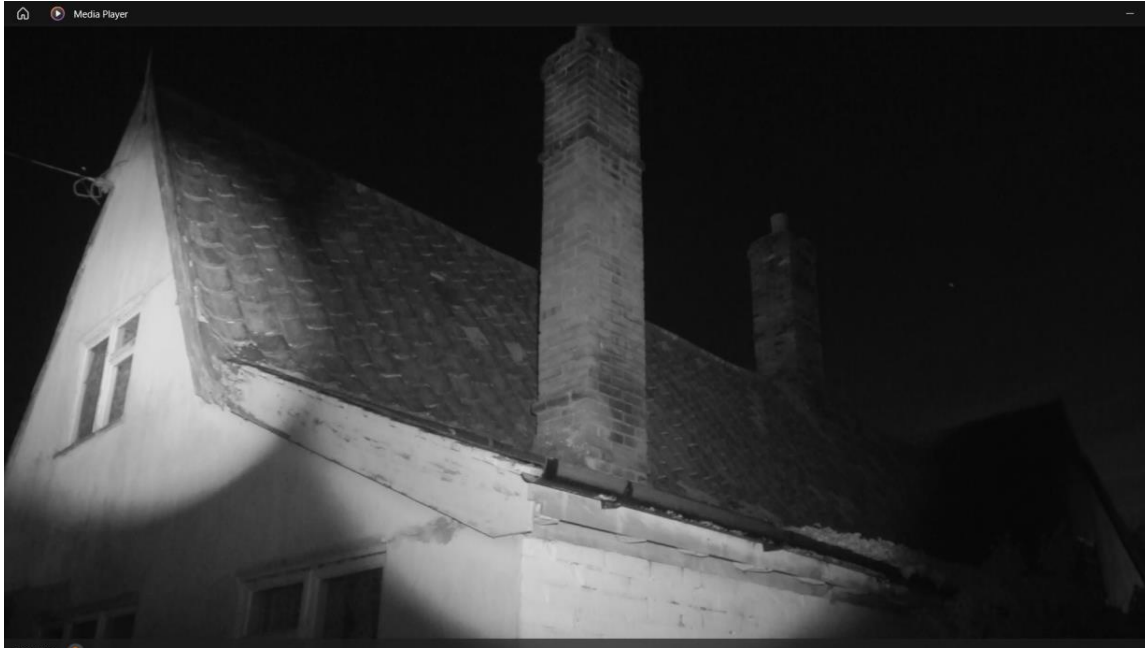
Plate 3.5: Canon XA11 with Nightfox XB5 and 12-Led 90°Wide Angle IR Illuminator – north-eastern elevation and south-eastern gable end of Cottage – 03.09.23.
