Front Elevation of 7 Glenmere Avenue

DESIGN OBJECTIVES - GROUND FLOOR

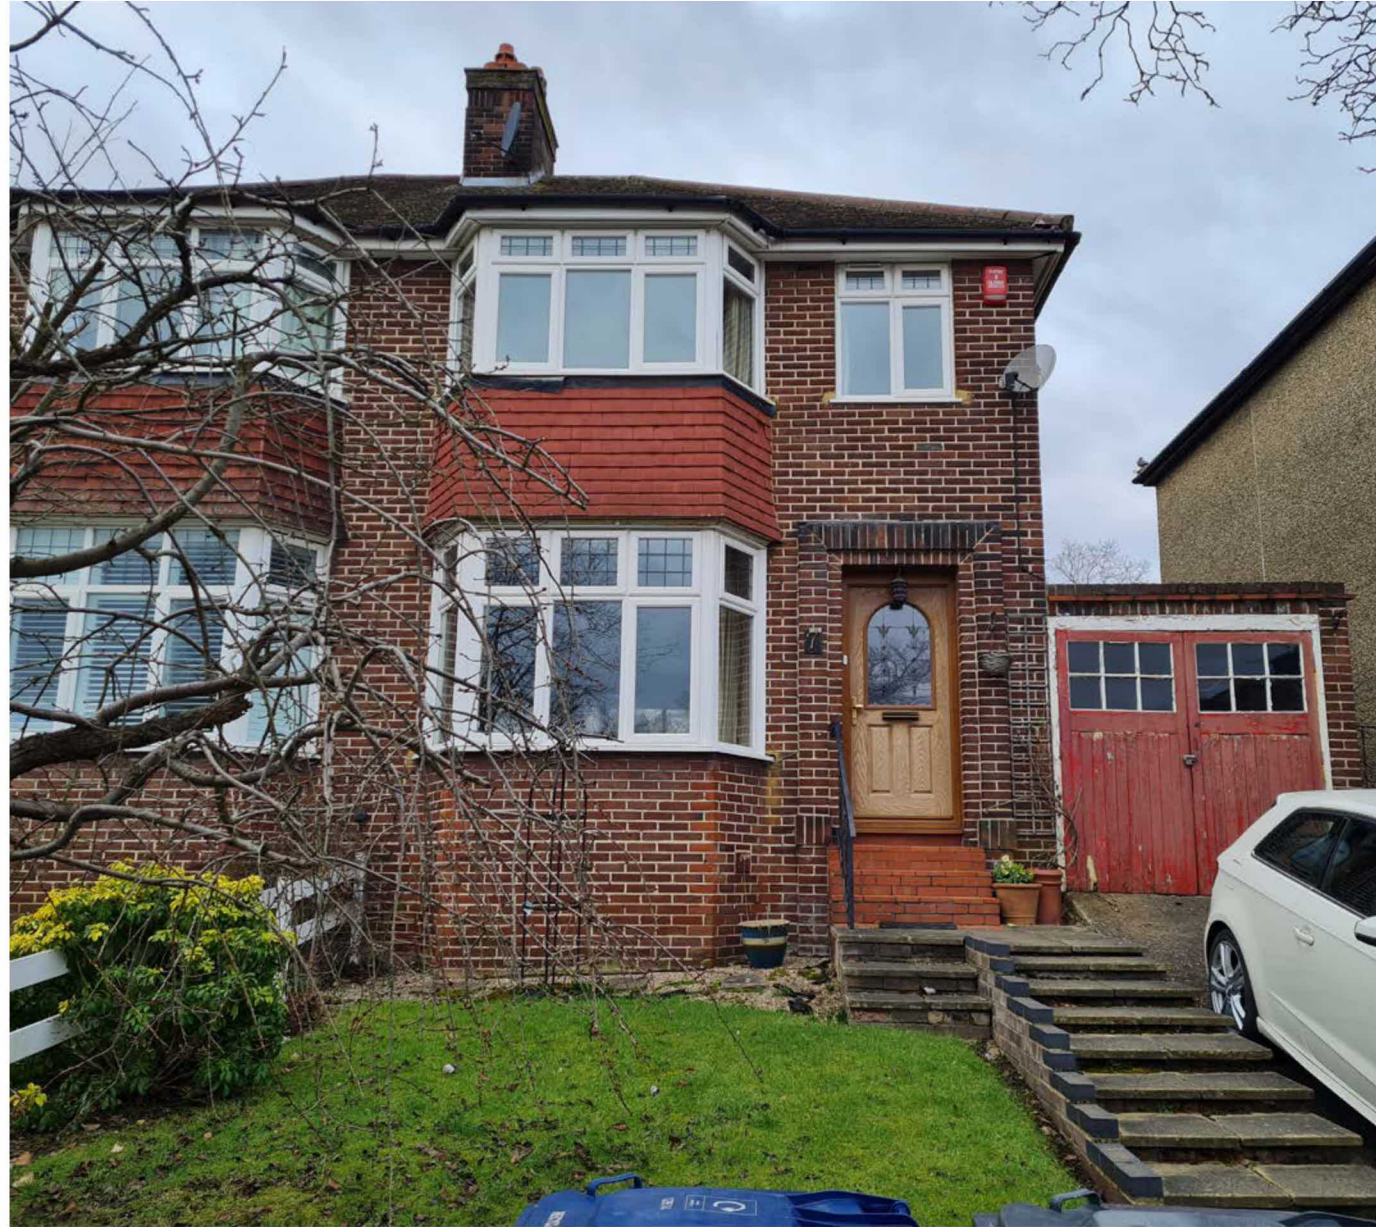
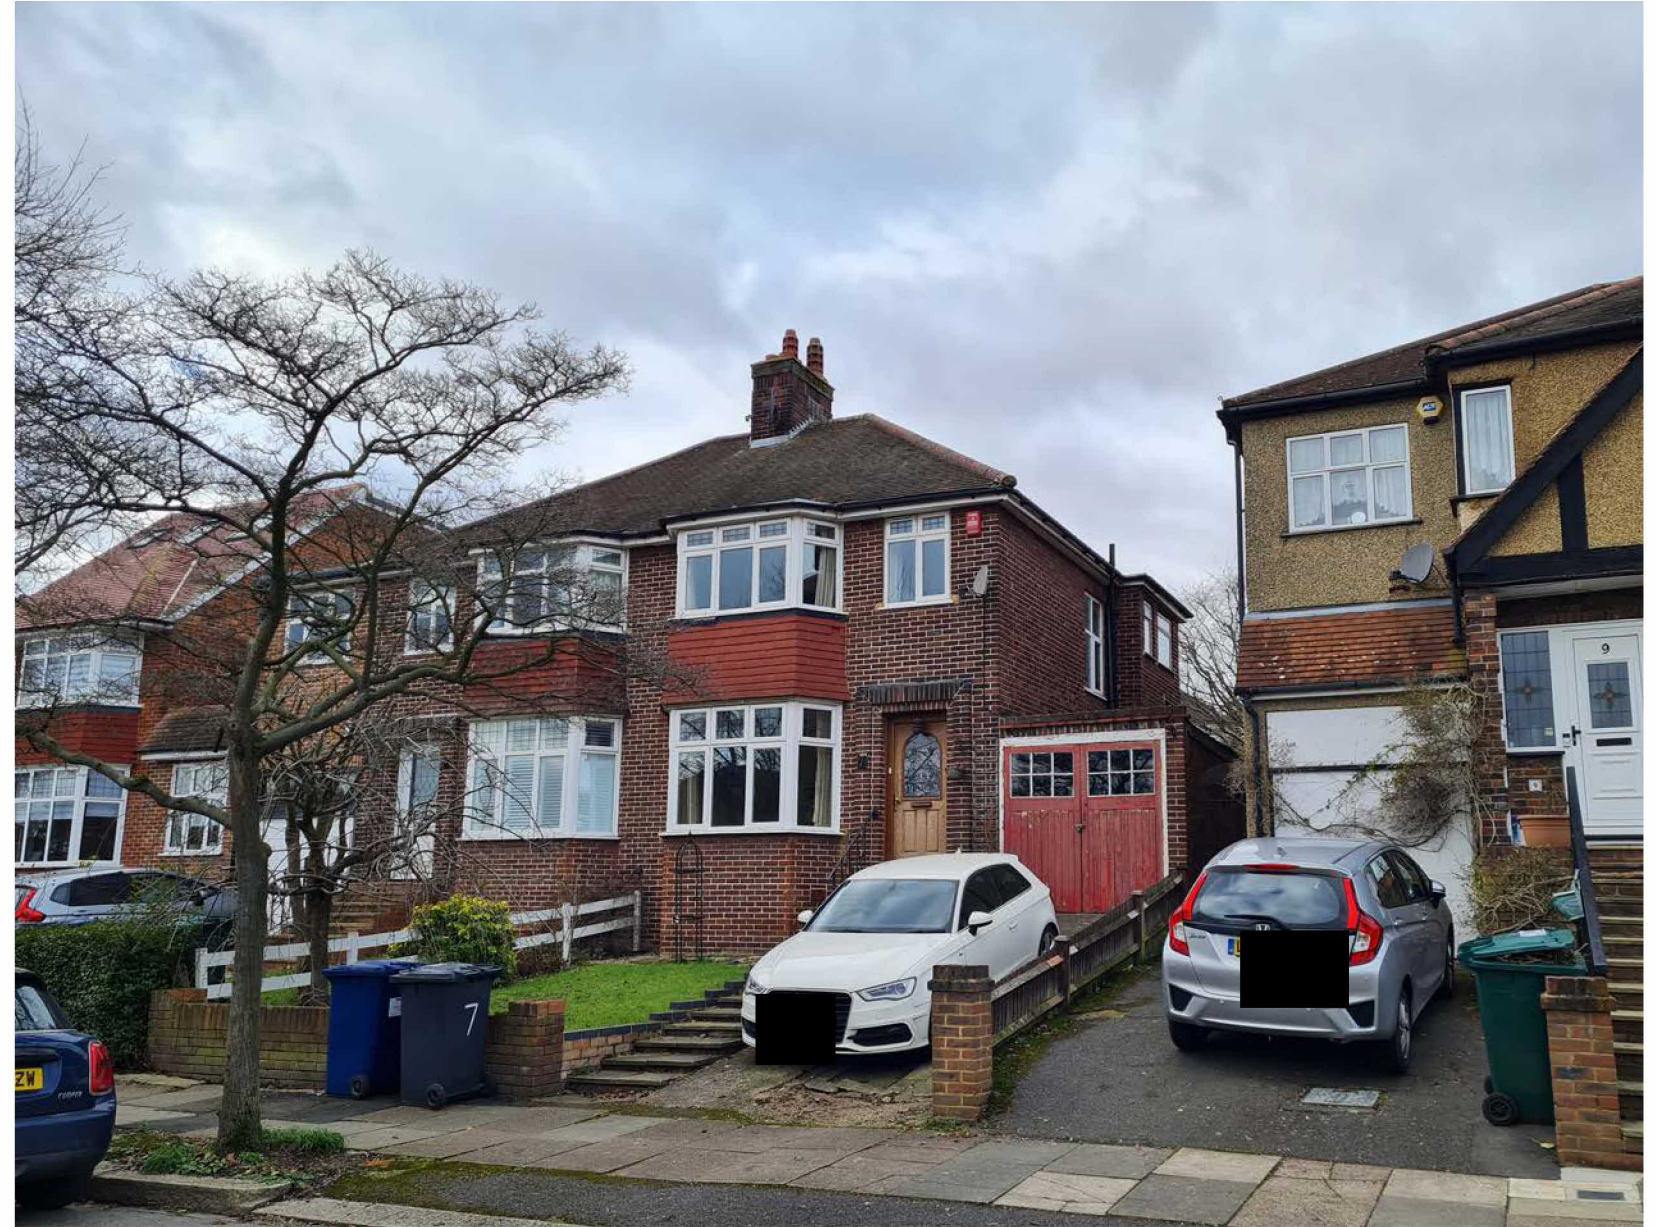
These exterior views demonstrate the front elevation fronting Glenmere Avenue. The existing driveway is very narrow, offering limited width for car occupants to exit a car. The driveway rises steeply to the garage, which is in a poor state of repair. With 6'6" wide doors and an internal width of 7'6", there is insufficient space to park even a modestly sized modern car within the garage.

The existing approach steps are non-compliant with Building Regulations, being too shallow and with inconsistent risers. These were installed to align with the existing driveway slope.

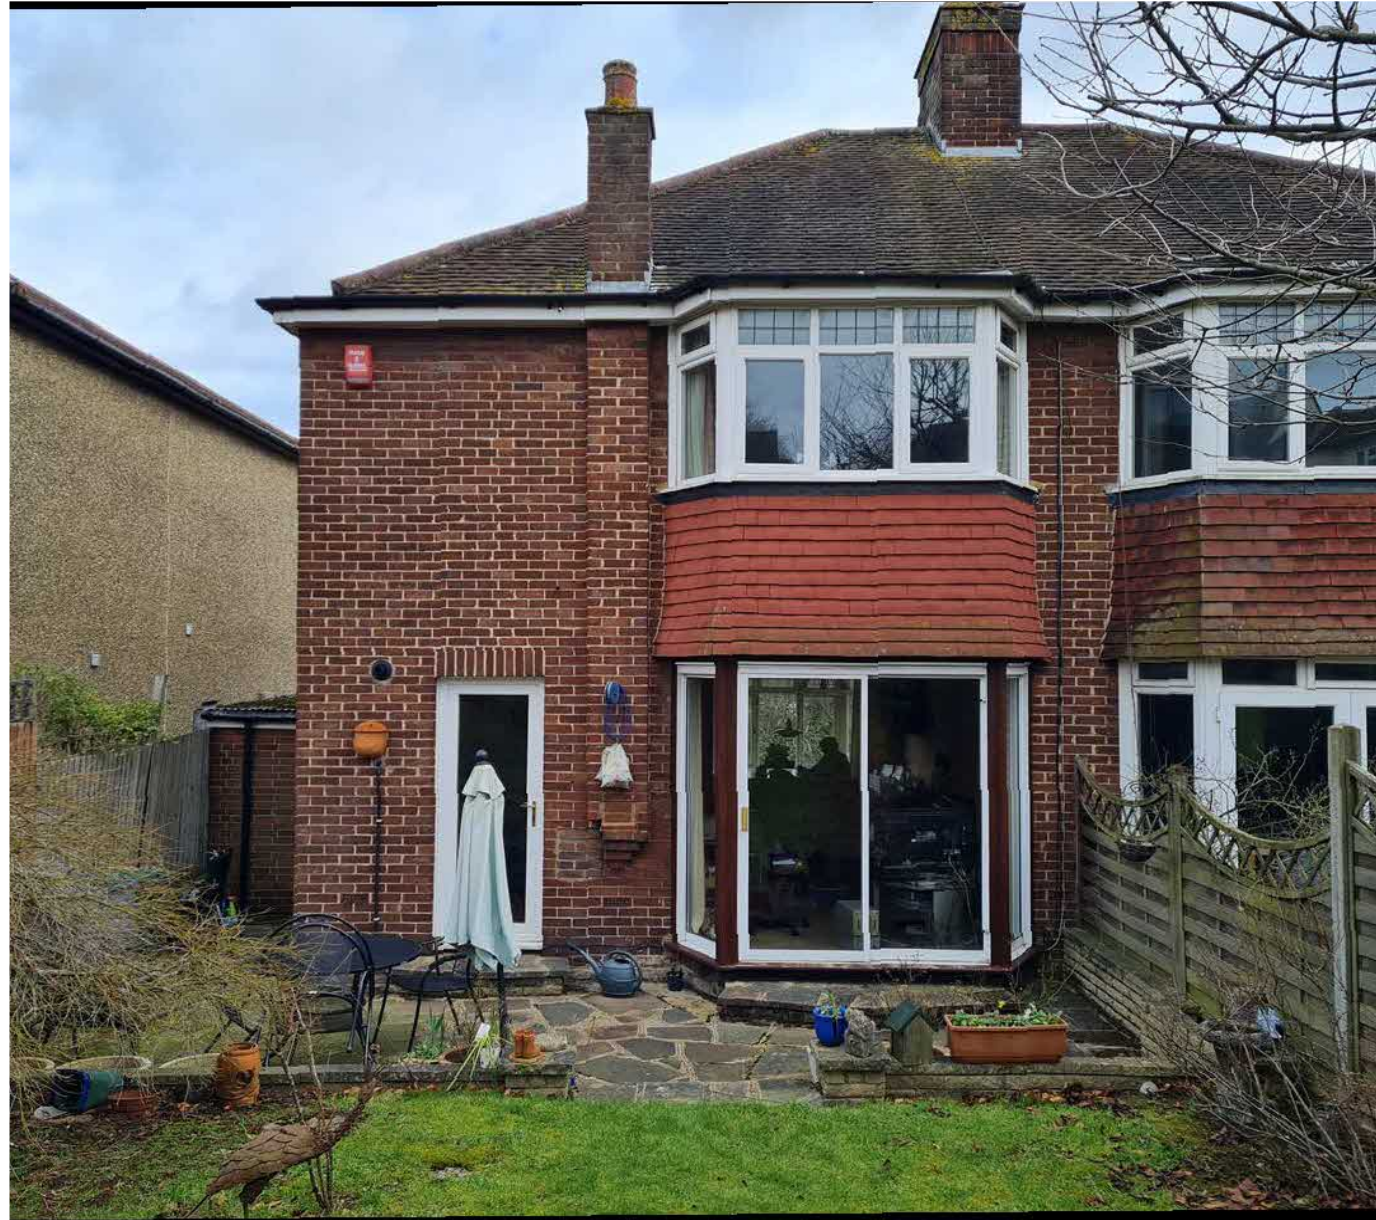
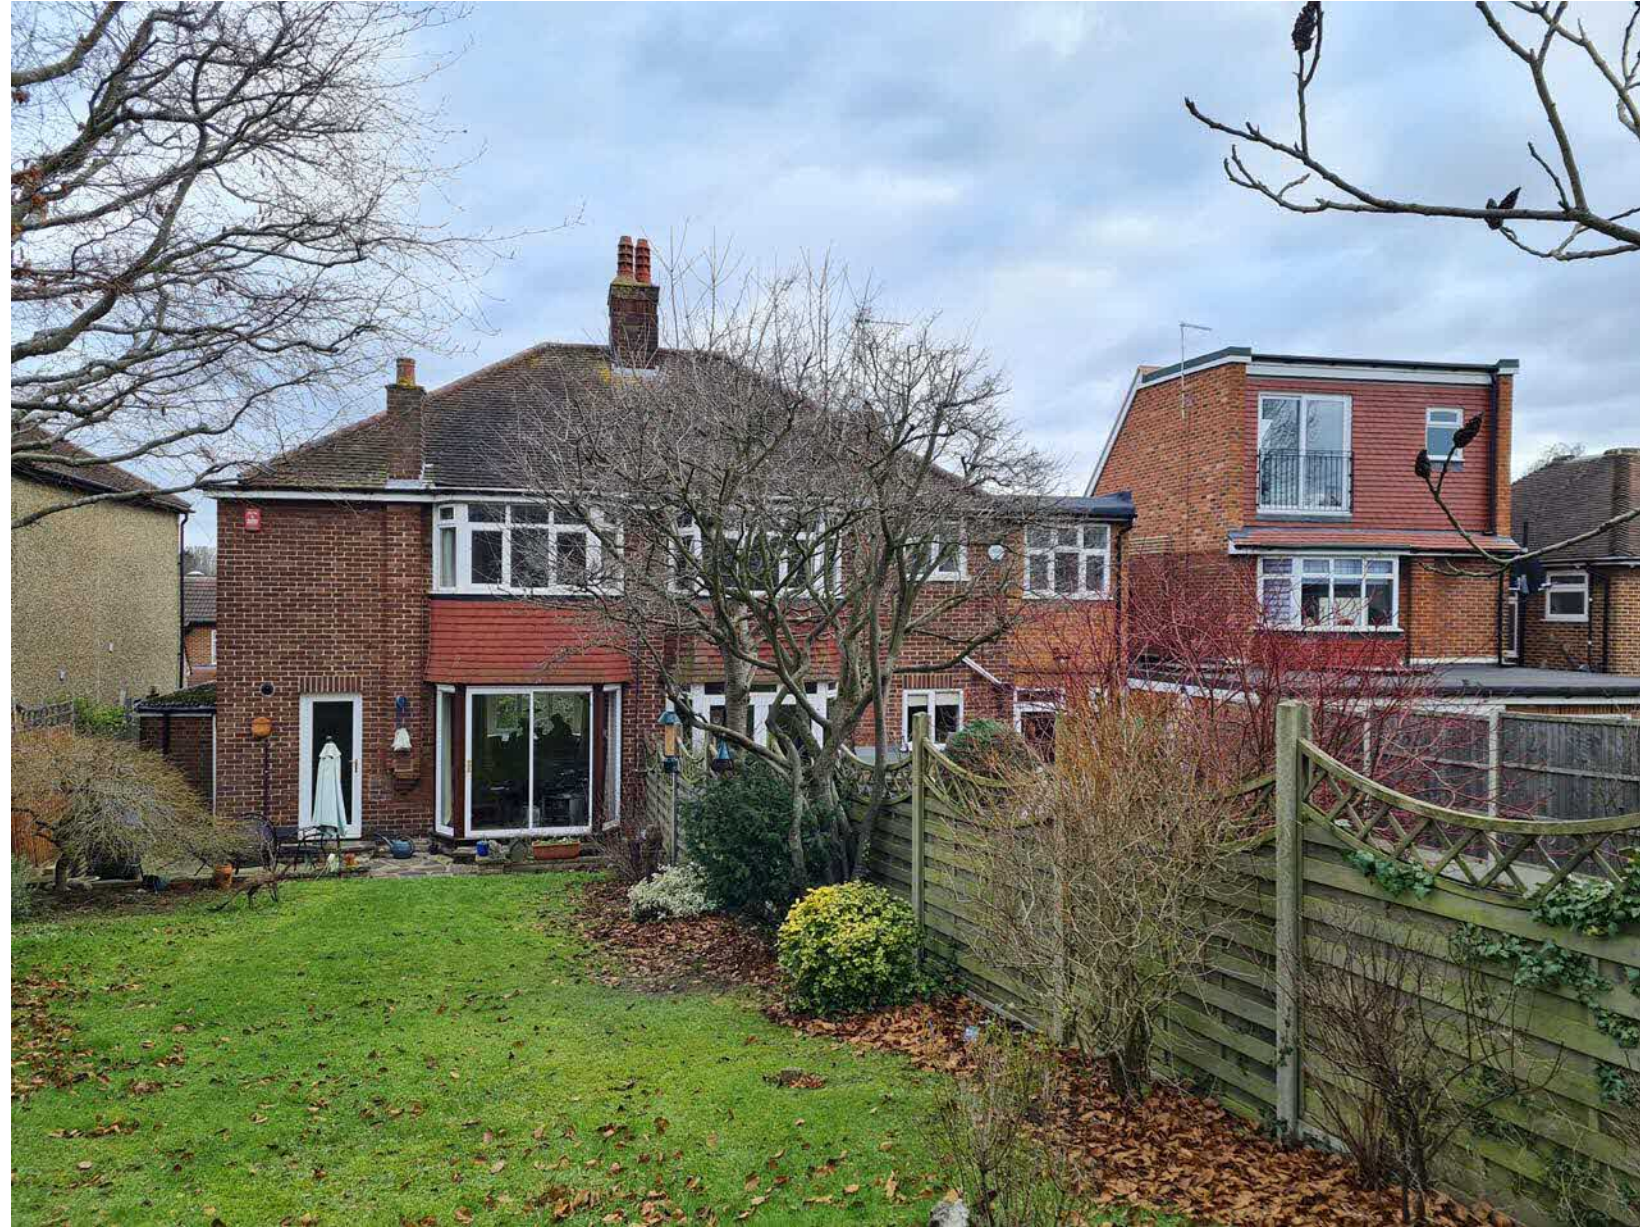
Rear Elevation of 7 Glenmere Avenue

These exterior rear views show the proposed location for the new rear extension.

The old flue chimney on this elevation is no longer in use and we intend to remove this as part of the works.

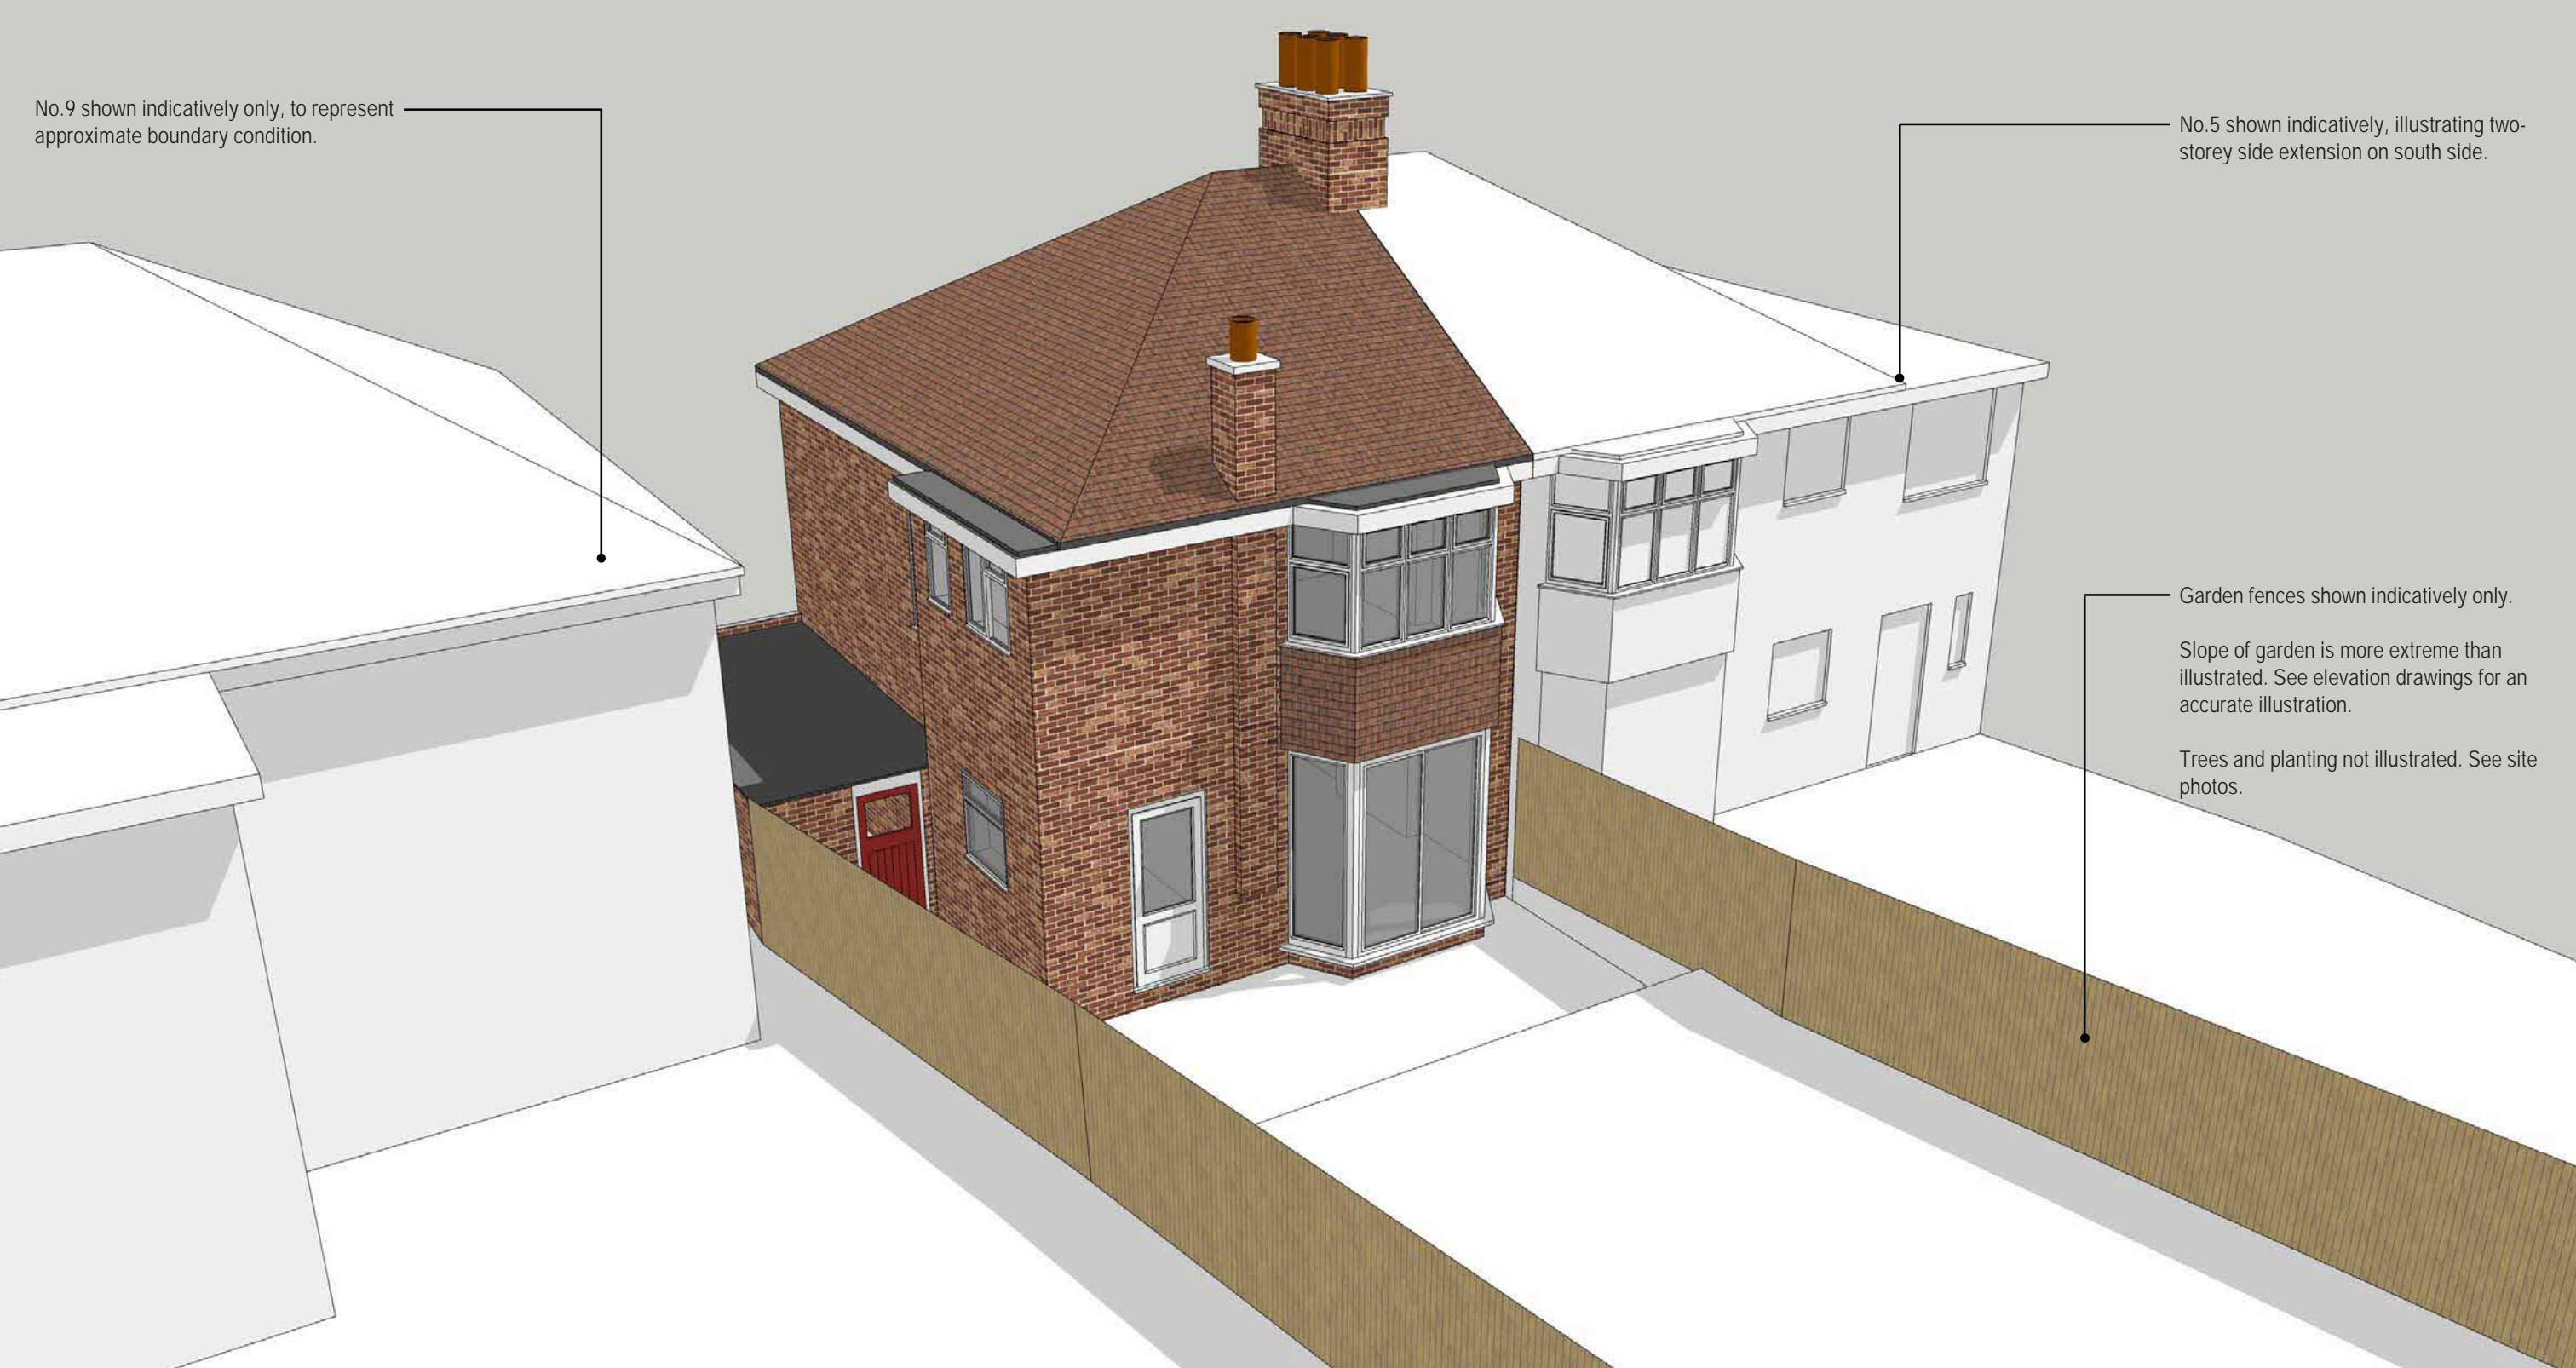
NORTH WEST AXONOMETRIC

No.9 shown indicatively only, to represent approximate boundary condition.

No.5 shown indicatively, illustrating two-storey side extension on south side.

Garden fences shown indicatively only.

Slope of garden is more extreme than illustrated. See elevation drawings for an accurate illustration.

Trees and planting not illustrated. See site photos.

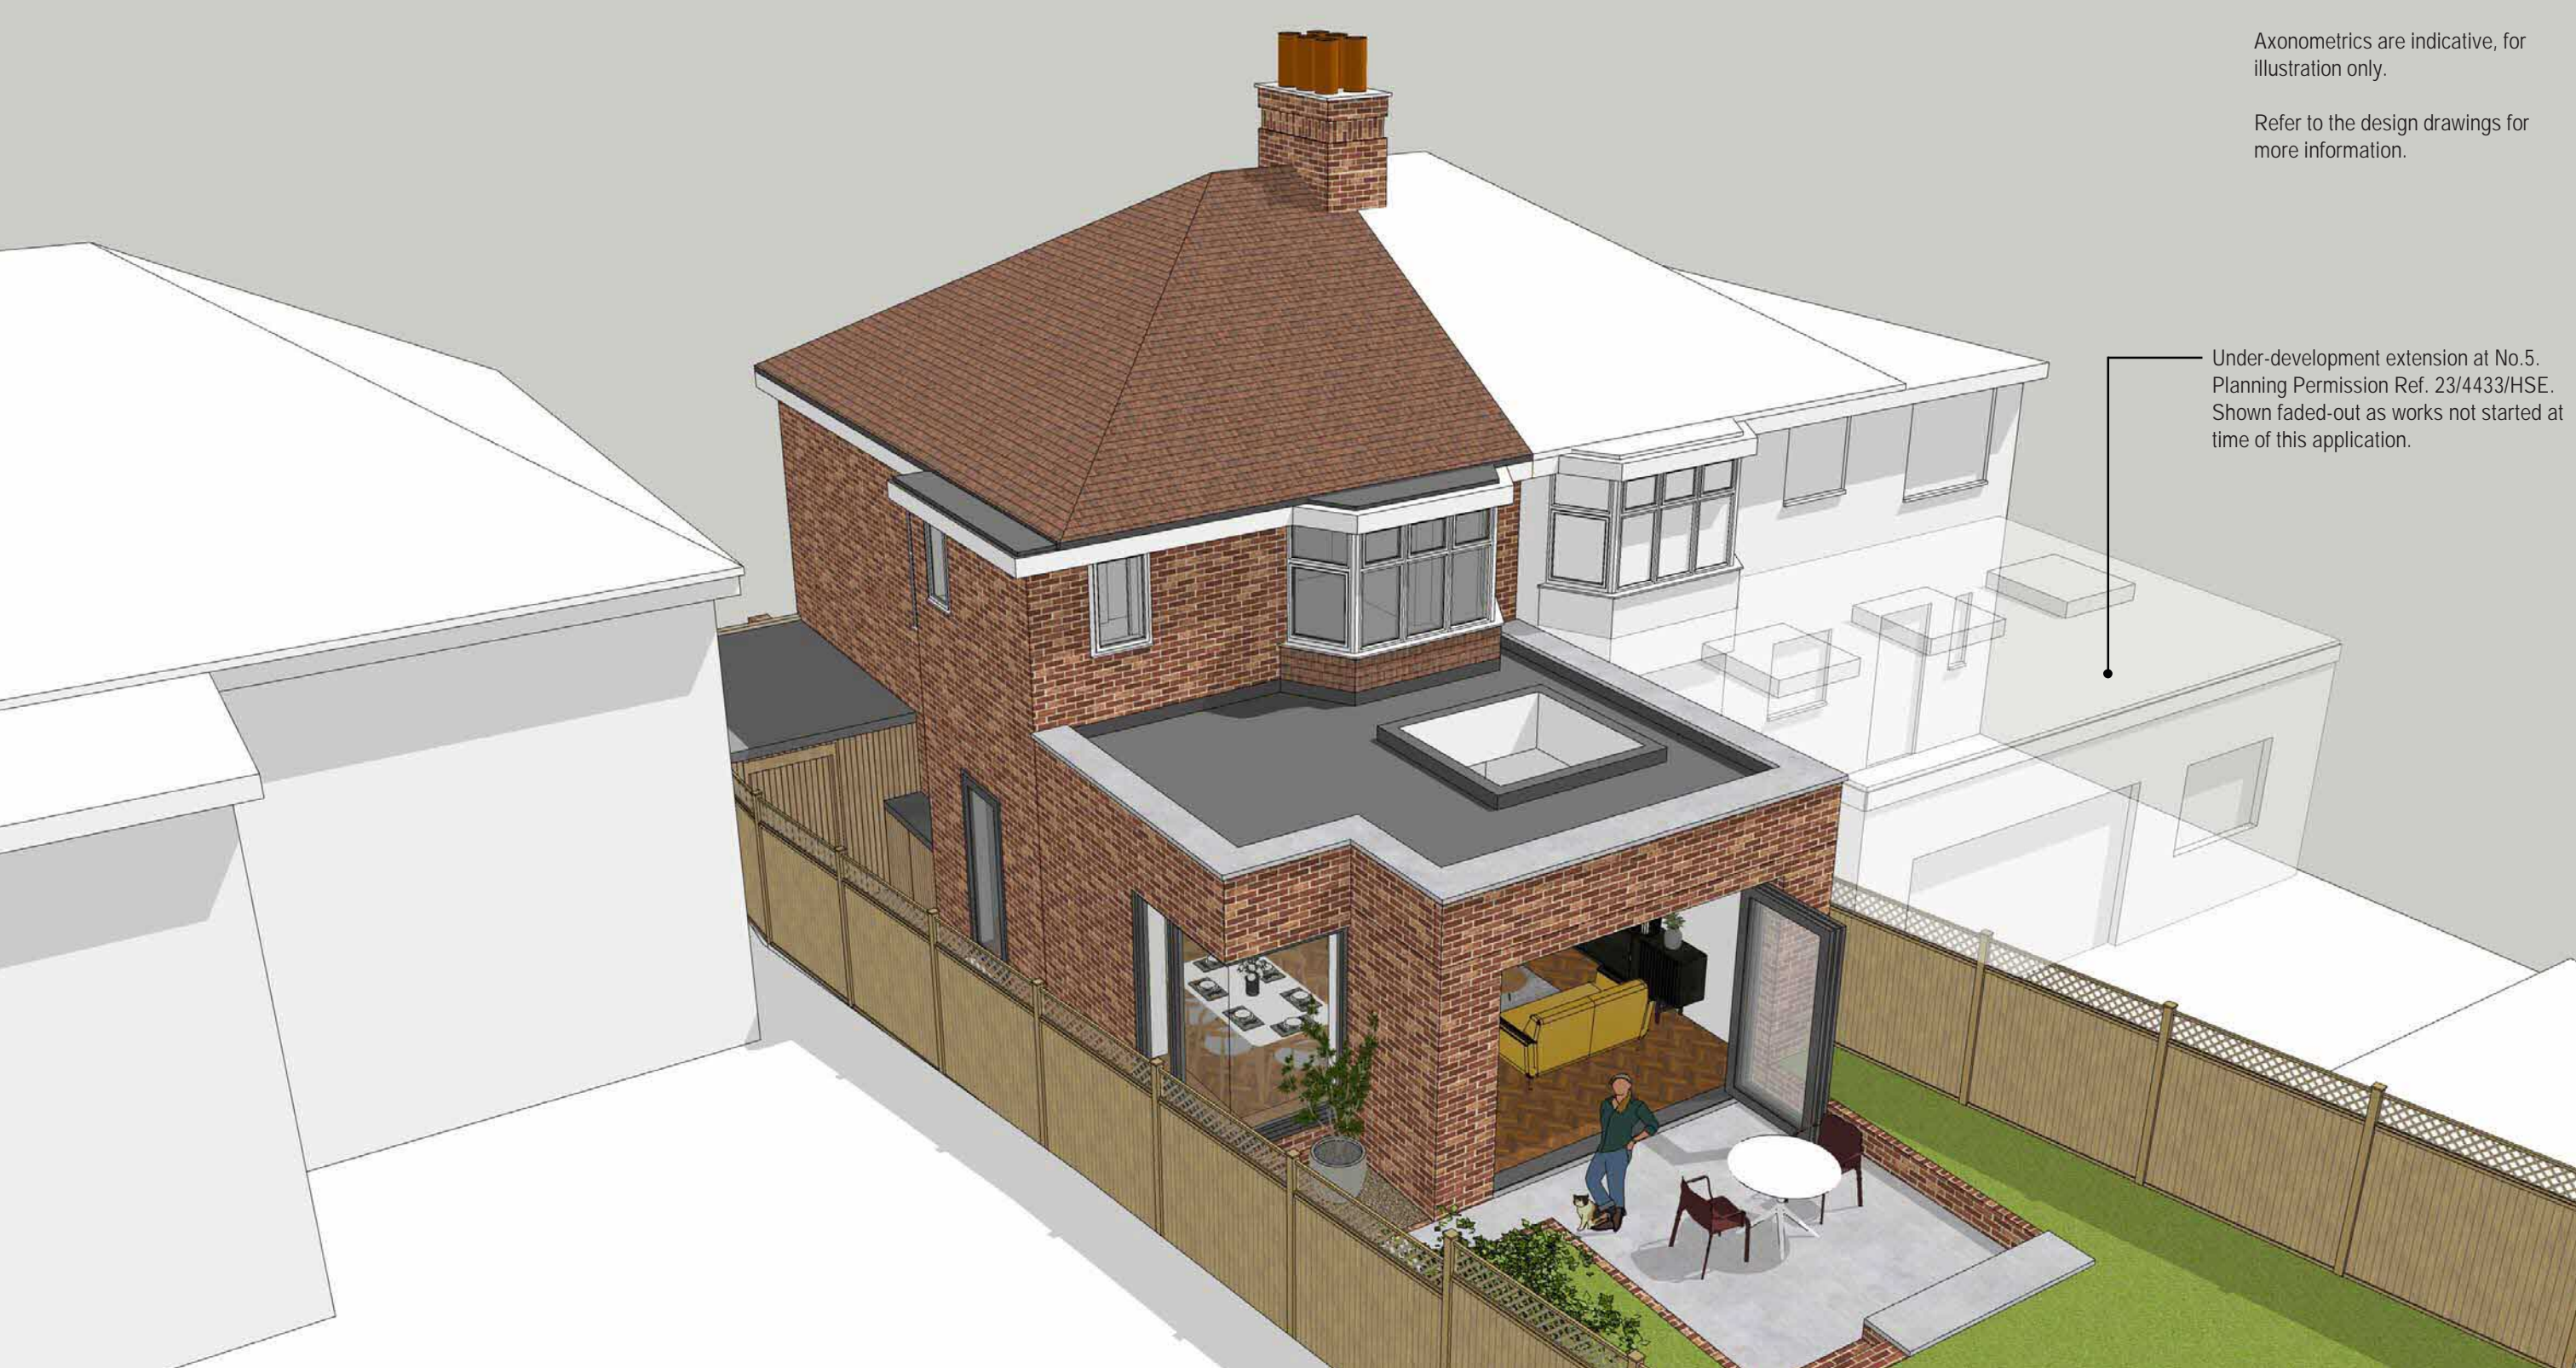
NORTH WEST AXONOMETRIC

Under-development extension at No.5. Planning Permission Ref. 23/4433/HSE. Shown faded-out as works not started at time of this application.
