REF: 9644762

## SITE RECORD DETAILS

ADDRESS: 1 College Farm Court Barton Cambridge CB23 7AL

DATE: 12-10-22

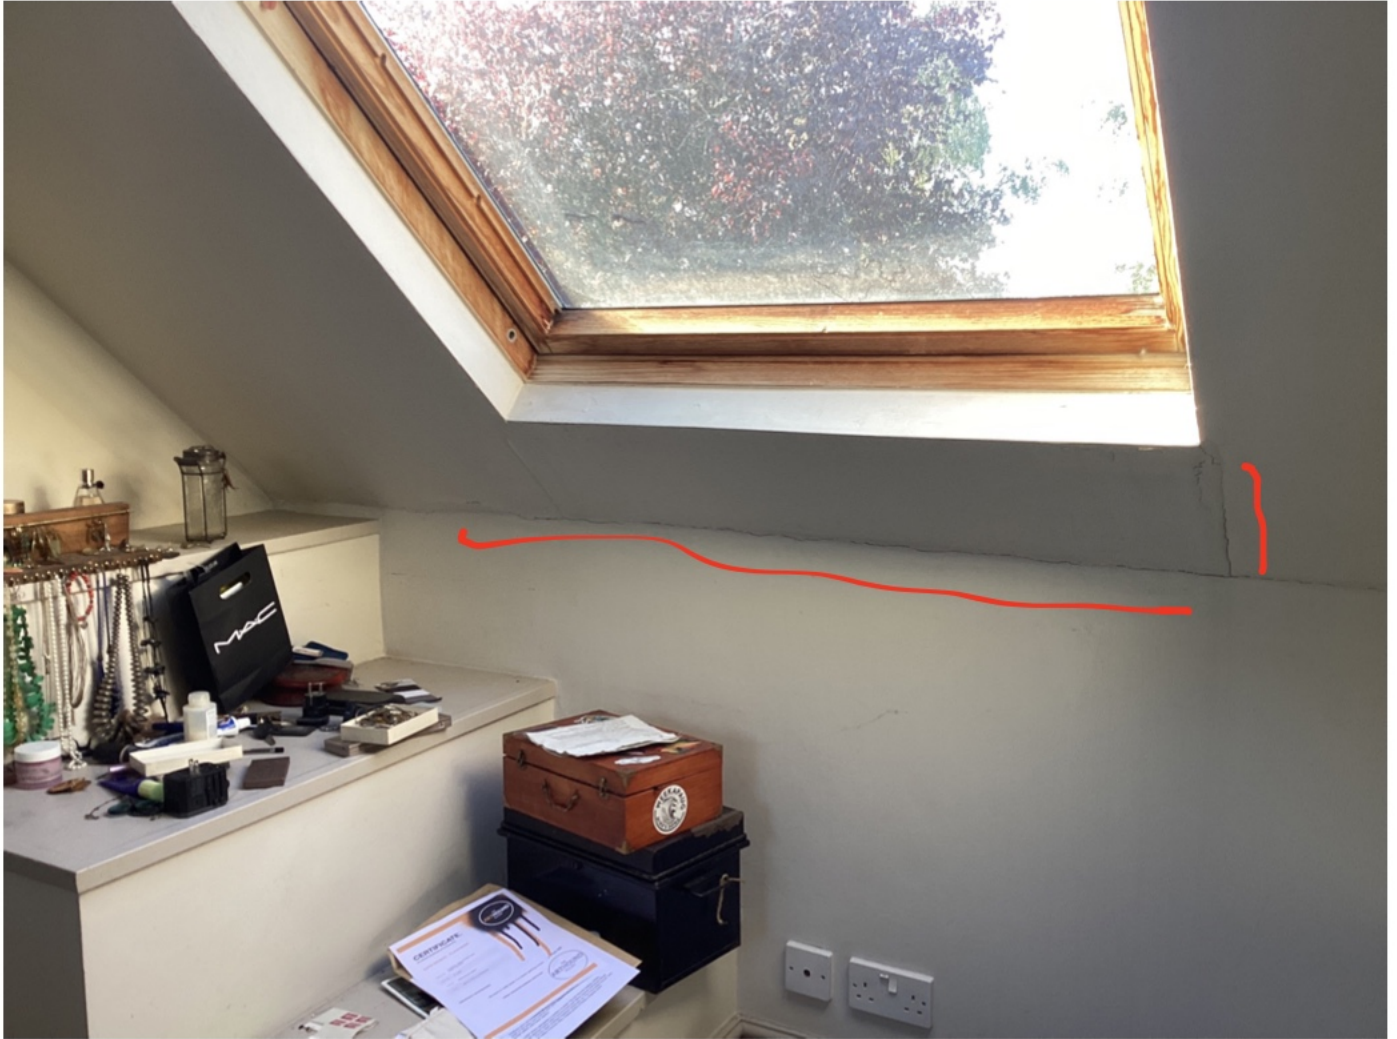
First floor bedroom

First floor bedroom-

5.2\*6.5\*2.3 m h-fine wall and ceiling cracks to be filled and walls and ceilings redecorated.

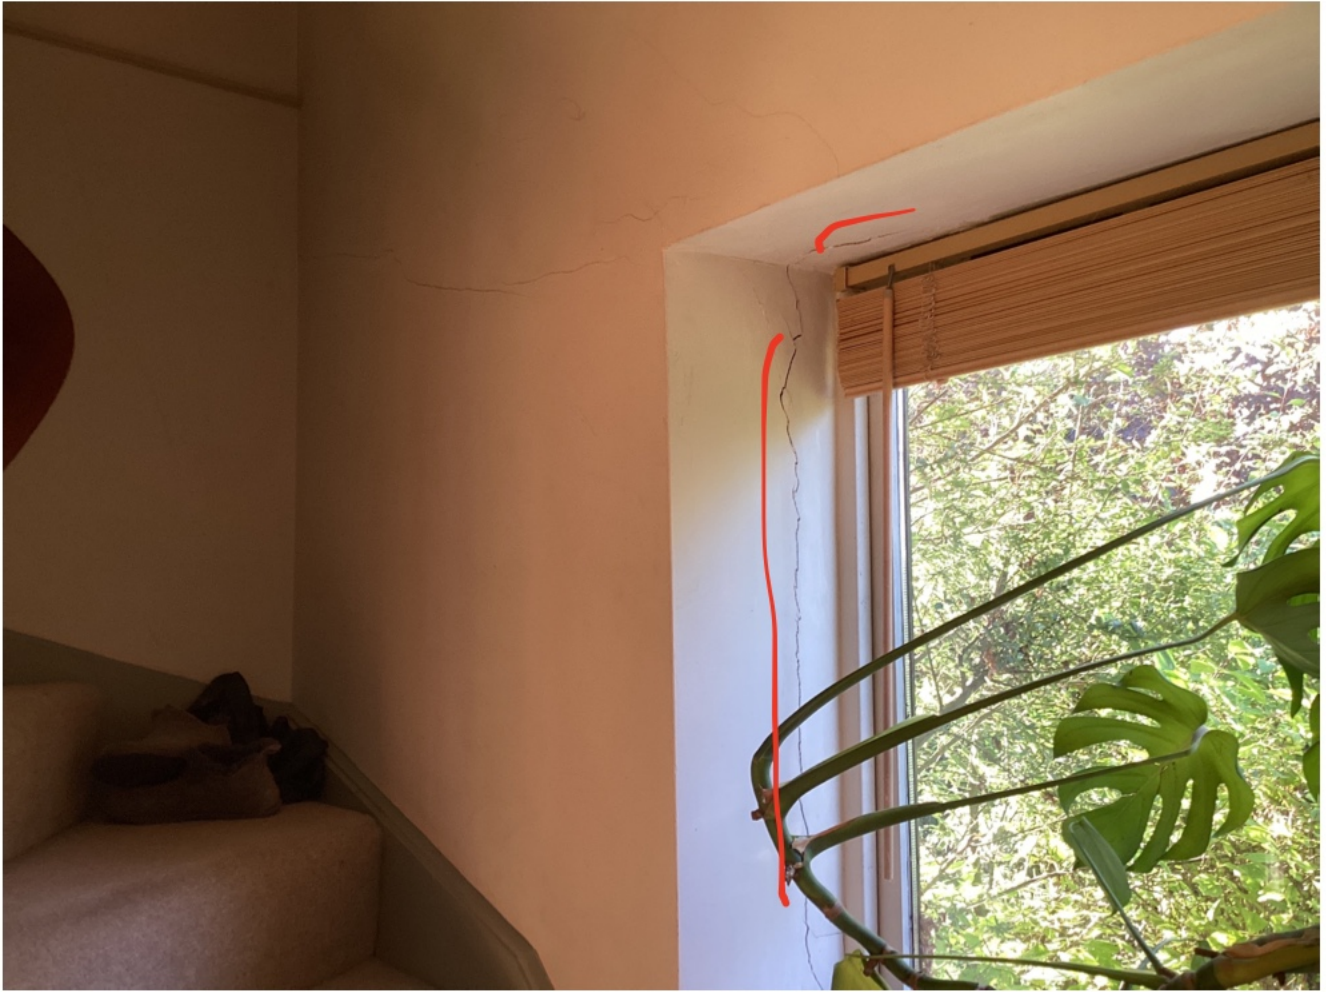
Back wall of rear right lounge

Lounge- including stairs-

6.4\*5.3\*2.2m h-Allow for mesh crack repairs to cracks on rear wall and minor crack filling elsewhere and full redecorations.

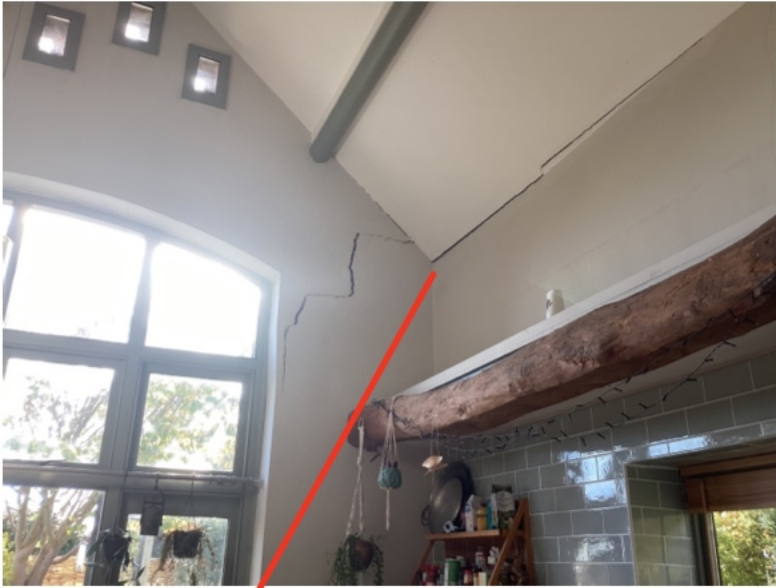
Worst cracking rear  
left corner

**LOCATION:** Kitchen rear left

Kitchen-

5.3\*3.6\*5.7m h-Crack repairs and possible localised reconstruction to rear left corner adjacent to door opening on left including replastering and redecorations to this room. Carpenter to assess the door - window frame to see if this can be removed a temporary screen put in place and the frame repaired or if a new frame is required.

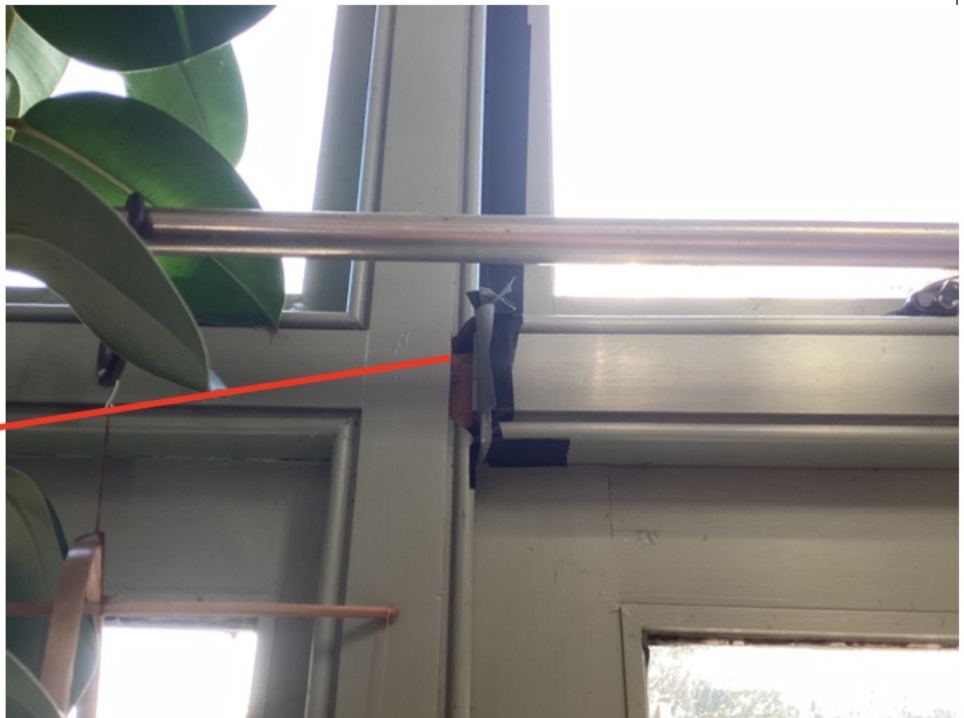
Window / door frame  
pulled significantly

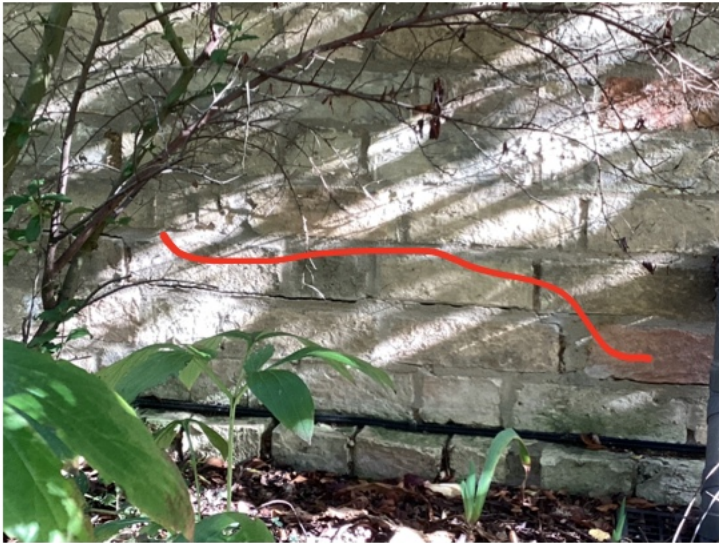
Rear kitchen wall

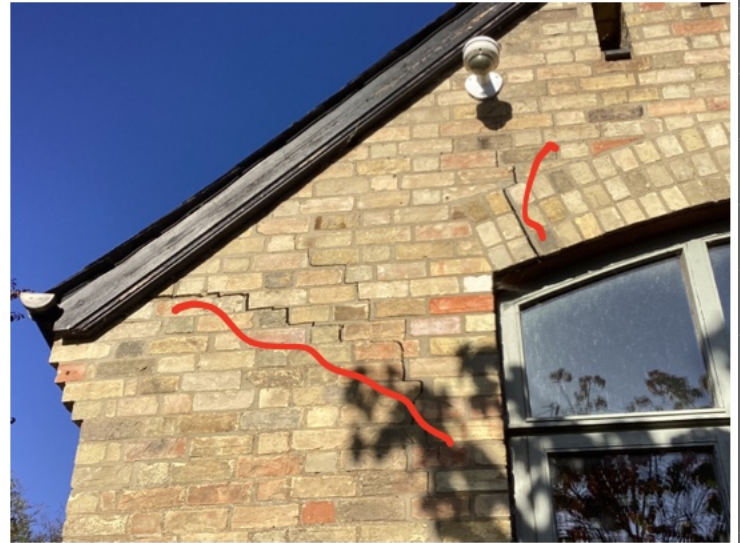
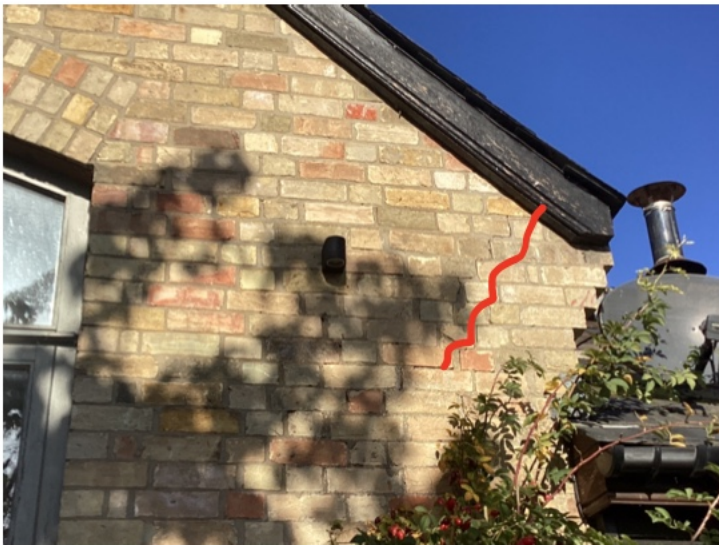
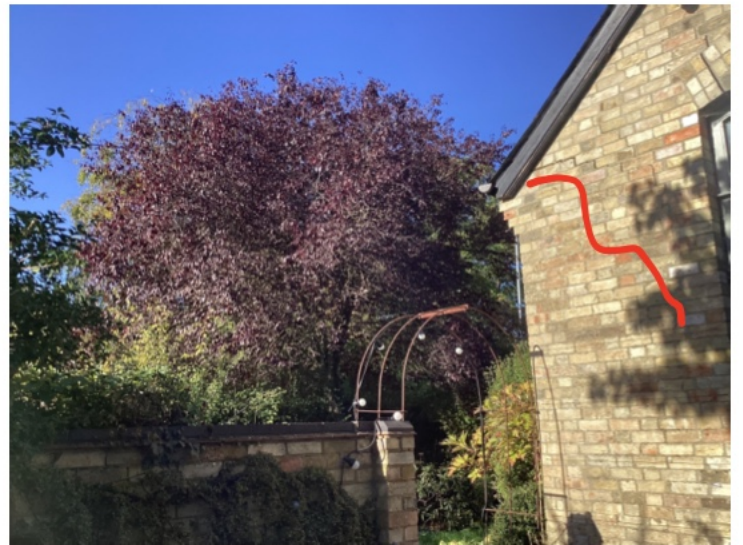
Left kitchen wall

Rear and left of kitchen
