Heritage Statement

Reinstatement of Property following Subsidence Damage

Works to a Curtilage Structure

1 College Farm Court, Barton, Cambridgeshire CB23 7AL

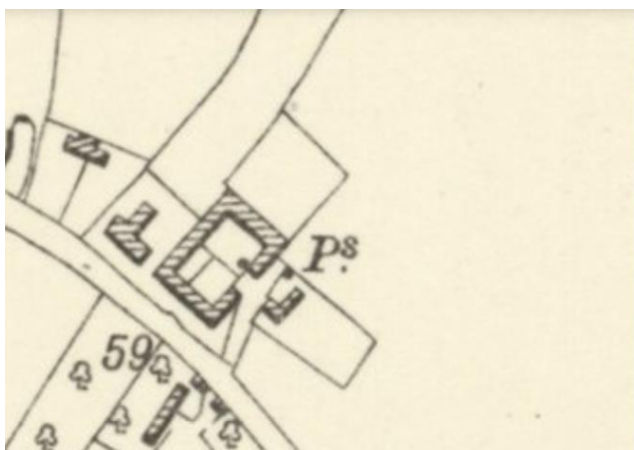
Looking at the National Library of maps, we note that comparing the property in 1902 with current day, the property remains predominantly unchanged:

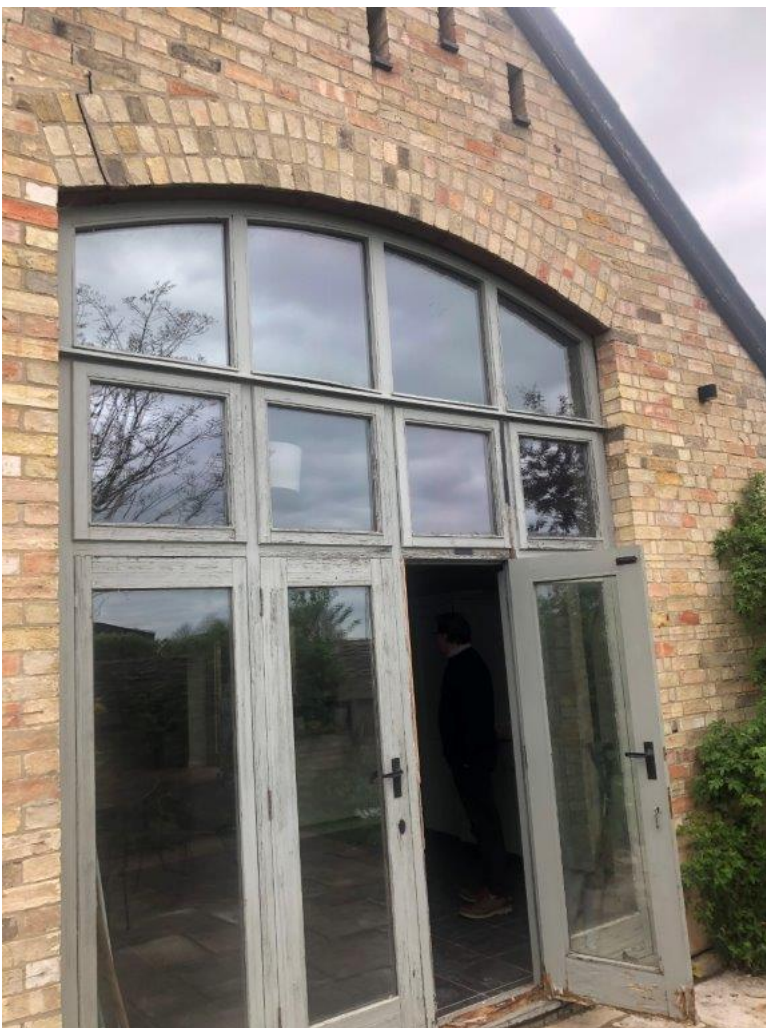
The main area of damage was to the rear left corner of the kitchen where significant tapering cracking to the left wall of the kitchen was found.

In addition to the localised repair works, we understand that the modern timber French doors will be replaced on a like-for-like basis using a new hardwood frame and door. There is concern that these works will displace the already weak brick arch over the doorway and hence you will see the Contractor has allowed for localised reinstatement of this arch within his schedule.
