**BAT, BARN OWL AND NESTING BIRD SURVEY**

**SEA DRIFT, MAENPORTH, FALMOUTH, CORNWALL**

**February 2024**

**Report No:** 23-088/CvK/Sea Drift, Maenporth\_BBONB

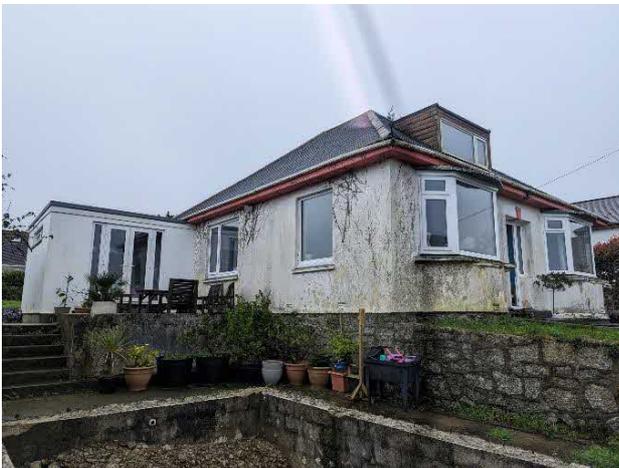
The building subject to this survey is a rectangular dormer bungalow, built from rendered blockwork, with a hip ended roof covered with composite slate which has dormer windows to the front and rear. The building has bay windows to the front with a small single storey flat roofed extension to the side and another to the rear. To the front of the house, dug into the slope of the hill and so sitting below ground level, is a single storey garage with a flat roof formed using plywood lined with bitumen felt, see Photos 1, 2 and 3.

Photo 1. Showing the property from  
the north east

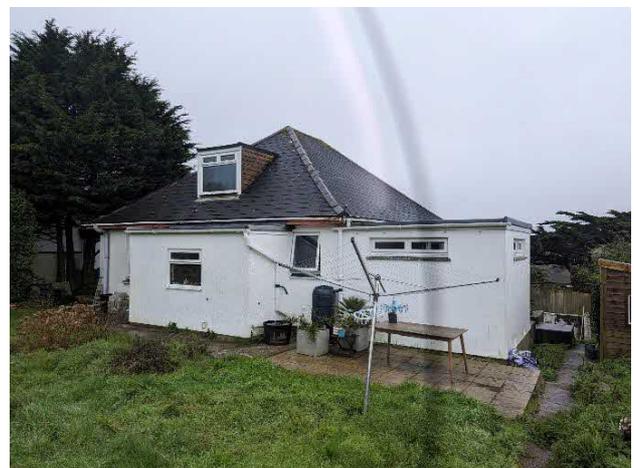
Photo 2. Showing the property  
from the south east

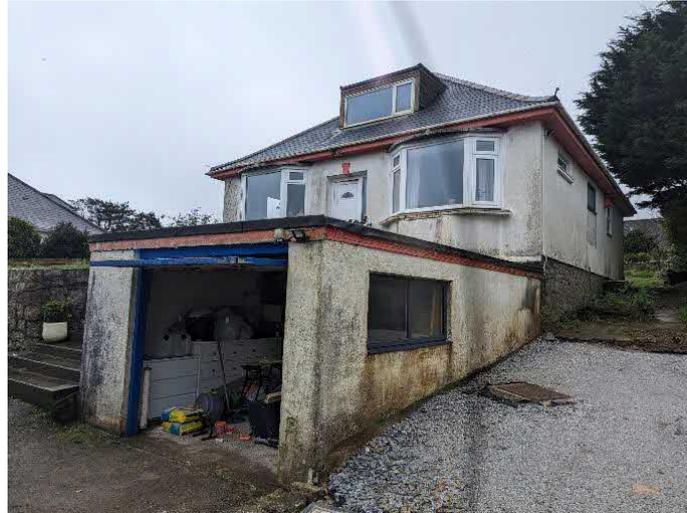
Photo 3. Showing the property from the north west including the garage

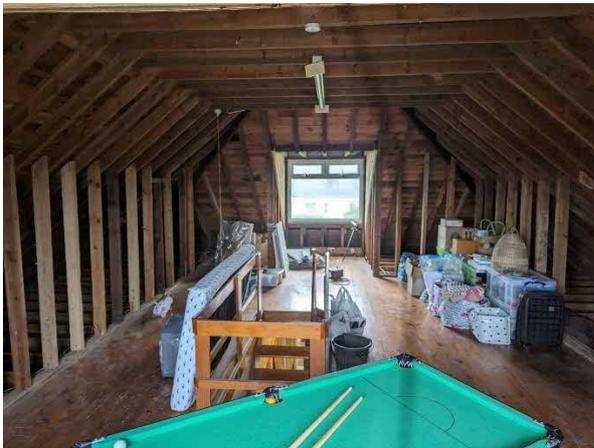
Internally the roof void is a single open space, which is arranged as a single room, running the length and width of the building, and has a mostly boarded floor and fixed staircase up from the ground floor. This room appears to have originally had lined walls and a ceiling but these have been removed and so the roof space is now a single completely open space, open from the floor to the underside of the roof which is lined with timber sarking, see Photos 4 and 5.

Photo 4. Showing the room in the roof space looking south

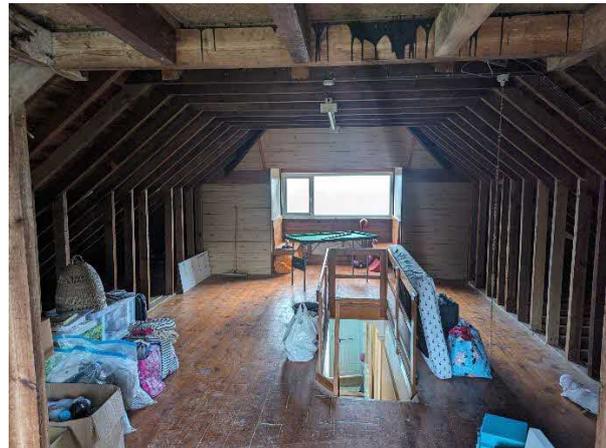
Photo 5. Showing the room in the roof space looking north

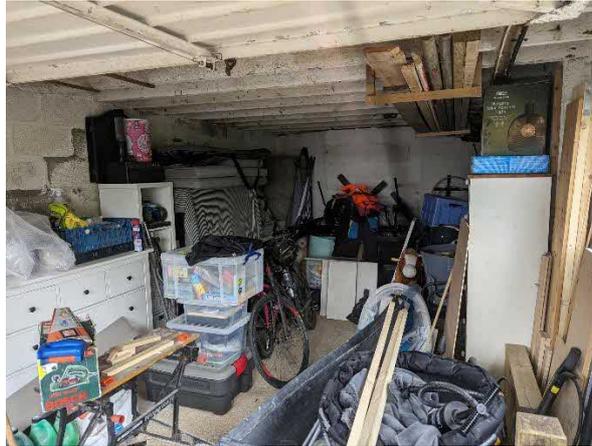
The garage has bare blockwork walls internally and is open from the concrete floor to the underside of the roof, which is formed from timber joists supporting a plywood roof, and is underground to the east and south, see Photo 6.

Photo 6. Showing the interior of the garage
