**Garage at 60 Vann Rd,
Fernhurst,
Haslemere
GU27 3NS**

Phase 1 Daytime Bat Assessment

20th February 2024

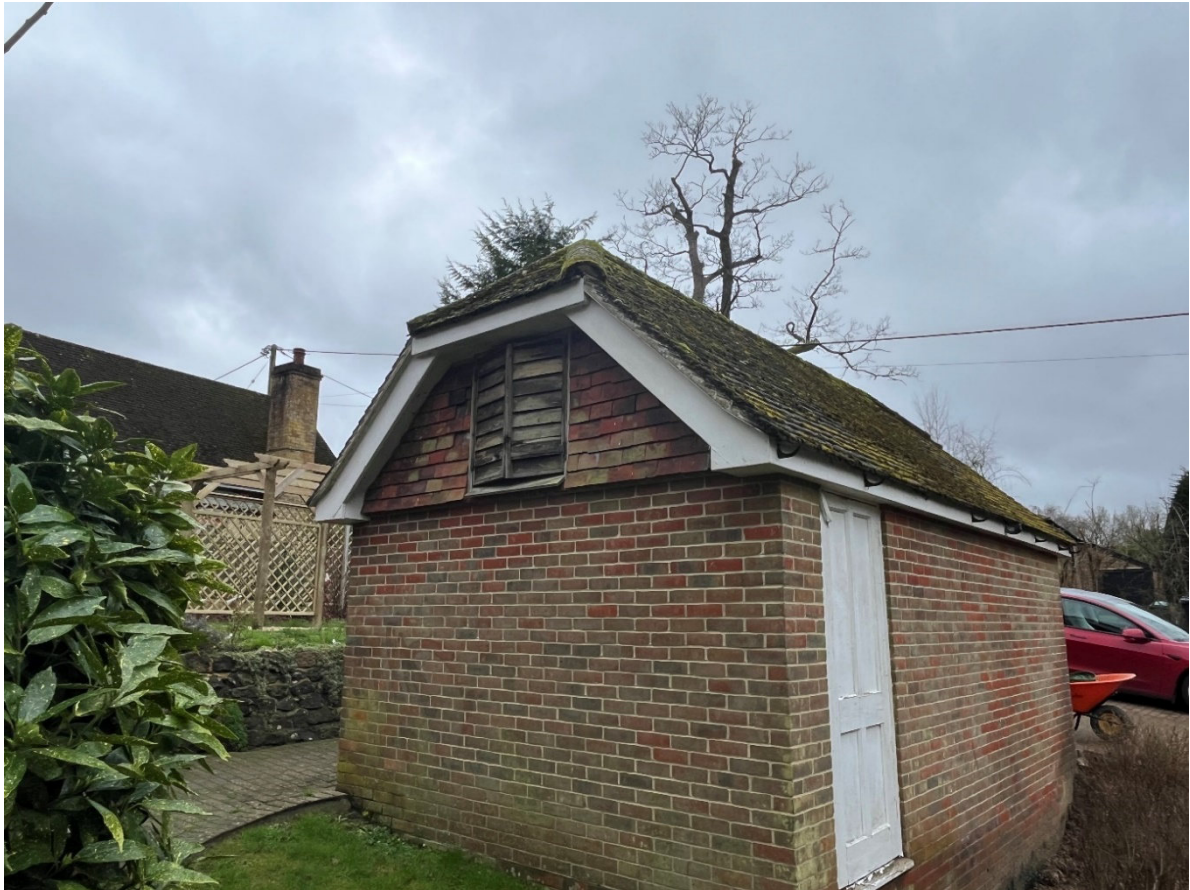
The garage dates to 2000 and is built of breeze block faced with brick with a pitched hipped roof of close-fitting cement tiles (see figures 1 and 2). One of these has broken off but the stub is still *in situ* with no access beneath. The gable ends are faced with close-fitting hang tiles with a wooden 'hayloft type double door at the north end. This is made of lap-planking which is unlined internally (See figures 3 and 5).

Figure 1. Northern and western elevation of garage looking south.

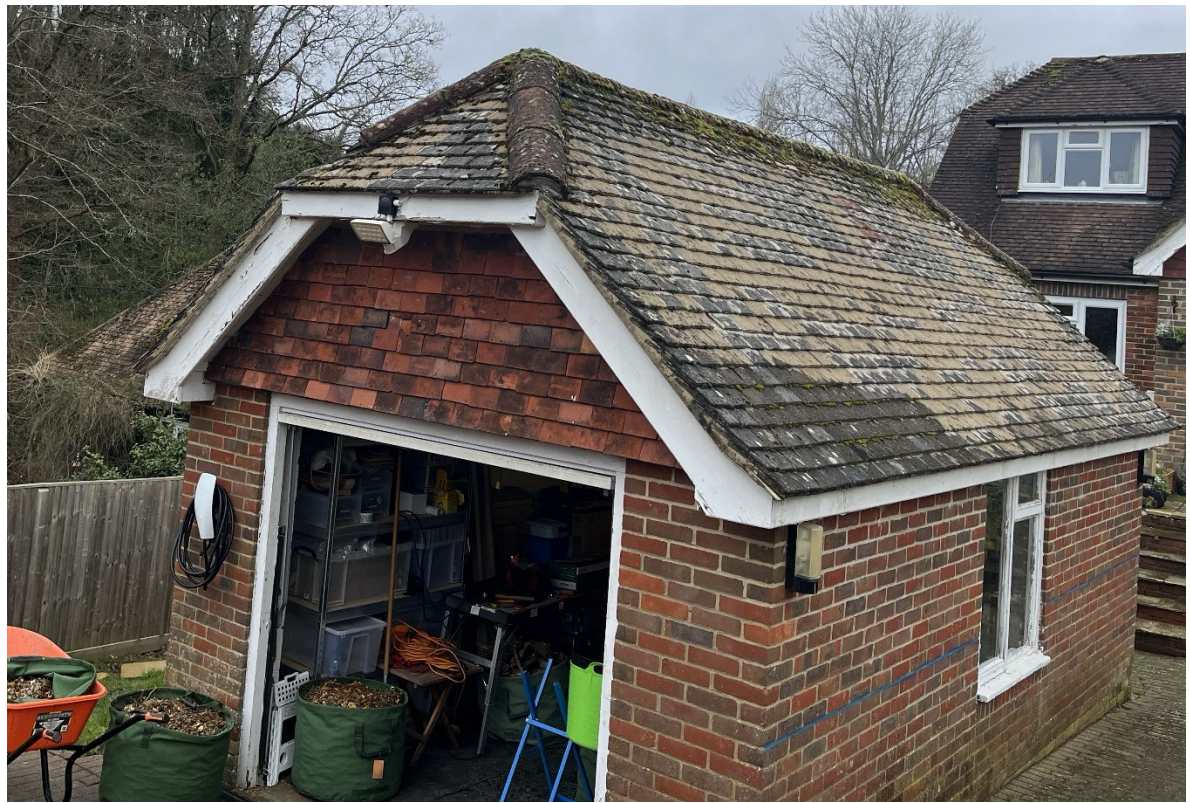
One tile is broken on the south gable but as with the roof the stub of the tile is *in situ* and no opening is available for bats. The fascias are of wood and are tight-fitting with no entry points. The roof is lined internally with bituminous felting which is in excellent order (see figure 4) and the internal space is permanently illuminated via a window on the eastern wall (see figures 2 and 4). There are no potential roost spaces in the framing or walls.

Figure 2. Southern and eastern elevation of garage looking north.

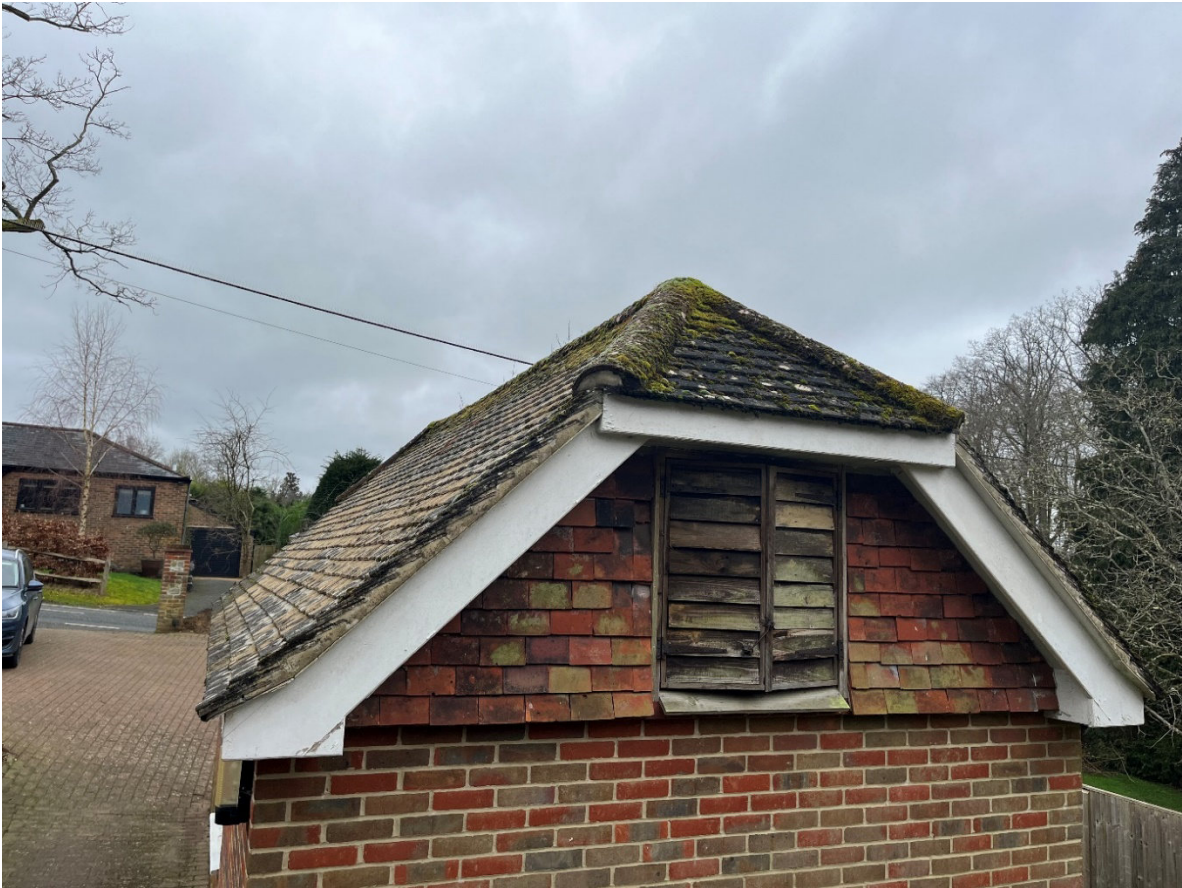
Figure 3. Northern elevation of garage showing doors.

There is potential access around the wooden doors on the upper part of the north gable, but there was no sign of any bat activity within the garage which is open internally with no enclosed voids, and the internal space is permanently illuminated via a window and the timbers are nailed with no holes or gaps.

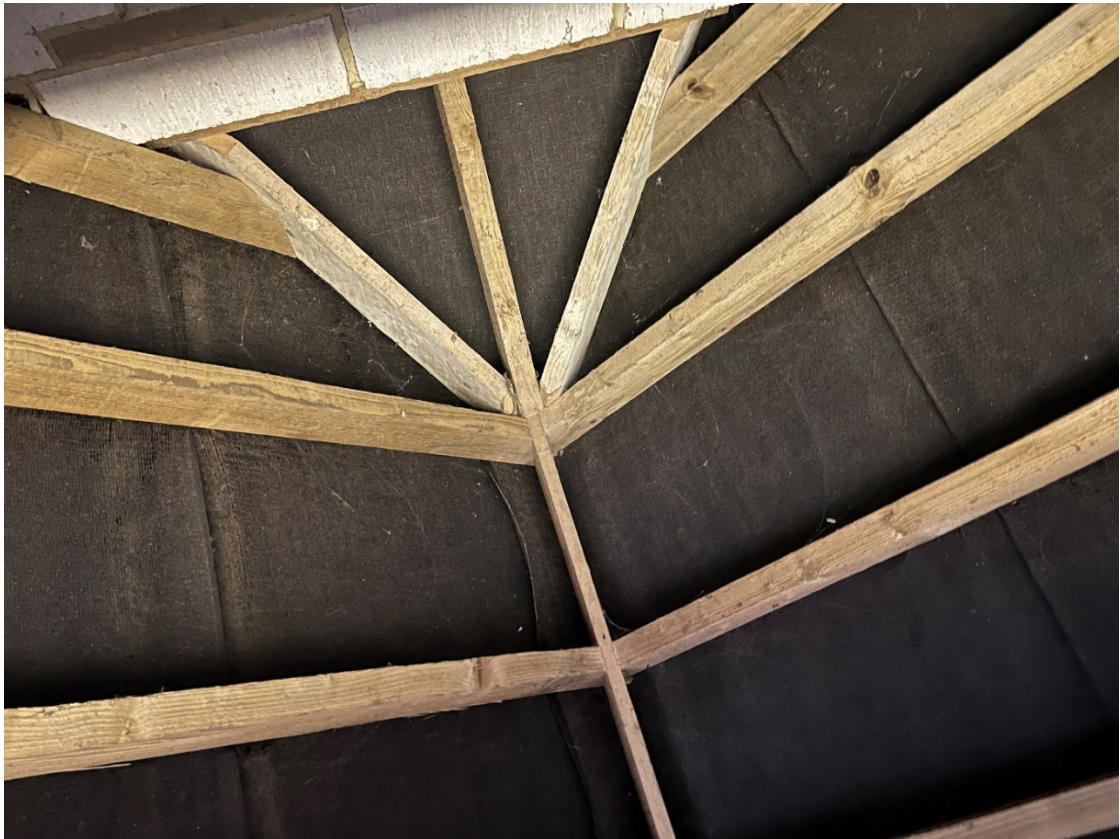
Figure 4. Garage roof looking southwest.

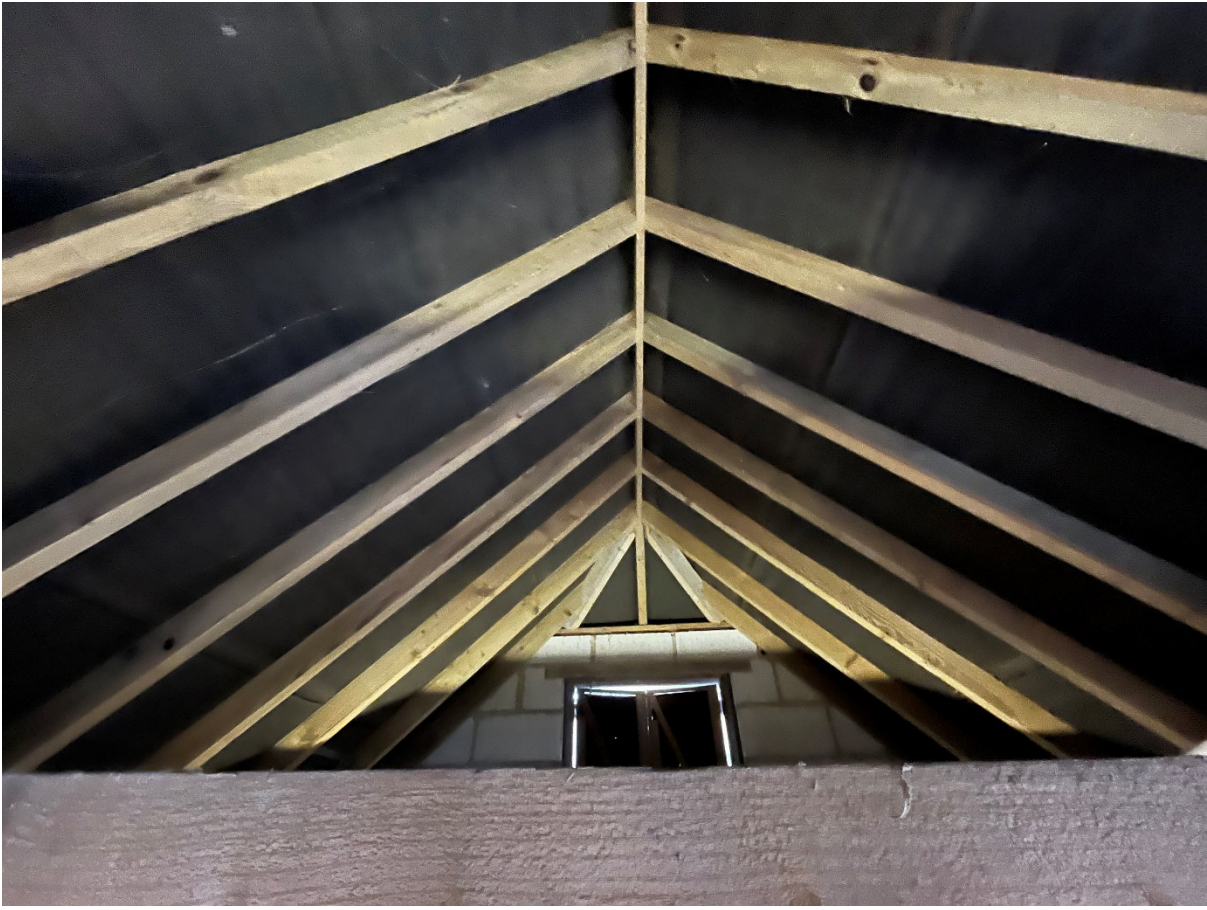
Figure 5. Garage roof looking northeast.
