# **Bat Assessment Report**

**Highclere**

**Easebourne Lane  
Easebourne  
Midhurst  
GU29 9AY**

**23-116  
August 2023**

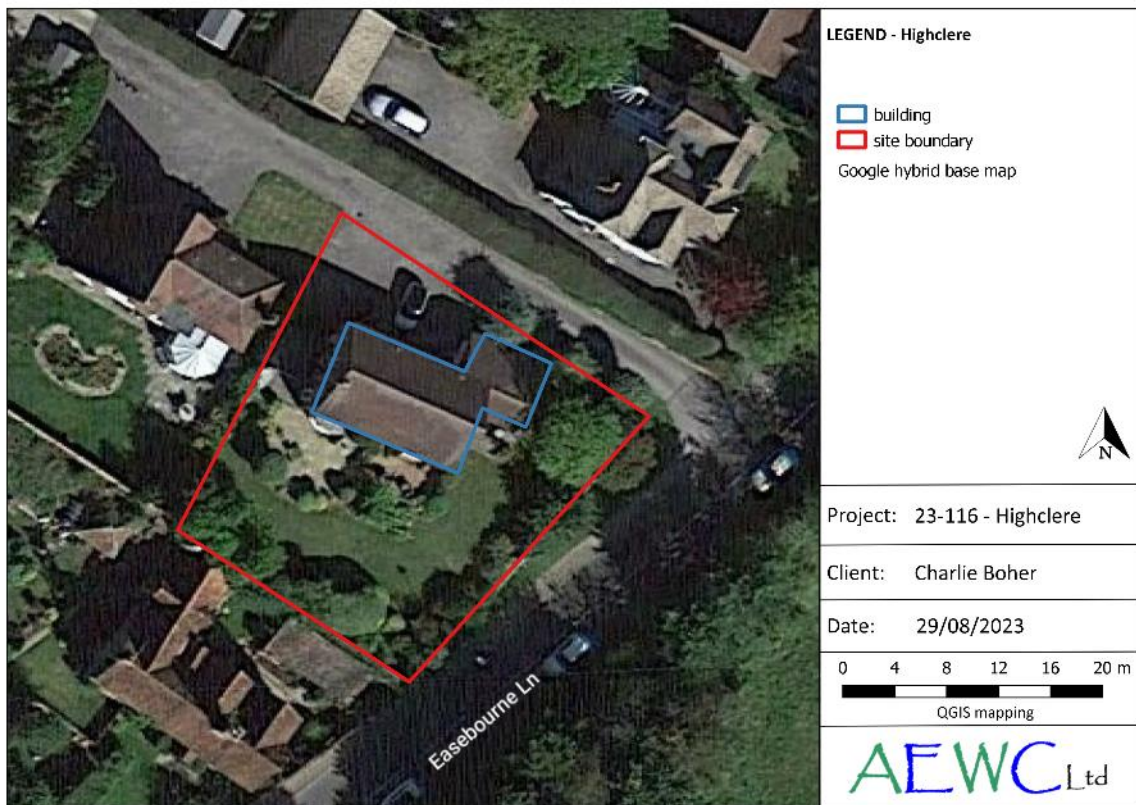
**FIGURE 2: SHOWING THE BUILDING SUBJECT TO SURVEY.**

1.7 The site contains a detached dwelling situated within an amenity garden.

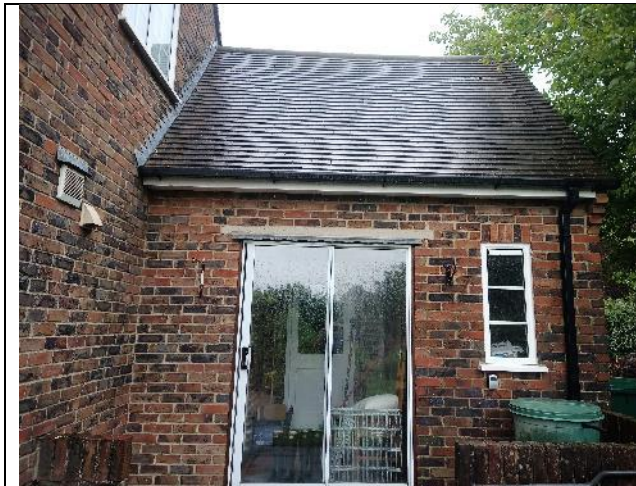
- 4.3 The eastern elevation wall of the house, and southern elevation of the extension, which will be directly impacted by the extension works are plain brick with no suitable bat roost features present.

**Photograph 1:** Southern elevation of the extension and eastern elevation of the house

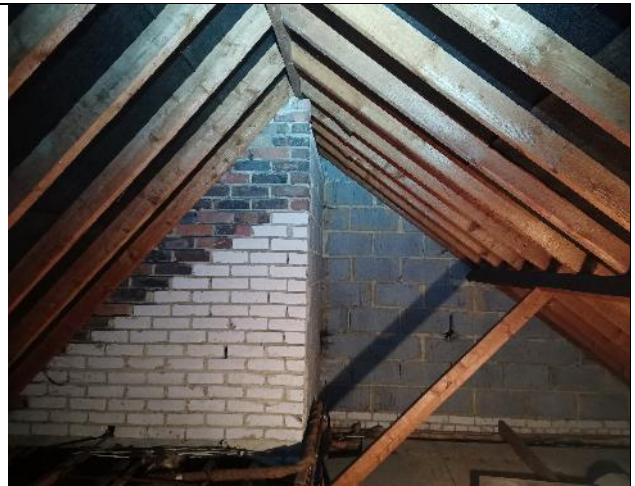
- 4.4 A roof void is present above the existing single storey extension, which will be directly impacted by the proposed works. Some cobwebbing was noted at the ridge of the void and at the gable walls. The tile hung wall was internally sealed with no obvious access from the batten space of the tile hangings into the roof void. No evidence of the likely presence of bat roosts was identified within the void and no natural light ingress was noted.

**Photograph 2:** Roof void above the single-storey extension

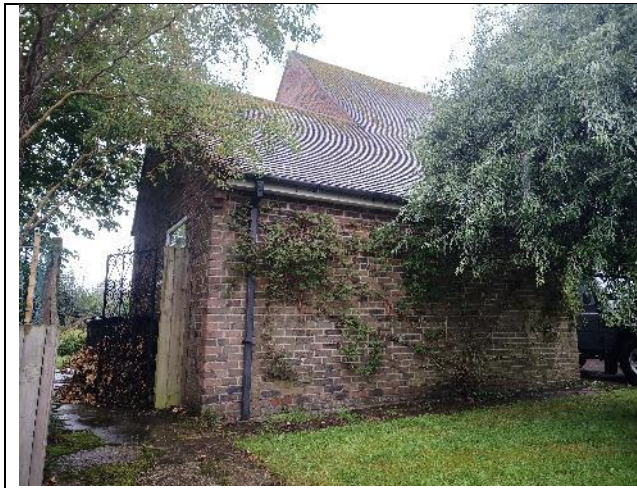
**Photograph 3:** *Northern elevation of the extension*

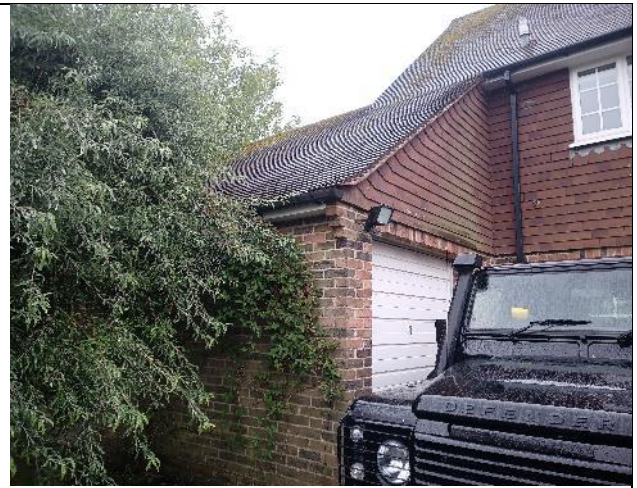
- 4.2 The roof and hanging tiles were noted to be very flat and tight fitting with no gaps suitable for access by bats noted to be present. Soffit boxes present around the eaves of the property were noted to be in good condition and tight fitting with no gaps suitable for access by bats noted.

**Photograph 4:** *Western elevation of the extension and partial northern elevation of the house, with tile hangings visible*
