BAT ROOST ASSESSMENT

NORTH LODGE, PARK LANE, SWANMORE SO32 2QQ

FINAL REPORT

October 2023

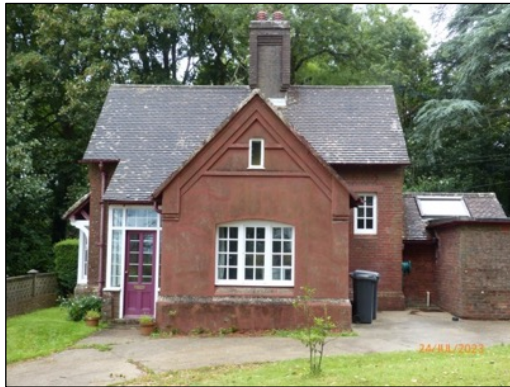
Figure 1: Southern elevation.

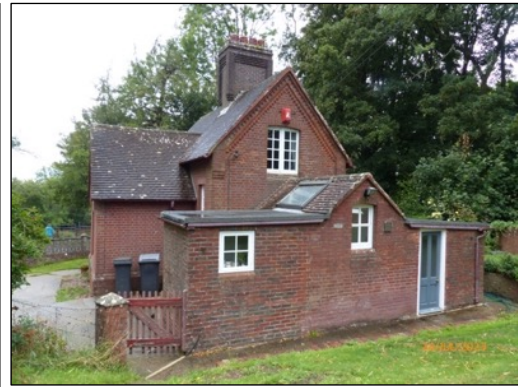
Figure 2: Eastern elevation, showing existing single storey extension.

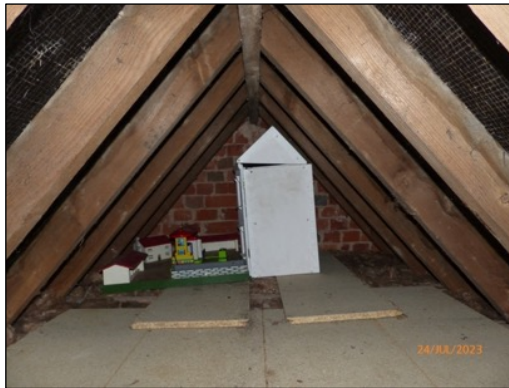
Void 1: This is the larger of the two voids and extends in a westerly direction from the central chimney stack. The roof is constructed with traditional rafters and a single beam extends along the ridge. The clay tiles are underlain with a bitumen type felt underlay and sheets of chipboard cover the floor (Figure 3).

Figure 3: Void 1 – extends in a westerly direction from the central chimney.

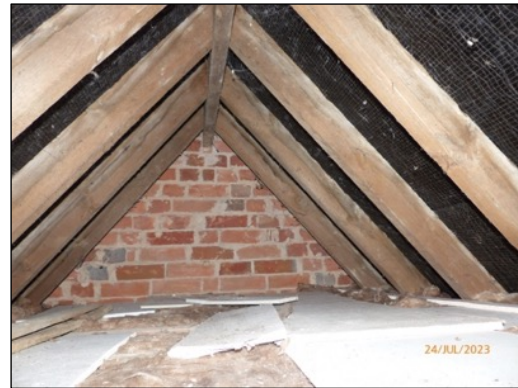
Figure 4: Void 2 – extends in an easterly direction from the central chimney.

Void 2: This void is constructed as void 1 but extends in an easterly direction from the central chimney stack. The floor was only partly covered with sheets of boarding and loft insulation in present (Figure 4).

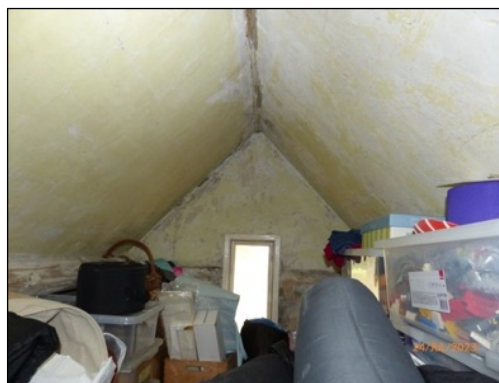
Void 3: Void 3 is effectively a small box room, that extends over the southern wing. It is accessed via a small door and a small window is present at the southern end. The void is plastered internally and therefore it was not possible to see the underside of the roof. The room is current used for storage (Figure 5).

Figure 5: Void 3 – showing plastered ceiling and window at southern end.

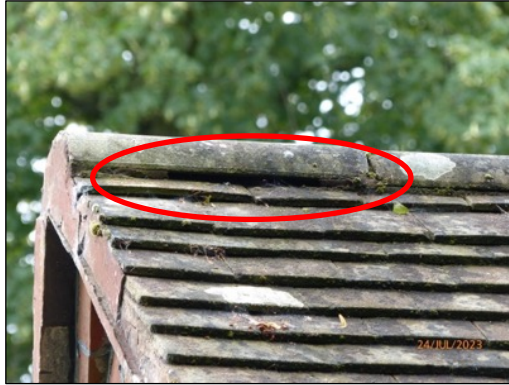
The exterior of the building is generally in good condition, although there were some small gaps on the roof where the tiles had slightly raised up (Figure 7) or broken creating apparent gaps and where mortar had dropped out from beneath a ridge tile on both the

Figure 6: Ridge tile with apparent gap where mortar had dropped out on northern elevation (red oval). Another apparent gap was also present on the southern side.

- Modified ridge tiles – Roosting voids will be created beneath two ridge tiles on the newly extended part of the roof. Access to the voids will be created by leaving a gap in the mortar line below the ridge tiles. A batten measuring at least 20mm high by 50mm long will be inserted into the wet mortar and removed in order to create a gap of sufficient size.
- Traditional roof membrane - Modern breathable membranes can be extremely harmful to bats, causing them to become entangled and die, while the bats make the membrane ineffective as they damage it. Traditional bitumen membrane should be used instead. Natural England will refuse bat licence applications where modern breathable membranes are proposed. See <https://www.bats.org.uk/our-work/buildings-planning-and-development/non-bitumen-coated-roofing-membranes> for more information on the current research into this.

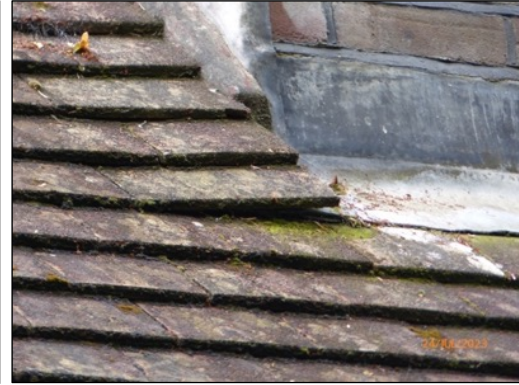
Figure 7: Raised tile on northern elevation by chimney stack.

- Raised roof tiles – Roosting opportunity will be provided in the form of two additional raised tiles (with a gap of 15mm), on different elevations of the building. These will provide alternative roosting opportunity with different environment conditions.
- Raised hanging tiles – if the extended building supports hanging tiles, the proposals will involve raising two tiles, to provide access gaps approximately 15mm deep for bats to enter.

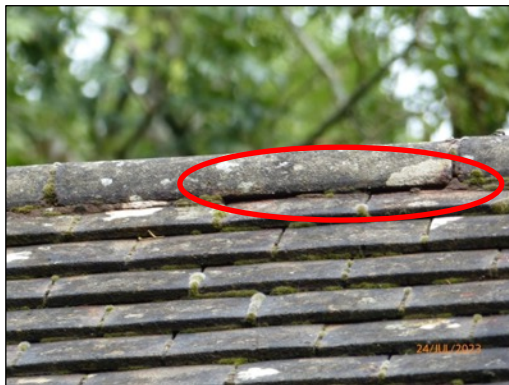
Figure 8: Ridge tile with apparent gap where mortar had dropped out on southern elevation (red oval). Another apparent gap was also present on the northern side.

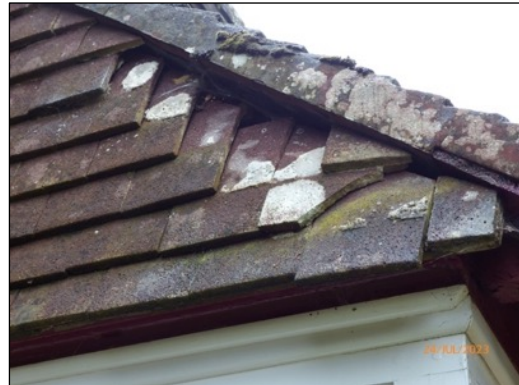
Further gaps were present where a tile was raised on the southern elevation, again next to the chimney stack and where some hanging tiles had broken on the western elevation above the porch (Figure 9).

Figure 9: Broken hanging tiles above the porch.

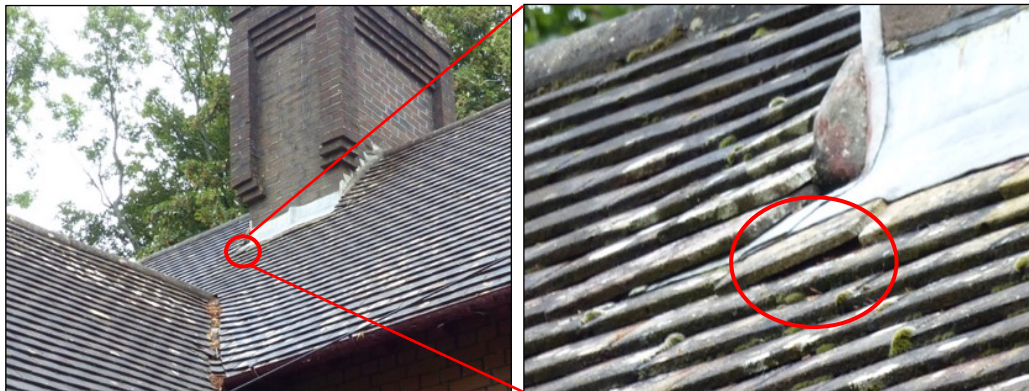
During the course of the emergence survey carried out on the 22nd August 2023, one common pipistrelle bat was recorded emerging from beneath a raised tile at the base of the chimney stack on the southern elevation of the building at 20:34 (Figures 10 and 11).

Figures 10 & 11: Location of confirmed common pipistrelle bat roost

The phase 2 surveys have confirmed that the building supports a common pipistrelle day roost, and based on the behaviour observed it is considered that the roost is also a male mating roost.
