Bat Risk Assessment

**23 Fawkham Avenue, New Barn,
Longfield, Kent DA3 7HS**

23rd February 2024

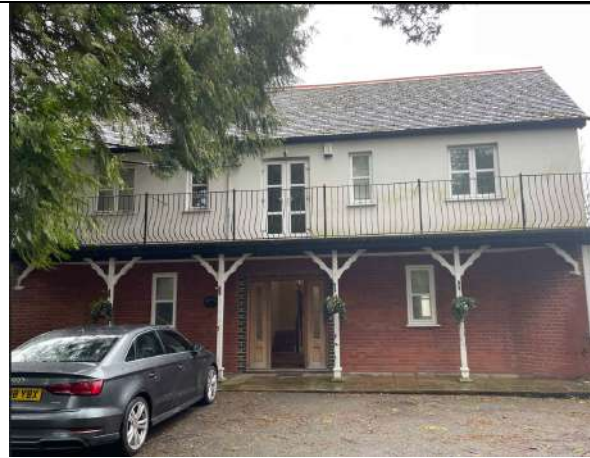
Southern elevation of B1 Dwelling.

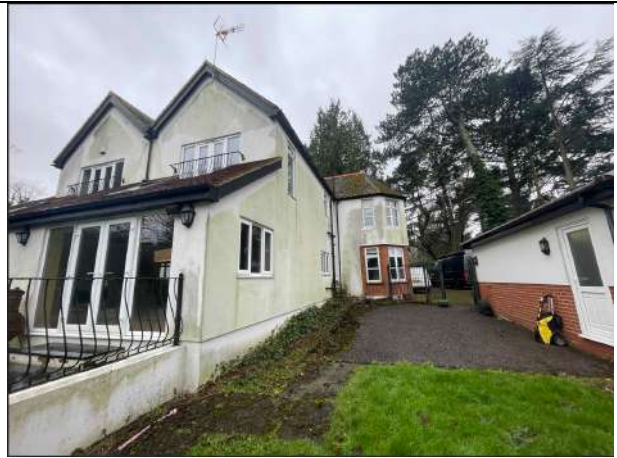
Northern and western elevations of B1 Dwelling, showing the 3 pitched roofs, the northern single storey extension and B3 outbuilding which will not be impacted.

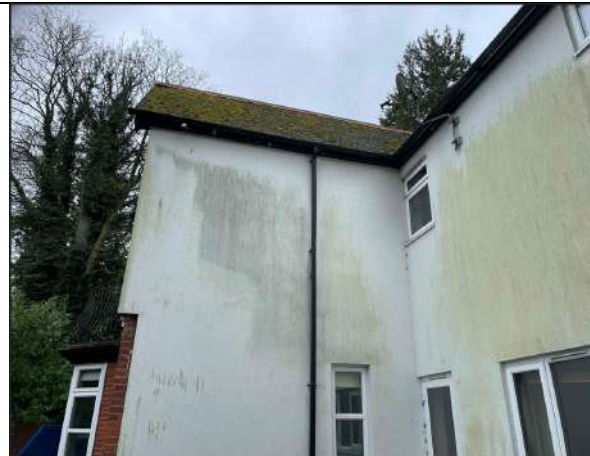
Eastern elevation of B1 Dwelling.

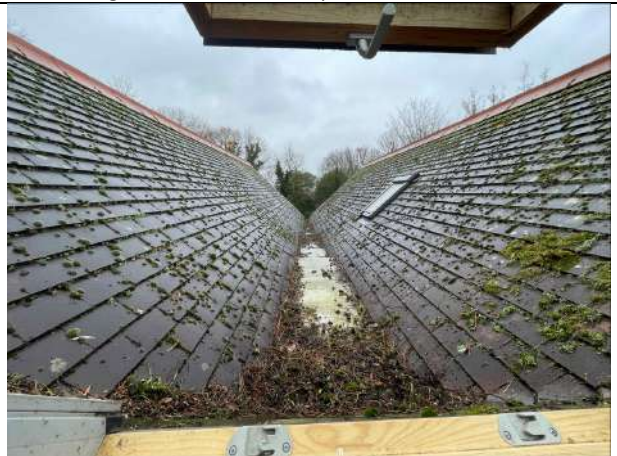
North facing view of the double pitch of B1 Dwelling, taken from the loft void window in the southern void. The roof tiles are in an excellent condition with no gaps.

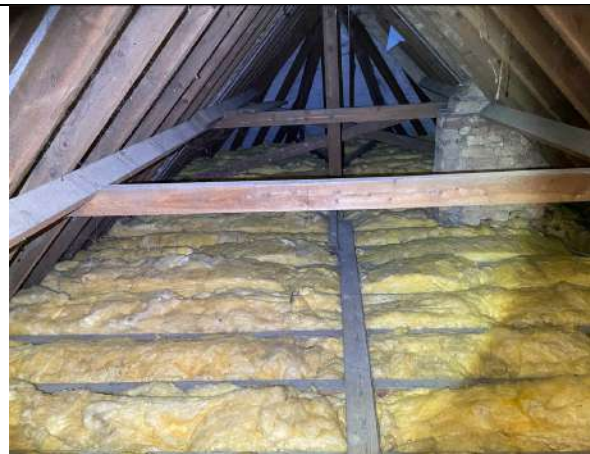
One of the loft voids in B1 Dwelling. It is in an excellent condition, with no bat evidence and no light ingress which could indicate bat access points.

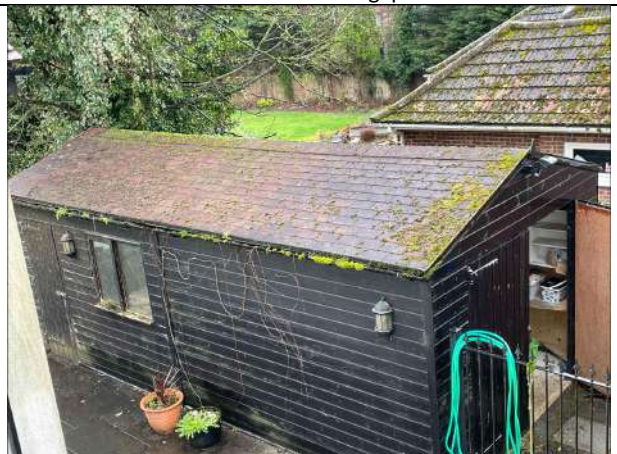
B2 Shed. The building is in an excellent condition with no potential roosting features for bats.
