**CCTV REPORT FOR: HELIOS HOUSE
CLARKES LANE
BARSHAM
NR34 8HN**

CONTENTS: SITE LAYOUT
FOUNDATION RECORD
PHOTOGRAPHS
LABORATORY TESTING RESULTS
ROOT IDENTIFICATION

Address: HELIOS HOUSE, CLARKES LANE, BARSHAM, NR34 8HN

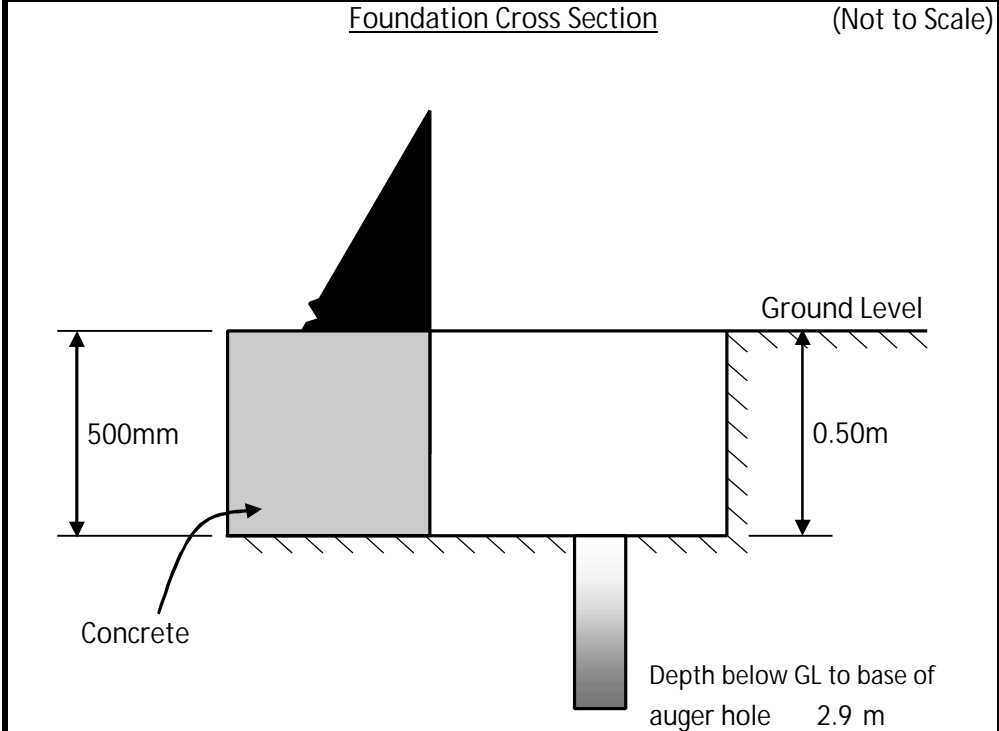
Location: Rear of Garage	T/H No. 3
Ground Surface: Dry	Weather: Dry
	Date: 16-Jan-24

Roots Depth & Diameter:
From 0.5m
Down to 1.9m
Water Depth Hit & Rise:
None observed on site
Reason for Termination:
Encountered obstruction
Sandstone

Depth (m)	Soil Descriptions (NB: Field crew description only)	Test Type	Depth (m)	
			From	To
G.L.				
0.50	Firm brown CLAY with some medium gravel (inc. chalk)	P.P. 4.5	0.500	
1.00	Firm/stiff brown slightly silty CLAY with some medium gravel (inc. chalk)	P.P. 4.5	1.000	
1.50	Firm/stiff grey/brown slightly silty CLAY with some medium gravel (inc. chalk)	P.P. 4.5	1.500	
2.00	Stiff grey/brown slightly silty CLAY with much medium gravel (inc. chalk)	P.P. 4.5	2.000	
2.50	Very stiff brown slightly sandy/silty CLAY with much medium gravel (inc. chalk)	P.P. 4.5	2.500	
2.90	End of Borehole	P.P. 4.5	2.900

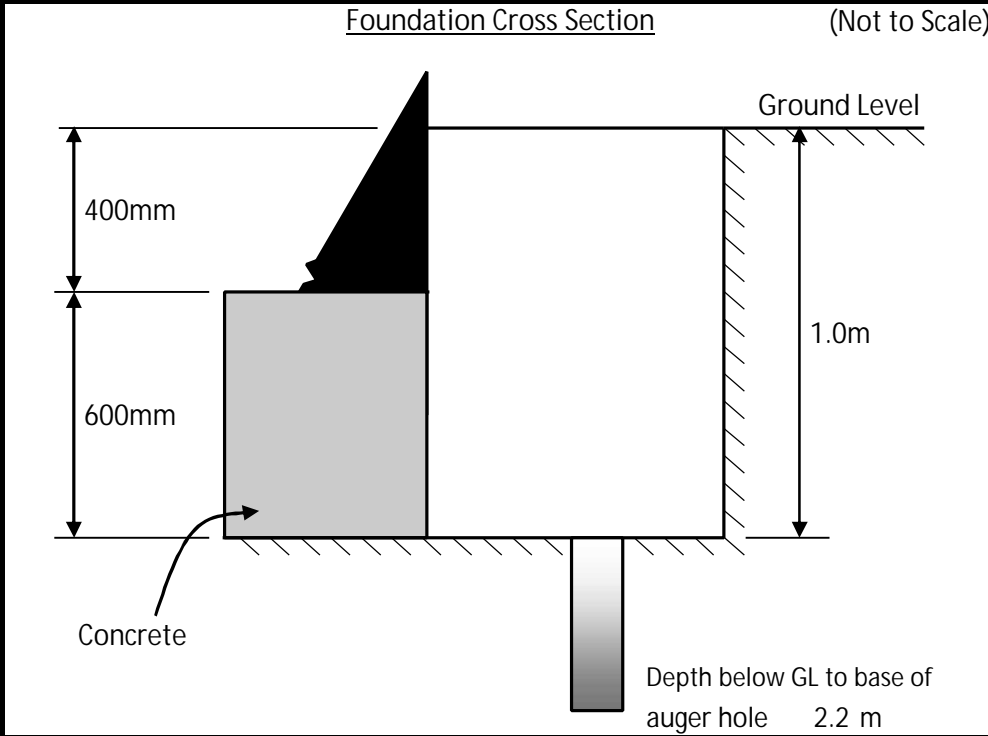
Location: Rear Left of House	T/H No. 4
Ground Surface: Dry	Weather: Dry
	Date: 16-Jan-24

Roots Depth & Diameter:
From 1.0m
Down to 1.7m
Water Depth Hit & Rise:
None observed on site
Reason for Termination:
Encountered obstruction
Chalk

Depth (m)	Soil Descriptions (NB: Field crew description only)	Test Type	Depth (m)	
			From	To
G.L.				
1.00	Firm/stiff brown CLAY with some medium gravel (inc. chalk)	P.P. 4.5	1.000	
1.50	Stiff grey/brown slightly silty CLAY with much medium gravel (inc. chalk)	P.P. 4.5	1.500	
2.00	<u>Very stiff grey/brown slightly silty CLAY with much medium gravel (inc. chalk)</u>	P.P. 4.5	2.000	
2.20	End of Borehole	P.P. 4.5	2.200

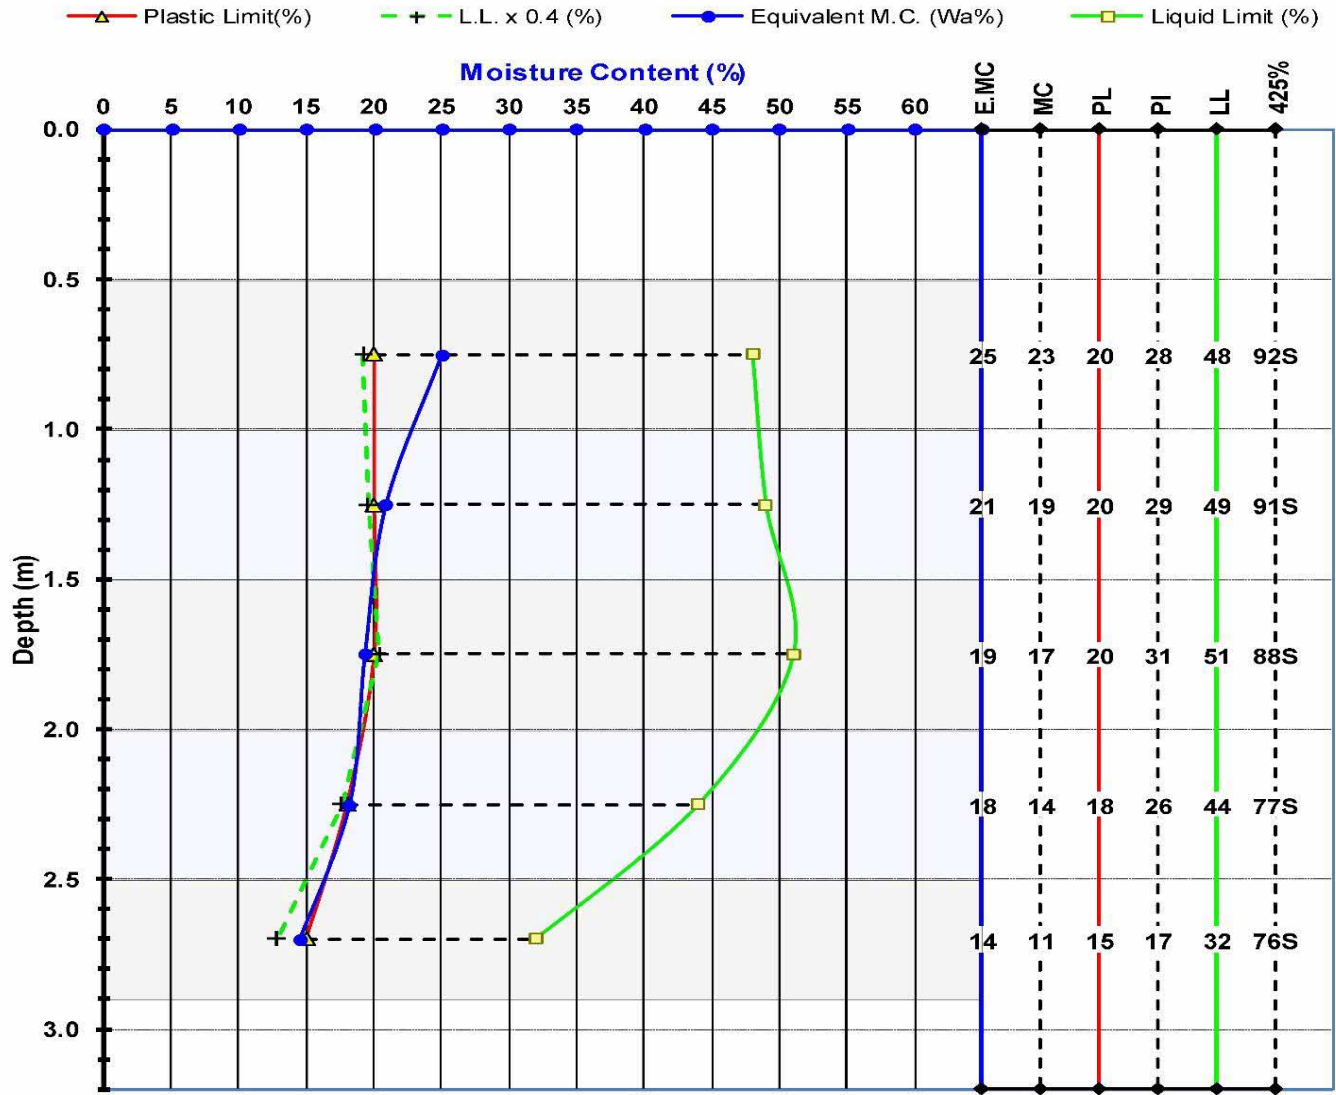
LABORATORY TESTING RESULTS

Depth T (m)	Depth B (m)	3 - Rear of garage		Plasticity (BS 5930)	Volume Change (BRE 240)
		Brief Soil Description			
0.5	1	Firm brown CLAY with some medium gravel (inc. chalk)		Intmd. CI	26% Medium
1	1.5	Firm/stiff brown slightly silty CLAY with some medium gravel (inc. chalk)		Intmd. CI	26% Medium
1.5	2	Firm/stiff grey/brown slightly silty CLAY with some medium gravel (inc. chalk)		High CH	27% Medium
2	2.5	Stiff grey/brown slightly silty CLAY with much medium gravel (inc. chalk)		Intmd. CI	20% Medium
2.5	2.9	Very stiff brown slightly sandy/silty CLAY with much medium gravel (inc. chalk)		Low ML	13% Low

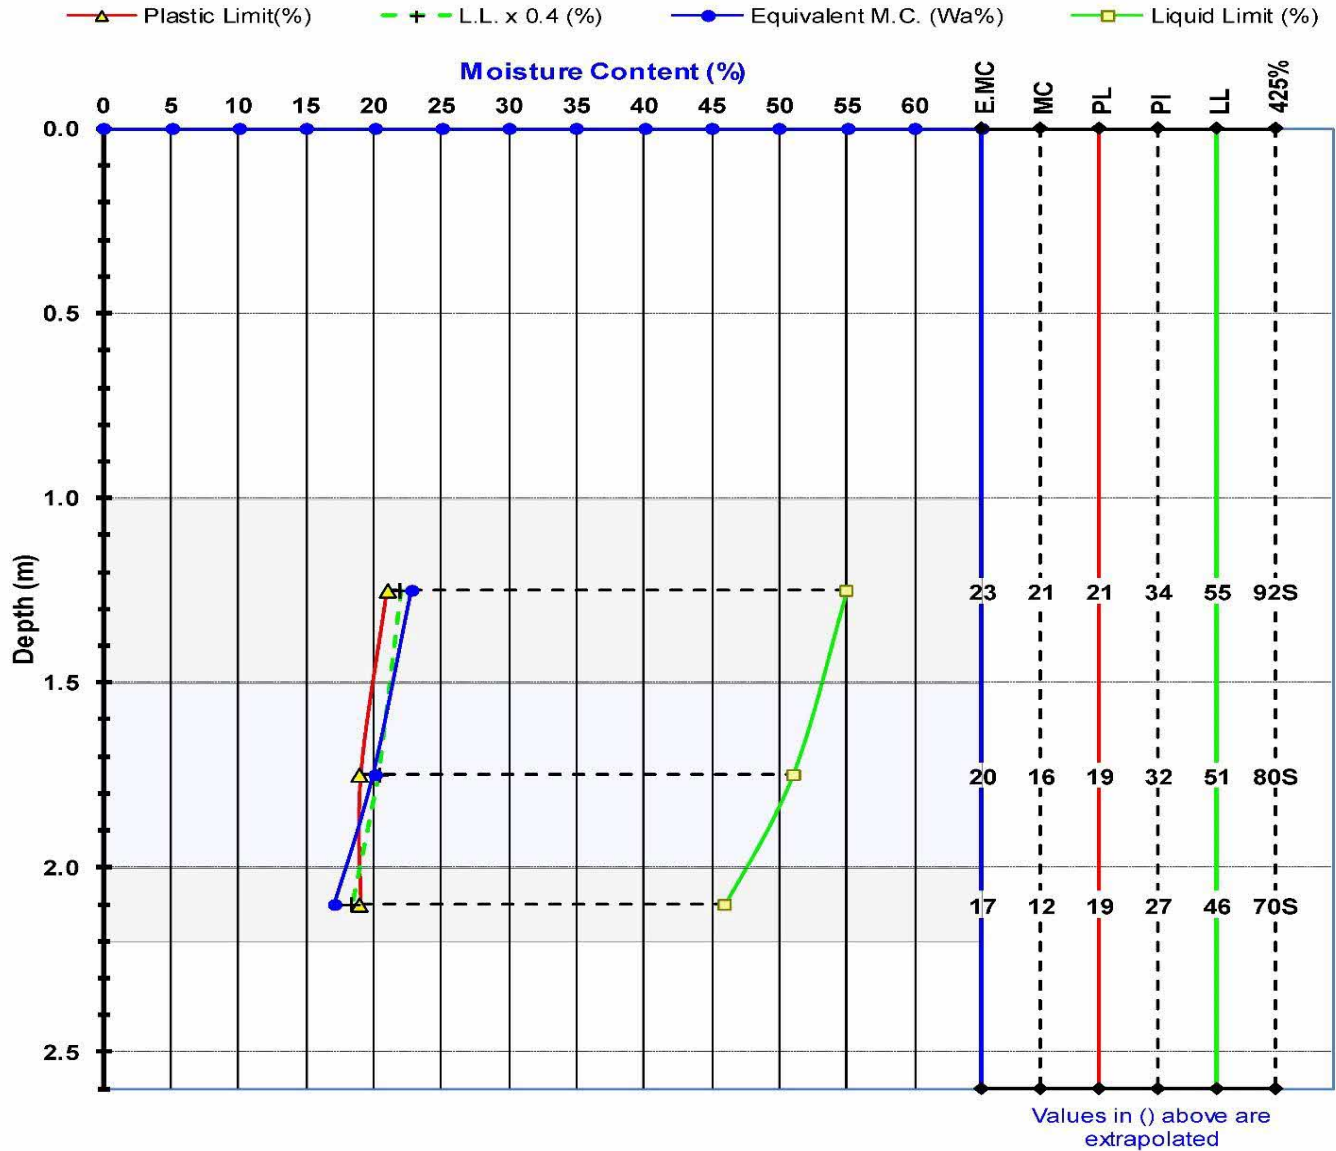
LABORATORY TESTING RESULTS

Depth T (m)	Depth B (m)	4 - Rear left of house		Plasticity (BS 5930)	Volume Change M.PI (BRE 240)
		Brief Soil Description			
1	1.5	Firm/stiff brown CLAY with some medium gravel (inc. chalk)		High CH	31% Medium
1.5	2	Stiff grey/brown slightly silty CLAY with much medium gravel (inc. chalk)		High CH	26% Medium
2	2.2	Very stiff grey/brown slightly silty CLAY with much medium gravel (inc. chalk)		Intmd. CI	19% Low
