Bat Assessment Report

Manor Barn

**Lucas Green Road
West End
Woking
GU24 9LY**

23-029
December 2023

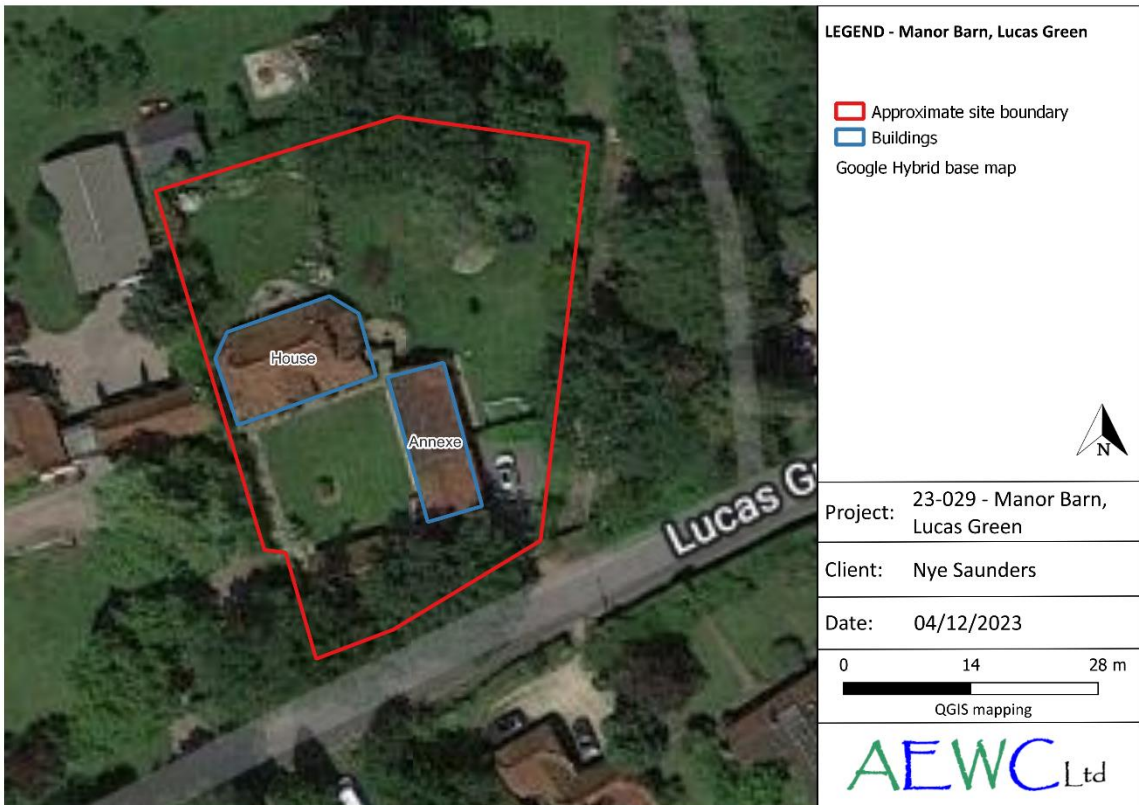
FIGURE 2: SHOWING THE BUILDINGS SUBJECT TO SURVEY.

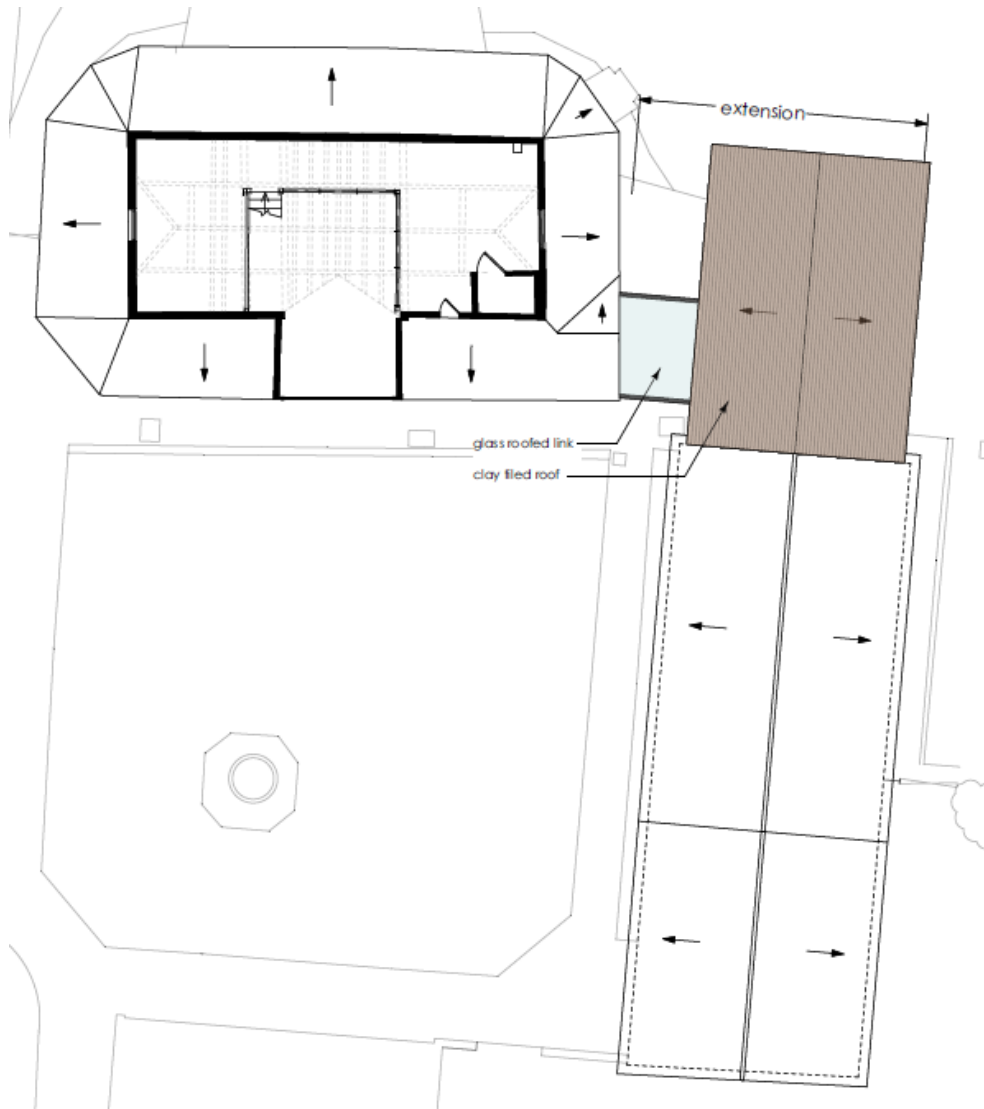
- 1.12 The proposal is for construction of a single-storey extension to the northern end of the existing annex. The extension will have a lower ridge height than the existing roof and will therefore only impact gable end weatherboarding, with no direct impacts to the existing roof or verges. In addition, a small glass link will be constructed to connect the new extension with the house. This will connect to the house at the single-storey extension on the eastern elevation where the existing door is, again below roof height and only impacting weatherboarding and a small lean-to boiler cupboard.

FIGURE 3: SHOWING THE PROPOSED PLANS.

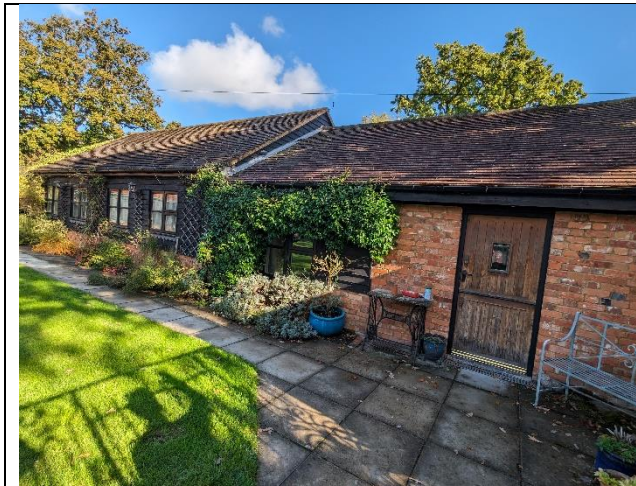
- 4.1 The annexe is a single-storey brick building in two sections, supporting pitched roofs of modern flat clay tile, with the roof of the southern section having a lower ridge height than the northern section. The walls of northern section are clad in modern feather-edge weatherboarding and climbing vegetation is present in several places. Externally the weatherboarding is in very good condition with no warping or lifting. The modern roof tiles are generally even and tight-fitting, although a low number of gaps were noted beneath slightly lifted or uneven tiles on both the east and west pitches. The ridge and verges were well-mortared, and the soffits sealed.

Photograph 1: *West elevation of the annexe*

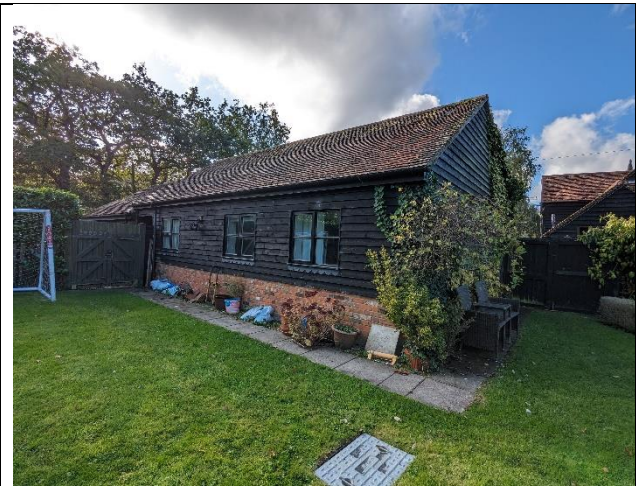
Photograph 2: *North and east elevations of the annexe*

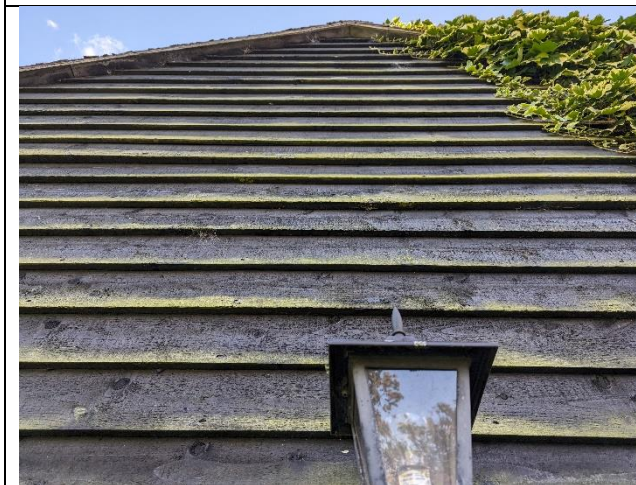
Photograph 3: *North gable of the annexe with tight-fitting weatherboarding where extension will tie in*

- 5.3 The annexe is considered to have moderate potential to support crevice-dwelling bat species within the batten spaces of the roof due to a low number of gaps beneath lifted roof tiles on the east and west pitches. There are no access points for bats through into the roof void of the building for void-dwelling species, nor are there any access points into the batten spaces of the weatherboarding. The proposed extension has a lower ridge height and will not directly affect any areas of the existing roof. **The area of the northern gable end subject to direct impacts under the current proposals is therefore considered to have negligible potential for bats due to a lack of access points within the weatherboarding.**

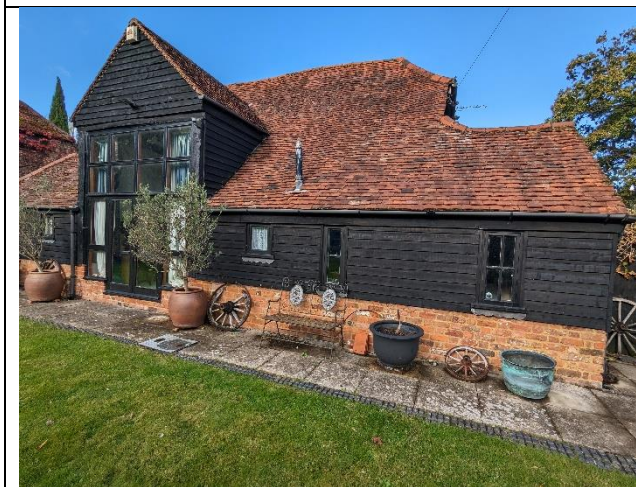
- 4.4 The house is a Grade II listed, double-storey timber-framed building with walls of brick plinth and timber weatherboarding. The roof is half-hipped supporting predominantly slightly cambered clay tiles, whilst the single-storey prentice roof extension to the eastern elevation supports predominantly flat clay tiles with a low proportion of slightly cambered tiles incorporated.

Photograph 5: *Southern elevation of the house*

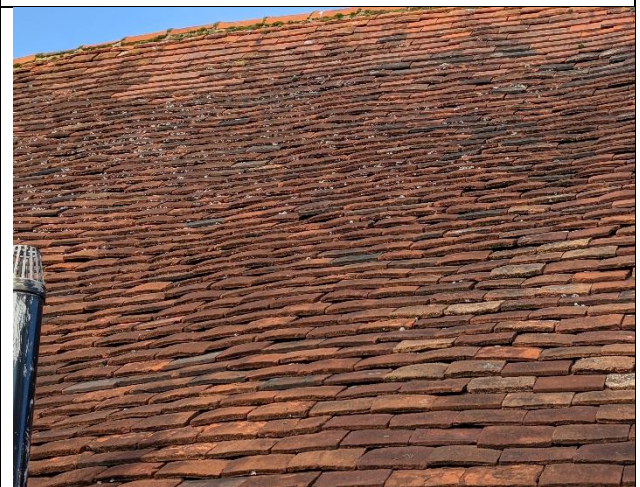
- 4.5 Gaps were noted present beneath cambered roof tiles across the main roof of the house, with only a low number of gaps noted present on the eastern prentice roof in addition to this area being mossed and frost-damaged, indicating cooler and damper conditions. Weatherboarding on the eastern areas of the house was found to be tight-fitting throughout with no lifting or warping of timbers.

Photograph 6: *Gaps beneath roof tiles on the main roof of the house*

- 5.2 The house overall is considered to have high potential to support bats due to numerous gaps beneath cambered roof tiles throughout the main roof. However, the only area of the house subject to impacts is a small section of eastern elevation weatherboarding alongside the existing doorway, including the small lean-to boiler cupboard, for construction of a small glass link to the annex. No areas of roof or roof void will be subject to impacts, and all areas of weatherboarding to be impacted are tight-fitting with no possible access for bats into the batten spaces. **As such, the areas of the house subject to direct impacts under the current proposals are considered to have negligible potential for bats.**

development. **Should the proposals change such that any areas of existing roof on either the house or annexe will be subject to impacts, the works must be fully discussed with a licensed bat ecologist in the first instance, as further surveys may be required to inform the updated proposals.**

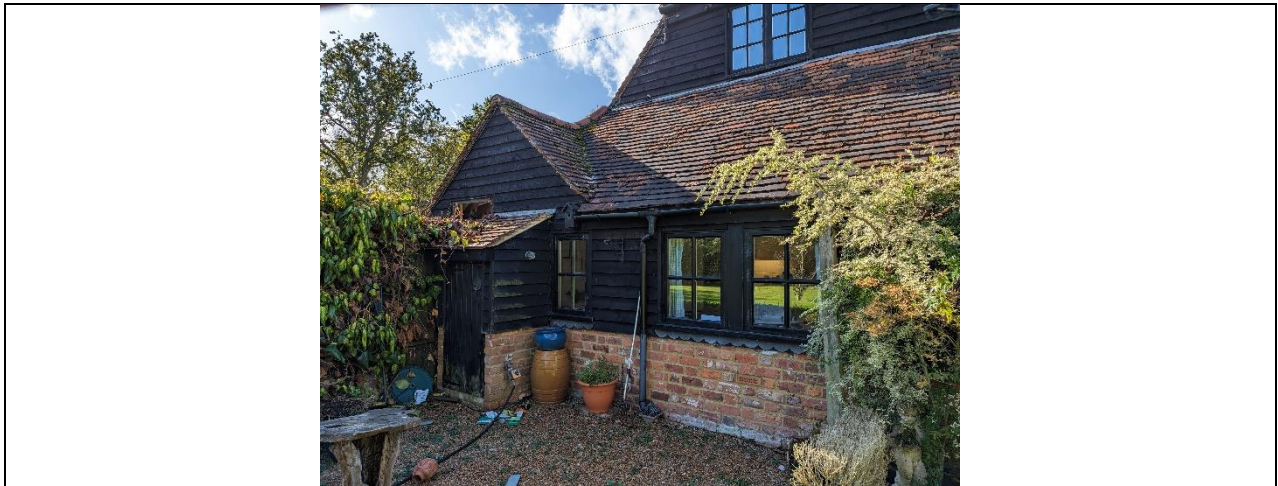
- 4.6 The only impact to the main house will be the connection of a small glass link to the eastern single-storey extension at the existing doorway; the vast majority of the house is not subject to any proposals, and the main roof void was therefore not assessed for the current proposals. The single-storey areas on the eastern side of the house were open internally to the apex, with no loft voids present. No evidence of bats was identified externally around the house.

Photograph 7: *Eastern elevation of the house where glass link will join the pitched roof door area*
