4 Hadham Hall Basement, Little Hadham

Archaeological Building Recording Report

Archaeological Building Recording

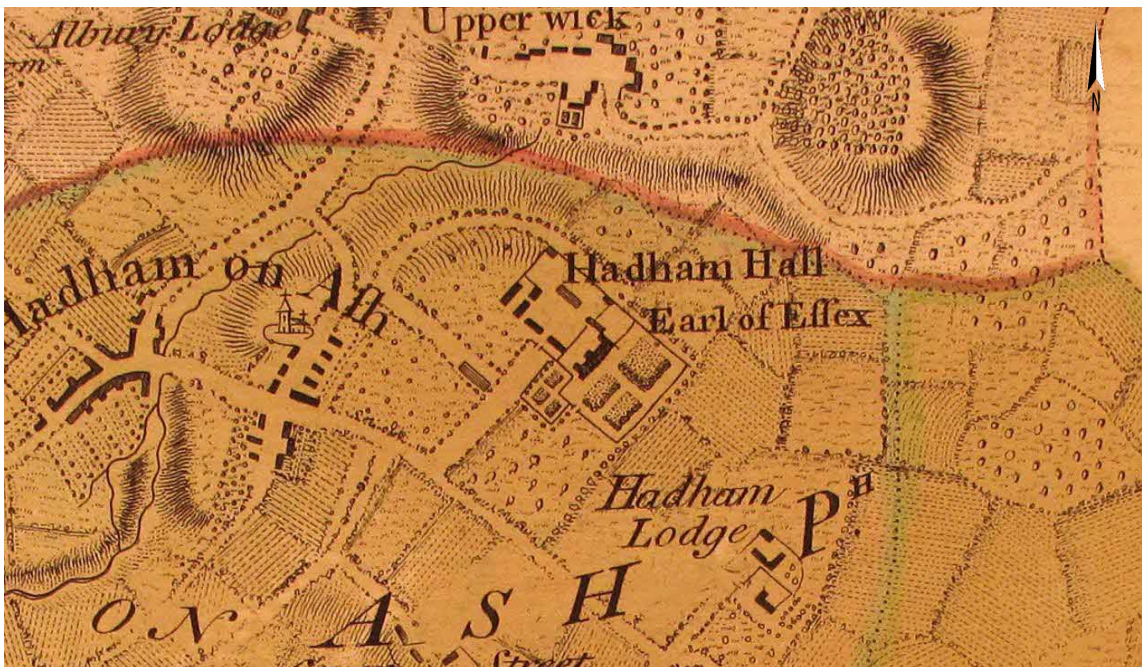
- 3.5. The 1766 Drury and Andrews map, of Hertfordshire, shows Hadham Hall and depicts the main ranges of the estate (**Figure 2**). The estate is noted as belonging to the Earl of Essex, who at this time was the 5th Earl, George Capel-Coningsby.

Figure 2 Drury and Andrews map of Hertfordshire, 1766. Hadham Hall visible, noted as owned by the Earl of Essex.

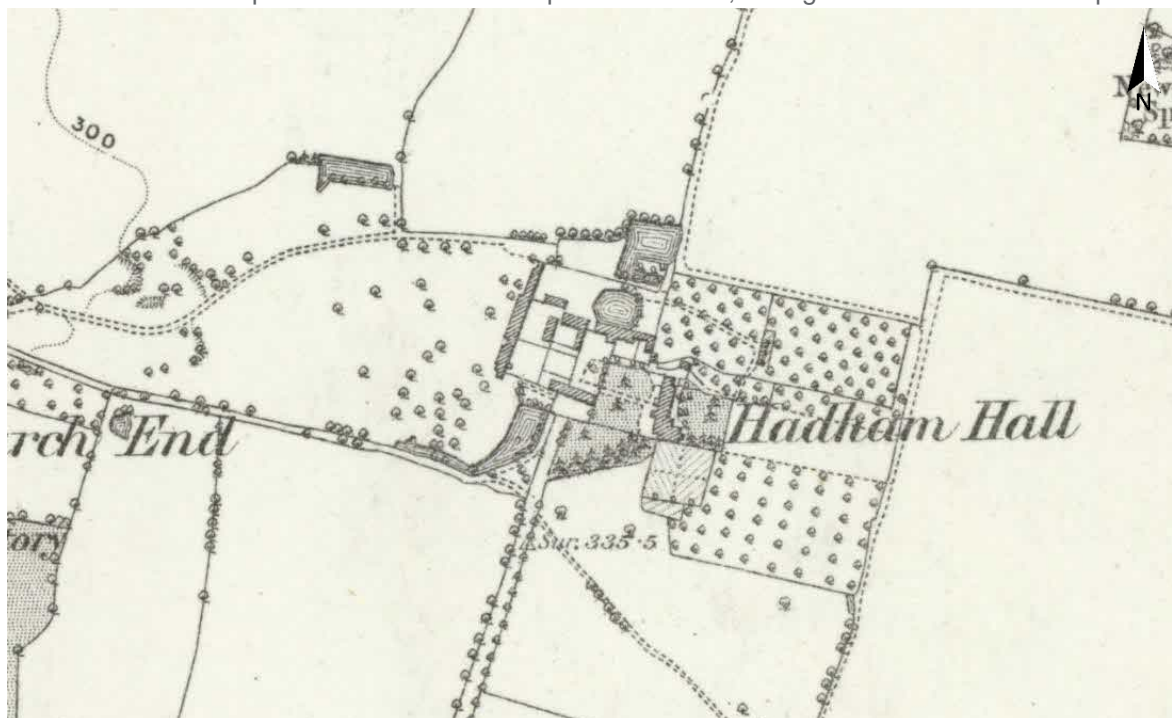
- 3.7. The 1878 Ordnance Survey (OS) map (**Figure 4**) shows the addition of a number of buildings to the estate, likely agricultural in nature and related to the boom in British farming in the mid-twentieth century. By this time Hadham Hall had passed into the ownership of the 7th Earl; George Devereux de Vere Capell.

Figure 4 6-inch Ordnance Survey map, surveyed in 1878.

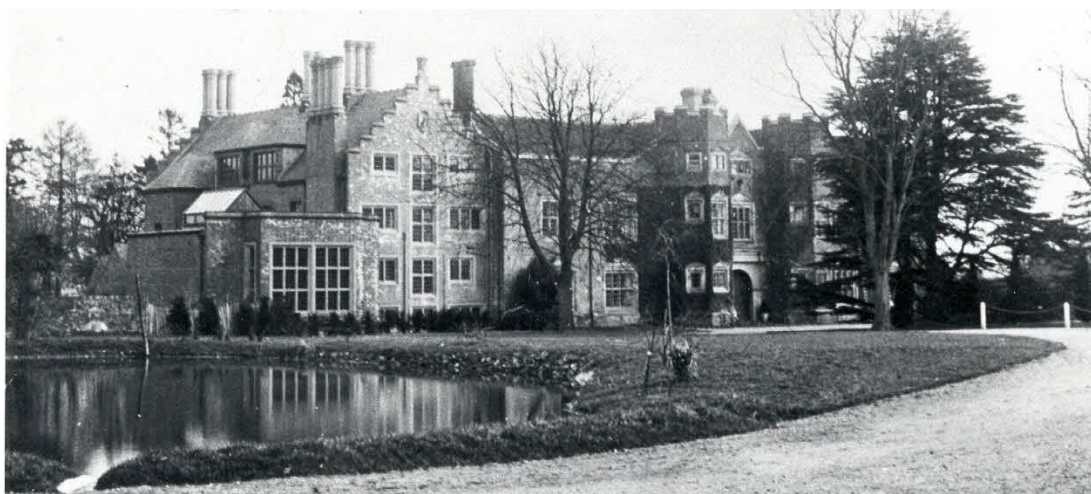
Figure 7 Early twentieth-century photograph of Hadham Hall after addition of northern wing. 4 Hadham Hall visible as single-storey extension on left of frame. Photograph from Hertfordshire Archives and Local Studies.

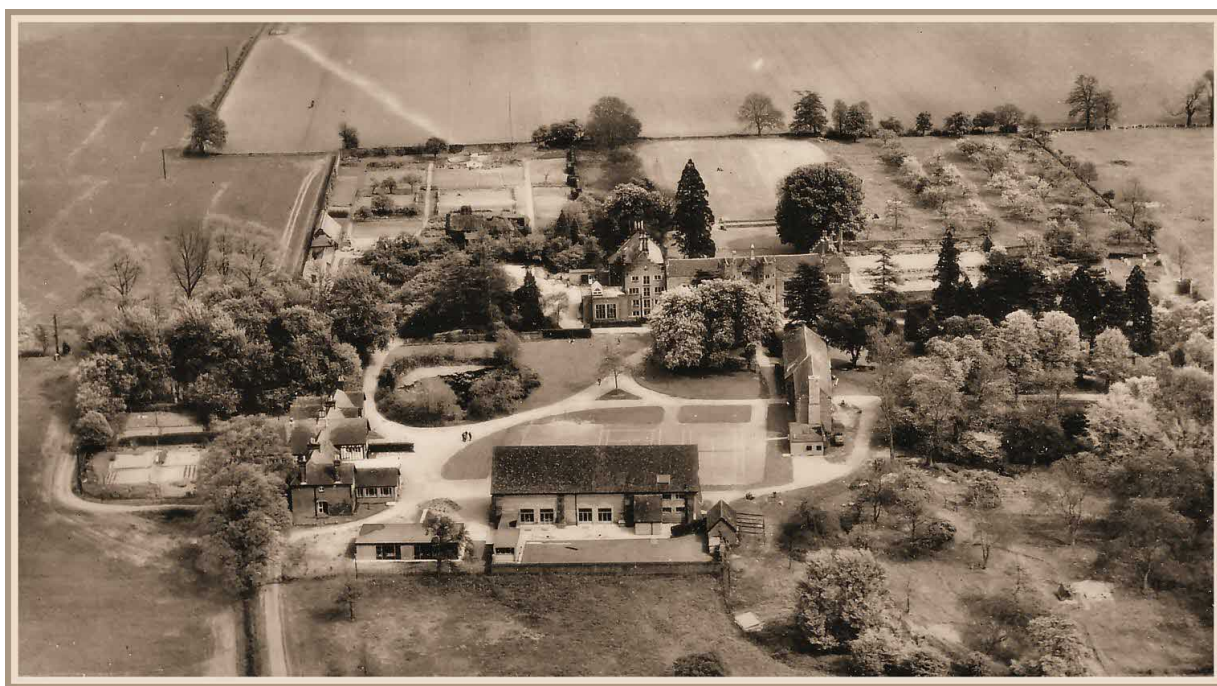
Figure 8 Aerial photograph of Hadham Hall after conversion into school. 4 Hadham Hall is visible centre frame. Photograph taken facing east. Photograph from Hertfordshire Archives and Local Studies.

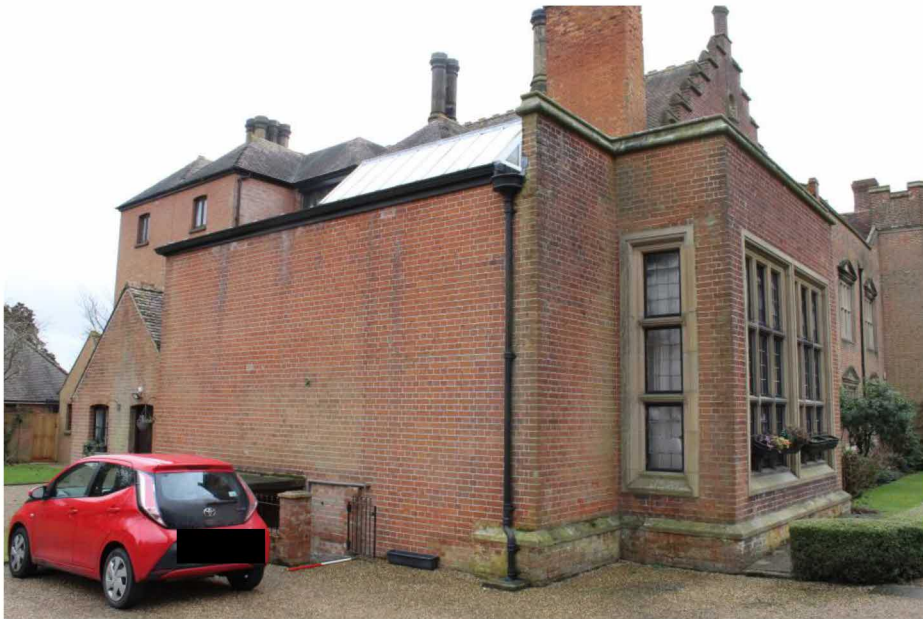
4.2. The basement is accessed via a brick exterior staircase added to the property in 2011, in the place of a coal chute (**Figures 10 & 11**). As previously described, the basement is located entirely beneath a billiard room added to Hadham House in 1902.

Figure 10 Northern elevation of 4 Hadham Hall, showing access into basement. Photograph taken facing south-east.

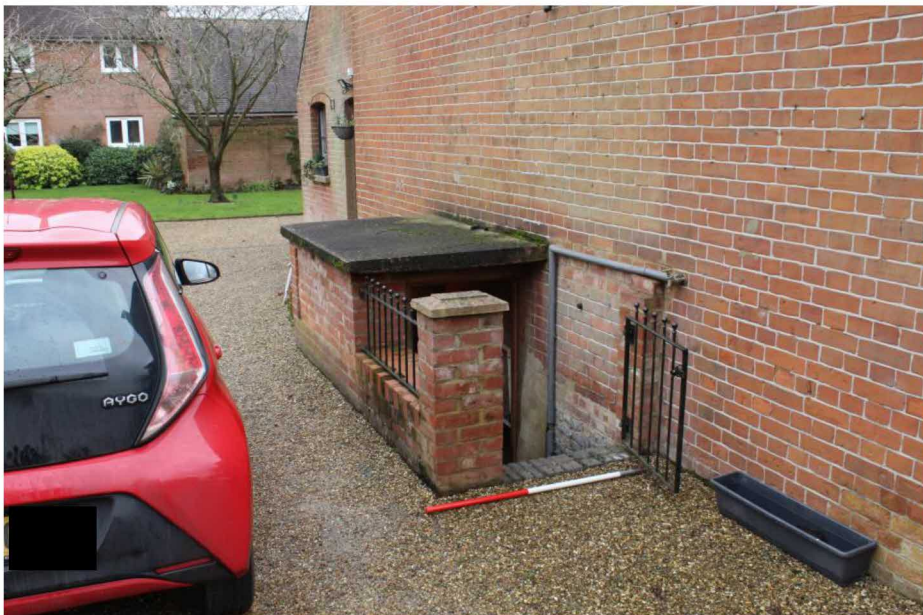
Figure 11 Detail of access into basement on northern elevation. Photograph taken facing south-east.

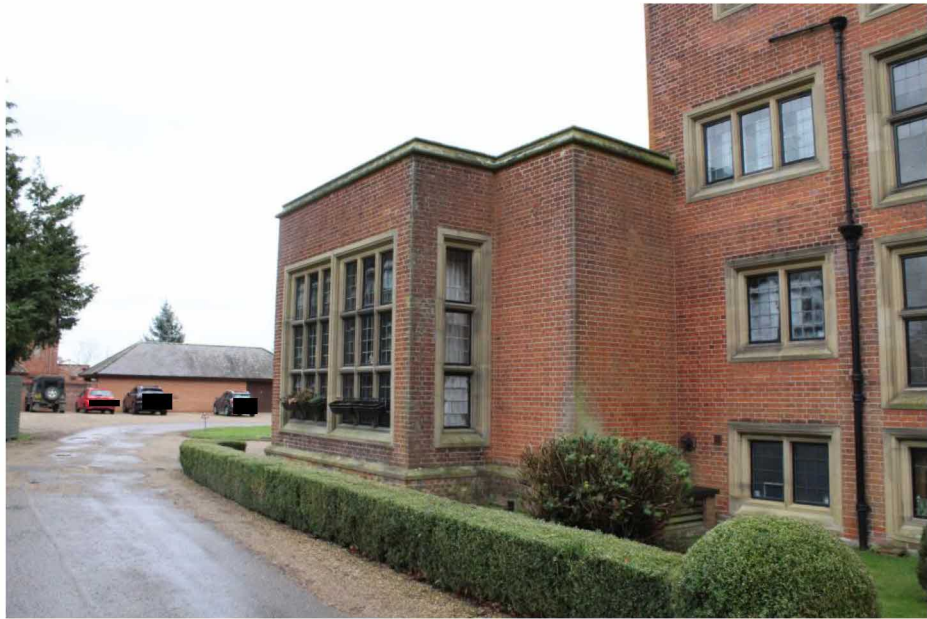
Figure 12 Southern and western elevation of 4 Hadham Hall. Photograph taken facing north-east.

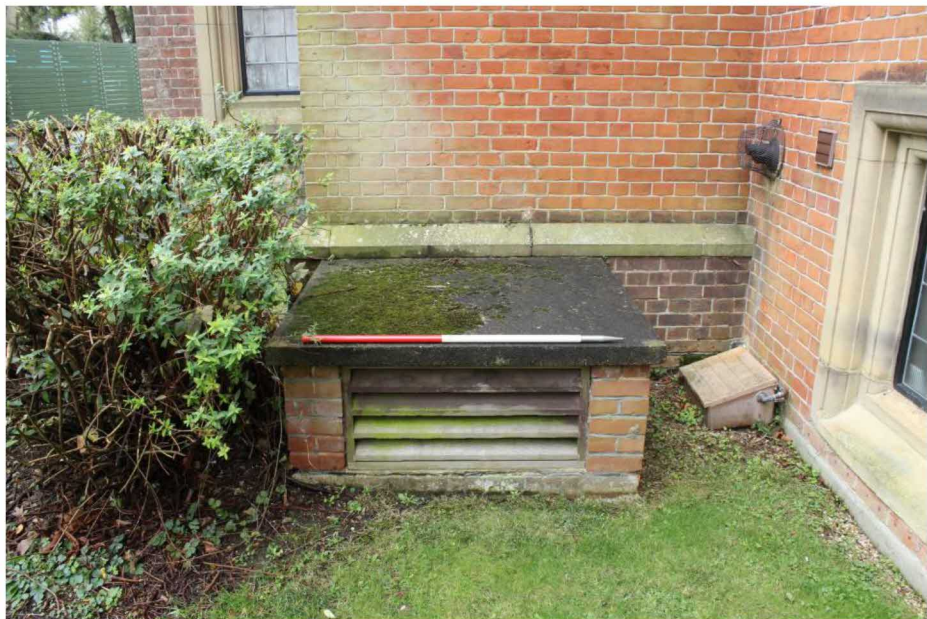
4.3. Projecting from the south of the building the location of a historic coal chute is capped by a small brick structure with a wooden vent (**Figure 13**).

Figure 13 Detail of vent above coal chute on southern elevation of 4 Hadham Hall. Photograph taken facing north.

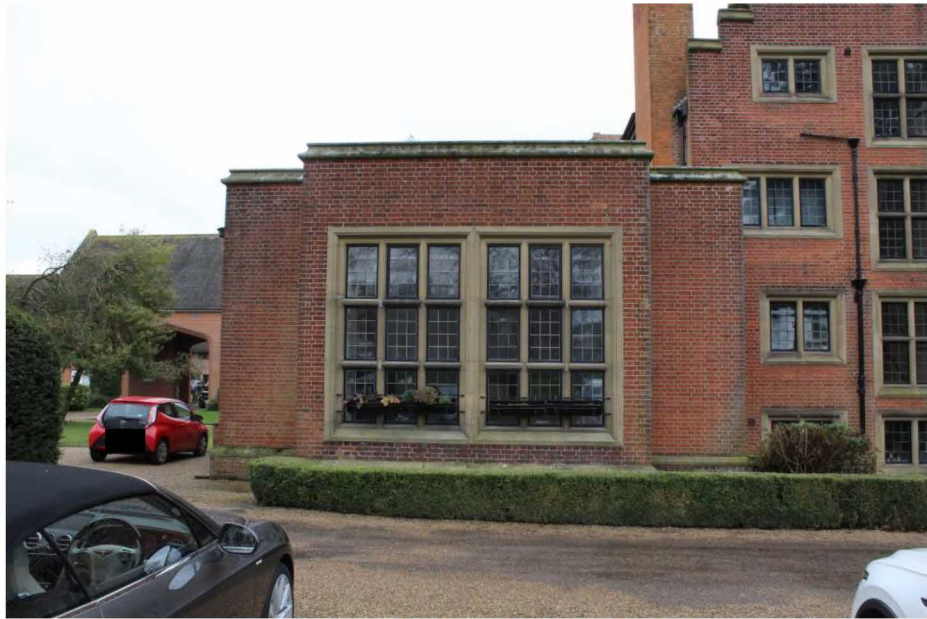
Figure 14 Western elevation of 4 Hadham Hall. Photograph taken facing east.

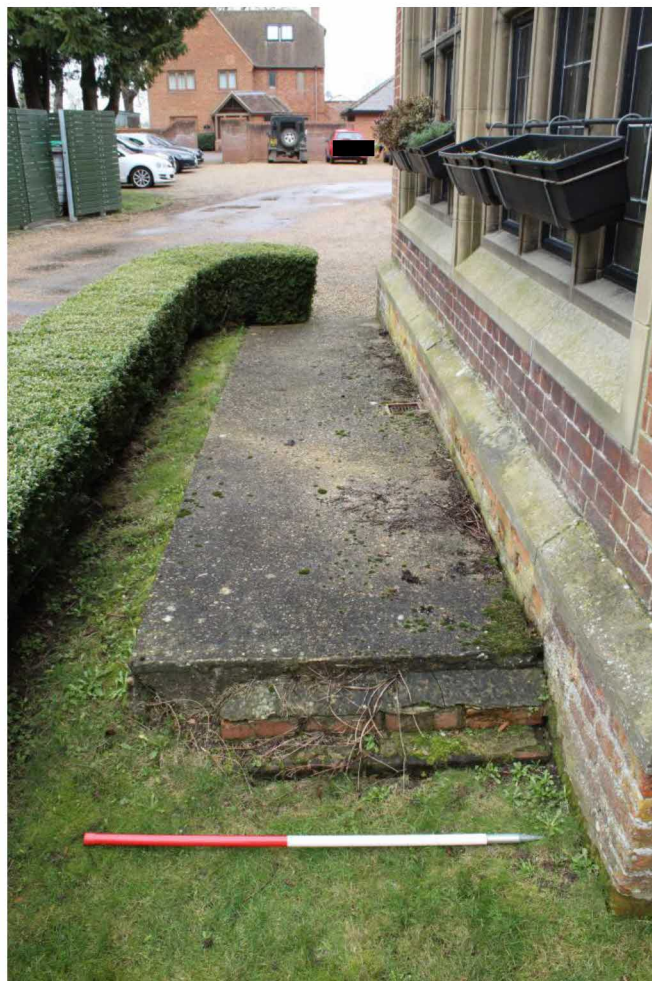
4.4. Projecting from the west of the building, beneath the large windows on this elevation, is a concrete cap above what appears to be a previous lightwell into the basement (**Figure 15**).

Figure 15 Detail of possible capped lightwell into basement on western elevation of 4 Hadham House. Photograph taken facing north.

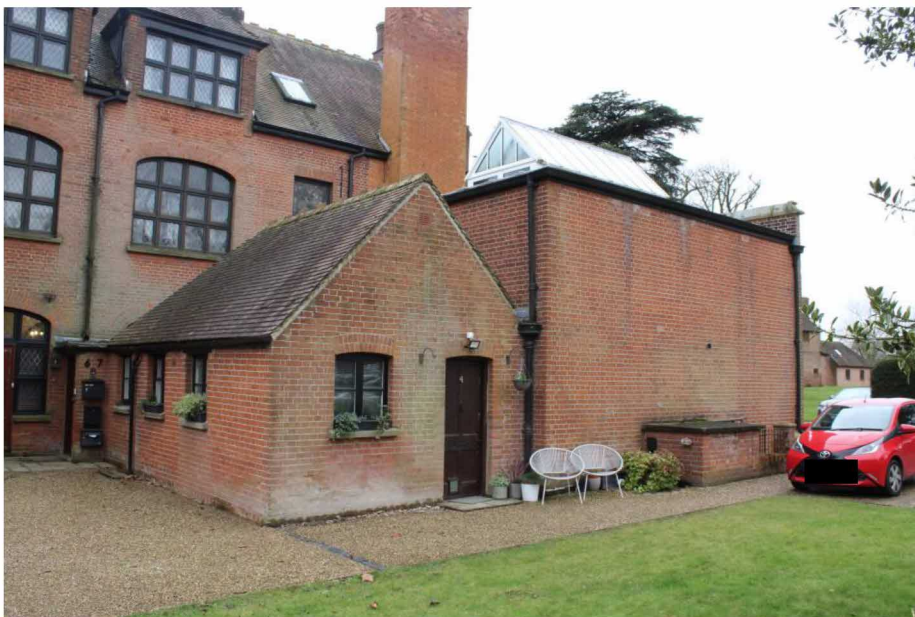
4.5. The west elevation of the building has no features related to the basement (**Figure 16**).

Figure 16 Northern and eastern elevations of 4 Hadham House. Photograph taken facing south-west.

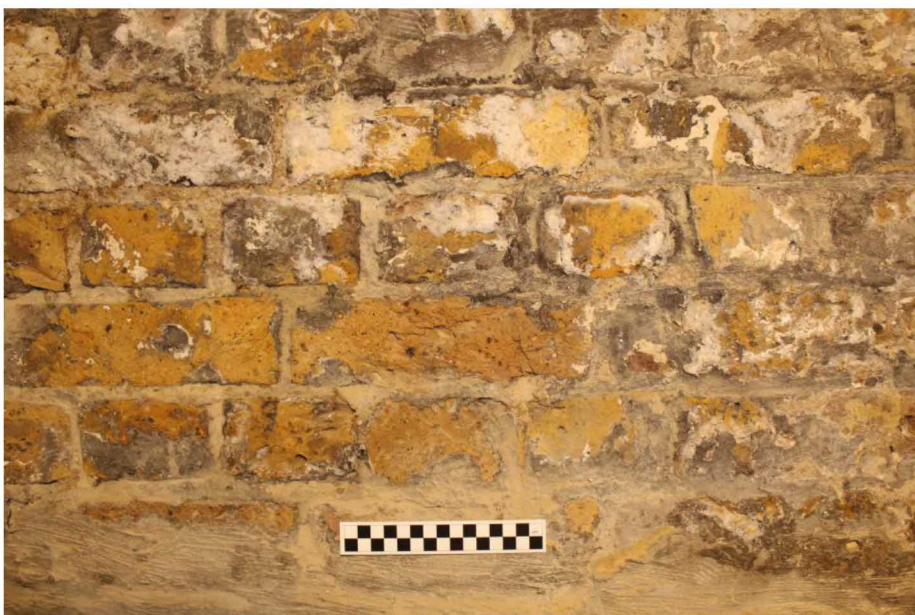
4.7. The brickwork of the basement is laid in English Bond and has measurements of 220mm x 105mm x 65mm. The walls have all been whitewashed but comprise gault brickwork, bonded with sandy lime mortar (**Figure 17**).

Figure 17 Detail of gault brickwork on eastern wall of Room 3. Photograph taken facing east.

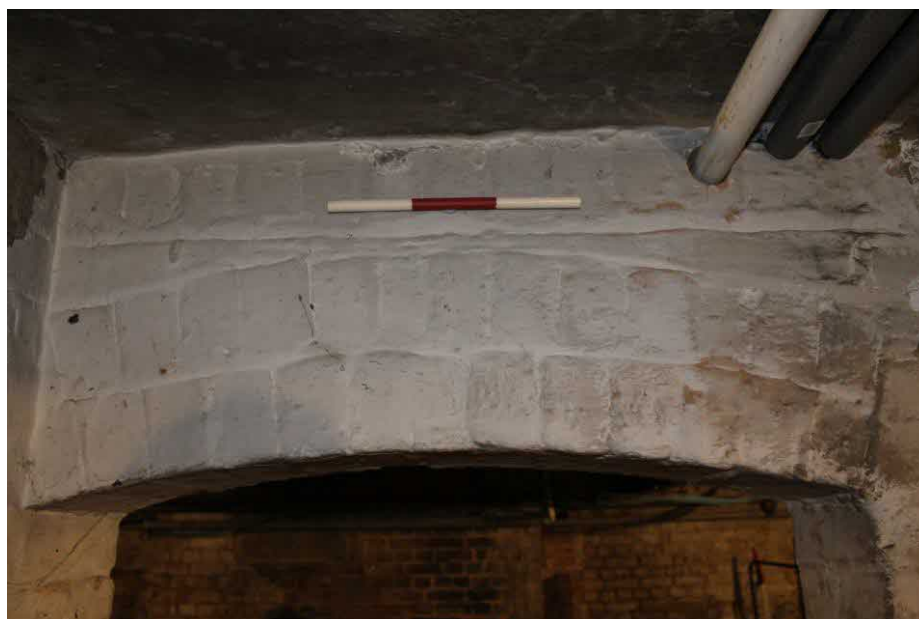
4.8. The tops of the basement's walls are capped with a course of soldier bricks (**Figure 18**), although in places this has been damaged or obscured by the insertion of later girders or pipework.

Figure 18 Detail of brick arch above entranceway between Rooms 1 and 3. Soldier course of bricks visible at top of wall. Photograph taken facing south.

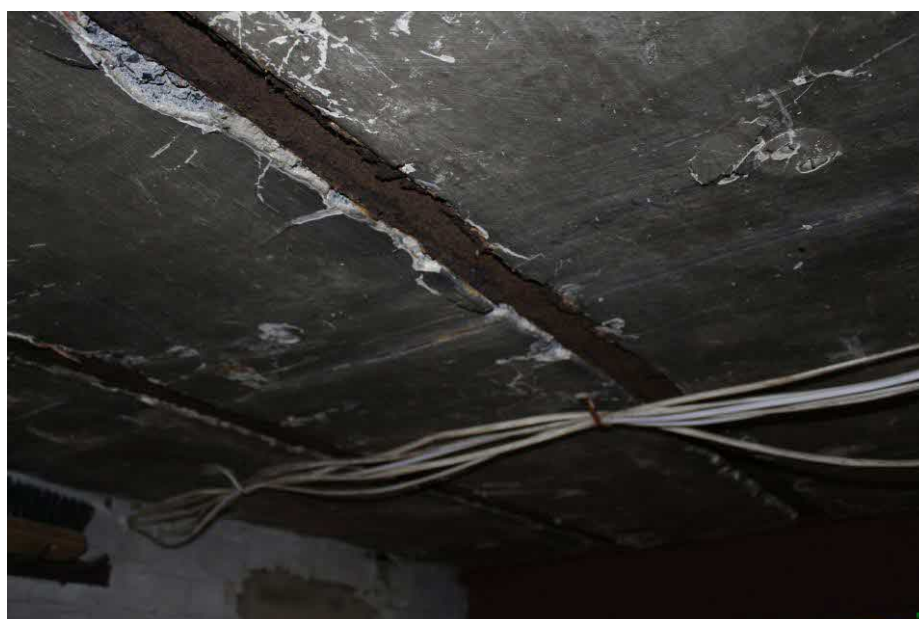
4.10. The ceiling of the basement comprises concrete blocks covered with a cement screed, reinforced with iron straps (**Figure 19**). In places the ceiling is slightly degraded; the entire ceiling is supported on a series of metal girders (**Figure 20**).

Figure 19 Detail of basement ceiling above Room 1. Photograph taken facing north-east.

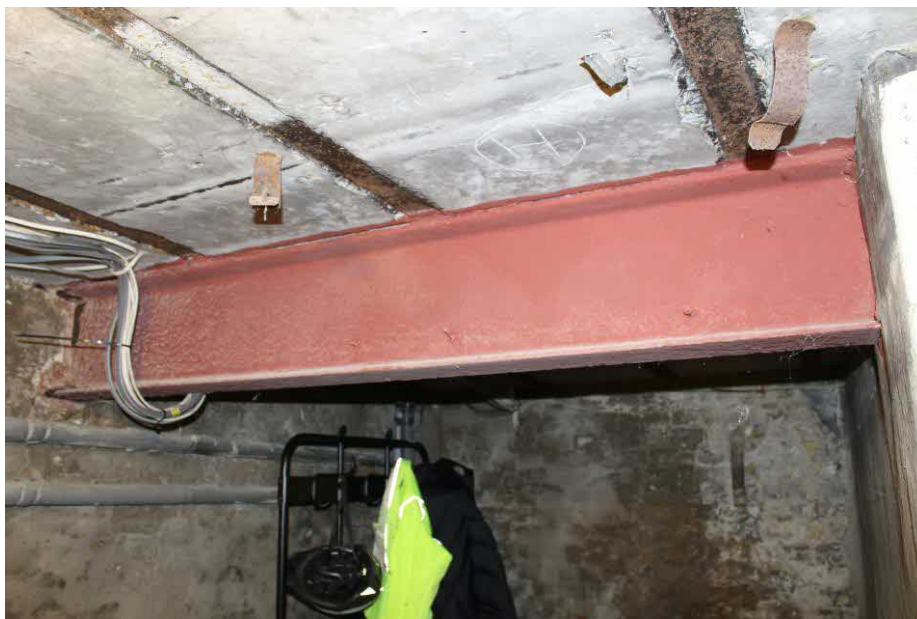
4.11. These girders are clearly later additions to the basement but are supported on original brickwork plinths and walls, albeit heavily altered with concrete.

Figure 20 Detail of girder supporting ceiling in Room 1. Photograph taken facing south-west.

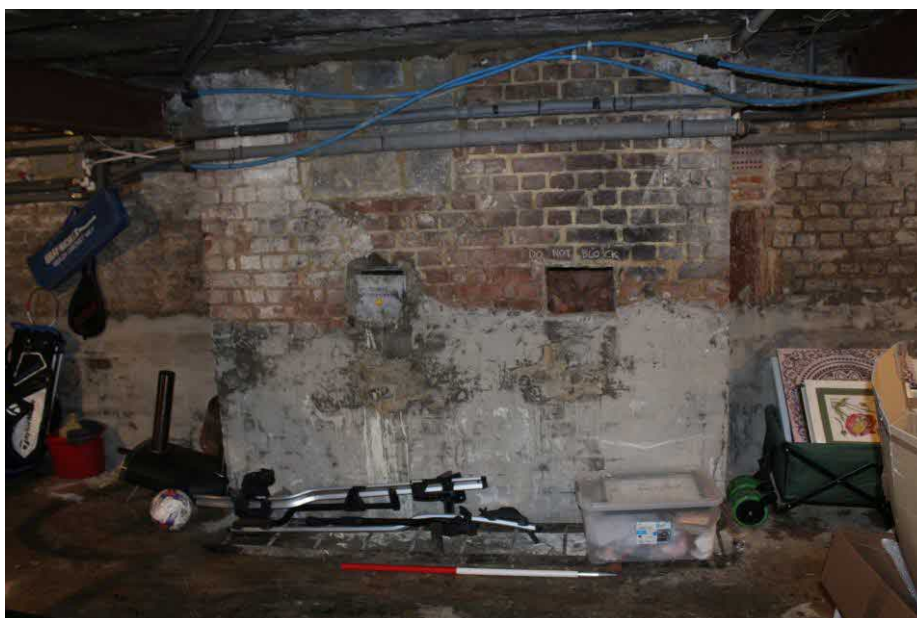
4.13. On the southern wall of Room 1 is a chimneybreast supporting a chimneystack and fireplaces above. Unlike the rest of the basement, the chimneybreast is constructed of red brick and has queen-closers. It has two access holes into the ash dump, which are both original (although neither now has an original door; **Figure 21**). Part of the chimneybreast has been repaired with concrete blocks.

Figure 21 Southern elevation of Room 1, showing chimneybreast. Photograph taken facing south-east.

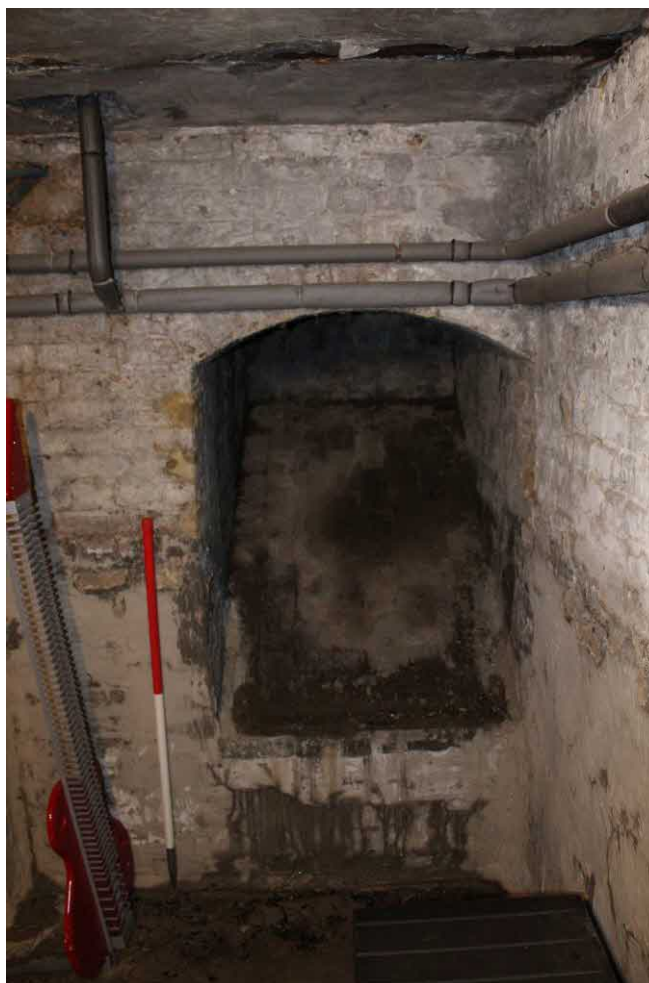
4.15. Also on the southern elevation of Room 1 is a brick-lined coal chute with a brick arch (**Figure 22**). This has been capped above ground (see above).

Figure 22 Detail of coal chute on southern elevation of Room 1. Photograph taken facing south.

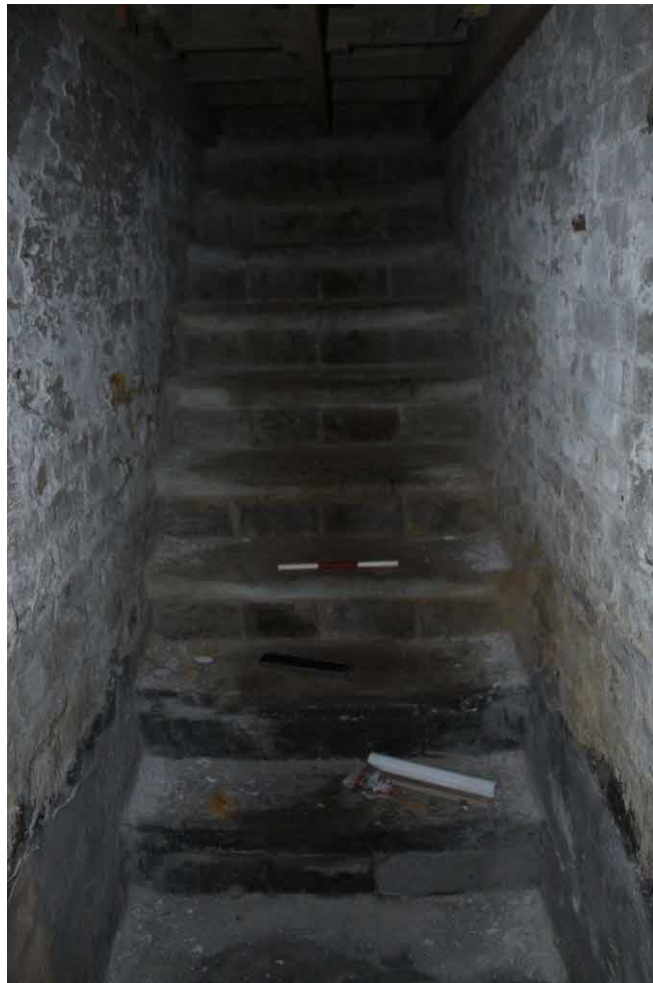
- 4.16. On the eastern elevation of Room 1 is the original staircase and entranceway into the basement, now blocked up from above by an inserted modern floor (**Figure 23**). The staircase is constructed of stone steps, supported by on-edge brickwork.

Figure 23 Detail of original staircase into Room 1 of basement, now blocked off above. Stone steps visible. Photograph taken facing east.

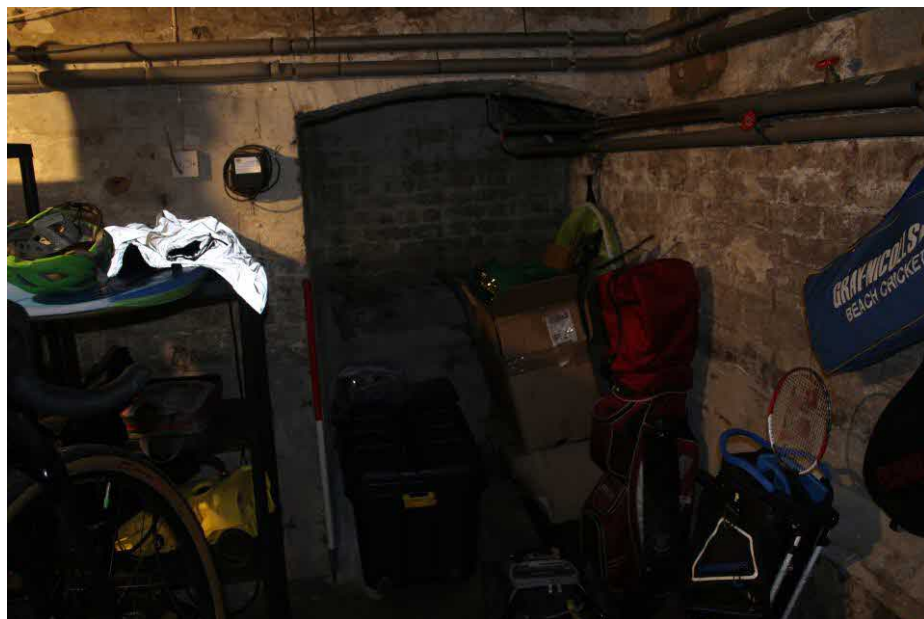
- 4.17. Also on the eastern elevation of Room 1 is a storage alcove (**Figure 24**). Above the entrance into the alcove is a brick arch formed by two courses of brickwork. The ceiling of this alcove is concreted over.

Figure 24 Detail of storage alcove in eastern wall of Room 1. Photograph taken facing east.

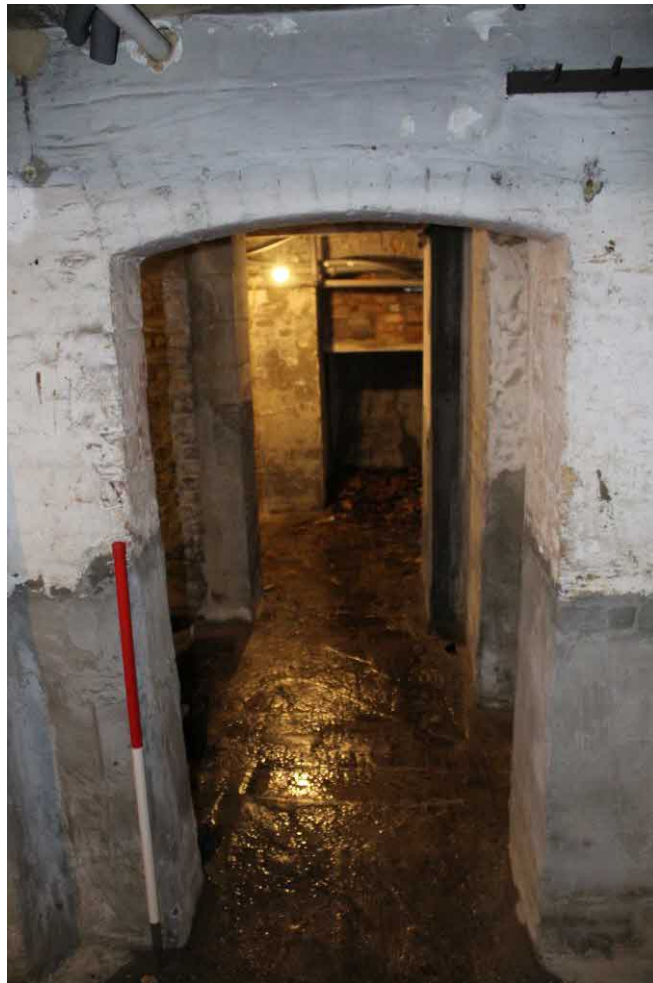
- 4.18. On the northern side of Room 1 are two openings into Room 2 and 3 (**Figure 9**). The entrance into Room 3 is an original opening with a brick arch (**Figure 25**), whilst the opening into Room 2 is larger and appears to have been created by removing part of a dividing wall (**Figure 26**).

Figure 25 Original arched entrance between Room 1 and Room 3. Water ingress into basement also visible.

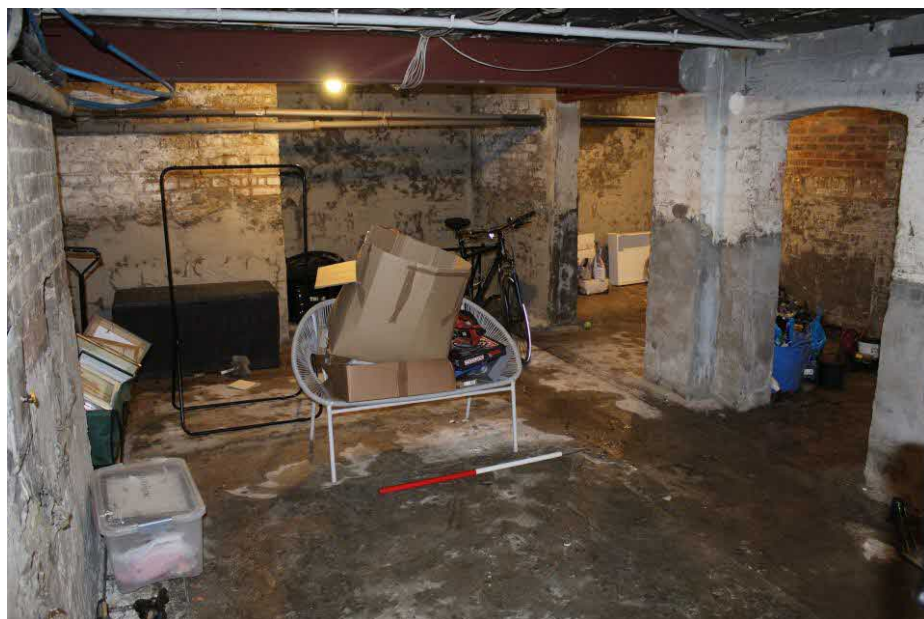
Figure 26 Western end of Room 1. Entrance into Room 2 visible in background. Original brick-arched entrance into Room 3 visible to right of frame. Photograph taken facing north-west.

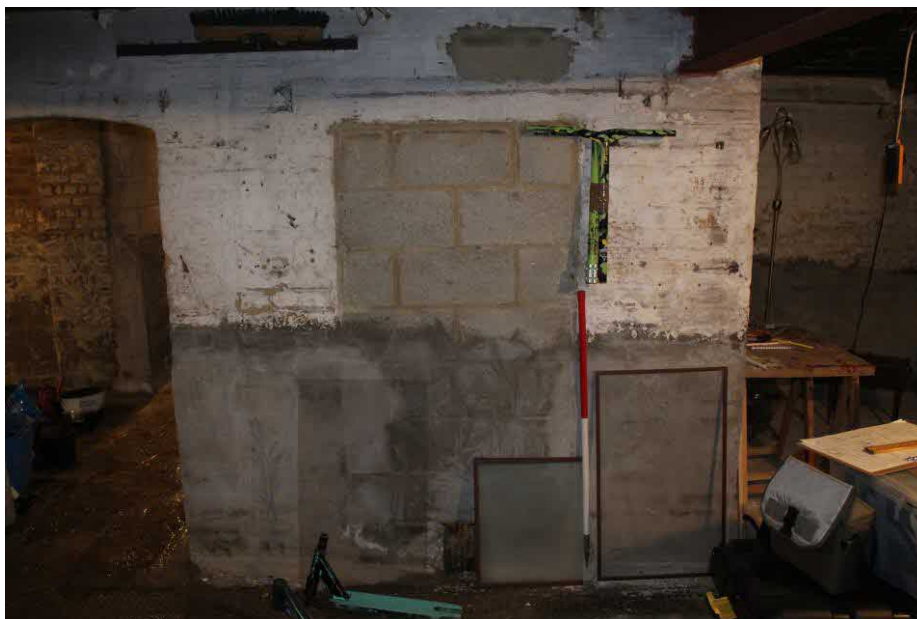
- 4.19. Also visible on the northern side of Room 1 is a blocked entranceway leading into Room 4. This blocked entranceway has a concrete lintel above, rather than a brick arch, suggesting it is a later addition to the basement (**Figure 27**).

Figure 27 Detail of blocked inserted entranceway between Room 1 and Room 4. Concrete lintel visible above. Photograph taken facing north.

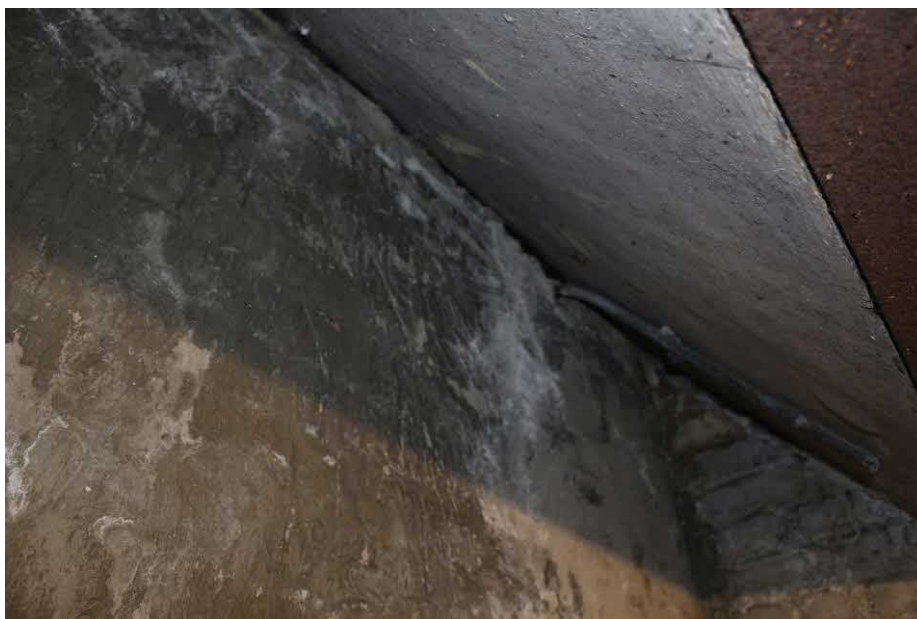
- 4.20. The ceiling at the western elevation of Room 1, as with Room 2, rises into the western alcove; presumably this would have been for a lightwell (**Figure 28**).

Figure 28 Detail of sloping ceiling at western end of Room 1, potentially indicating a lightwell. Photograph taken facing north-west.

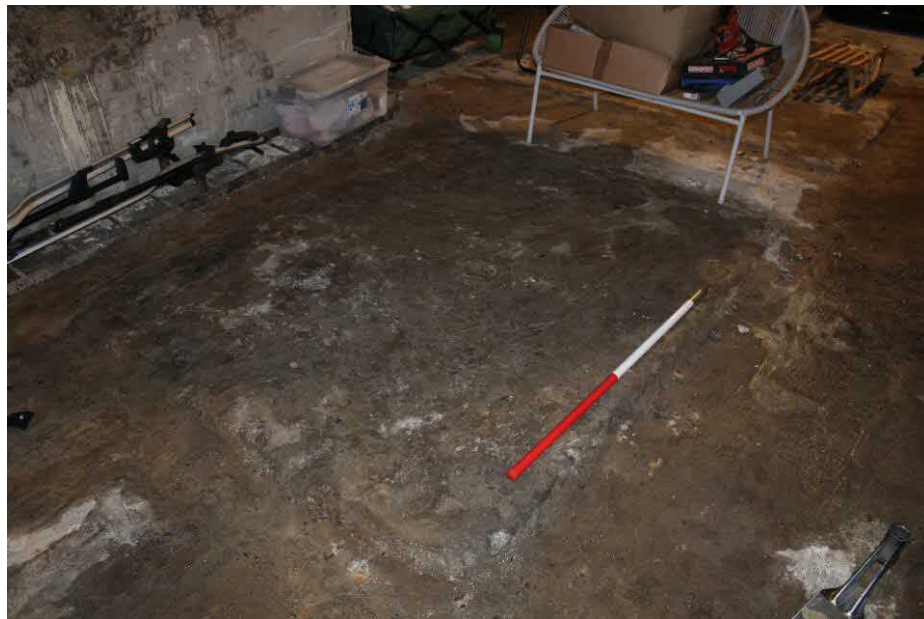
- 4.21. In the centre of Room 1 are two raised concrete areas (**Figure 29**). The purpose of these raised areas is unclear but they may possibly have held boilers or similar machinery.
- 4.22. On the floor of Room 1 are also a series of grated drainage gullies (**Figure 30**).
- 4.23. Room 2, like Room 1, has evidence of a possible lightwell on its western elevation.
- 4.24. Part of the original northern wall of Room 2 is half-height (still capped with a soldier course), but above this is an area of modern brickwork infill (**Figure 31**). A small trial-pit has been excavated against this wall, exposing the foundations of the basement (**Figure 32**).

Figure 29 Detail of raised concrete area in Room 1. Photograph taken facing south-west.

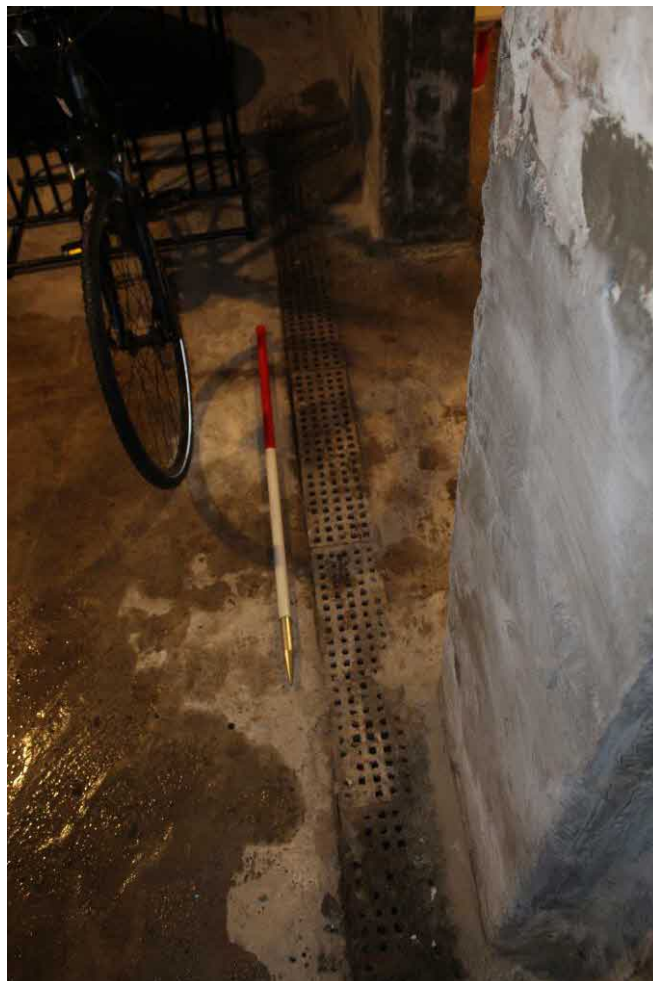
Figure 30 Detail of grated drainage gully in floor of Room 1. Photograph taken facing west.

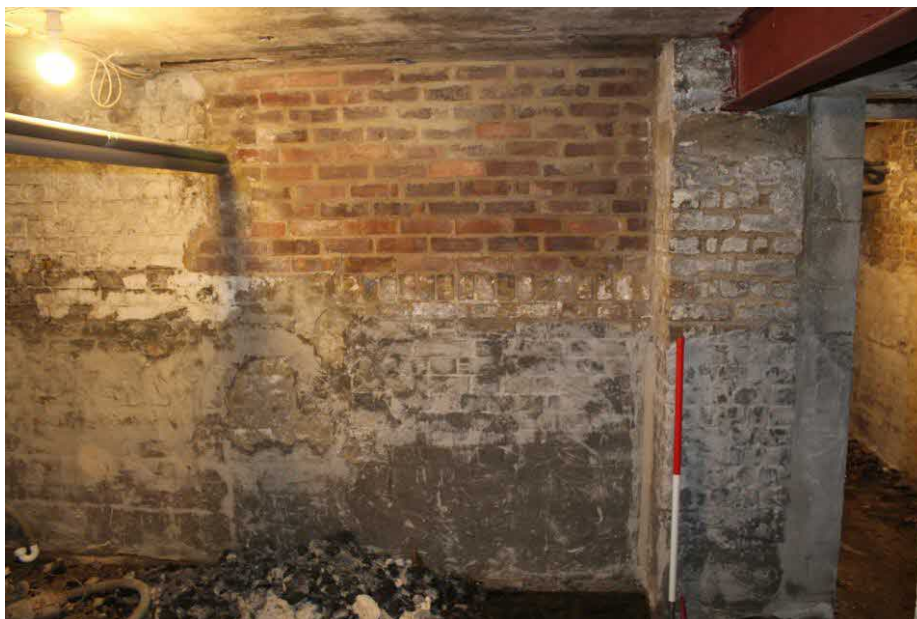
Figure 31 Detail of northern wall of Room 2, showing half-height original wall with modern brickwork above. Photograph taken facing north.

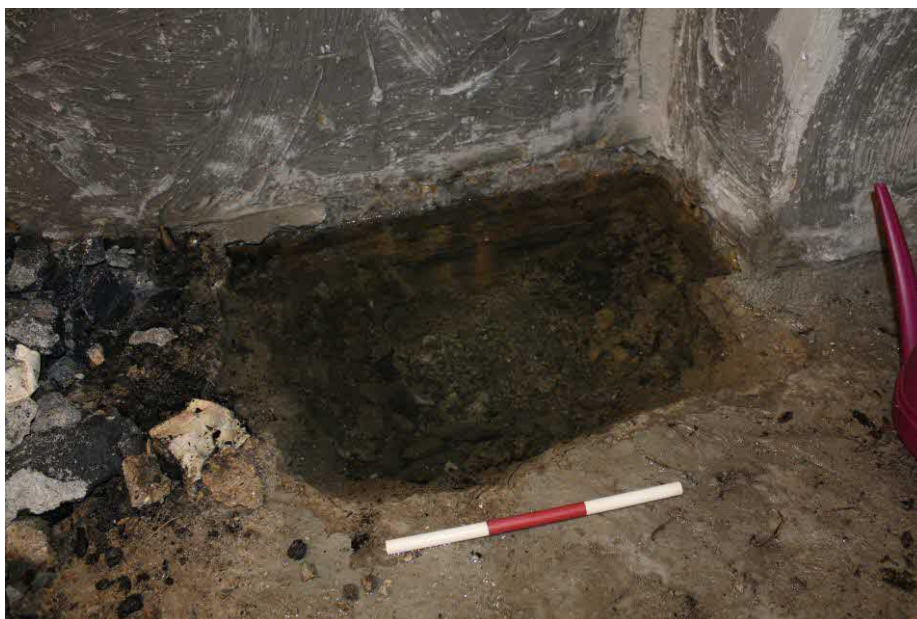
Figure 32 Trial pit excavated in Room 2, showing brick foundations of basement. Photograph taken facing north-east.

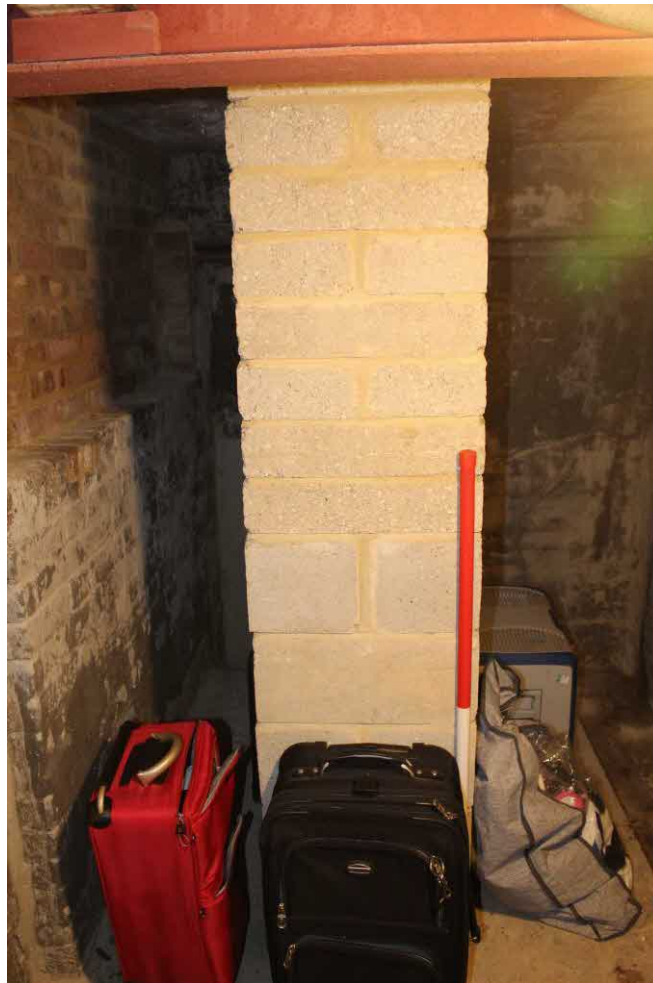
- 4.25. Room 3 contains an inserted concrete block pillar supporting the ceiling, sitting on a raised concrete plinth (**Figure 33**).
- 4.26. As with Room 2, the southern wall of this room was originally lower and has had modern brickwork added above (**Figure 33**). The brick pillar adjacent to this area of lower wall has had concrete and brickwork added on its eastern side (**Figure 34**).
- 4.27. The ceiling above Room 3 is partially supported by timber beams supported on iron brackets (**Figure 34**). These beams are also supported on metal girders so are unlikely to be original but may be re-used from an earlier phase of alteration to the basement.
- 4.28. On the northern elevation of Room 3 is a storage alcove with a brick arch above, now partially blocked by the inserted exterior access staircase (**Figure 35**).

Figure 33 Inserted modern concrete block pillar in Room 3. Modern brick above half-height wall visible to left of frame. Photograph taken facing west.

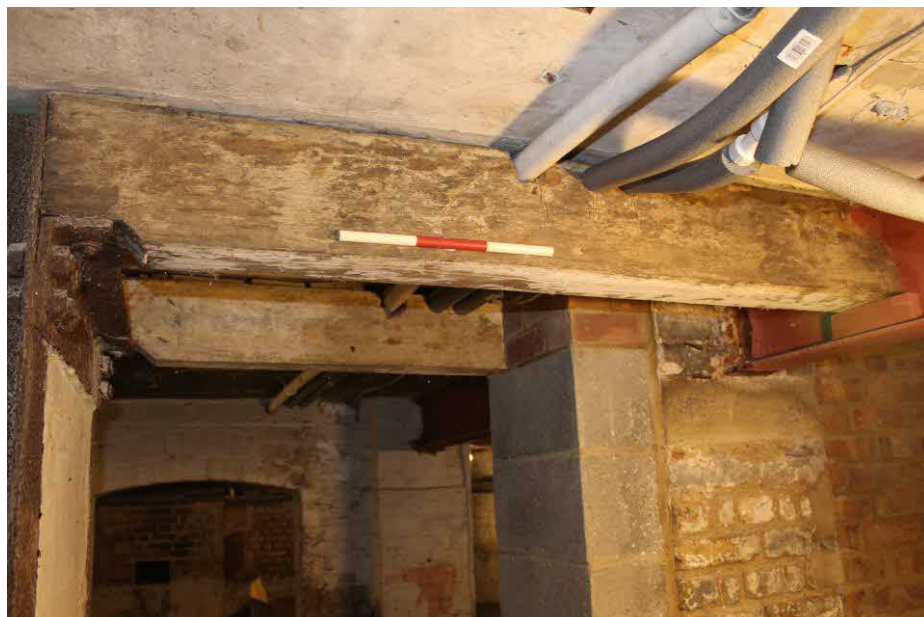
Figure 34 Timber beam supported on ironwork to left of frame and modern girder to right. Concrete blocks added to original brick pillar visible behind. Photograph taken facing south.

- 5.3. Originally the ceiling above (and therefore ground-floor) would have been supported on timber-beams, some remnants of which may survive (albeit re-used) in Room 3.

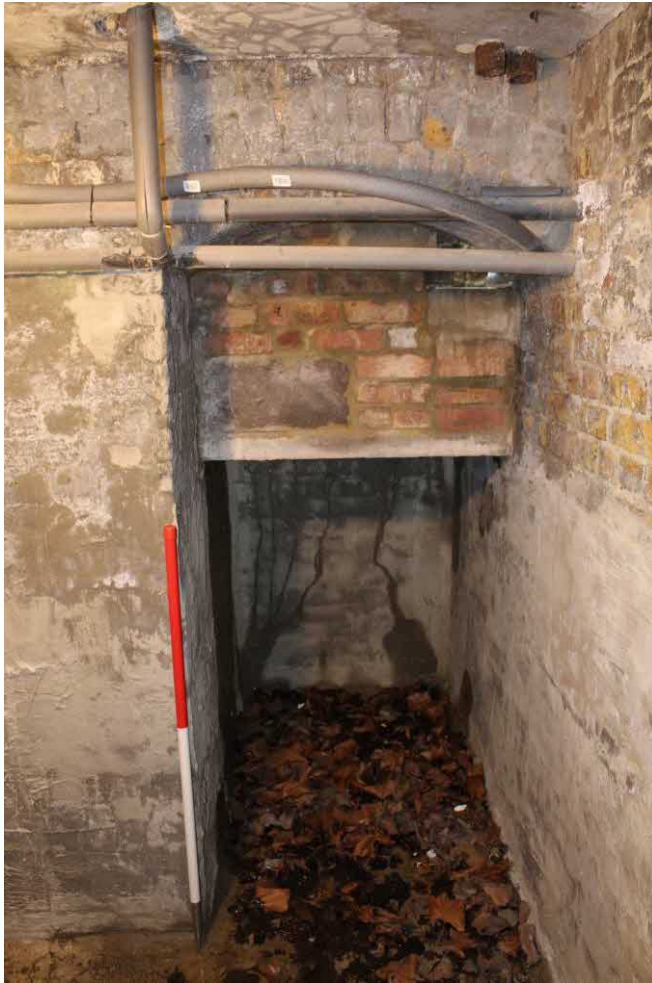
Figure 35 Detail of storage alcove in northern wall of Room 3. Partially blocked by inserted exterior staircase. Photograph taken facing north.

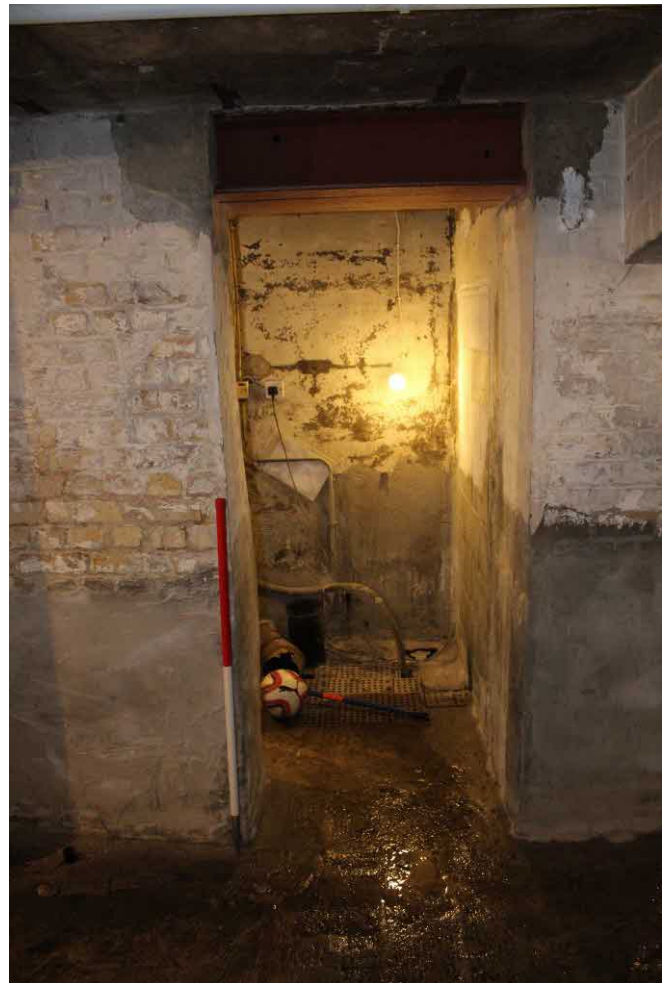
Figure 36 Entranceway between Room 3 and 4. Sump visible in background. Photograph taken facing east.

- 4.29. The entranceway between Room 3 and Room 4 appears to be a modern insertion, with cut brickwork and a metal girder above (**Figure 36**). This raises the question of how Room 4 was originally accessed, which is addressed in the conclusion (see below).
- 4.30. The current entrance into the basement is via the converted coal chute in Room 4; concrete steps have been added leading up to the chute and an exterior staircase added (**Figures 37-38**).
- 4.31. In the floor of Room 4 is a sump (**Figure 35**).

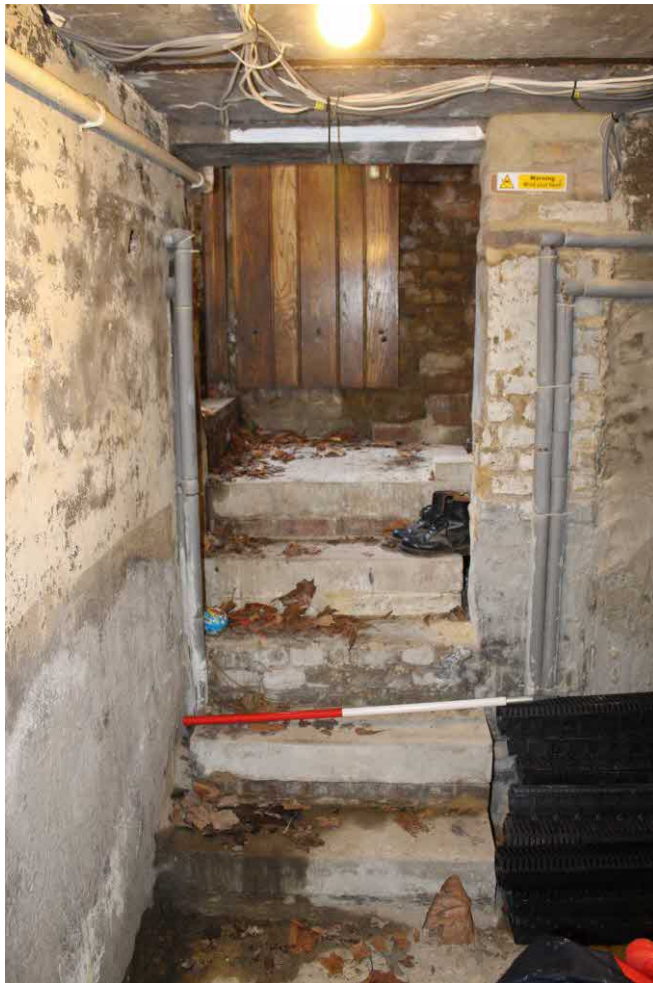
Figure 35 Modern access into basement from converted coal chute. Photograph taken facing north.

- 5.4. Originally the basement was only accessible from inside the building on the eastern side of Room 1; the conversion of the coal chutes on the northern elevation in 2011 altered this, and presumably also dates the boarding over of the interior staircase.

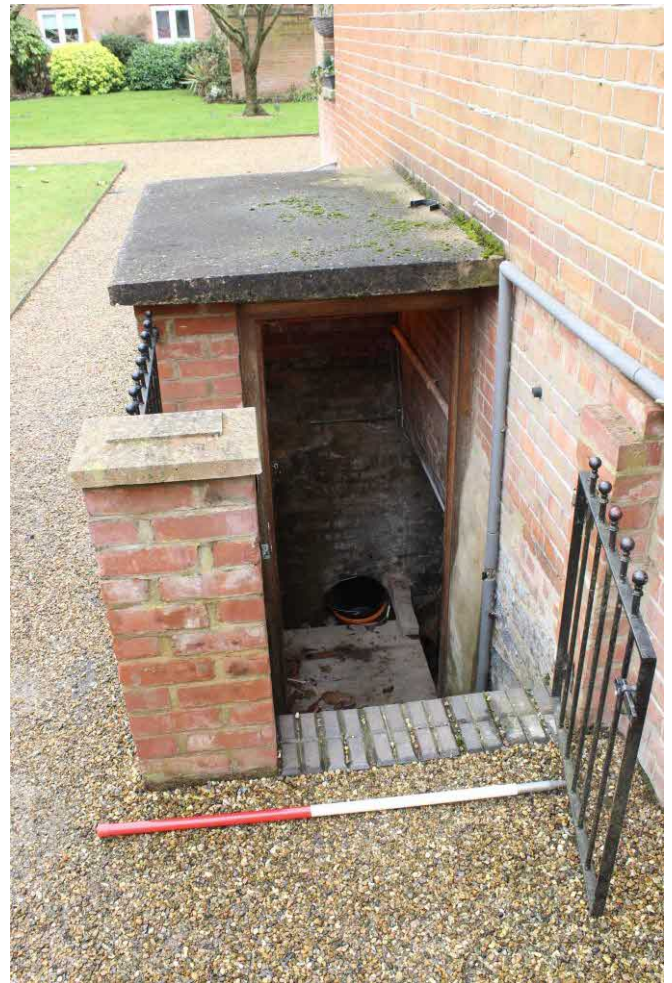
Figure 36 Detail of exterior access into basement. Photograph taken facing east.
