**PRELIMINARY ROOST
ASSESSMENT & PRESENCE /
ABSCNECE SURVEY (BATS)**

The Barn, The Green, Croft Village
Leicestershire LE9 3EQ

Report reference: PR085A_07_19PRA/PA

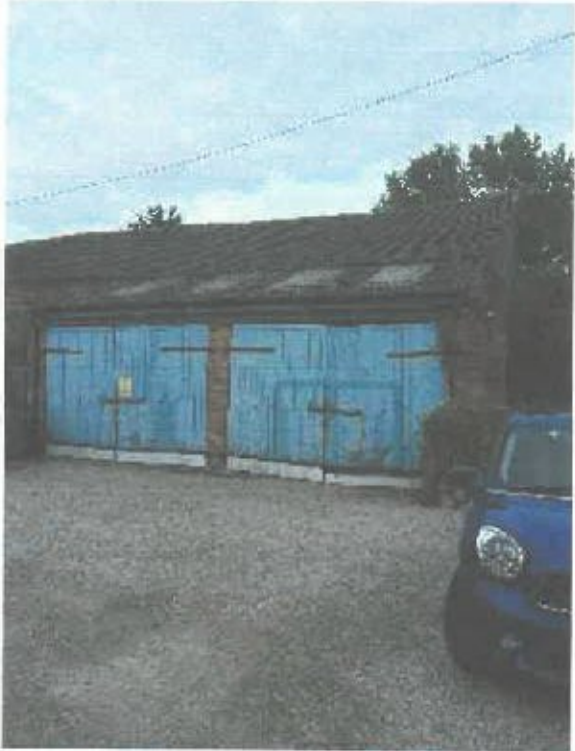
TARGET NOTE	HABITAT DESCRIPTION	PHOTOGRAPH(S)
1	<p>Facing east toward the front of the barn. The roof has numerous gaps at the ridge. There is no roof lining present throughout. The south west gable is leaning outward which prevented entry for internal inspection. The two single storey garages are a more recent extension and the removal of supporting structures to create this extension has compromised the structure of the building.</p>

leaning outwards. The roof tiles along the length of the barn were visibly unaligned and the east walls are bowing suggesting the whole building has moved towards the outward leaning gable end, refer to Photograph 1 Appendix A.

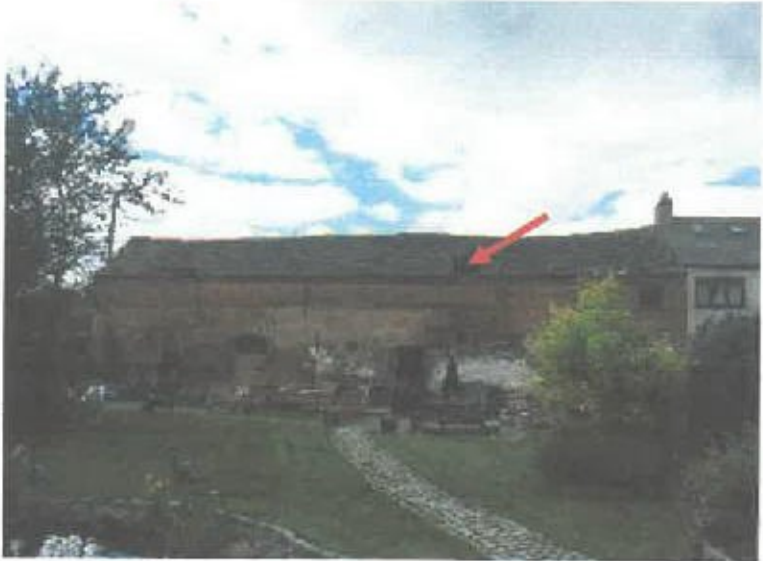
A photograph showing the front of a barn with a dark, gabled roof. The roof appears to have several gaps or missing sections, particularly along the ridge. In the foreground, there is a gravel area and a blue car parked on the right side. The sky is overcast.
2	<p>Facing west toward the barn. The roof is damaged and a <i>P. pipistrellus</i> is utilising the gap in the roof (arrowed).</p>

- 7.1.3 Compensation should include a like for like (or as near as possible) bat roost replacements in a location as close as possible to the original roost entrance, Photograph 2.

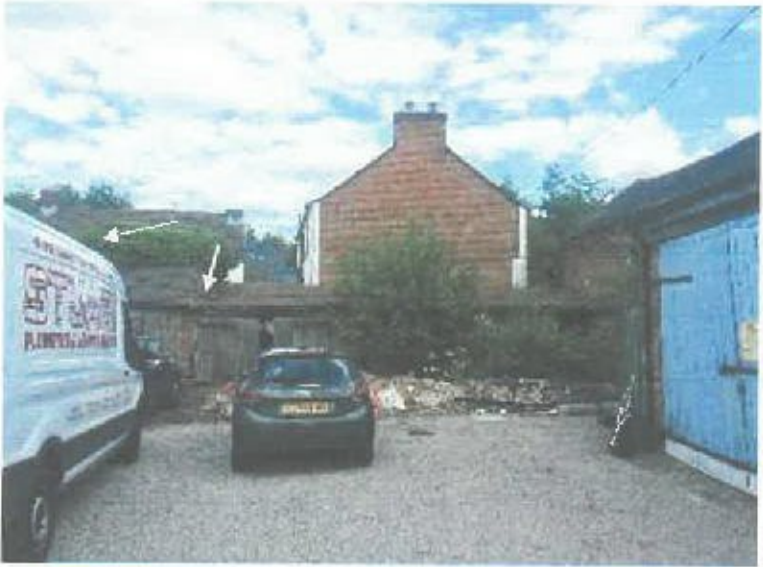
<p>3</p>	<p>Facing north east toward the lean to which backs on to a neighbouring garden. The roof is corrugated tin with no roof lining present. Bats can enter through missing windows or a damaged door.</p>

- 5.4.4 A single storey lean to is attached to the barn at its northern end and runs north west making an L shaped plan. The roof is corrugated tin with no roof lining present. There is a missing window and damaged front door allowing bat access to the interior.
- 5.4.5 The interior of the lean to is light filled via a missing window and damaged front door. The area is dusty and subject to regular disturbance as it is used for storage. No signs of bats throughout. The lean to has no day roosting potential but may serve as a feeding perch or night roost for *P. auritus*. The hibernacula qualities of the lean to are currently unknown. Photographs 3 – 4.

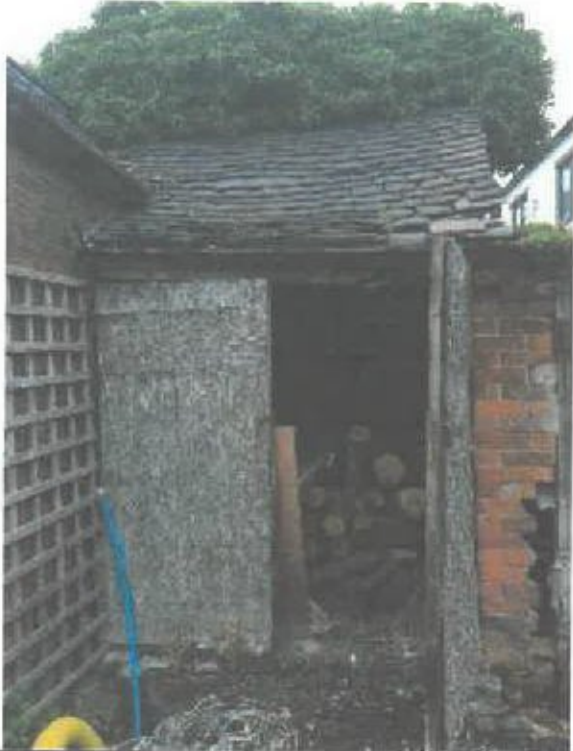
<p>5</p>	<p>The attached brick shed is used for storing logs. There are gaps between roof tiles and brickwork.</p>

- 5.4.6 A small single storey brick shed is attached to the eastern end of the lean to. The roof covering is clay tiles with ae roof lining of lath and plaster. There are gaps between loose fitting roof tiles to the front which provide potential access between the tile and roof lining. The shed is used for storing logs and is subject to regular disturbance and is lit at night by security lighting from the main house. No signs of bats throughout. The shed has 'low' bat roosting potential. The hibernacula qualities of the shed are currently unknown. Photographs 5 – 6.

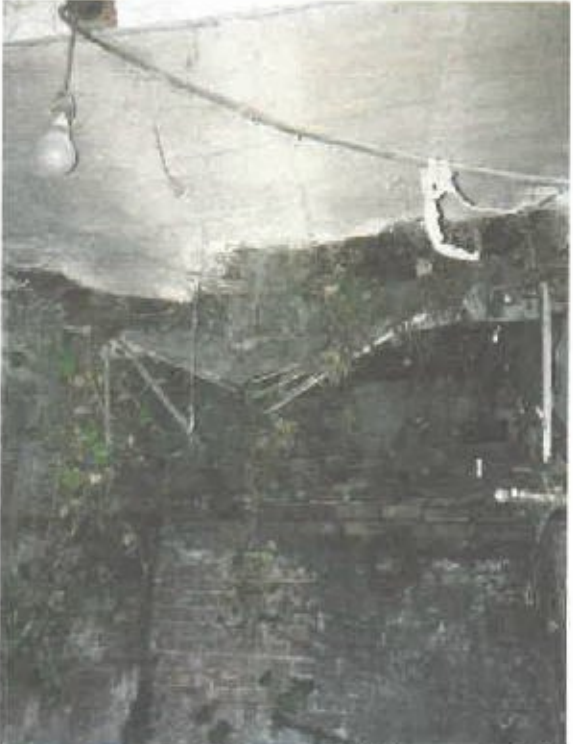
<p>6</p>	<p>The interior of the shed shows the ceiling to have collapsed. The roof is lined with plaster so bats may be able to roost between the roof tiles and plaster ceiling. No signs of bats were found during the internal inspection.</p>

- 8.2.5 It would be prudent to soft strip some sections of the shed roof as some loose tiles were observed with lath and plaster underneath. The lean to will not require any supervised works.

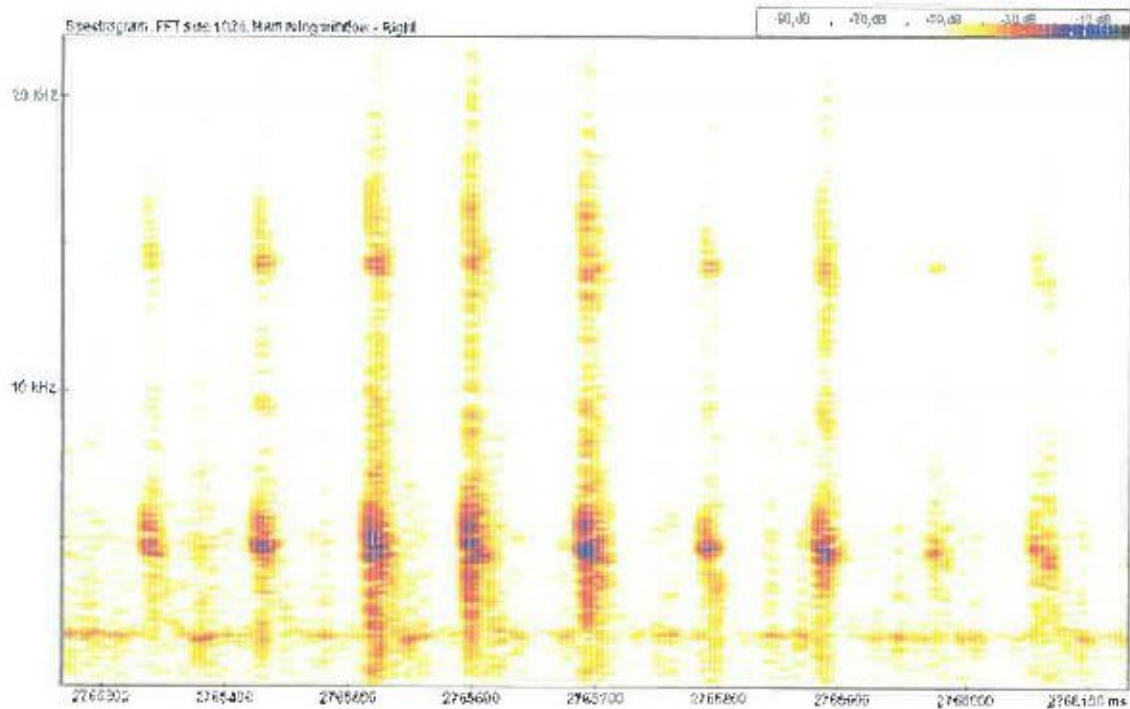
The following sonogram is an image of the call structure of the **P. pipistrellus** bat. This recording was made on 6 July 46 minutes after the start of the dusk survey. The bat was observed emerging from the hole at the east elevation. The bat circled the surveyor and headed east to forage, refer to Appendix B and flight number 5 to view the flight pattern when this recording was made.

Bat Sound analysis program shows peak frequency around 43 kHz.

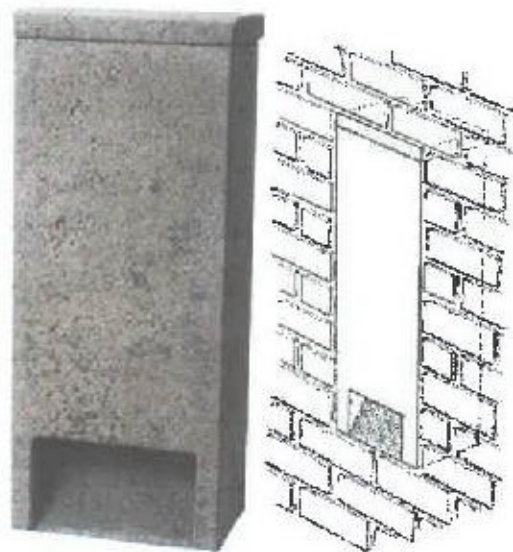
Figure 1. 1 FR Schweggler Bat Tube

The 1FR is specifically designed to meet the characteristic behavioural requirements of the types of bats that inhabit buildings. It has an integrated wooden panel onto which bats can cling and a ridged entrance slope which makes it easy for them to enter and leave the box safely. The design maintains excellent climatic conditions inside providing bats with a safe and stable environment in which to roost and it requires no maintenance because droppings fall out of the entrance ramp.

Ideally facing south fitted to gable of house as near as possible to original roost location, refer to Photograph 1.

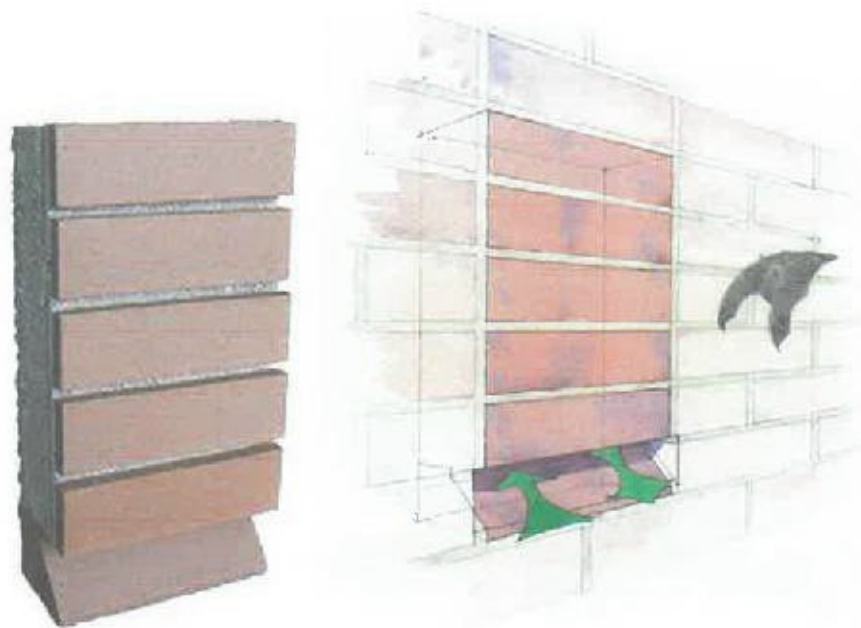
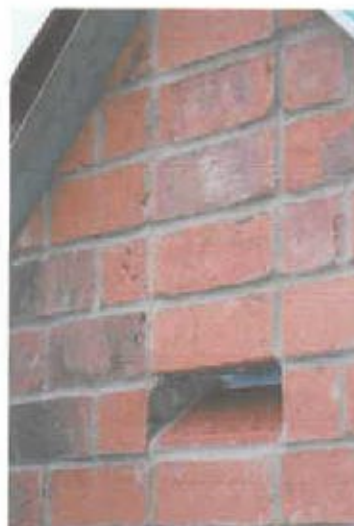
Figure 2. Habitat Bat Box 001.

The Habitat Bat Box is a large, solid box made of insulating concrete with an internal roost space, which can be incorporated into the fabric of a building as it is built or renovated. A variety of facings can be fitted to suit any existing brick, wood, stonework or rendered finish, rendering the box unobtrusive and aesthetically pleasing. The Habitat box is suitable for species which are most commonly found roosting in buildings in the UK, such as Pipistrelle, Natterer's, Whiskered, and Brandt's bats.

Ideally facing south fitted to gable of house as near as possible to original roost location, refer to Photograph 1.

This box can be faced in standard Staffordshire Smooth Red brick, blue brick or buff brick and is ideal for new builds. It is supplied un-pointed so it can be matched as closely as possible to the building.

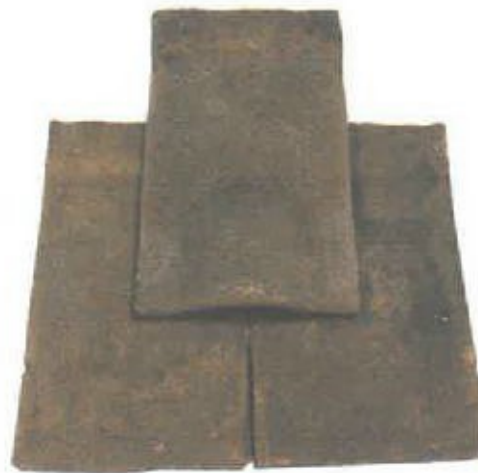
Figure 4. Spicer Tiles Bat Access Tile Set - Medium Antique

A very attractive tile for use on barn conversions or to mix in with second hand Spicer peg tiles. With its unique pitted surface, the Medium Antique is ideal where the benefits of a new clay tile are required, but weathers quickly to give a mellow aged look.

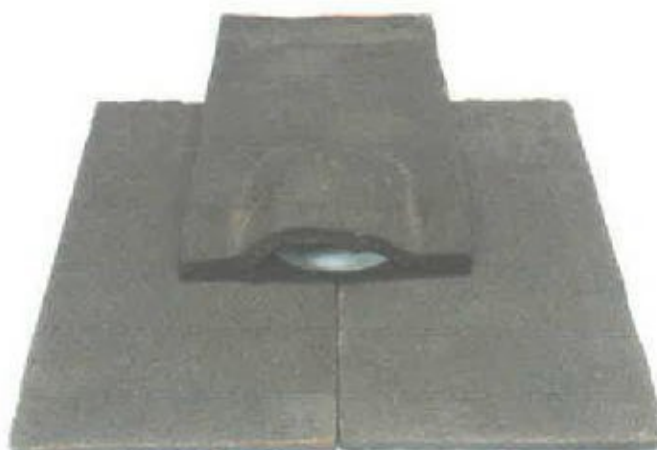
Figure 5. Spicer Tiles Hanbury Bat Access Tile Set - Appledore Blend

Hanbury clay roof tiles are hand-crafted to the highest standards to create authentic and good-looking roof tiles to achieve a roof full of character and individuality. One of the last few handmade clay roof tiles available in the UK, a British clay is made to produce the warm tones found in the Hanbury range. Accessories alongside Hanbury tiles, such as the half round ridge tile and valley tile, aren't handmade however these tiles still meet all of the British standard requirements for clay roof tiles.

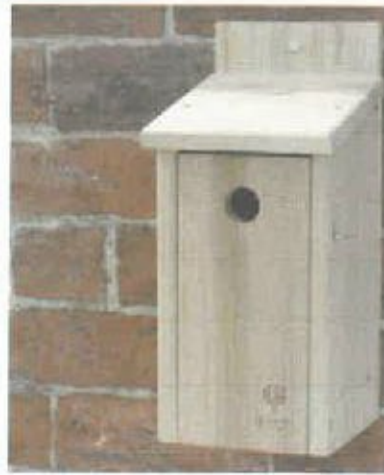
Figure 6. Jacobi Jayne Cedarwood Modern Nest Box 26mm & 32mm hole

Avoid siting nest boxes south facing to avoid full sun to increase take up. Ideally facing north or east. Height should be 3-4m above ground minimum. Box can be tilted slightly forward to allow rain for fall clear of the entrance.

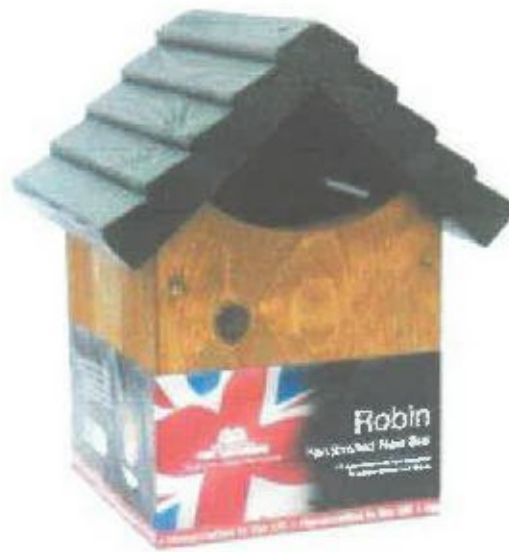
Figure 9. Tom Chambers Robin Nest Box

Should be sited north, north east or east
