## Tree Survey and Arboricultural Impact Assessment

**Residential Development at  
Springwell Lane  
Whetstone  
Leicester**

**TREE SURVEY AND  
ARBORICULTURAL IMPACT ASSESSMENT**

**REPORT REF: 2356- PHA**

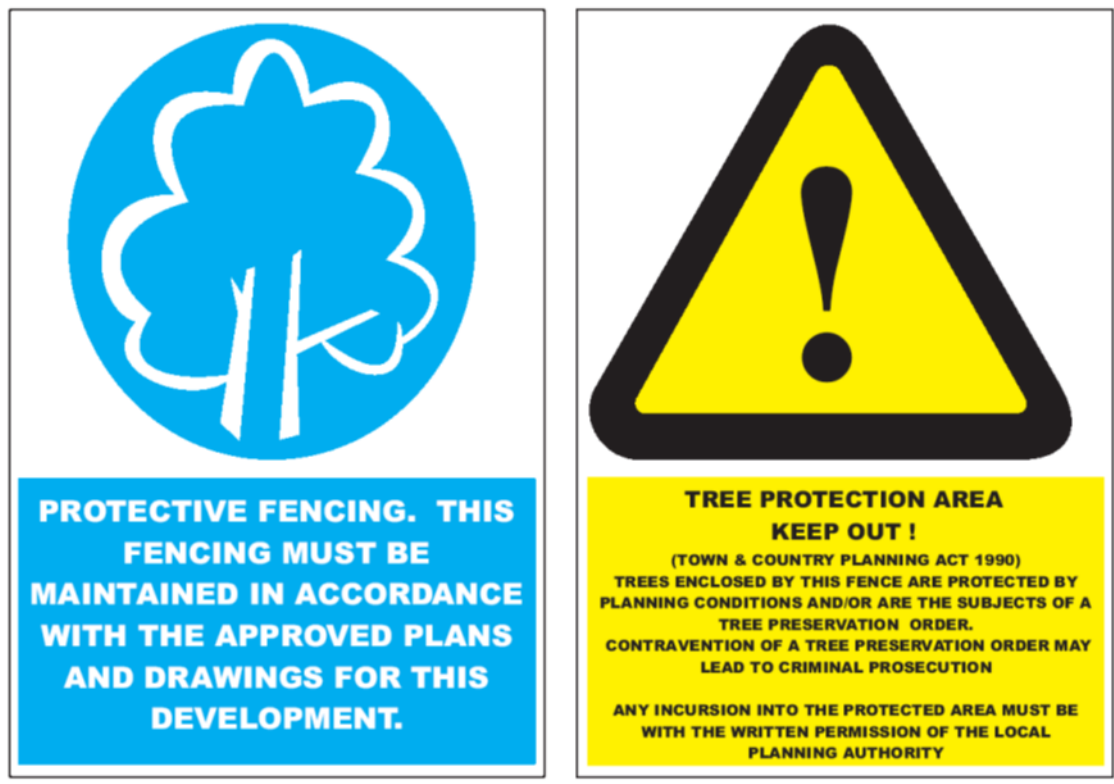
Fig. 1. Example of protective fencing and signage:

Trees to be retained will require protection throughout the duration of the proposed development with protective fencing and signage (see Fig. 1 and 2 below). To ensure retention of adequate protection throughout the development process, regular site monitoring should be carried out on a formal and agreed basis to report on the condition and status of protective fencing and other methods. Protection methods

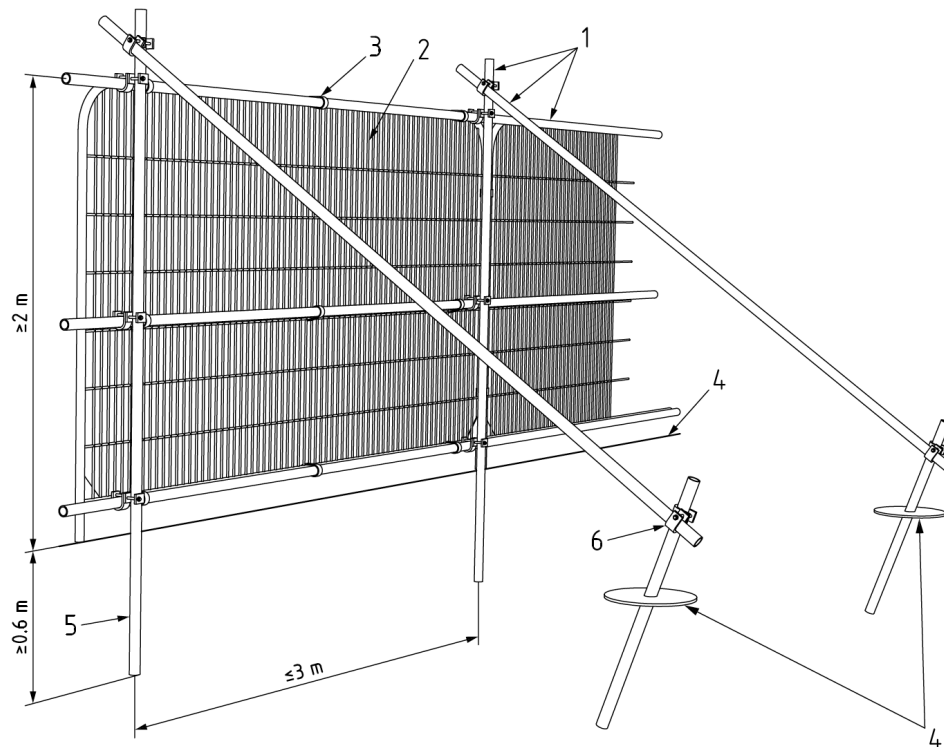
Fig. 2. Protective fencing for tree root protection:

- 1 Standard scaffold poles
- 2 Heavy gauge 2 m tall galvanized tube and welded mesh infill panels
- 3 Panels secured to uprights and cross-members with wire ties
- 4 Ground level
- 5 Uprights driven into the ground until secure (minimum depth 0.6 m)
- 6 Standard scaffold clamps

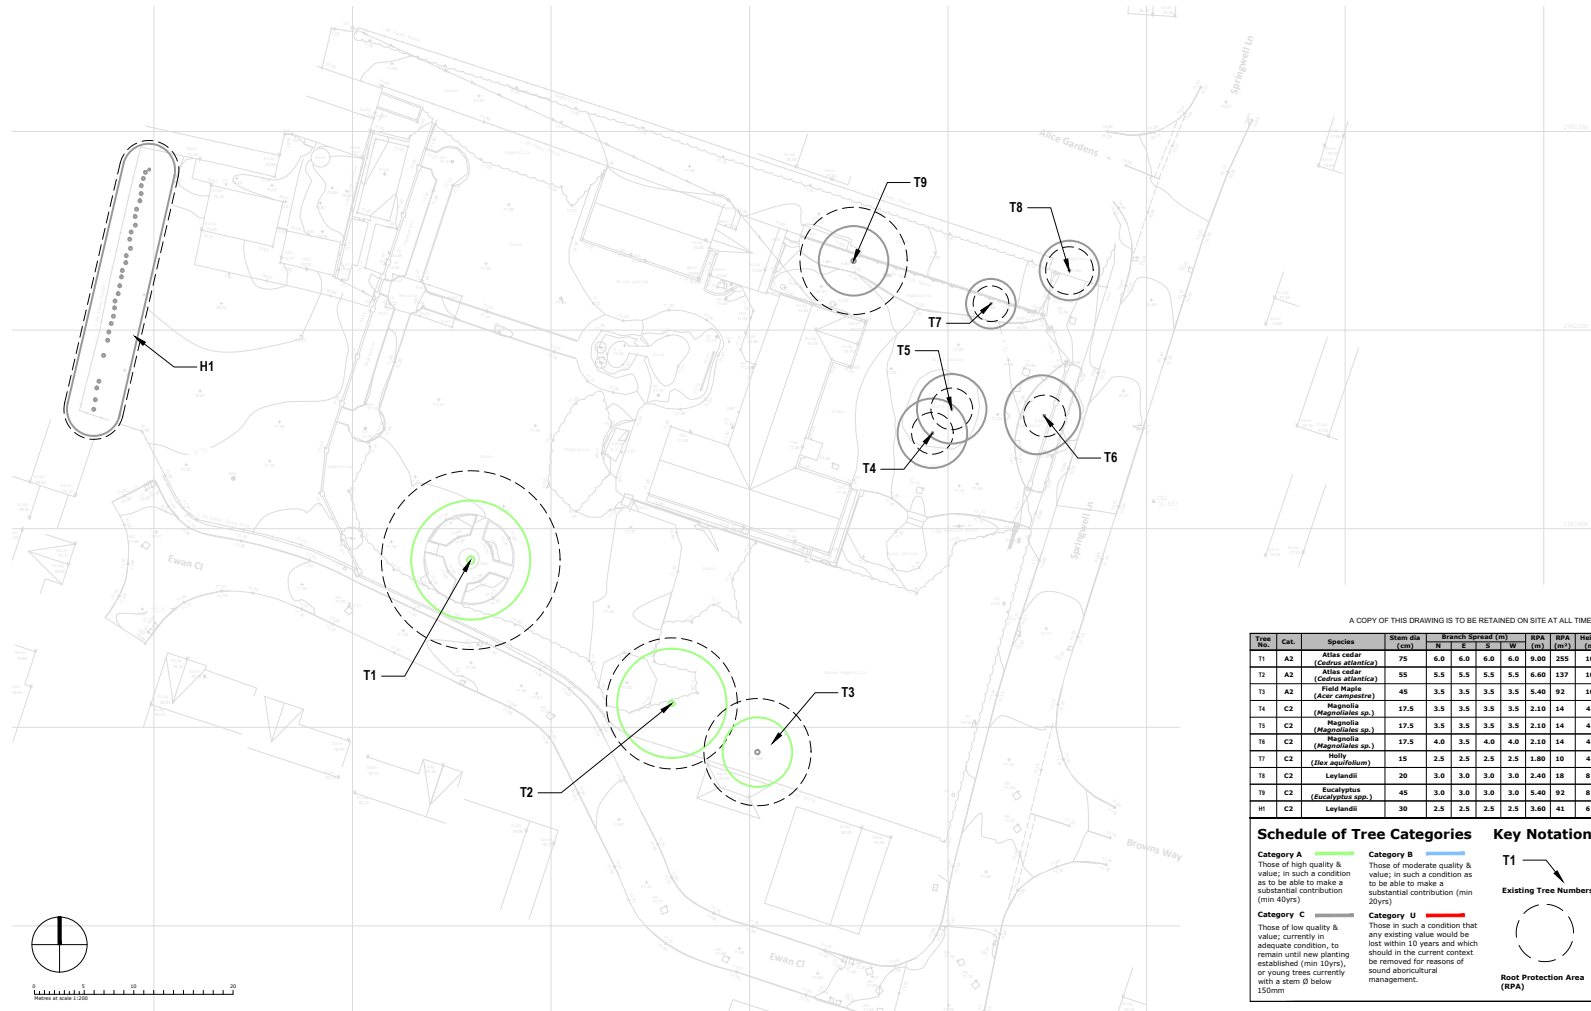
APPENDIX 2 – TREE SURVEY CONSTRAINTS PLAN

Tree No.	Cat.	Species	Stem dia (cm)	Branch Spread (m)				SRA (m)	SRA (m)	Height (m)
				N	E	S	W			
T1	A2	Alnus cordata (Cedrus atlantica)	75	6.0	6.0	6.0	6.0	9.00	255	10
T2	A2	Alnus cordata (Cedrus atlantica)	55	5.5	5.5	5.5	5.5	6.60	137	10
T3	A2	Field Maple (Acer campestre)	45	3.5	3.5	3.5	3.5	5.40	92	10
T4	C2	Magnolia (Magnolia sp.)	17.5	3.5	3.5	3.5	3.5	2.10	14	4
T5	C2	Magnolia (Magnolia sp.)	17.5	3.5	3.5	3.5	3.5	2.10	14	4
T6	C2	Magnolia (Magnolia sp.)	17.5	4.0	3.5	4.0	4.0	2.10	14	4
T7	C2	Holly (Ilex aquifolium)	15	2.5	2.5	2.5	2.5	1.80	10	4
T8	C2	Leylandii	20	3.0	3.0	3.0	3.0	2.40	18	8
T9	C2	Eucalyptus (Eucalyptus spp.)	45	3.0	3.0	3.0	3.0	5.40	92	8
H1	C2	Leylandii	30	2.5	2.5	2.5	2.5	3.60	41	6

We have inspected all the trees that would be influenced by the development proposals. Their reference number and canopy spread are shown on drawing nos. 2356-01 Existing Tree Survey and Root Protection Areas.

The location of root protection areas is shown on drawing nos. 2356-01 Existing Tree Survey and Root Protection Areas. However, a further pre-construction phase plan will be required for the approval by the Local Planning Authority Tree Officer to confirm the following:

Where necessary, a root protection area was calculated for each tree in accordance with BS 5837:2012. Drawing Nos. 2356-01 Existing Tree Survey and Root Protection Areas provides details of the extent of calculated RPA. Protective barriers are to be placed around these areas or beyond the line of the canopy, whichever is the greater.
