Modified Barn

Preliminary Ecological Appraisal
Red House Farm, Ashbocking, Suffolk
Evolution Town Planning LLP

Bat Surveys

Red House Farm, Ashbocking, Suffolk

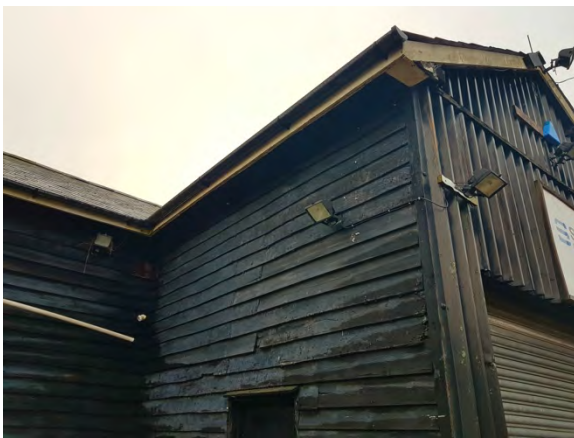
Fig. 01: Previous roost location

The exterior of the barn features a pitched slate roof, rendered brickwork at the wall base, and timber cladding across the gable ends and mid- and upper sections of the walls. The rear (northern edge) of the barn also features extensive repairs formed from wooden cladding and corrugated metal, which have been fitted to remediate significant structural damage and deterioration.

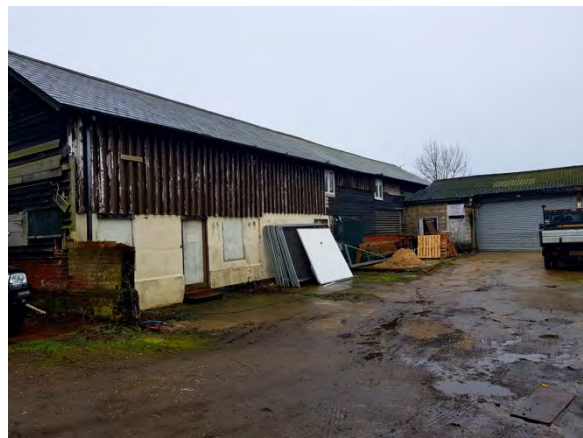
Fig.02: Barn rear and stock yard

The timber frontage and slate roof of the barn are considered of good structural condition. The open eaves surrounding the far western lean-to provide internal access into the barn. No signs were however noted around the barn, including within and around the previous small common pipistrelle *Pipistrellus pipistrellus* day roost (recorded in June 2015 opposite the western annex). The rear of the barn features numerous cracks and crevices beneath the timber and metal cladding due to the make-shift repairs that have been made. No signs of presence were similarly noted.

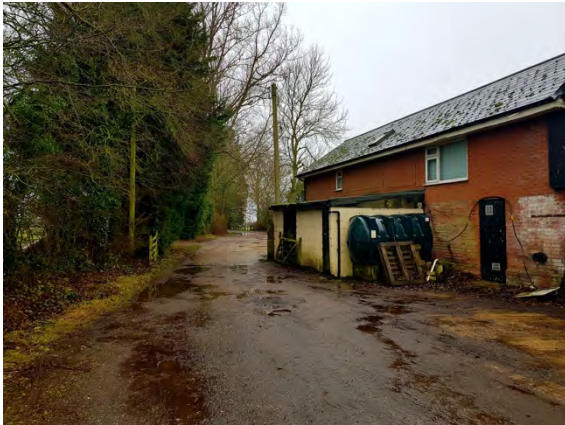
Fig. 03: Eastern annex

The eastern annex forms the most recent extension of the main barn building. The building is considered in a good state of repair at the time of survey. Very minor damage was noted to the soffits on the south-western corner, which could provide roosting opportunity for crevice dwelling species such as pipistrelles. No signs, however, such as scratch marks, staining or droppings were noted around these features or around the surrounds of the entire annex. The presence of thick cobwebs also indicated no recent through passage.

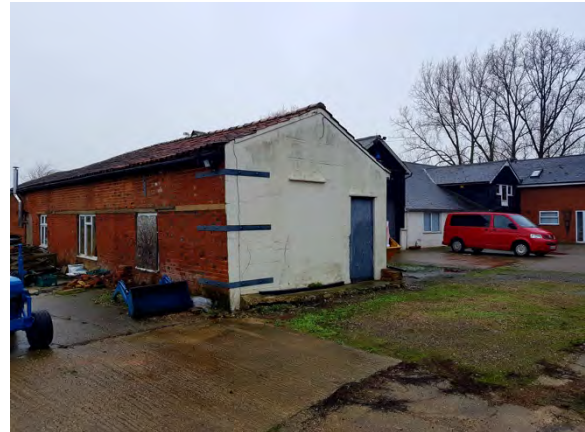
Fig.04: Western Annex

The western annex is constructed from Flemish bond walls (alternative courses of headers and stretchers), with a pantiled roof and brick gables at either end. The annex features wooden fascias and soffits on one side only (on the short eastern side opposite the stock yard).

The roof of the building features numerous raised / missing / broken pantiles, and damaged brickwork around the window plinths. A number of windows have also been boarded up with plywood. The overall structural condition for roosting purposes is, therefore, considered moderate. No signs were however noted around any of these features or around the wider building during the course of the updated inspection.

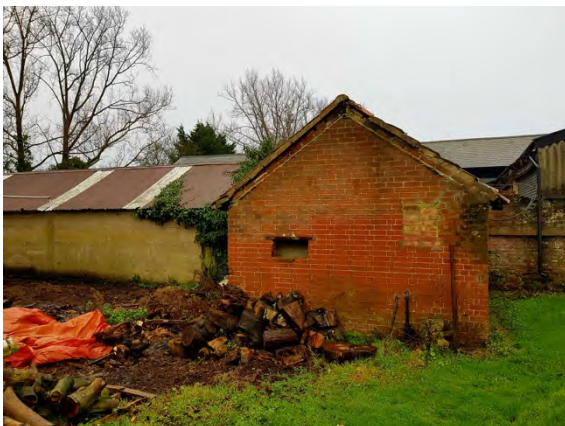
Fig. 05: Outbuilding 1

Three outbuildings are located to the north and north-east of the modified barn. The first outbuilding features an open frontage and is constructed from Flemish bond walls and a pantilled roof. It is considered of moderate structural condition, with raised / missing tiles, gaps underneath the ridge tiles, and damaged brickwork. No signs of bats were noted during the updated inspection.

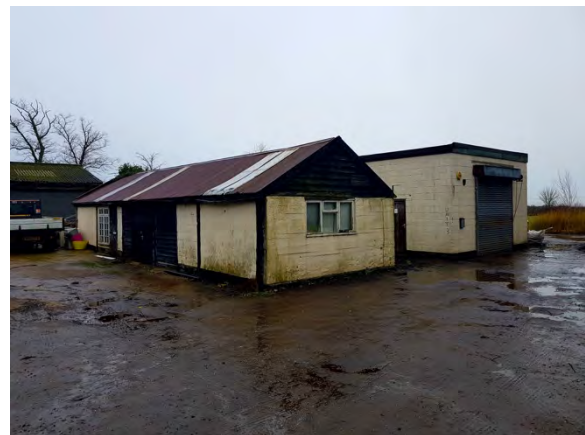
Fig.06: Outbuilding 2 & 3

The second gable-ended outbuilding is located on the northern edge of the stockyard. Building materials include breezeblock walls, a corrugated metal roof, wooden fascias / soffits / bargeboards, and timber clad gables at either end. Three scattered pipistrelle droppings were previously noted on the southern face opposite the stockyard although no signs were noted during the updated inspection.

The third outbuilding is constructed from breezeblocks, with a flat roof covered in felt, and wooden fascias around the eaves. The northern edge also supports a small timber clad lean-to with an open frontage and felt roof. No signs of bats were noted during the updated inspection.

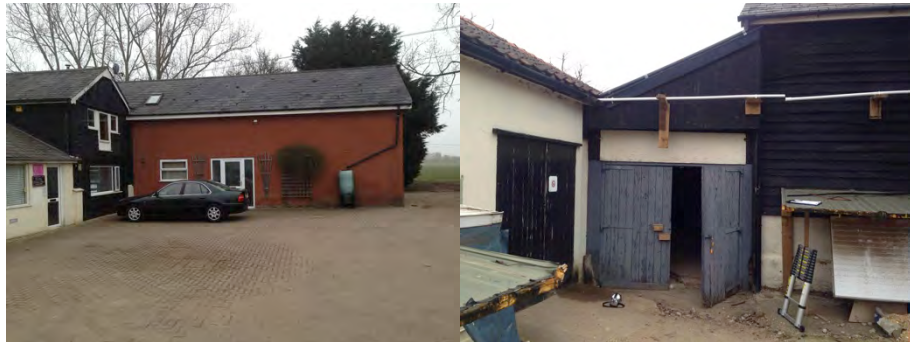
Eastern edge of the mid- section (also showing the eastern annex) and western lean-to

3.1.3 The exterior of the building features a pitched slate roof, rendered brickwork at the wall base, and timber cladding across the gable ends and mid- and upper sections of the walls. The rear (northern edge) of the building also features extensive repairs formed from wooden cladding and corrugated metal, which have been fitted to remediate significant structural damage and deterioration. The footprint of the building measures approximately 7.5 m x 25 m (width x length).

3.1.4 The timber frontage and slate roof of the building are considered of good structural condition. The open eaves surrounding the far western lean-to provide internal access into the building, and therefore, roosting opportunities within. No signs were, however, noted across the front of the building to indicate the presence of a significant roost.

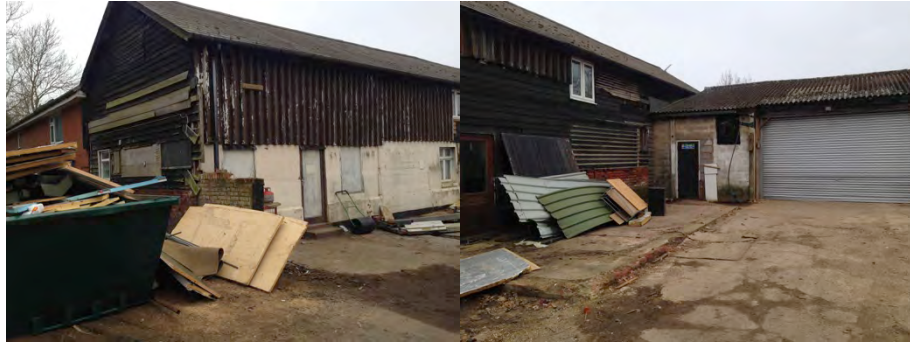
3.1.5 The rear of the building features numerous cracks and crevices beneath the timber and metal cladding due to the make-shift repairs that have been made. No signs of presence were noted.

Southern face of the old barn and stockyard

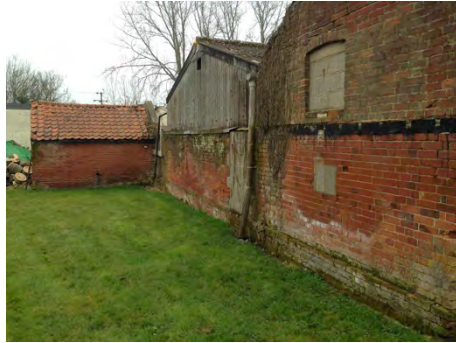
3.1.9 **External inspection:** The large extension has been built onto the northern edge of the old barn, in-between the main section and western annex opposite the pond. The building footprint measures approximately 9 m x 14 m (width x length).

3.1.10 It incorporates an old Flemish bond wall on the northern side, which previously formed an external wall that enclosed the stockyard area. The remaining external walls are constructed from breezeblocks, with large metal shutter doors on the eastern face bordering the stockyard. The roof and northern gable are covered in corrugated asbestos cladding. No signs of presence were noted around the building exterior.

Northern face of asbestos clad extension opposite the pond. Also showing the north face of the western annex (closet) and Outbuilding 1

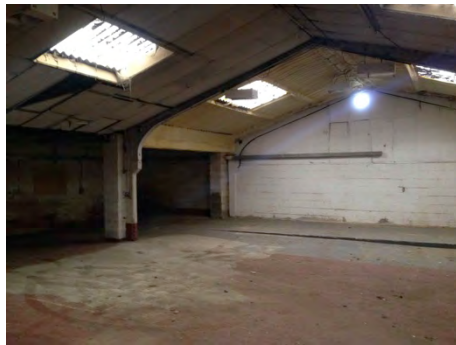
- 3.1.11 **Internal inspection:** The building interior is open plan. It incorporates half of the western annex (northern section), which was previously opened up to increase the availability of work / storage space. The building is supported by a bolted metal frame, and also features an open roof with no attic space. No signs of presence were noted.

Interior of asbestos clad barn

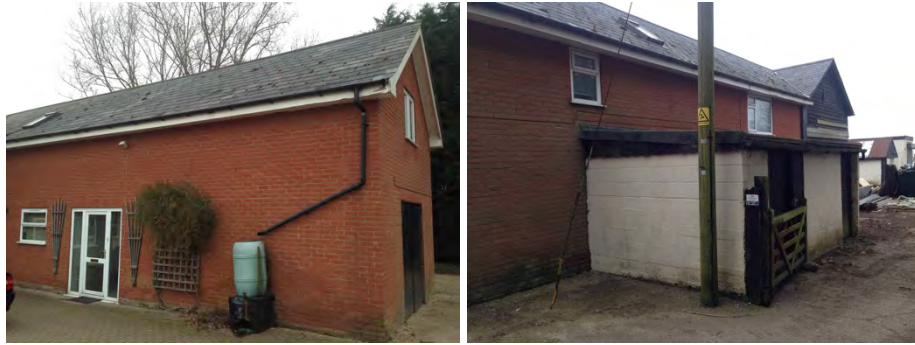
- 3.1.14 The building is considered in a good state of repair at the time of survey. Very minor damage was noted to the soffits on the south-western corner, which could provide roosting opportunity for crevice dwelling species such as pipistrelles. No signs, however, such as scratch marks, staining or droppings were noted around these features or around the surrounds of the entire annex. The presence of thick cobwebs also indicated no recent through passage.

- 3.1.15 The eastern edge of the annex also features a single-storey flat-roofed extension. The extension is constructed from breezeblocks with a felt roof and wooden fascias. No signs were noted around the exterior.

Eastern and western faces of the eastern annex (also showing the flat-roofed extension on the eastern side)

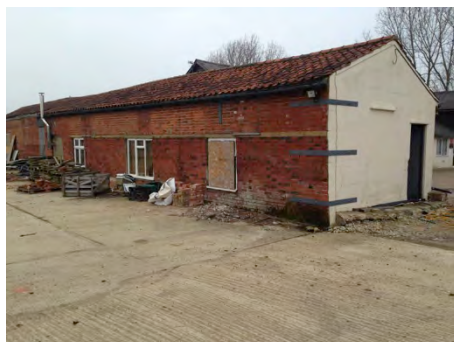
- 3.1.18 The annex footprint measures approximately 140 m². It is constructed from Flemish bond walls (alternative courses of headers and stretchers), with a pantiled roof and brick gables at either end. The annex features wooden fascias and soffits on one side only (on the short eastern side opposite the stock yard).

- 3.1.19 The roof of the building features numerous raised / missing / broken pantiles, and damaged brickwork around the window plinths. A number of windows have also been boarded up with plywood. The overall structural condition for roosting purposes is, therefore, considered moderate. No signs were noted around any of these features or around the wider building exterior during the course of the PRA.

Western face of the western annex

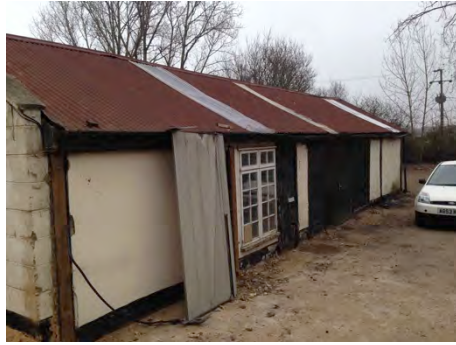
3.1.25 **External inspection:** The gable-ended outbuilding is located on the northern edge of the stockyard. Building materials include breezeblock walls, a corrugated metal roof, wooden fascias / soffits / bargeboards, and timber clad gables at either end. The footprint of the outbuilding measures approximately 6 m x 15 m (width x length).

3.1.26 Three scattered pipistrelle droppings were noted c. 1 m from ground level on the southern face opposite the stockyard. Closer inspection revealed no damage and / or obvious points of access / egress above within the soffits.

Southern face of Outbuilding 2

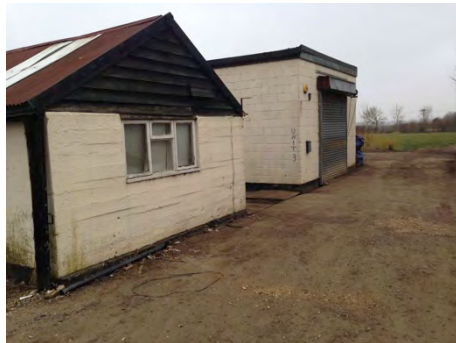
- 3.1.28 **External inspection:** The flat-roofed building is located to the immediate north-east of the gable-ended outbuilding, and east of the pond. The outbuilding is a square shaped design measuring approximately 9 m x 9 m (width x length). It is constructed from breezeblocks, with a flat roof on top covered in felt, and wooden fascias around the eaves. The northern edge also supports a small timber clad lean-to with an open frontage and felt roof. The lean-to measures approximately 7 m x 1.5 m. No signs were noted around the exterior of the flat-roofed outbuilding or lean-to.

Eastern faces of Outbuilding 2 (closest) and 3
