Preliminary Bat Roost Assessment and Method Statement.

**Hill House, Gravel Hill,
Nayland, Suffolk, CO6 4JB**

Survey Commissioned by:	Mr James Durance
Project Number:	REP23016
Report issued:	29 th March 2023
Date of survey:	13 th March 2023
Surveyor:	Odette Robson BSc (Hons) PhD MCIEEM

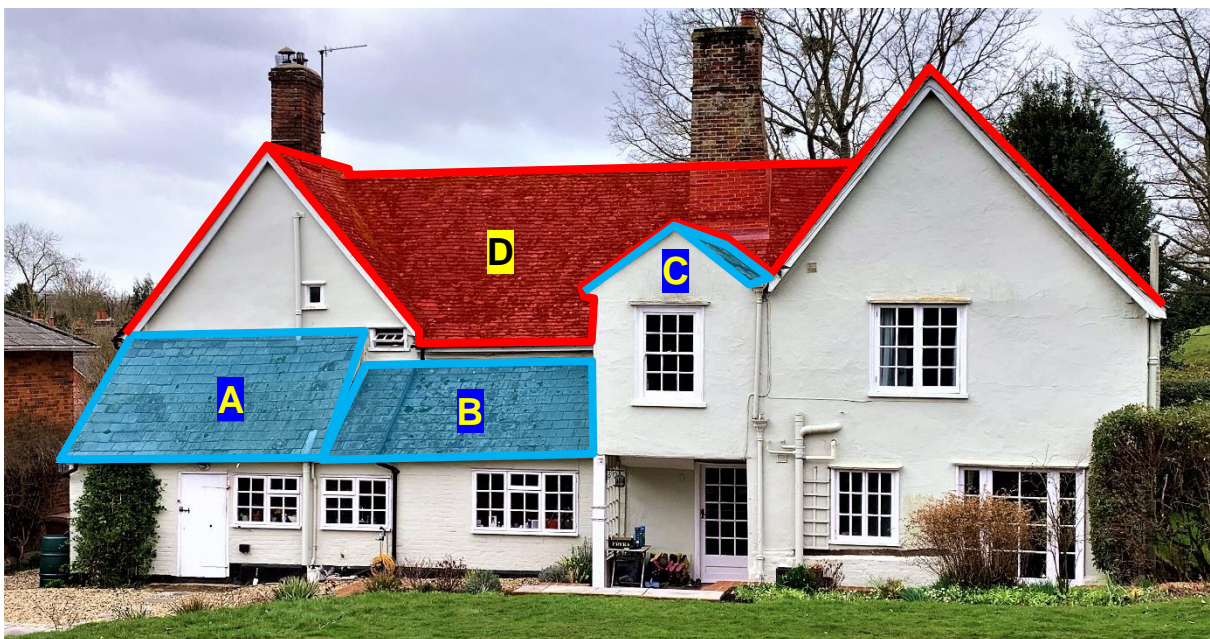
Figure 3.2: Slate roofs scheduled for replacement (A, B and C) – see descriptions in Table 3.2.

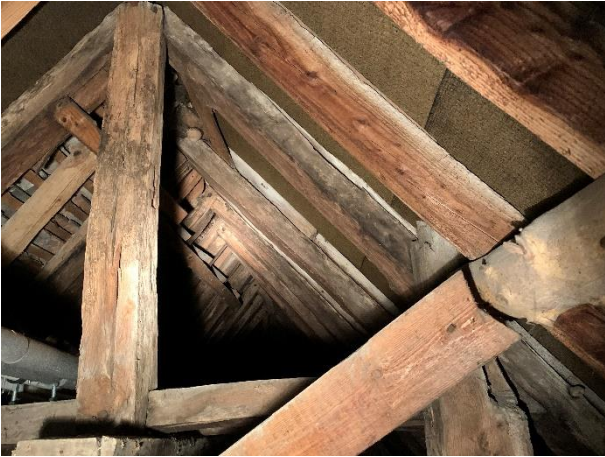
Description	Photo
<p>Main House (D): Timber-framed dwelling with rendered external walls – all intact and sealed. Complex roof, mainly peg-tiled with slate-covered additions. No notable missing tiles however, numerous minor damage and gaps under tiles which could facilitate access for bats into the roof void. Windows all well-sealed into surrounds.</p> <p>Internally, the loft had a large void (2+m height from floor to ridge) with king post roof trusses. Bitumen felt lining and lath and plaster at gables.</p> <p>Daylight showing through in places (at eaves and ridge): Lagging insulation on floor of loft, but eaves access still possible for bats/birds. Hole in bitumen felt at ridge with daylight showing.</p>

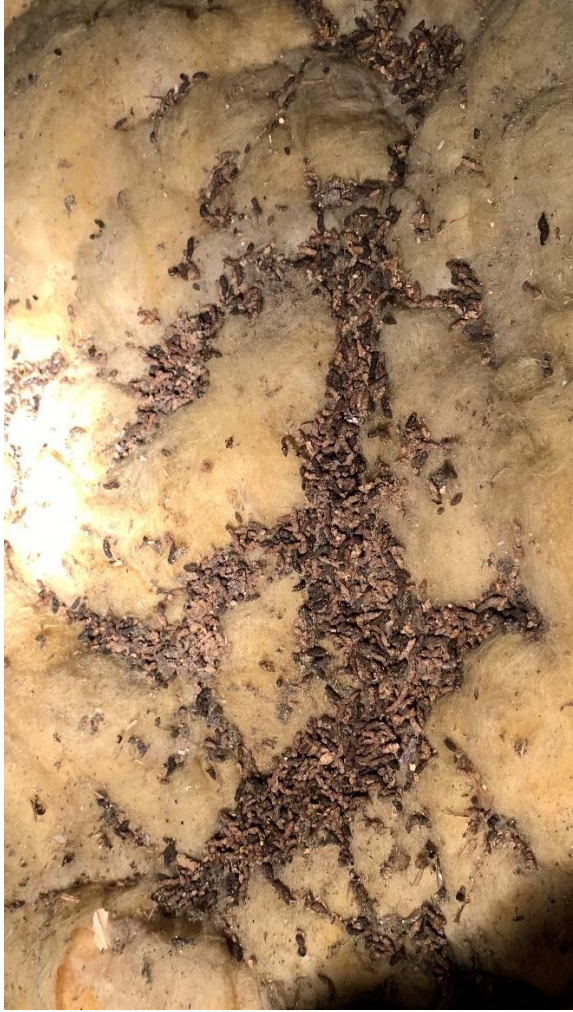
<p>Loft (Main House - D) – Approximately 300 droppings, characteristic of brown long-eared bats, beneath the ridge beam (NW main roof section). A second significant accumulation at the SW-facing gable end (approx. 200 droppings). The accumulated droppings were likely to be several years old, and no evidence of recent (past 12 months) bat activity at these frequently used roost locations. Frequent scattered droppings were present throughout the main roof-void (approx. 100 total): Some of these were fresher (likely from past active season) - of more recent origin than the droppings in the accumulations.</p> <p>Bird nesting material (possible house sparrow) was visible at the slope of the gable end on SW-facing gable: Nests were accessed externally, with no evidence of birds entering the roof void itself.</p>

An assessment was made under the criteria detailed in current Best Practice Guidelines (Collins, 2016). There was evidence that bats have roosted in the main roof void of the property (D) in the past: It is likely that this was a well-used brown long-eared day-roost, but may not have been extensively used in more recent years – the majority of droppings were old, grey and crumbling, though some fresher droppings were present, scattered throughout below the ridge, likely cast during flight within the void.

The following working methods must be followed to ensure that any bats using the main roof void (which will not be re-roofed, or impacted by proposals), will not be impacted during the re-roofing and installation of roof lights to the slate-roofed parts of the house.

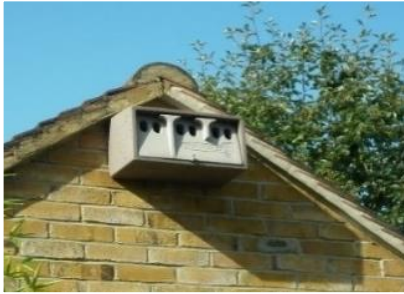
<p>Sparrow Terrace - Schwegler 1SP (for buildings)</p> <p>This terrace provides nesting opportunities for three families. Made of wood-concrete mix, this terrace is durable, breathable and will last many decades. The terrace can be fixed on to the surface of a suitable wall or incorporated into the wall. Place the terrace two metres or more above the ground or install directly into the wall. Cleaning is advisable but not necessary. As high as possible – below eaves.</p>

A sparrow-terrace could be best sited on a north-east facing elevation of the house or detached garage, where there is access to vegetation. At least two boxes, or a dual/triple terrace box, should be installed for this colonial-nesting species. Various designs are available: Boxes can be externally mounted on the house or garage. Alternatively, two/three boxes designed to be mounted on trees could be used in a mature garden tree.
