# **Hill House**

## **11 Gravel Hill, Nayland, Suffolk**

### **Outline Heritage Asset Assessment**

**February 2024**

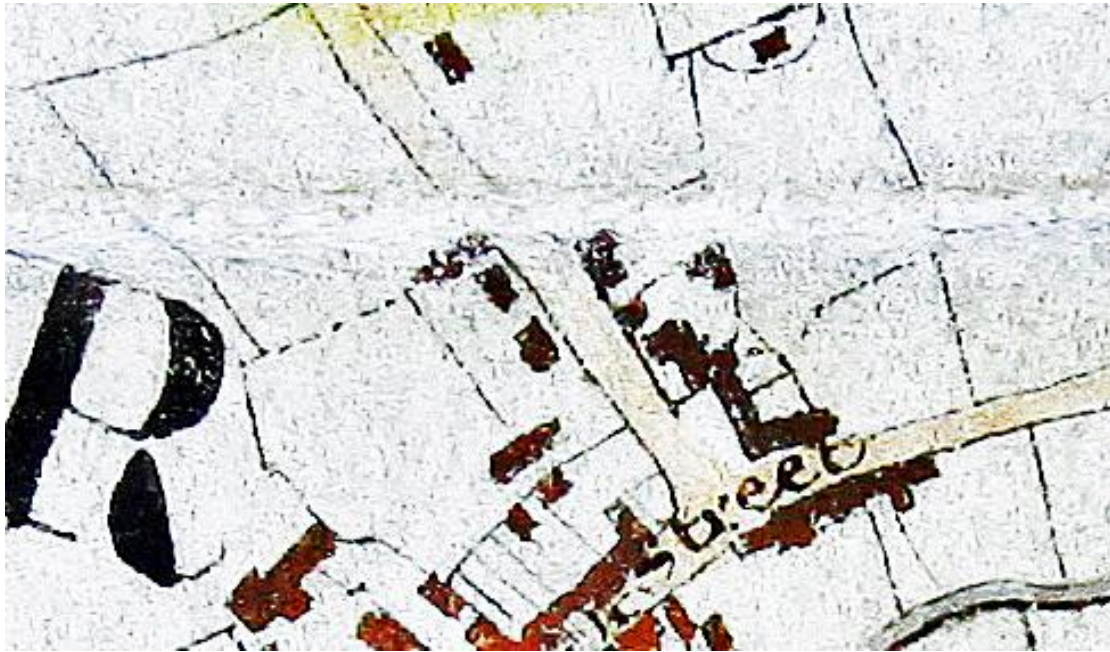
**Figure 3.** The 1817 Enclosure Map which shows a number of buildings in the paddock to the west of the house (i.e. in the plot numbered 78 in figure 4). William Sinnott may have removed these to improve his view. The rear garden also appears to have been enlarged between 1817 and 1838. The outline of the house is partly concealed by a crease in the map but the projection of its north-western cross-wing is still apparent.

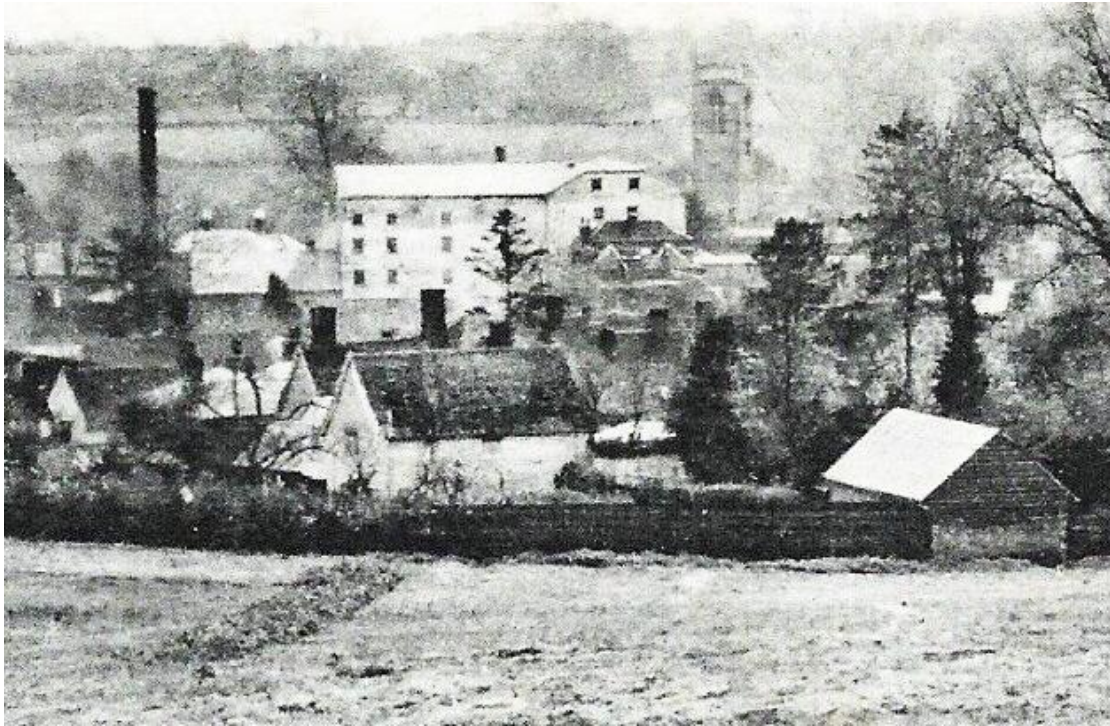
**Figure 7**

**The house from Gravel Hill to the north in a postcard of *circa* 1905 showing the mill and church tower in the rear with the outbuilding to the right. The lean-to structures against the back wall are clearly visible but unfortunately the definition of the image is not sufficient to identify their exact configuration. The mill was largely demolished in 1922 and the church tower was rebuilt in 1963.**

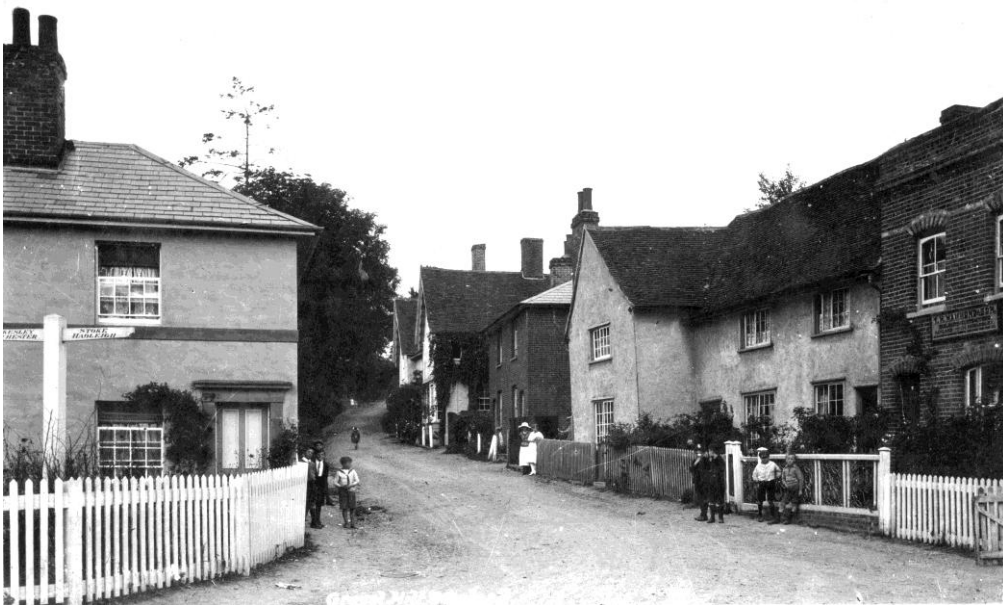
**Figure 8**

**A postcard view of the 1920s showing the twin gables of Hill House in the centre with the junction of Gravel Hill and Birch Street in the foreground. At this period Nayland's streets were plagued by a surfeit of urchins that severely hampered photography. Birch Street was labelled Back Street on the 1817 enclosure map in figure 3.**

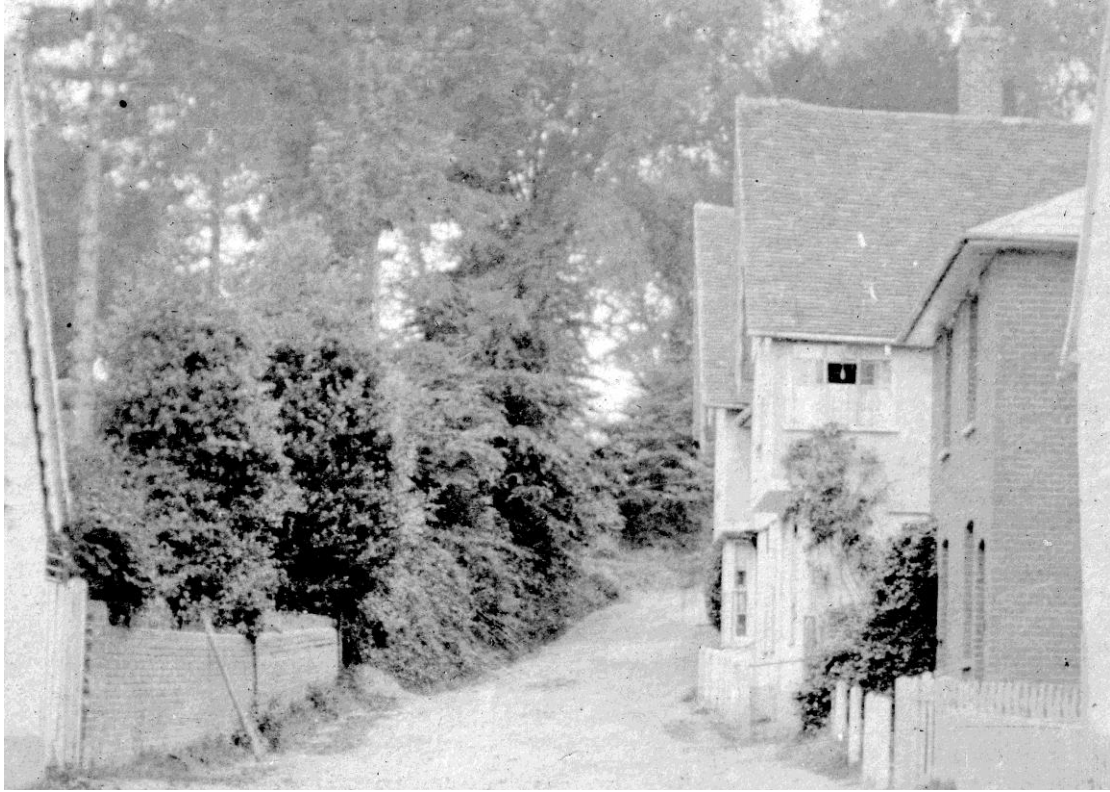
**Figure 9. An early-20th century image showing a good 18th century casement window with leaded lights above the jetty of the service cross-wing. This has since been replaced by a sash window to match those of the street facade but probably indicates the building's appearance when acquired by William Synnott.**

figure 12), concealing the genuine Tudor joists, and probably inserted the present sash windows to replace leaded-light 18<sup>th</sup> century casements like the example that still survived in the south-eastern side wall at the turn of the 20<sup>th</sup> century (figure. 9). Much if not all the ground-floor external walls were rebuilt in brick, indicating the structure was previously in poor condition, and Synnott may well have demolished the large buildings in the paddock opposite to create a property worthy of his new status as a country gentleman. The 1838 tithe map shows a small rear projection in the angle of the open hall and the parlour wing, and this almost certainly represented a stair turret. Small turrets containing narrow newel (spiral) stairs were often built in this position during the 17<sup>th</sup> century to replace the straight internal stairs of the Middle Ages. Synnott evidently replaced this cramped turret with the present structure to accommodate the more spacious and fashionable Victorian stair that still survives, and he also appears to have rebuilt the high-end chimney to incorporate an arched passage linking the new stair to the former lobby entrance (in a standard development of the 19<sup>th</sup> century). The open lower storey of the new turret is an unusual feature that may represent a later alteration.

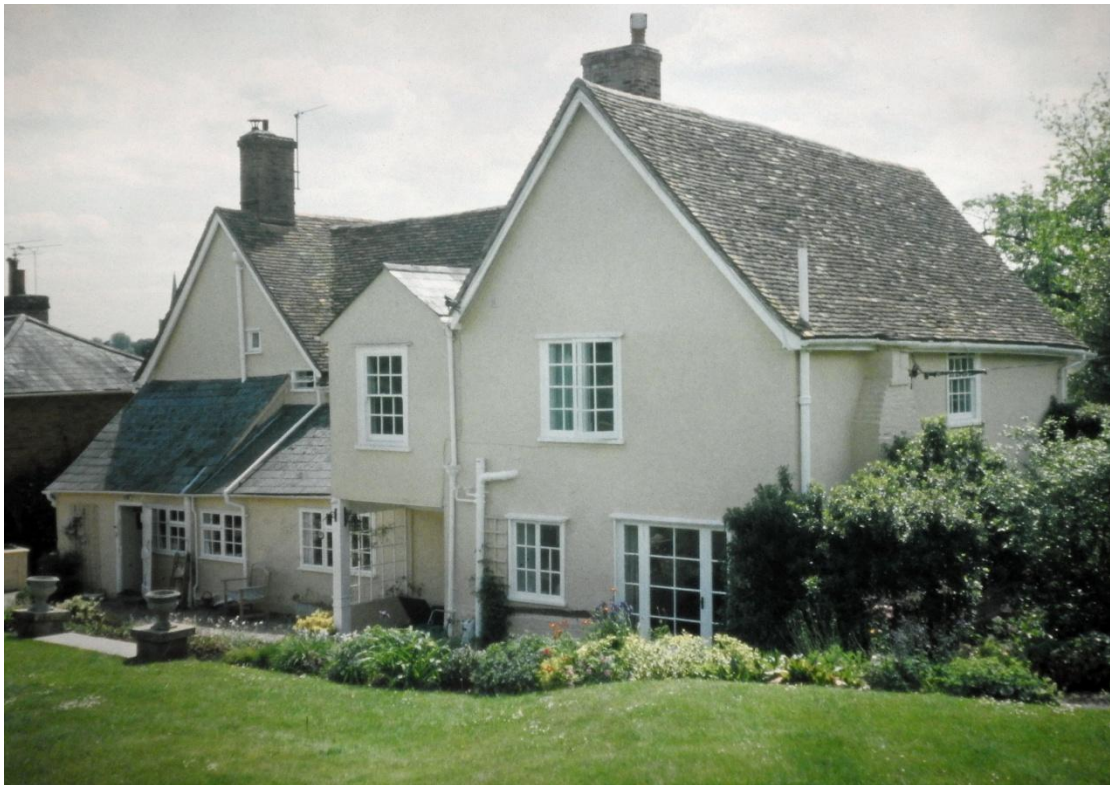
**Figure 10. The rear elevation in 1999, looking much as it does today.**

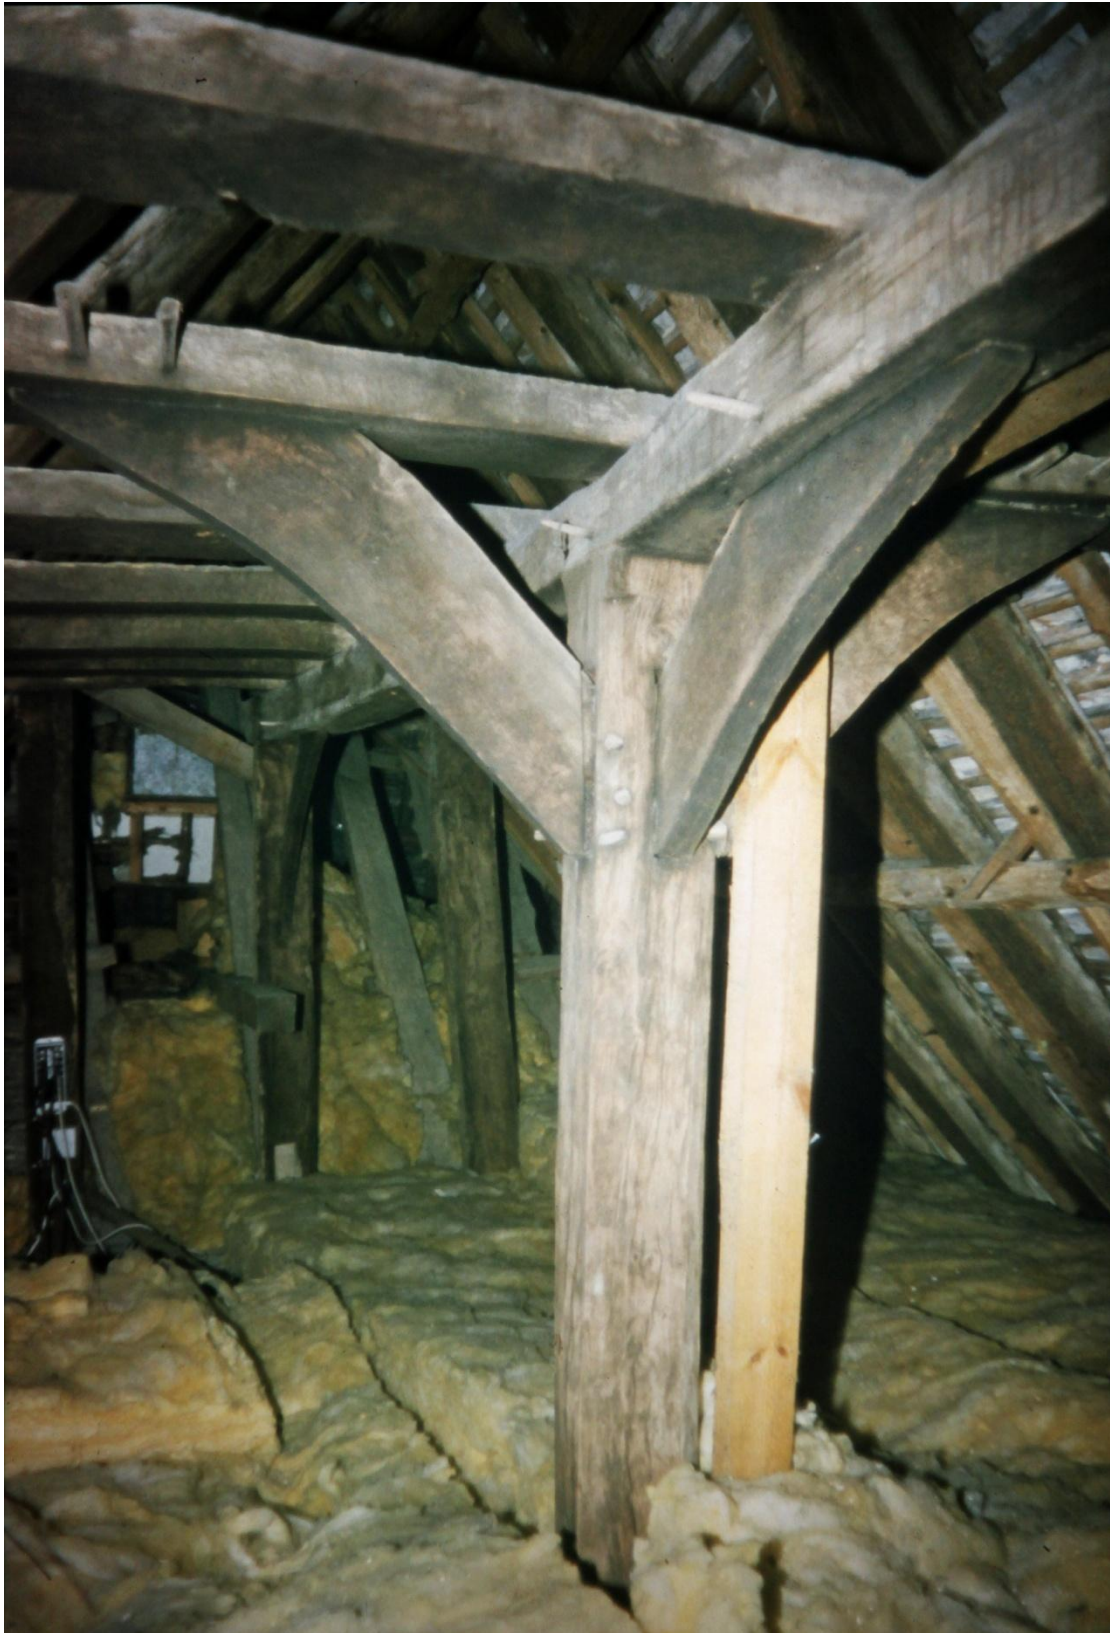
**Figure 11. The plainly chamfered and step-stopped crown-post of the central open hall, as photographed in 1999 from the high end to the north. A modern pine plank has been inserted alongside, and the wattle-and-daub infill of the low-end wall in the rear has been removed to expose the rafters of the service cross-wing. The rafters and other original timbers are all evenly but lightly sooted, suggesting an open hearth was replaced by a chimney within months rather than years.**

The open hall extended to a very respectable 21.5 ft in length by 17 ft in internal width between its roof-plates. It was divided into two unequal bays by an arch-braced open truss that retains its original chamfered crown-post as shown in figure 11. The sooting to this post and the intact rafters is evenly distributed but exceptionally light and suggests the open hearth was quickly replaced by a chimney. Any leakage from an original timber-framed chimney is likely to have been concentrated in a particular area. This unusual feature is consistent with the late-15<sup>th</sup> and early-16<sup>th</sup> centuries when many houses were built with chimneys and floored halls from the outset. The high arch-braces of the open truss formed a flat Tudor arch typical of this period. The wider high-end bay of 12 ft was lit by large diamond-mullion windows in the usual way, and the remains of the rear window are now adjoined by the stair turret (illus. 6 & 18). There is no exposed evidence of the cross-passage but it may have been placed within the service wing rather than the hall as its rear door would then have aligned perfectly with a matching passage in the later lean-to (illus. 17). Both the parlour and service wings were 17 ft in internal width and the former possessed a third bay that projected behind the hall and appears to have formed a separate rear parlour. A plain crown-post survives in its roof with thin braces of standard early-Tudor form. An original partition forms a narrow first-floor compartment of 3 ft to the rear of the service wing that probably enclosed the stair rising from the back of the cross-passage.

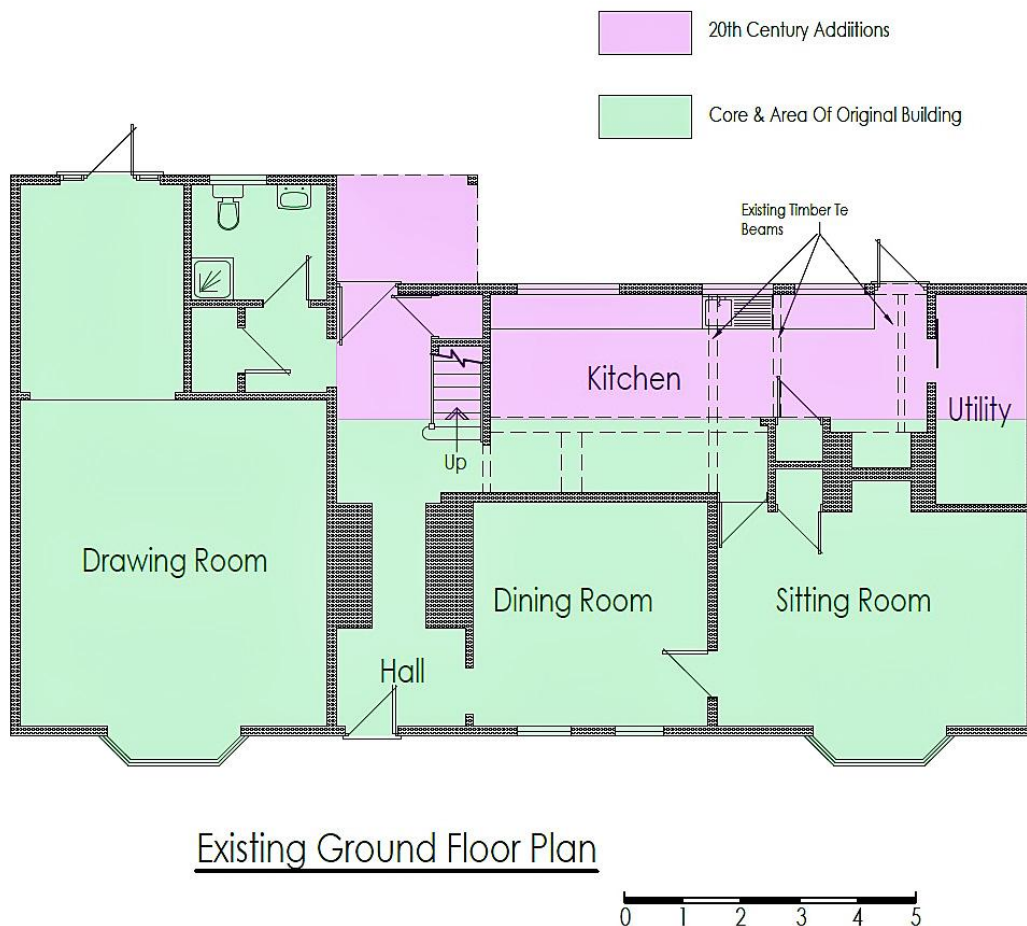
**Figure 12**

A current ground plan of the house by Whymark & Moulton Architects of Sudbury (scale in metres). The timber-framed late-medieval house is coloured green with the mid-19<sup>th</sup> century additions to the rear in purple (wrongly described as 20<sup>th</sup> century on the basis of the inaccurate listing entry below). The entrance hall and dining room represents the original open hall (with the addition of part of the rear kitchen), while the drawing room occupies the contemporary parlour wing and the sitting room the area of the service cross-wing. The original cross-passage may have been undershot (i.e. within the service wing), as it would then have opened into a matching passage in the rear lean-to for which evidence survives in the form of two closely spaced partitions.

The hall would have been provided with a new ceiling and chimney during the 16<sup>th</sup> century, but most of the evidence for these early changes were lost or hidden by a major refurbishment of the mid-19<sup>th</sup> century. This was almost certainly the work of William Synnott who acquired the house in the 1830s and occupied it until his death aged 71 in 1864. He inserted fashionable Mock Gothic panelled ceilings in the dining and sitting rooms (as labelled in

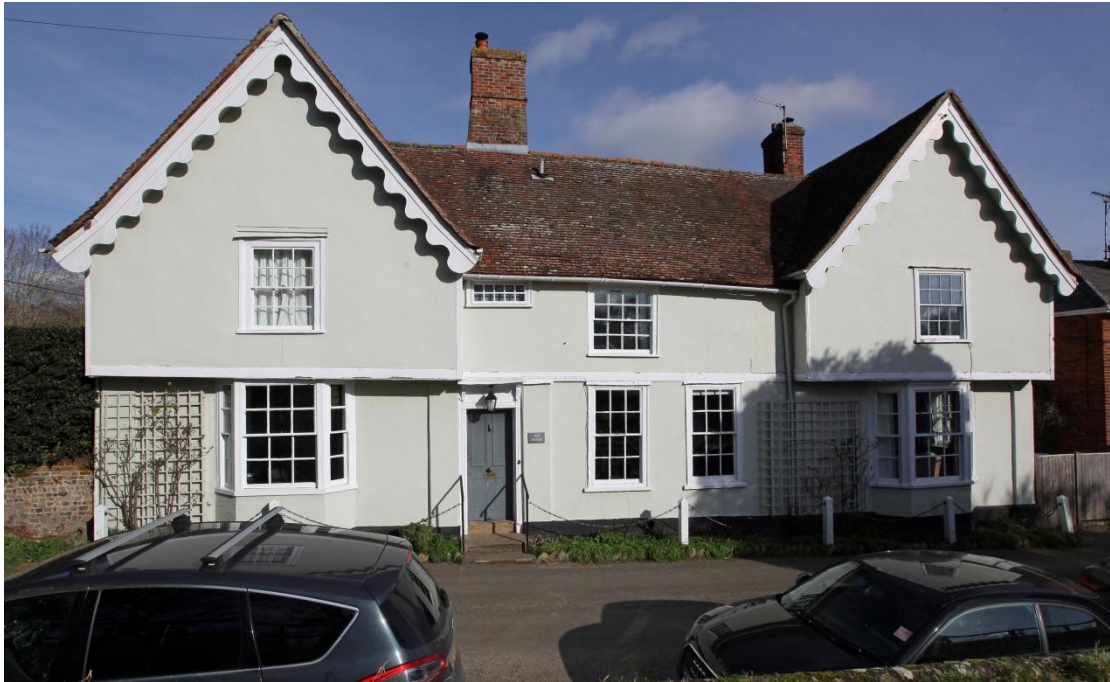
**Illus. 1.** The picturesque south-western facade showing the barn-like open hall in the centre with the jettied parlour cross-wing on the left and the matching service wing to the right. The original cross-passage lay to the right of the hall and probably under the service jetty but was later replaced by a lobby entrance in front of the inserted chimney which heated both the hall and parlour. This chimney was largely or wholly rebuilt along with the brick ground-floor walls as part of a major mid-19<sup>th</sup> century refurbishment that included the reeded door case, sash windows and barge-boards.

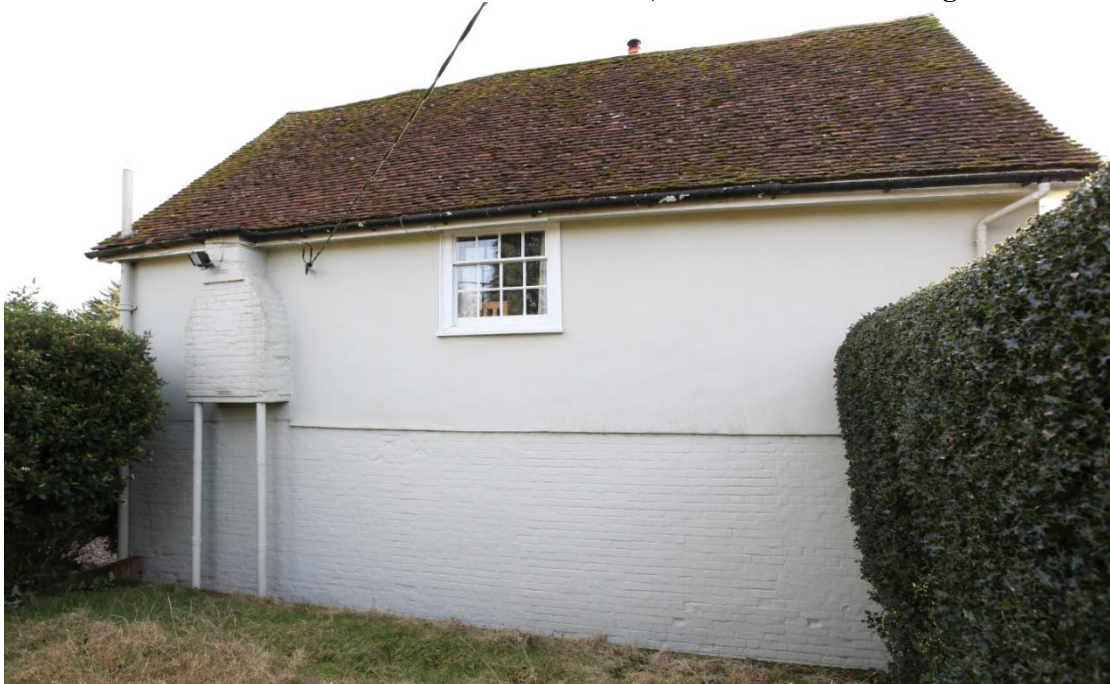
**Illus. 2.** The northern side of the parlour wing showing the Flemish Bond brickwork of its lower storey and a first-floor chimney curiously supported by iron posts. There is no evidence of a fireplace in the brickwork beneath, and it is unclear whether the chimney was designed in this way or was truncated when the lower wall was rebuilt.

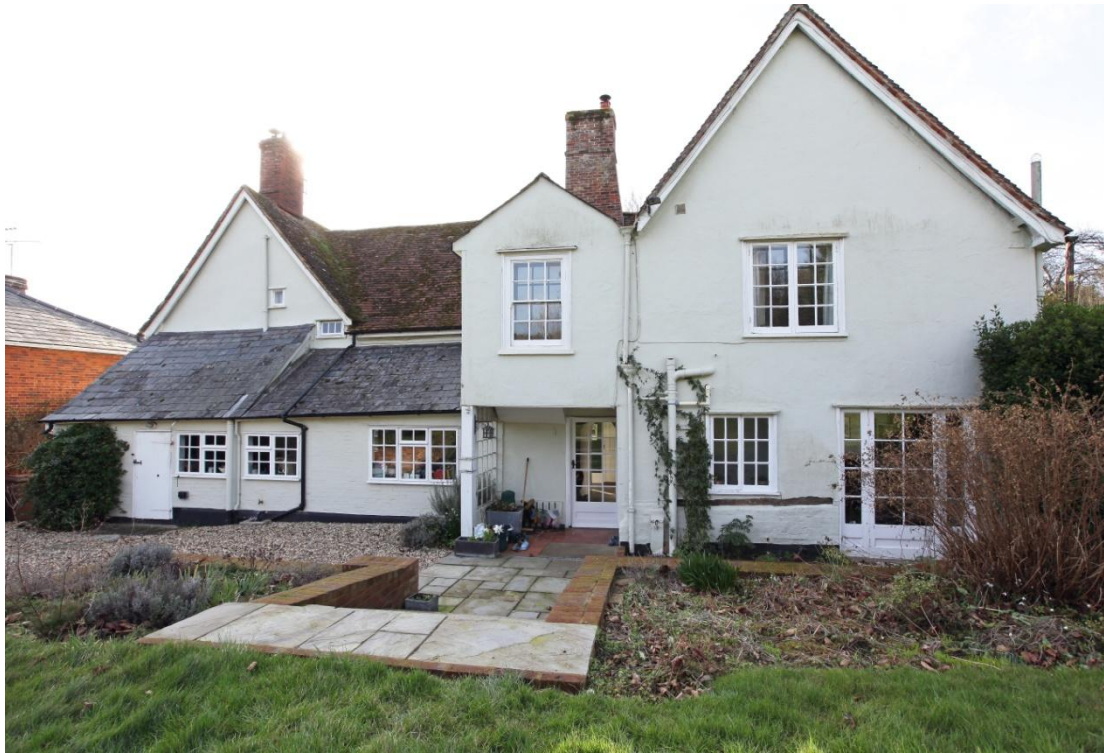
**Illus. 3. The equally picturesque rear elevation with the slate-roofed lean-to additions behind the service wing and hall on the left. The three-bay parlour wing on the right contained an additional room that projected behind the hall and is now adjoined by a stair turret that was extended or rebuilt to accommodate the present staircase as part of the mid-19<sup>th</sup> century refurbishment. The position of this turret is typical of the 17<sup>th</sup> century but it is unclear whether any older fabric survived its extension.**

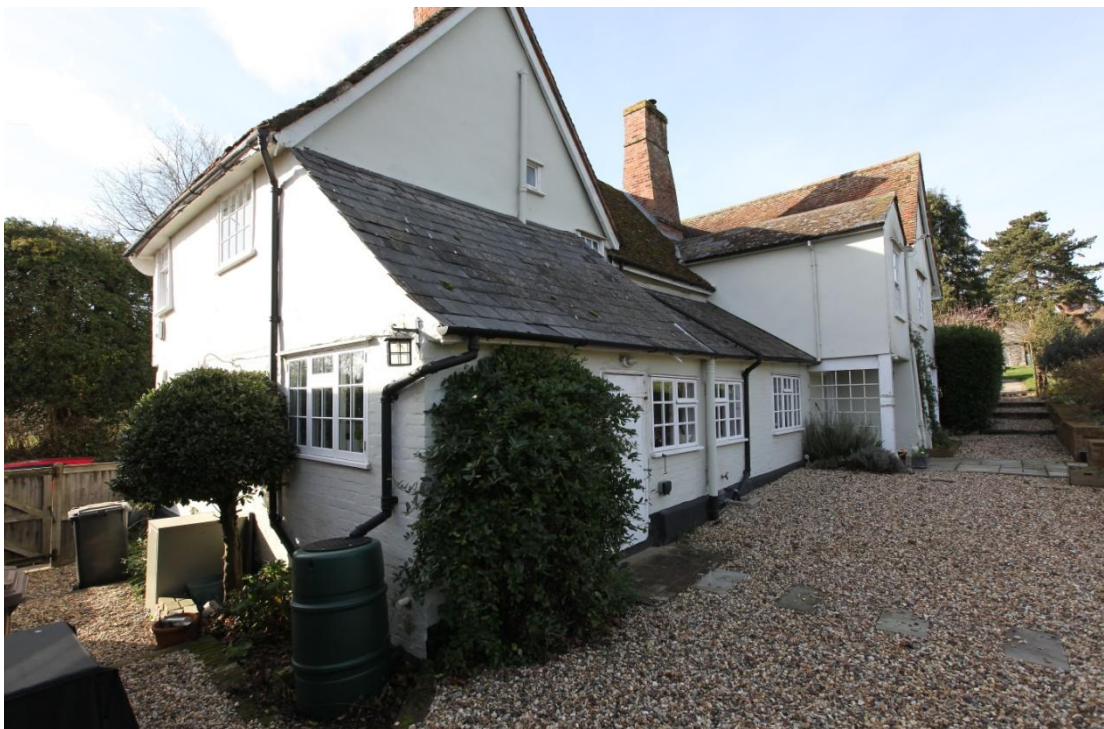
**Illus. 4. The house from the south-east showing the painted brick fabric of the slate-roofed lean-to which appears to be integral to the lower storey of the service wing. The projection of the stair turret and parlour wing in the rear is just as depicted in 1884.**

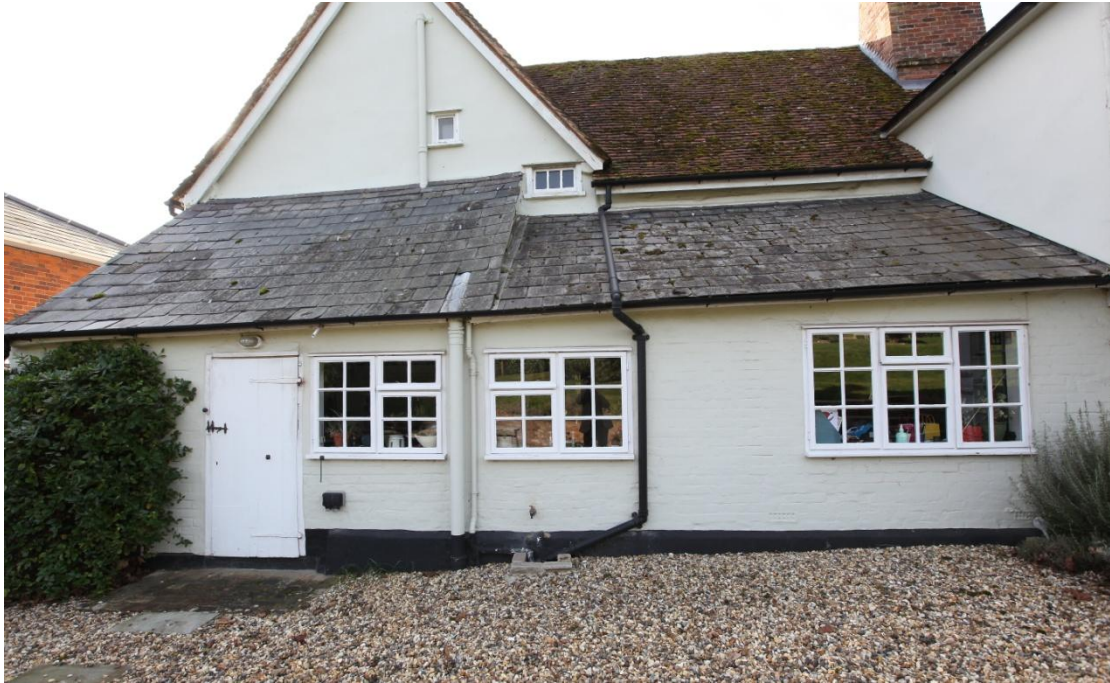
**Illus. 5.** The step in the slate roof of the rear lean-to is not matched by any obvious break in its external brickwork and probably relates to the lower eaves of the medieval hall on the right (rather than indicating two phases of construction). The structure was added in or about the 1840s as part of William Synnott's remodelling. The windows are late-20<sup>th</sup> century replacements and the 19<sup>th</sup> century door with characterful pintle hinges on the left also appears to interrupt the brickwork. The partly removed internal partitions suggest the original door occupied the position of the central window.

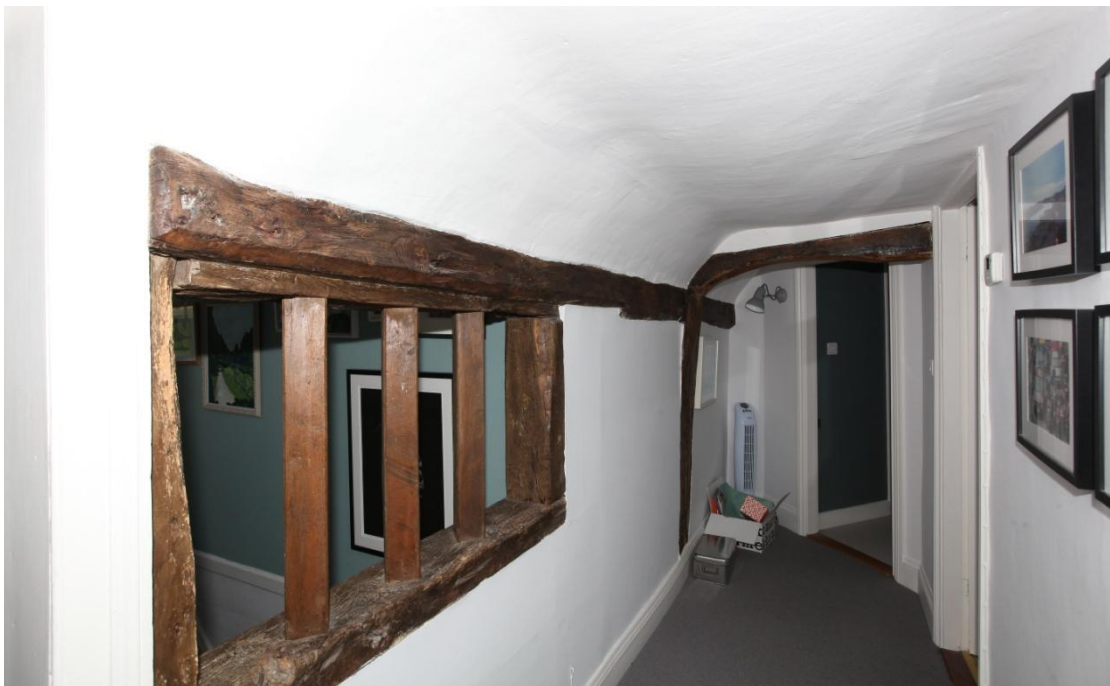
**Illus. 6.** The first-floor corridor to the rear of the former open hall, showing the tie-beam of the open truss carrying the crown post in figure 11 in the rear. The roof-plate on the left contains the shutter rebate and mullion mortices of a tall high-end window that lit and ventilated the hall, but this is now overlapped by the stair turret and its diamond mullions are modern replicas.

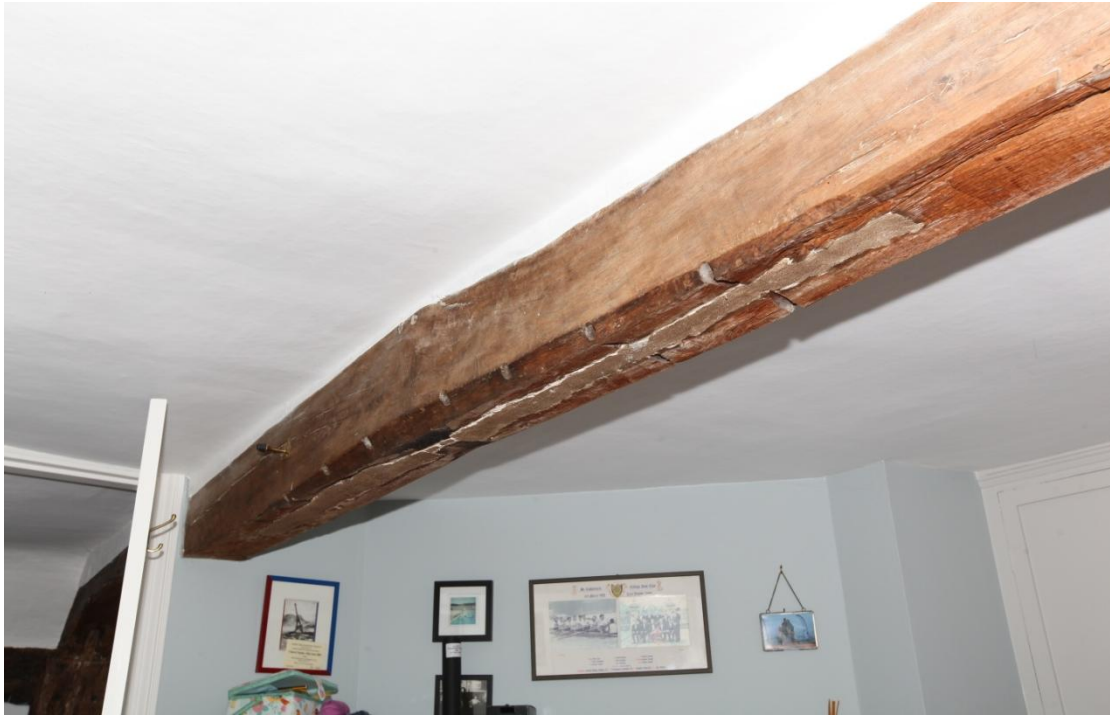
**Illus. 7. The centre of the tie-beam in illustration 6 contains plaster-filled pegged mortices for the missing arch-braces of the open truss. These braces rose from matching mortices in the wall posts and formed a high and relatively flat Tudor arch in the fashion of the late-15<sup>th</sup> and early-16<sup>th</sup> centuries.**

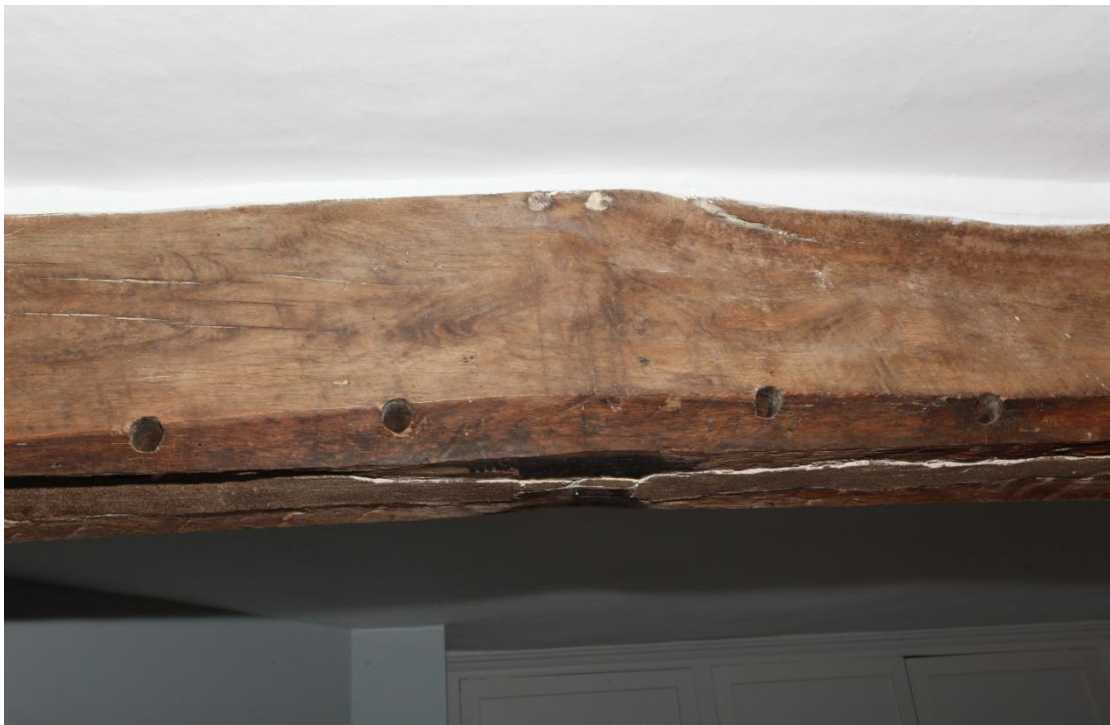
**Illus. 8. A detail of the centre of the tie-beam in illustration 6 showing the narrow gap between the brace mortices and two pegs for the crown-post above (figure 11). The timber bears a 'dagaz' symbol scratched by the carpenter to indicate the timber's best surface, which faces the high end of the hall. Although the timber has been cleaned it has escaped the usual sand-blasting and preserves its original surface with unusually fine deposits of soot from an open hearth. Similar deposits are visible on the rafters.**

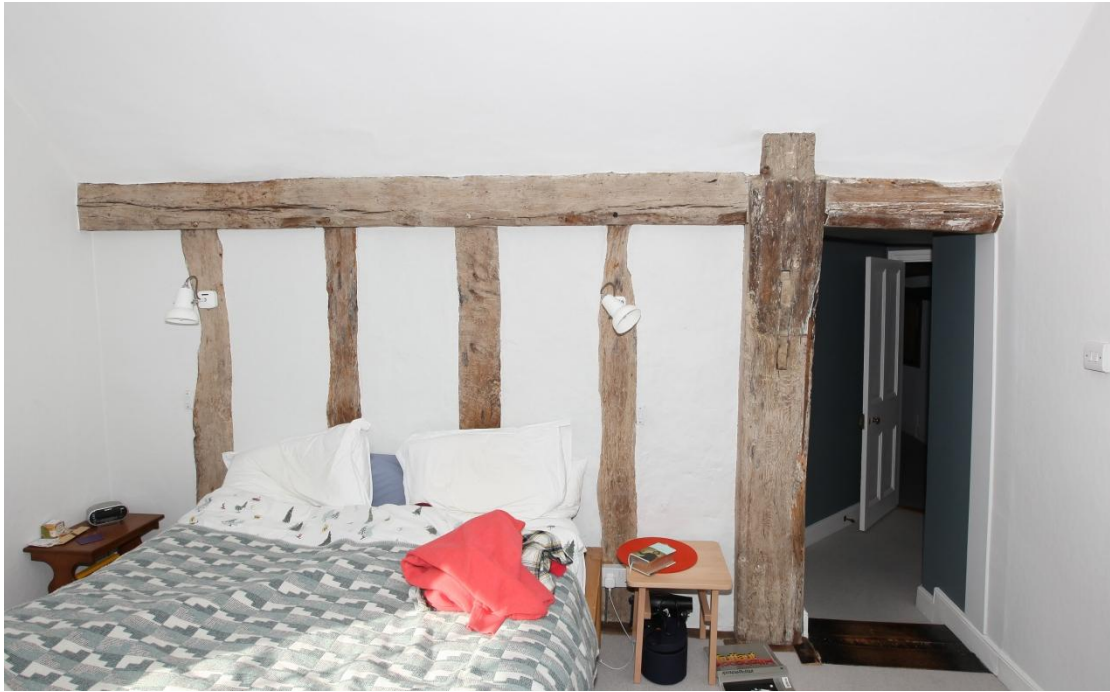
**Illus. 9.** The relatively widely spaced studs of the service cross-wing which are exposed in the first-floor wall of the service chamber adjoining the hall. A mortice for a high arch-brace to a missing tie-beam is visible in the jowled post alongside the present door. This is one of few areas of wall fabric currently exposed in the house and reflects the framing of the front wall (as indicated by the pattern of stud pegs in the hall's roof-plates and the parlour wing's exposed tie-beam). Many merchants' houses of the same period in Nayland contain expensive 'close-studding', with infill panels of no more than six inches, but the builder of Hill House focused on scale rather than ostentation.

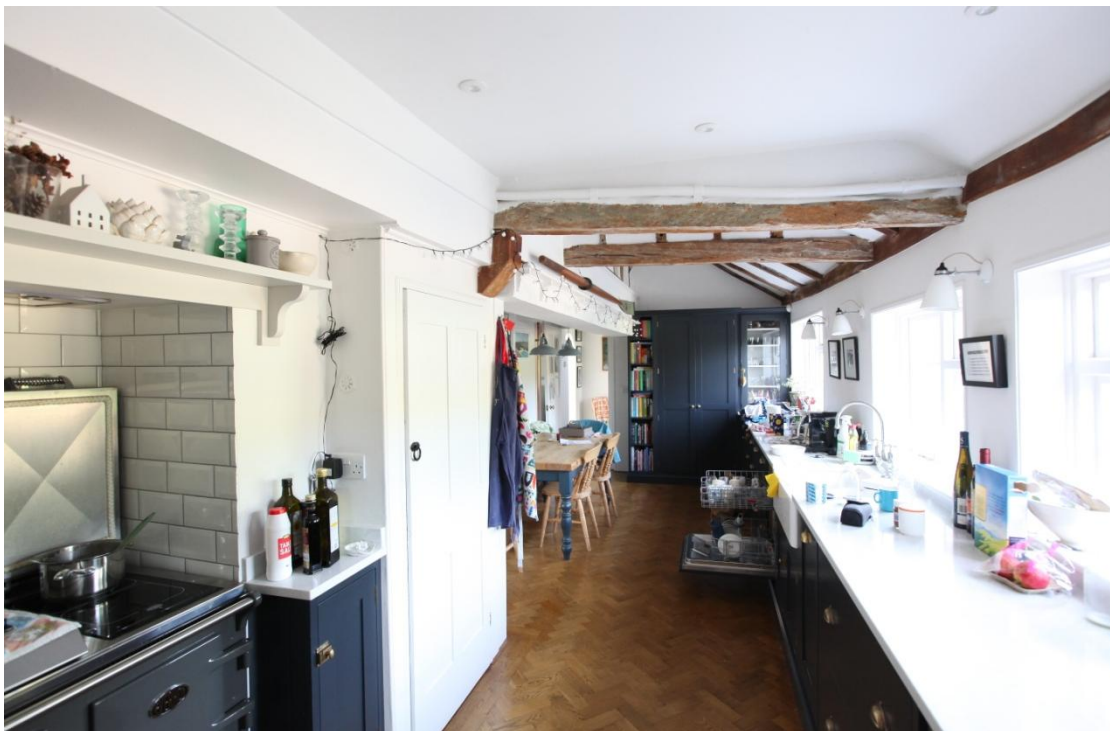
**Illus. 10.** The interior of the rear lean-to containing the modern kitchen from its south-eastern gable. The space is undivided and heated by an inserted 19<sup>th</sup> century chimney in the service cross-wing on the left that probably occupies the position of its original stair.

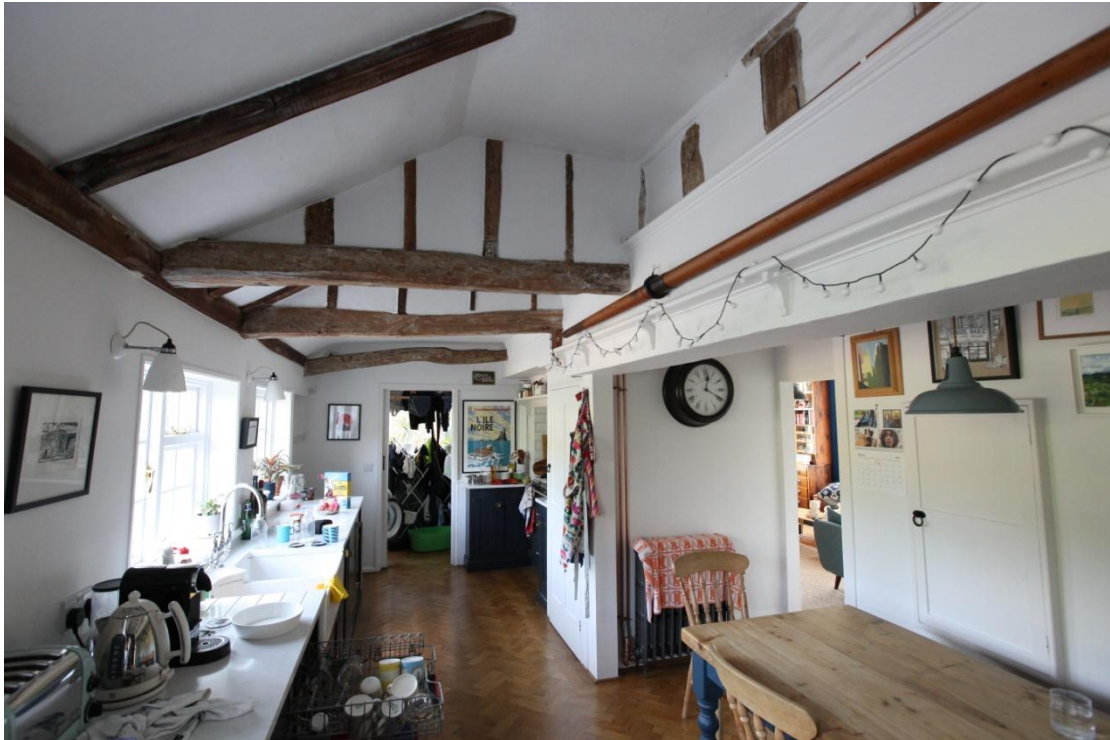
**Illus. 11. The lean-to rear kitchen from the north-west. Little historic fabric is visible internally, with the brick wall on the left concealed by modern plaster. The three tie-beams in the rear are original features, as are most of the vertical studs above, but the exposed roof-plates and rafters are modern replicas. The window on the left is flanked by the tie-beams of former partitions suggesting it occupies the position of an original external door, although there is no obvious evidence of this in the external brickwork.**

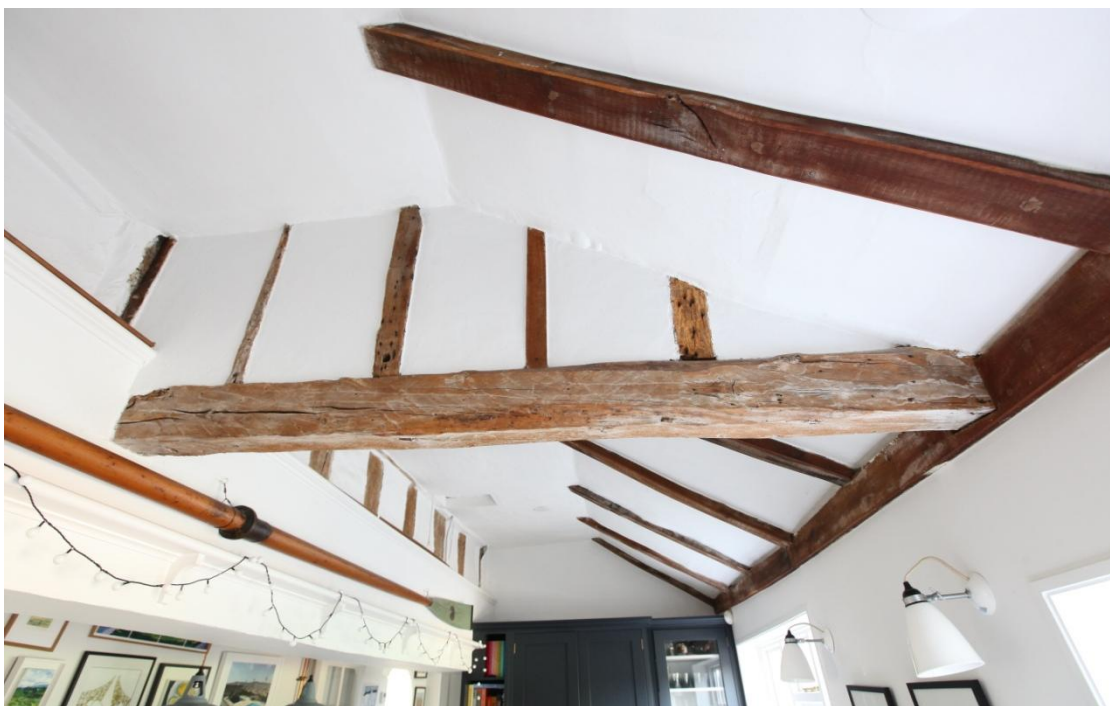
**Illus. 12. A detail of the tie-beam in illustration 11, as seen from the south-east. The timber was formerly hidden by plaster, as indicated by the scars of laths nailed to its sides, and nails for the missing studs of a ground-floor partition are visible in its underside. The false roof-plate and rafters to the right bear modern saw marks.**

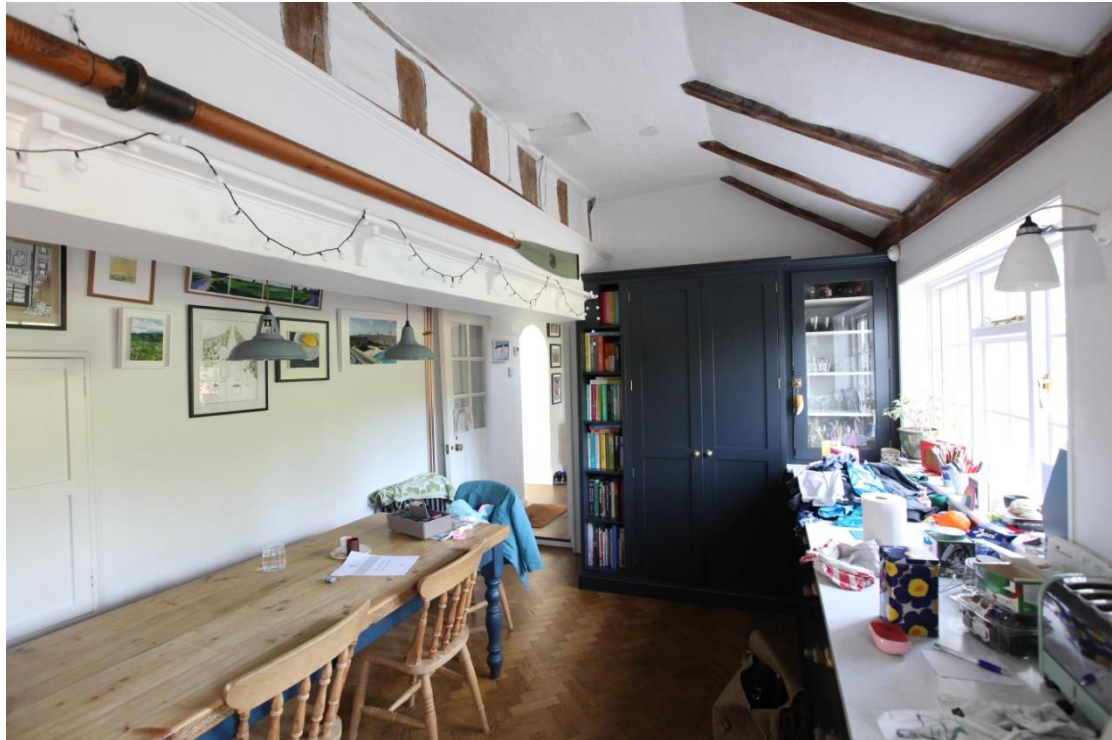
**Illus. 13.** The north-western end of the kitchen showing the modern machine-sawn false rafters to the right and the original weathered external studs of the open hall to the left. The lower section of the hall has been removed to enlarge the kitchen and the surviving studs and post are presumably supported by a hidden RSJ. The false roof-plate and rafters of the lean-to were inserted beneath the sloping plaster ceiling to create a semblance of age, but the original rafters survive above (illustration 16).

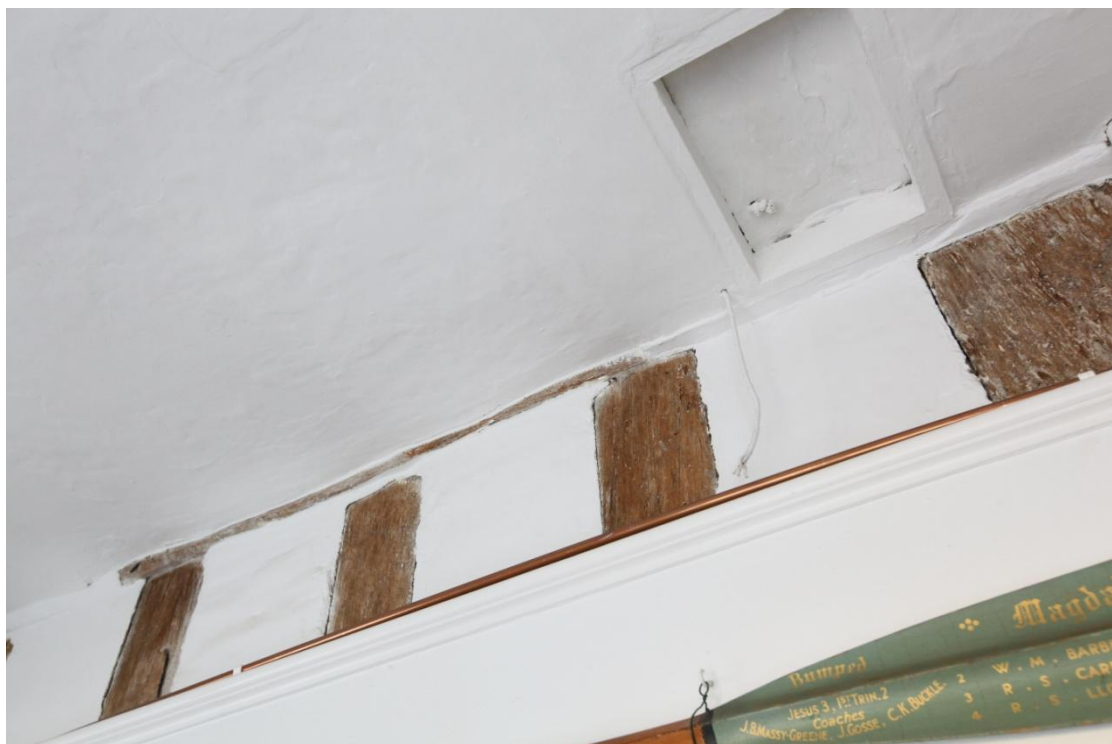
**Illus. 14.** A detail of the weathered studs of the hall's rear wall to the left in illustration 13 showing the nailed rail or clamp supporting the ceiling joists in illustration 16. The undulating lath-and-plaster ceiling is an original mid-19<sup>th</sup> century feature.

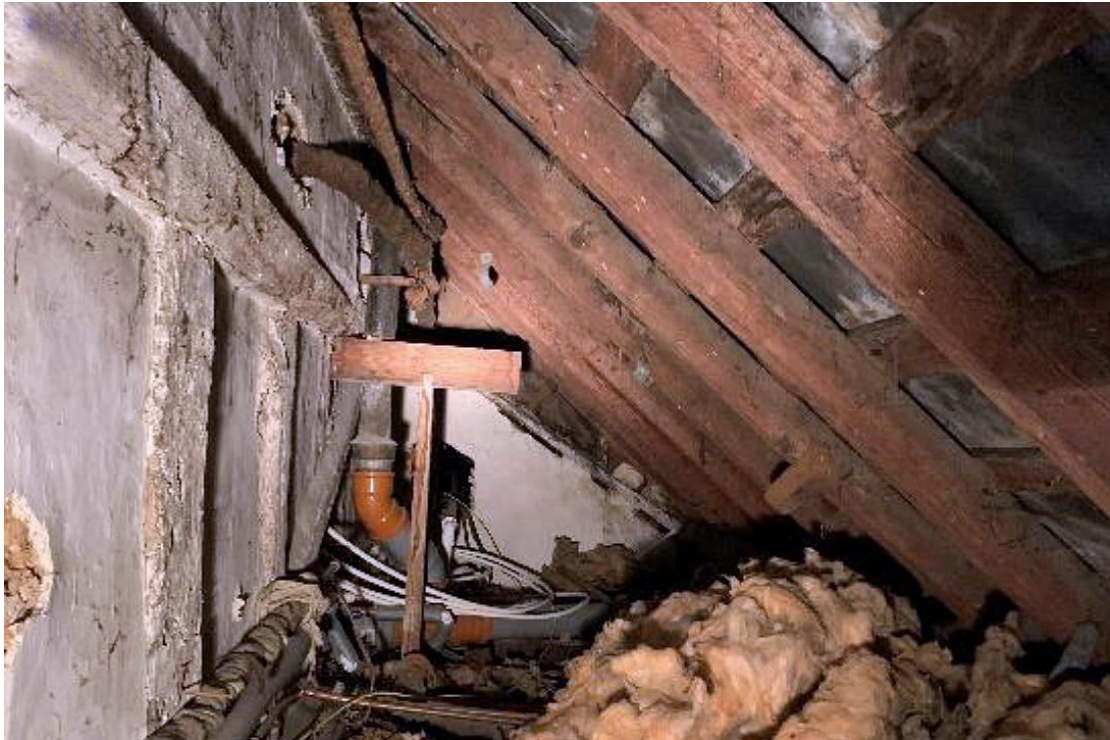
**Illus. 15.** The south-eastern end of the lean-to above the ceiling in illustration 10 (photographed by Odette Robson for her Bat Roost Assessment of March 2023). The roughly hewn hardwood rafters in the rear are typical of the mid-19<sup>th</sup> century and the machine-sawn pine example on the right is presumably a replacement. Unless both the rafters and ceiling joists are secondary, the whitewash of the service wing's gable on the left was exposed externally prior to the lean-to construction.
