# **Hill House**

## **11 Gravel Hill, Nayland, Suffolk**

### **Outline Heritage Asset Assessment**

**February 2024**

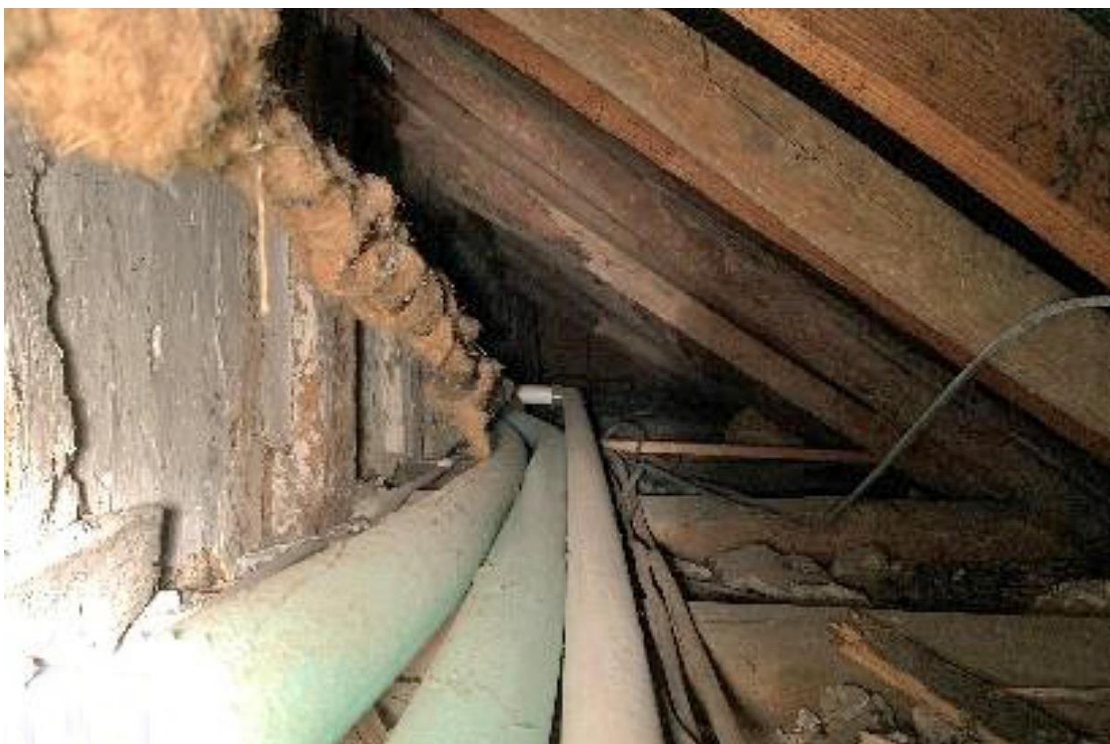
**Illus. 16.** The rafters above the ceiling in illustration 14, with the whitewashed studs of the hall on the left. As in illustration 15, the roughly hewn rafters and ceiling joists in the rear are typical of the 19<sup>th</sup> century while the softwood examples are replacements.

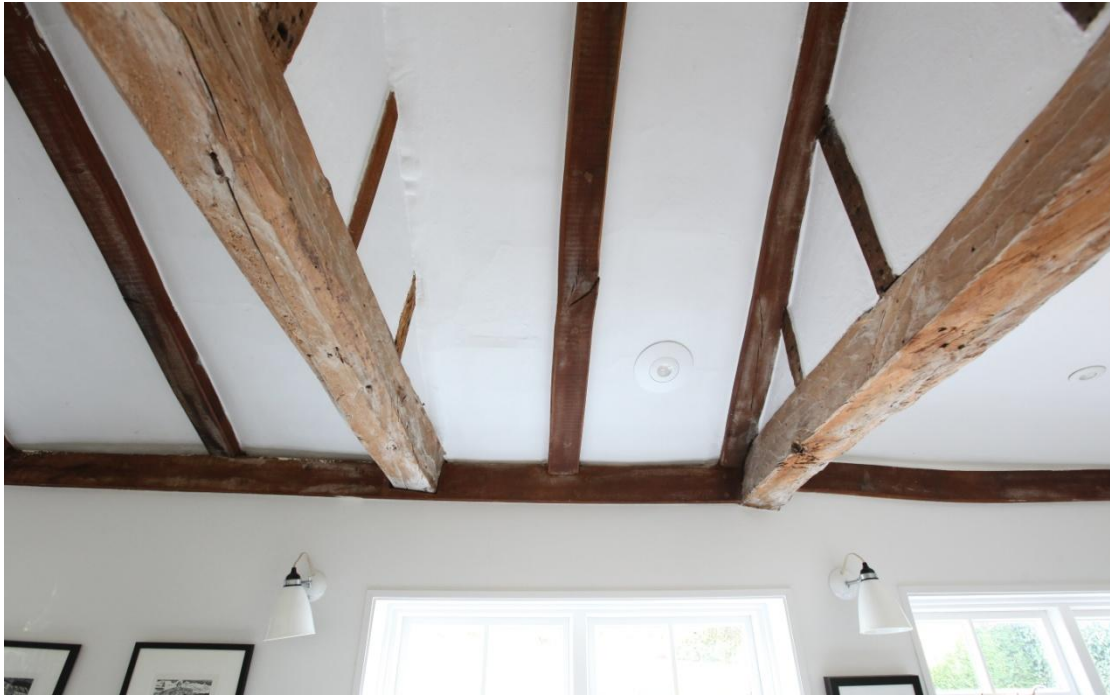
**Illus. 17.** The narrow gap between the original tie-beams in the centre of the lean-to suggests that a rear door occupied the position of the 20<sup>th</sup> century window. Nail holes and scars in the undersides of both timbers indicate the missing studs of two partitions forming a narrow passage that probably linked the external door to the medieval cross-passage (assuming the latter was undershot – i.e. beneath the ceiling of the service wing rather than within the open hall). The exposed rafters and roof-plate are modern.

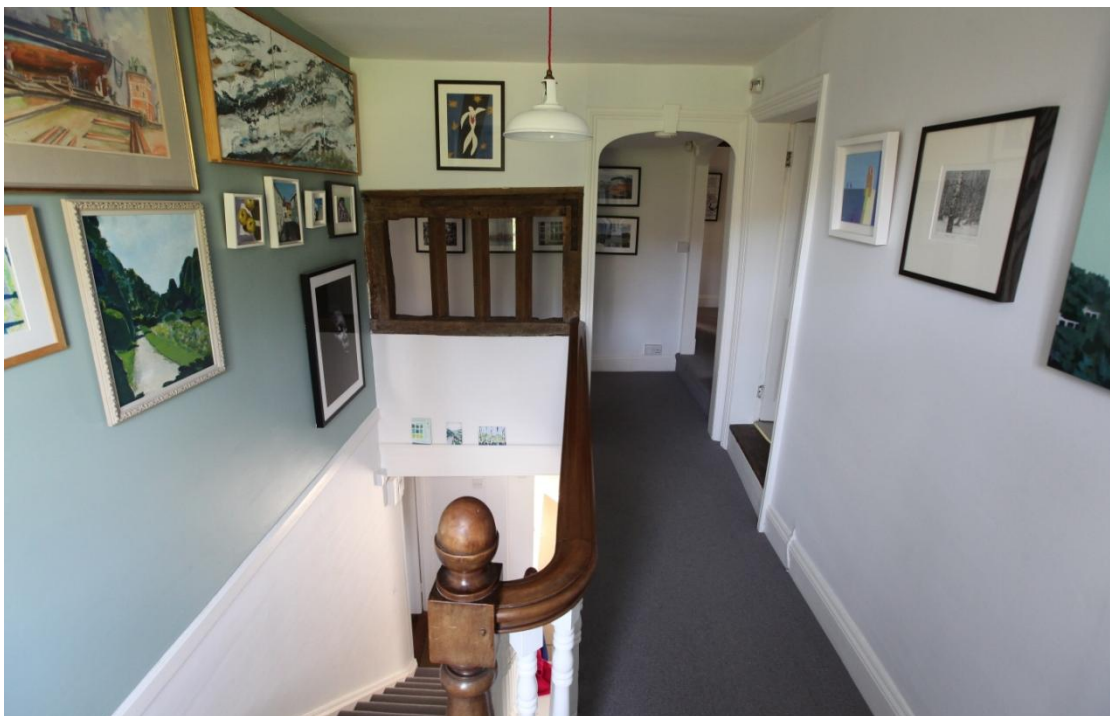
**Illus. 18.** The first-floor stair landing from the rear, showing the heavy moulded mahogany rail of the Victorian stair in the foreground and the modern mullions of the medieval hall window in the rear. A tight spiral stair of the 17<sup>th</sup> century is likely to have occupied the smaller turret depicted in 1838 which was later extended to accommodate the present stair.
