## Bat and Barn Owl Assessment

### Commercial Properties at Penzance Harbour

Bat and Barn Owl Assessment – CEC4079 – Penzance Harbour

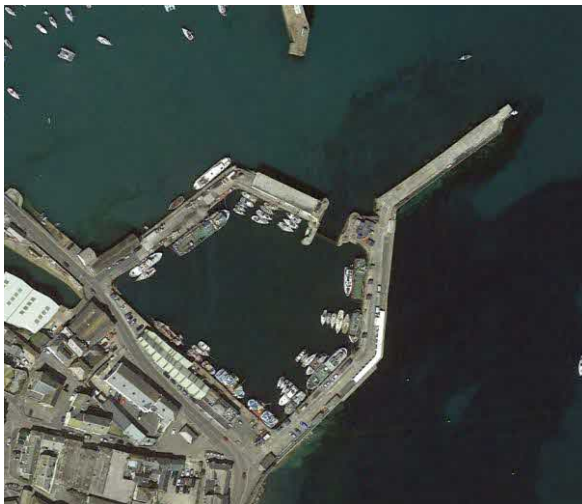
*Figure 1: Aerial view of site*

- The Waterside Meadery
- Penwith Marine services
- Boat Repairs and Marine Supplies
- South Pier Public Toilets
- The Rank Building

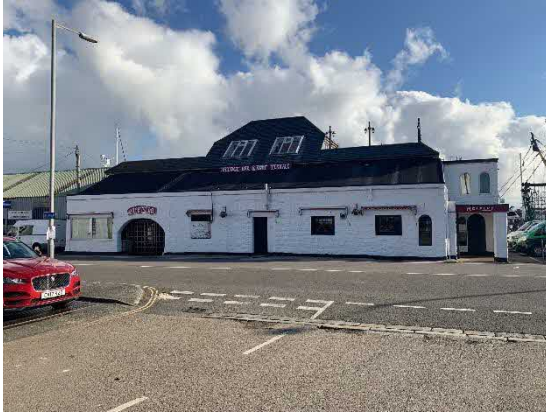
*Figure 2: The Waterside Meadery*

A three-storied restaurant constructed from rendered cavity block wall, slate roof with a non-breathable membrane, wooden fascia boards with metal ventilation plates. The first floor ceiling on the south western elevation is partially vaulted on the south western elevation and has a pitched roof covered with roofing felt.

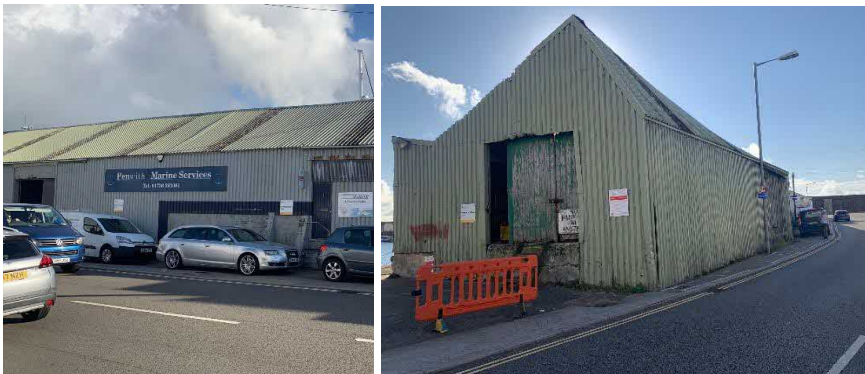
*Figure 3: Penwith Marine Services*

The Penwith Marine Services building is constructed from a wooden frame clad with corrugated metal sheets and a pitched corrugated metal roof. There is a partition wall dividing the area from the damaged section of the building at the northern end of the building. This northern section has damaged sections of corrugate metal sheeting in the roof.

An old pigeon *Columba livia* nest was found within the northern section of the Penwith Marine Services building and the floor and joists have significant amounts of bird droppings throughout the section. Although no current sign of nesting birds was recorded within the building at the time of the survey, if the works are to be carried out within the bird breeding season (March to September) the building should be searched for nesting birds. If nesting birds are present, works should not commence and further advice sought from Cornwall Environmental Consultants (tel 01872 245510) or Natural England (tel 01872 245045) as the nests and eggs of all wild birds are protected against taking, damage or destruction under the Wildlife and Countryside Act 1981

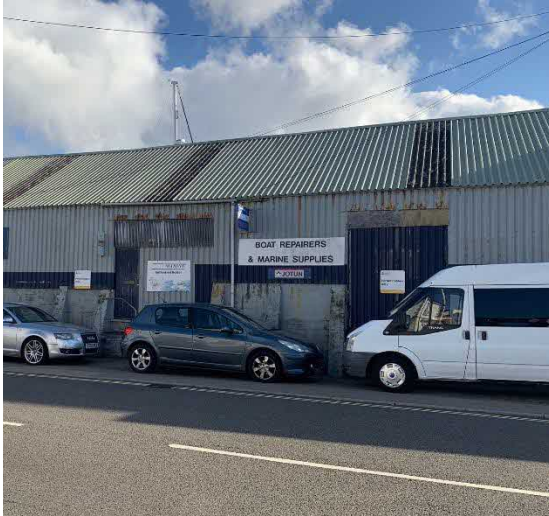
*Figure 4: Boat Repairs and Marine Supplies Building*

The building is constructed from wooden frame clad with corrugated metal sheets and a pitched corrugated metal roof, internally there are some walls dividing the area between the Boat repairs and Marine supplies area, harbour storage and Penwith Marine services sections.

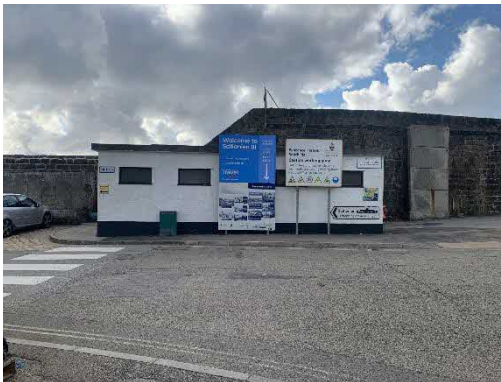
*Figure 5: South Tier Public Toilets*

The toilet block is constructed from single skin block with a rendered exterior and a concrete roof covered with roofing felt.

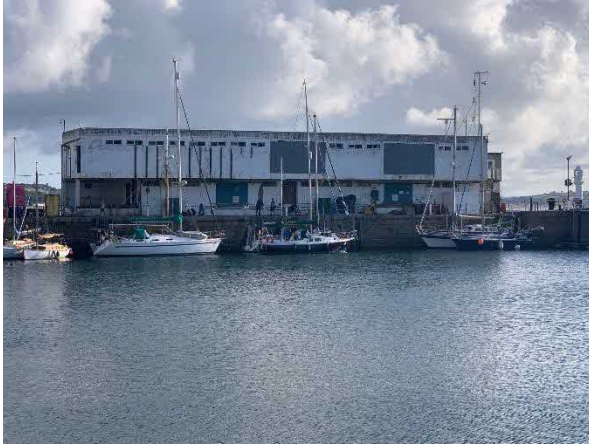
*Figure 6: The Rank Building*

This building is constructed from reinforced concrete panels for the walls and roof, leaving no crevices suitable for bats. The floors, walls and stored materials were searched in case of access via the windows or doors left open.
