# Phase II Ground Investigation

Penzance Harbour Modernisation Scheme

<b>Client</b>	MWJV Ltd
<b>Project Title</b>	Penzance Harbour Modernisation Scheme
<b>Document Title</b>	Phase II Site Investigation
<b>Document No.</b>	SI21155/PH2

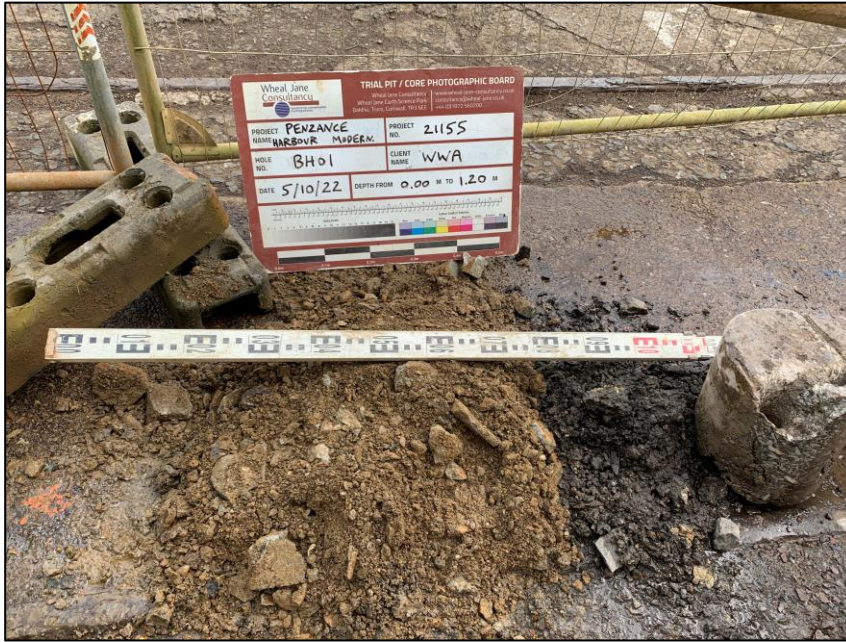
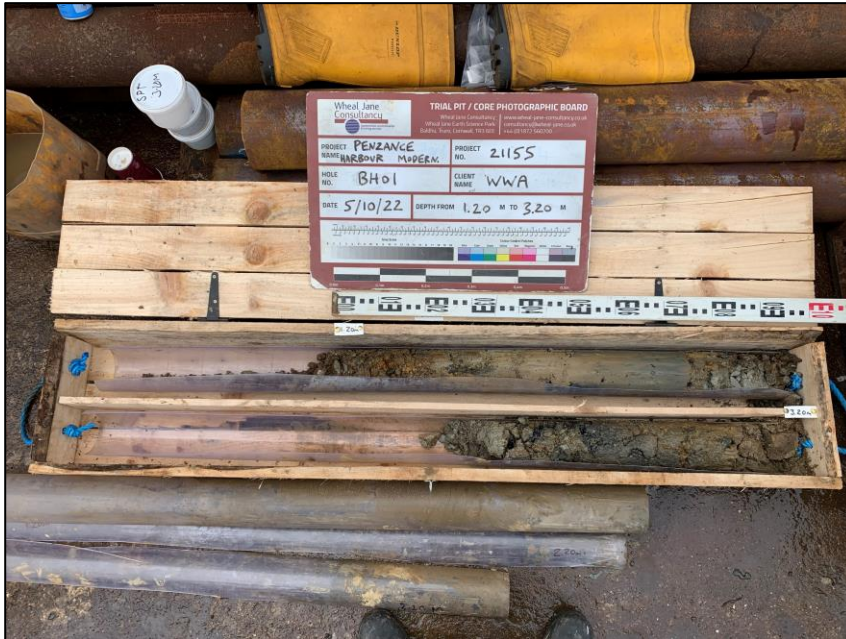
BH01 0.00-3.20m

- 3.3.1 Three (3 No) Rotary Boreholes, designated BH01 – BH03 inclusive, were advanced to depths of between 9.00 – 10.30mBGL using a Comacchio 205 drilling rig on 5<sup>th</sup> – 10<sup>th</sup> October 2022.
- 3.3.2 All boreholes were advanced using rotary percussive techniques until refusal, at which point rotary coring commenced.
- 3.3.3 The drilling equipment on this particular contract utilised air-mist as the flushing medium.
- 3.3.4 The locations of all Rotary Boreholes can be seen on the exploratory hole location plan, contained as Figure 3.1.
- 3.3.5 Logs are contained within Appendix A, and core Photographs are contained as Appendix B.
- 3.3.6 All boreholes were backfilled with bentonite.
