## Preliminary Ecological Assessment – 1 Great Close, Culmstock, Cullompton, Devon, EX15 3HQ.

### Terms of Reference

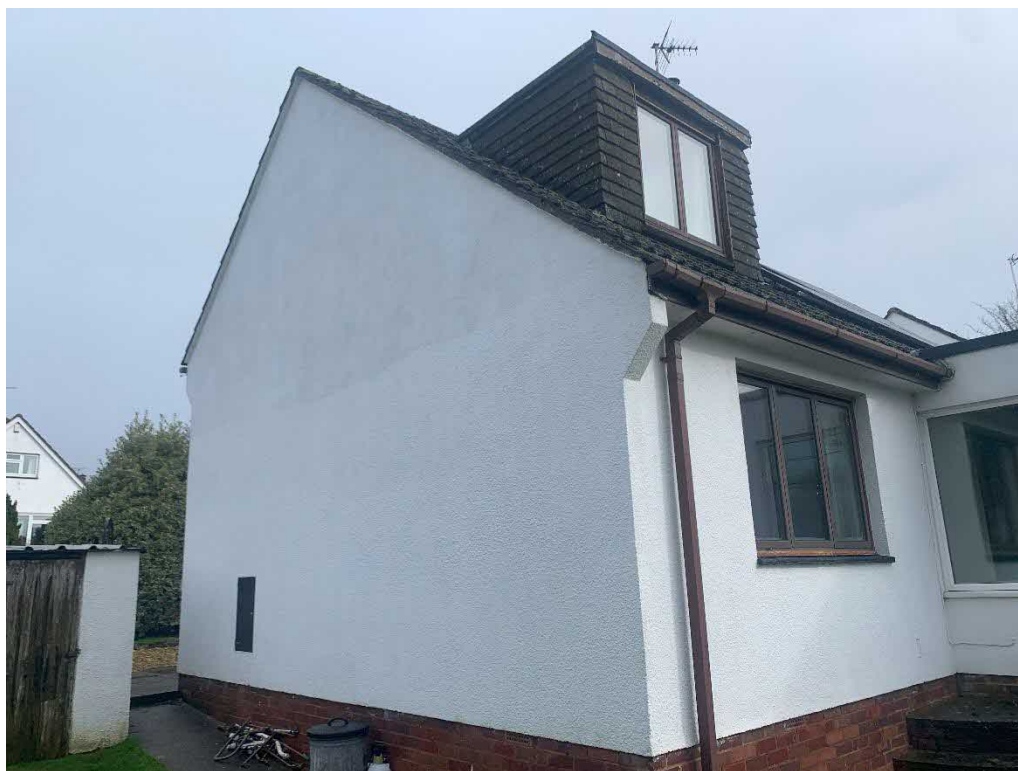
To the rear of the property on the southern side there is a large dormer type window clad in flat, composite hanging tiles to suit the existing roof covering. The western gable end of the property currently comprises a rendered wall without windows. The wall tops are secure along the gable end, with the cement fillet beneath the roof tiles having been inspected and found to be intact throughout its length, such that there were no opportunities for wildlife ingress. The dormer window, ridge tiles and wall-tops around the property are also in good condition without obvious entry points for wildlife.

In so far as bat presence, the exterior of the property was surveyed by eye and using binoculars along the length of the wall-tops, with especial attention paid to the western gable end and roof areas throughout. There was no evidence of any bat droppings along the wall-tops or elsewhere around the property that would indicate likely bat presence and no potential points of entry. Coupled with the lack of any indications of bat usage within the loft area, then bats are not considered to be present and are not a constraint to the works planned. Currently, no mitigation is required.

**Photograph 1:** Existing western gable end of 1 Great Close, Culmstock property.

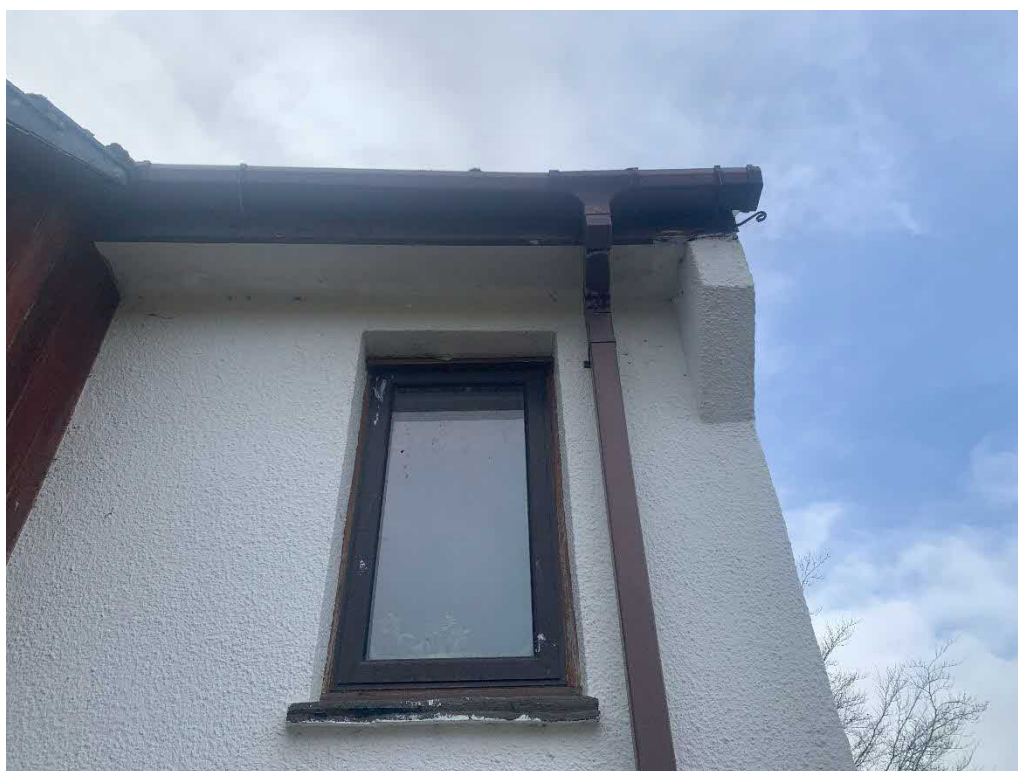
With regards to breeding birds, the double ridged pan tiles present on the roof of the property were all tight fitting and secure, without breakages. The wall tops around the property were also secure without any potential ingress for wildlife, see *photographs*. There was no evidence of breeding birds using the property, either outside of within the loft space and without obvious entry points, breeding birds are not considered to be a constraint to the plans proposed.

**Photograph 2:** Typical wall-top detail showing well-maintained nature of the property and lack of potential ingress for wildlife into property.

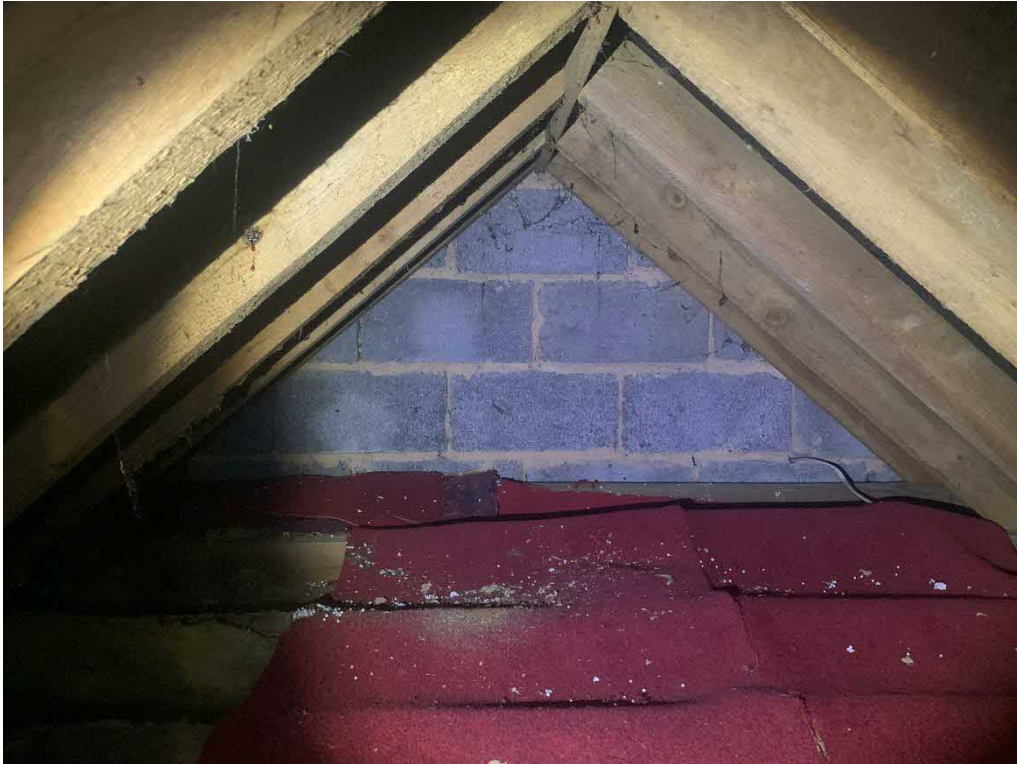
An internal loft inspection was undertaken at the time of survey which documented a small, continuous, low loft space (height circa 1 metre given the dormer type living accommodation below) that extends along the entire length of the property. There are traditional wooden rafters and central ridge-board present, covered in a traditional bitumen type under-felt, typical for this age of property.

**Photograph 3:** Internal view of loft space showing low ridge height.

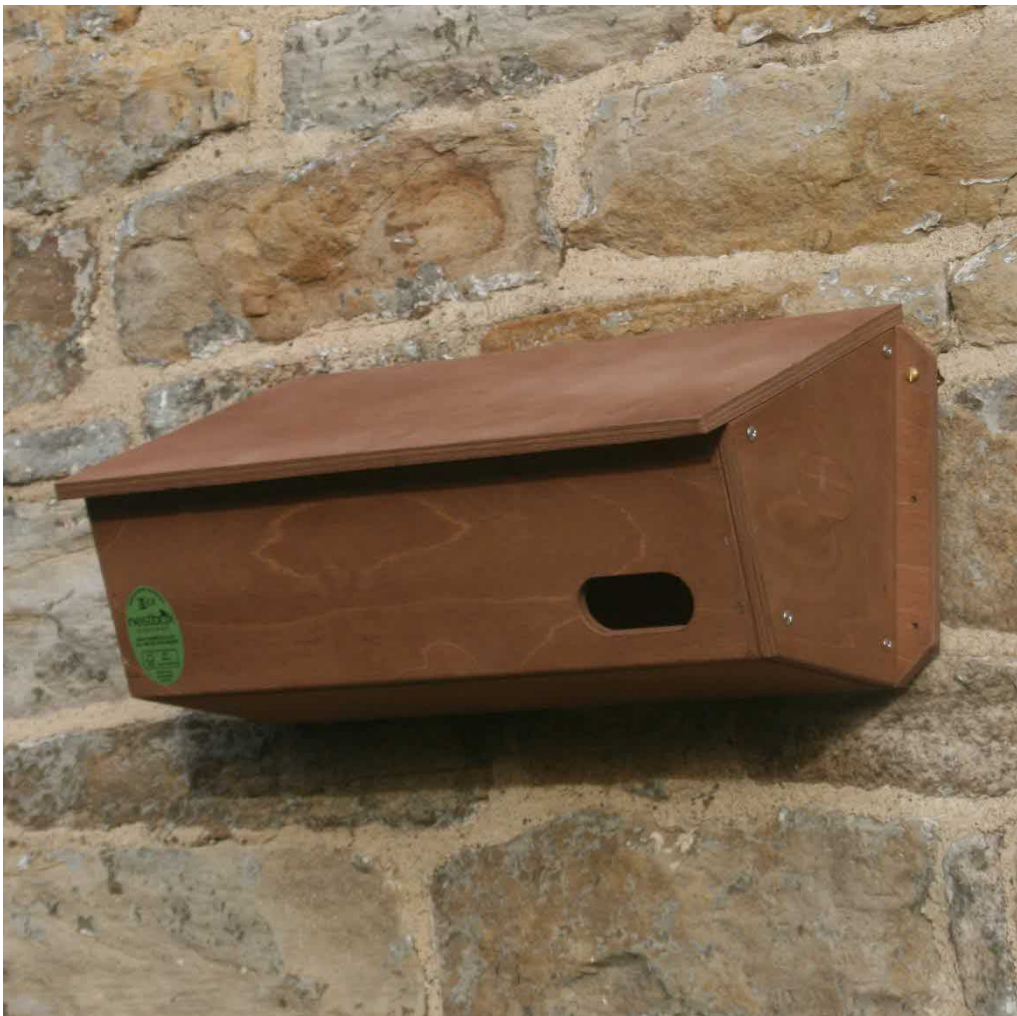
**Photograph 4:** Type of retro-fitted swift box to be placed on new western gable end to provide a general bird nesting enhancement (these types of boxes are used by a variety of species).

In accordance with NPPF guidance we would suggest a biodiversity enhancement through the provision of one retro fitted swift box to the new western gable end of the proposed extension, a type of bird box that provides nesting opportunities for a variety of species. We would consider that an in-built bird box would not be suitable on an exposed western facing elevation. Given the low level eaves on both the northern and southern elevations of the bungalow, the western elevation poses the most suitable location. This approach can be seen to work well on the adjacent property to the east in which similar nest boxes are likely being used by House Sparrows.
