**Robin Cottage,
Reading Road,
Mattingley, Hook,
Hampshire,
RG27 8JZ**

Phase 1 Daytime Bat Assessment

PHASE 2 BAT SURVEY

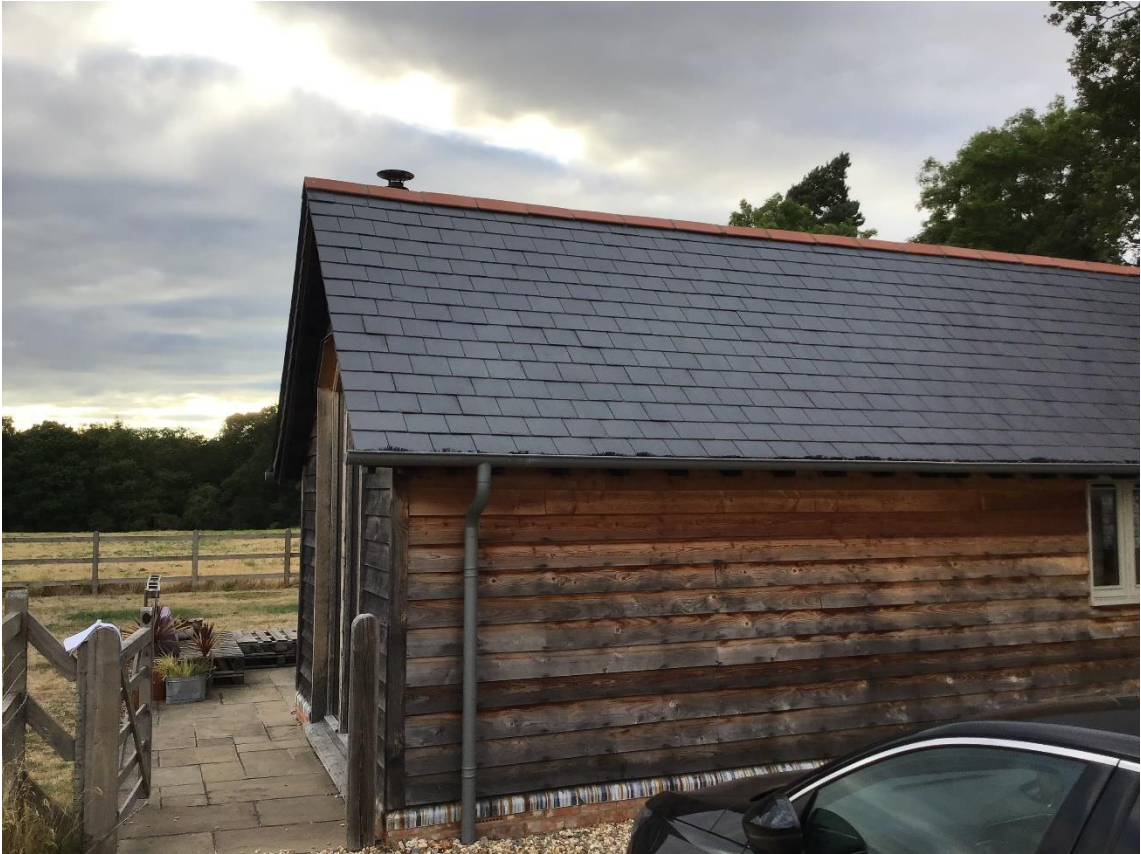
Figure 1. Eastern elevation of South wing of dwelling looking west.

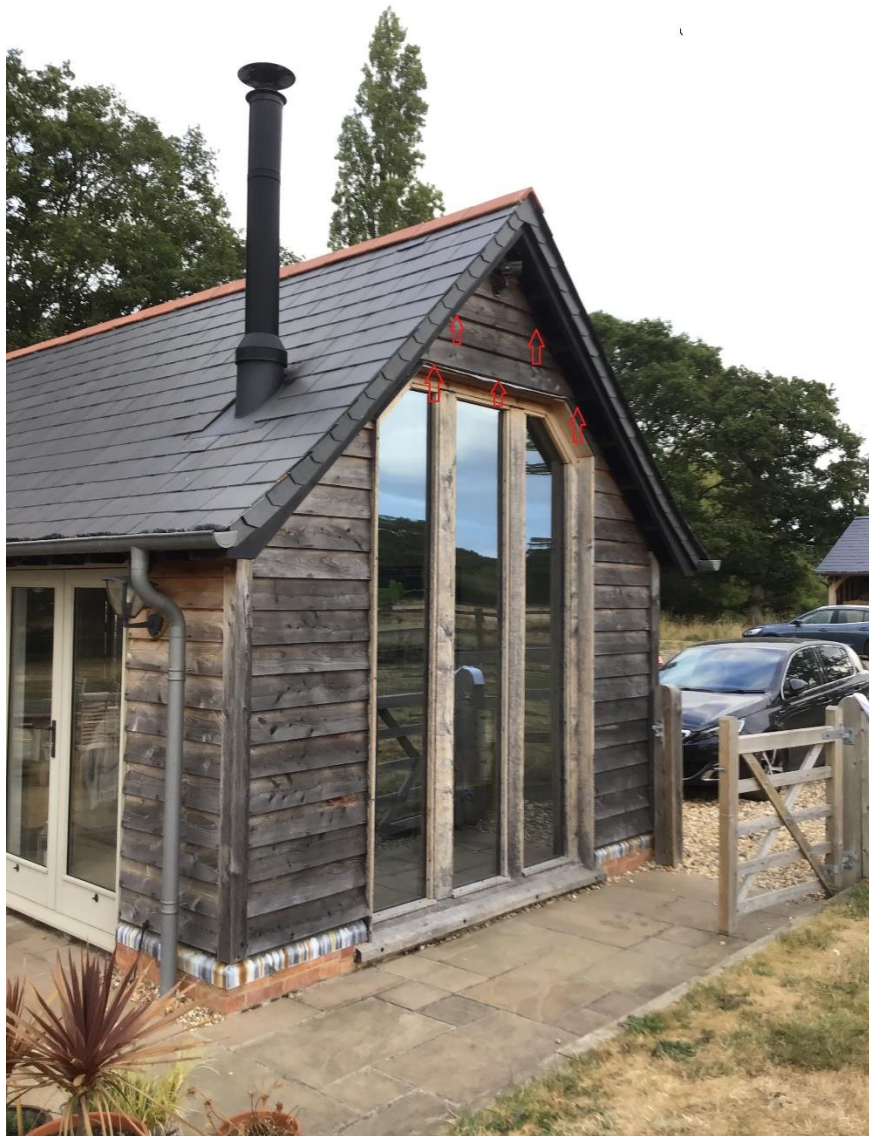
The south gable to which the proposed development would be connected has ship-lap planking which has some small gaps along the upper edges against the under-eaves. These are sufficient for bats to enter the space beneath (see figure 2)

Fig 2. Southern elevation looking north. Red arrow indicate potential access points for bats.

There are a few potential openings into the wall facing woodwork and around the door and window framing. Therefore, the structure has low potential for roosting bats and a phase 2 bat survey is recommended to elucidate the current state of useage by bats.

A programme of dusk emergence surveys is required to confirm whether bats are utilising the building.
