Project Title
**Honicknowle Youth Centre,
Honicknowle Green, Honicknowle,
Plymouth, PL5 3PX**

Drawing Title
Existing plan

Project Number	RIBA Stage	Drawing number	Revision
2325	3	L02 01	00

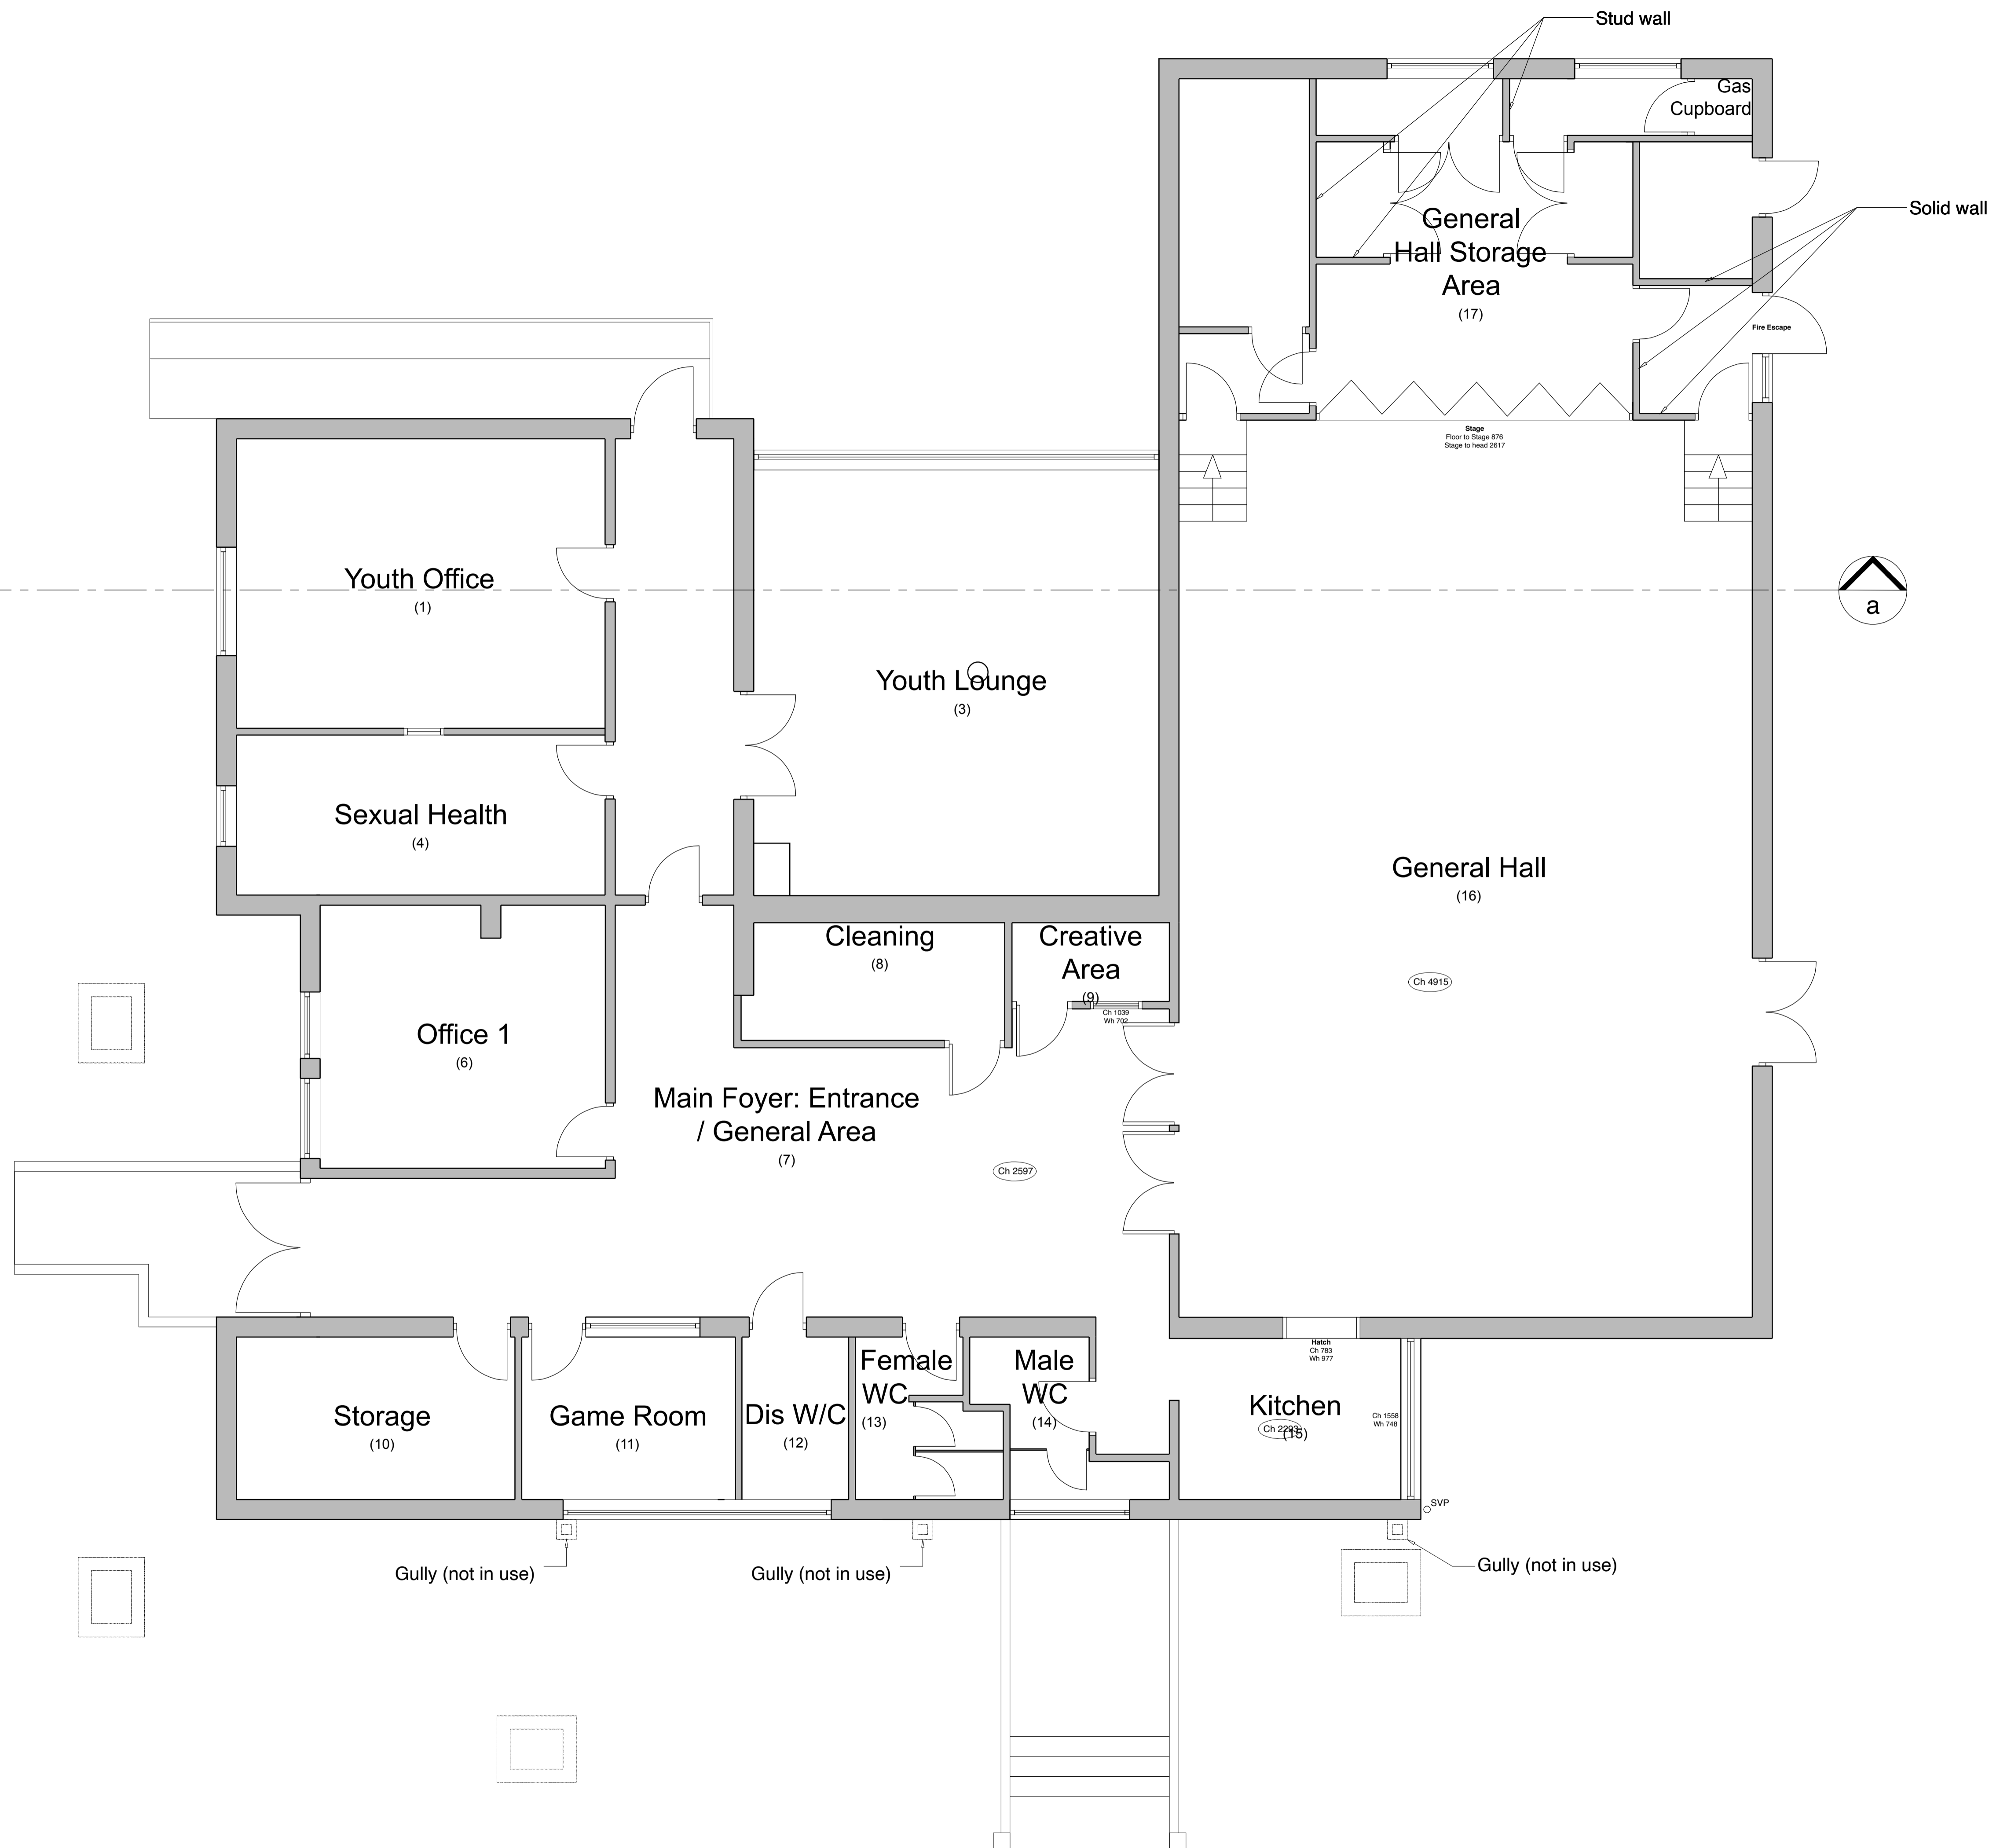
- 1) All site levels approximate only.
- 2) Notes regarding condition of existing rooms;
 - Youth Office [Room number 1]
Carpet ripped, uneven - trip hazard
Some damage to walls, blockwork showing

- Corridor (to Youth Office - Youth Lounge) [Room number 2]
Damage to small area of flooring
Water damage on walls, some areas not plastered, showing blockwork

- Youth Lounge [Room number 3]
Flooring water damage (moldy)
Some areas have water damage on walls
 - Sexual Health [Room number 4]
Carpet ripped, uneven - trip hazard
Some damage to walls, areas of no plaster, blockwork showing

- Office [Room number 6]
Ceiling tile - some water damage
 - Main Foyer: Entrance / General Area [Room number 7]
Flooring patched up (decorative), Entrance carpet - small rod exposed through carpet, trip hazard.
Walls, some areas of water damage.
Ceiling tile damage.
Exposed pipe work - walls, some areas of water damage

- Creative Area [Room number 9]
No comment
 - Storage [Room number 10]
Box in electric box
 - Game Room [Room number 11]
Walls damaged - patch up, uneven
 - Disabled W/C [Room number 12]
Female W/C [Room number 13]
Male W/C [Room number 14]
Walls damaged - damp, plaster coming away, exposed pipe works

- Kitchen [Room number 15]
No comment
 - General Hall [Room number 16]
New Flooring needed
Wall damaged
Roof tiles damaged
 - General Hall Storage Area [Room number 17]
Flooring, uneven, tiles lifted - trip hazard
New Storage cupboard/shelves required
