PROJECT SEGL21
Scotland England Green Link 2
North Yorkshire and
East Yorkshire

CLIENT AECOM

ILLUS 223 XY trace plot of minimally processed magnetometer data; Sector 61

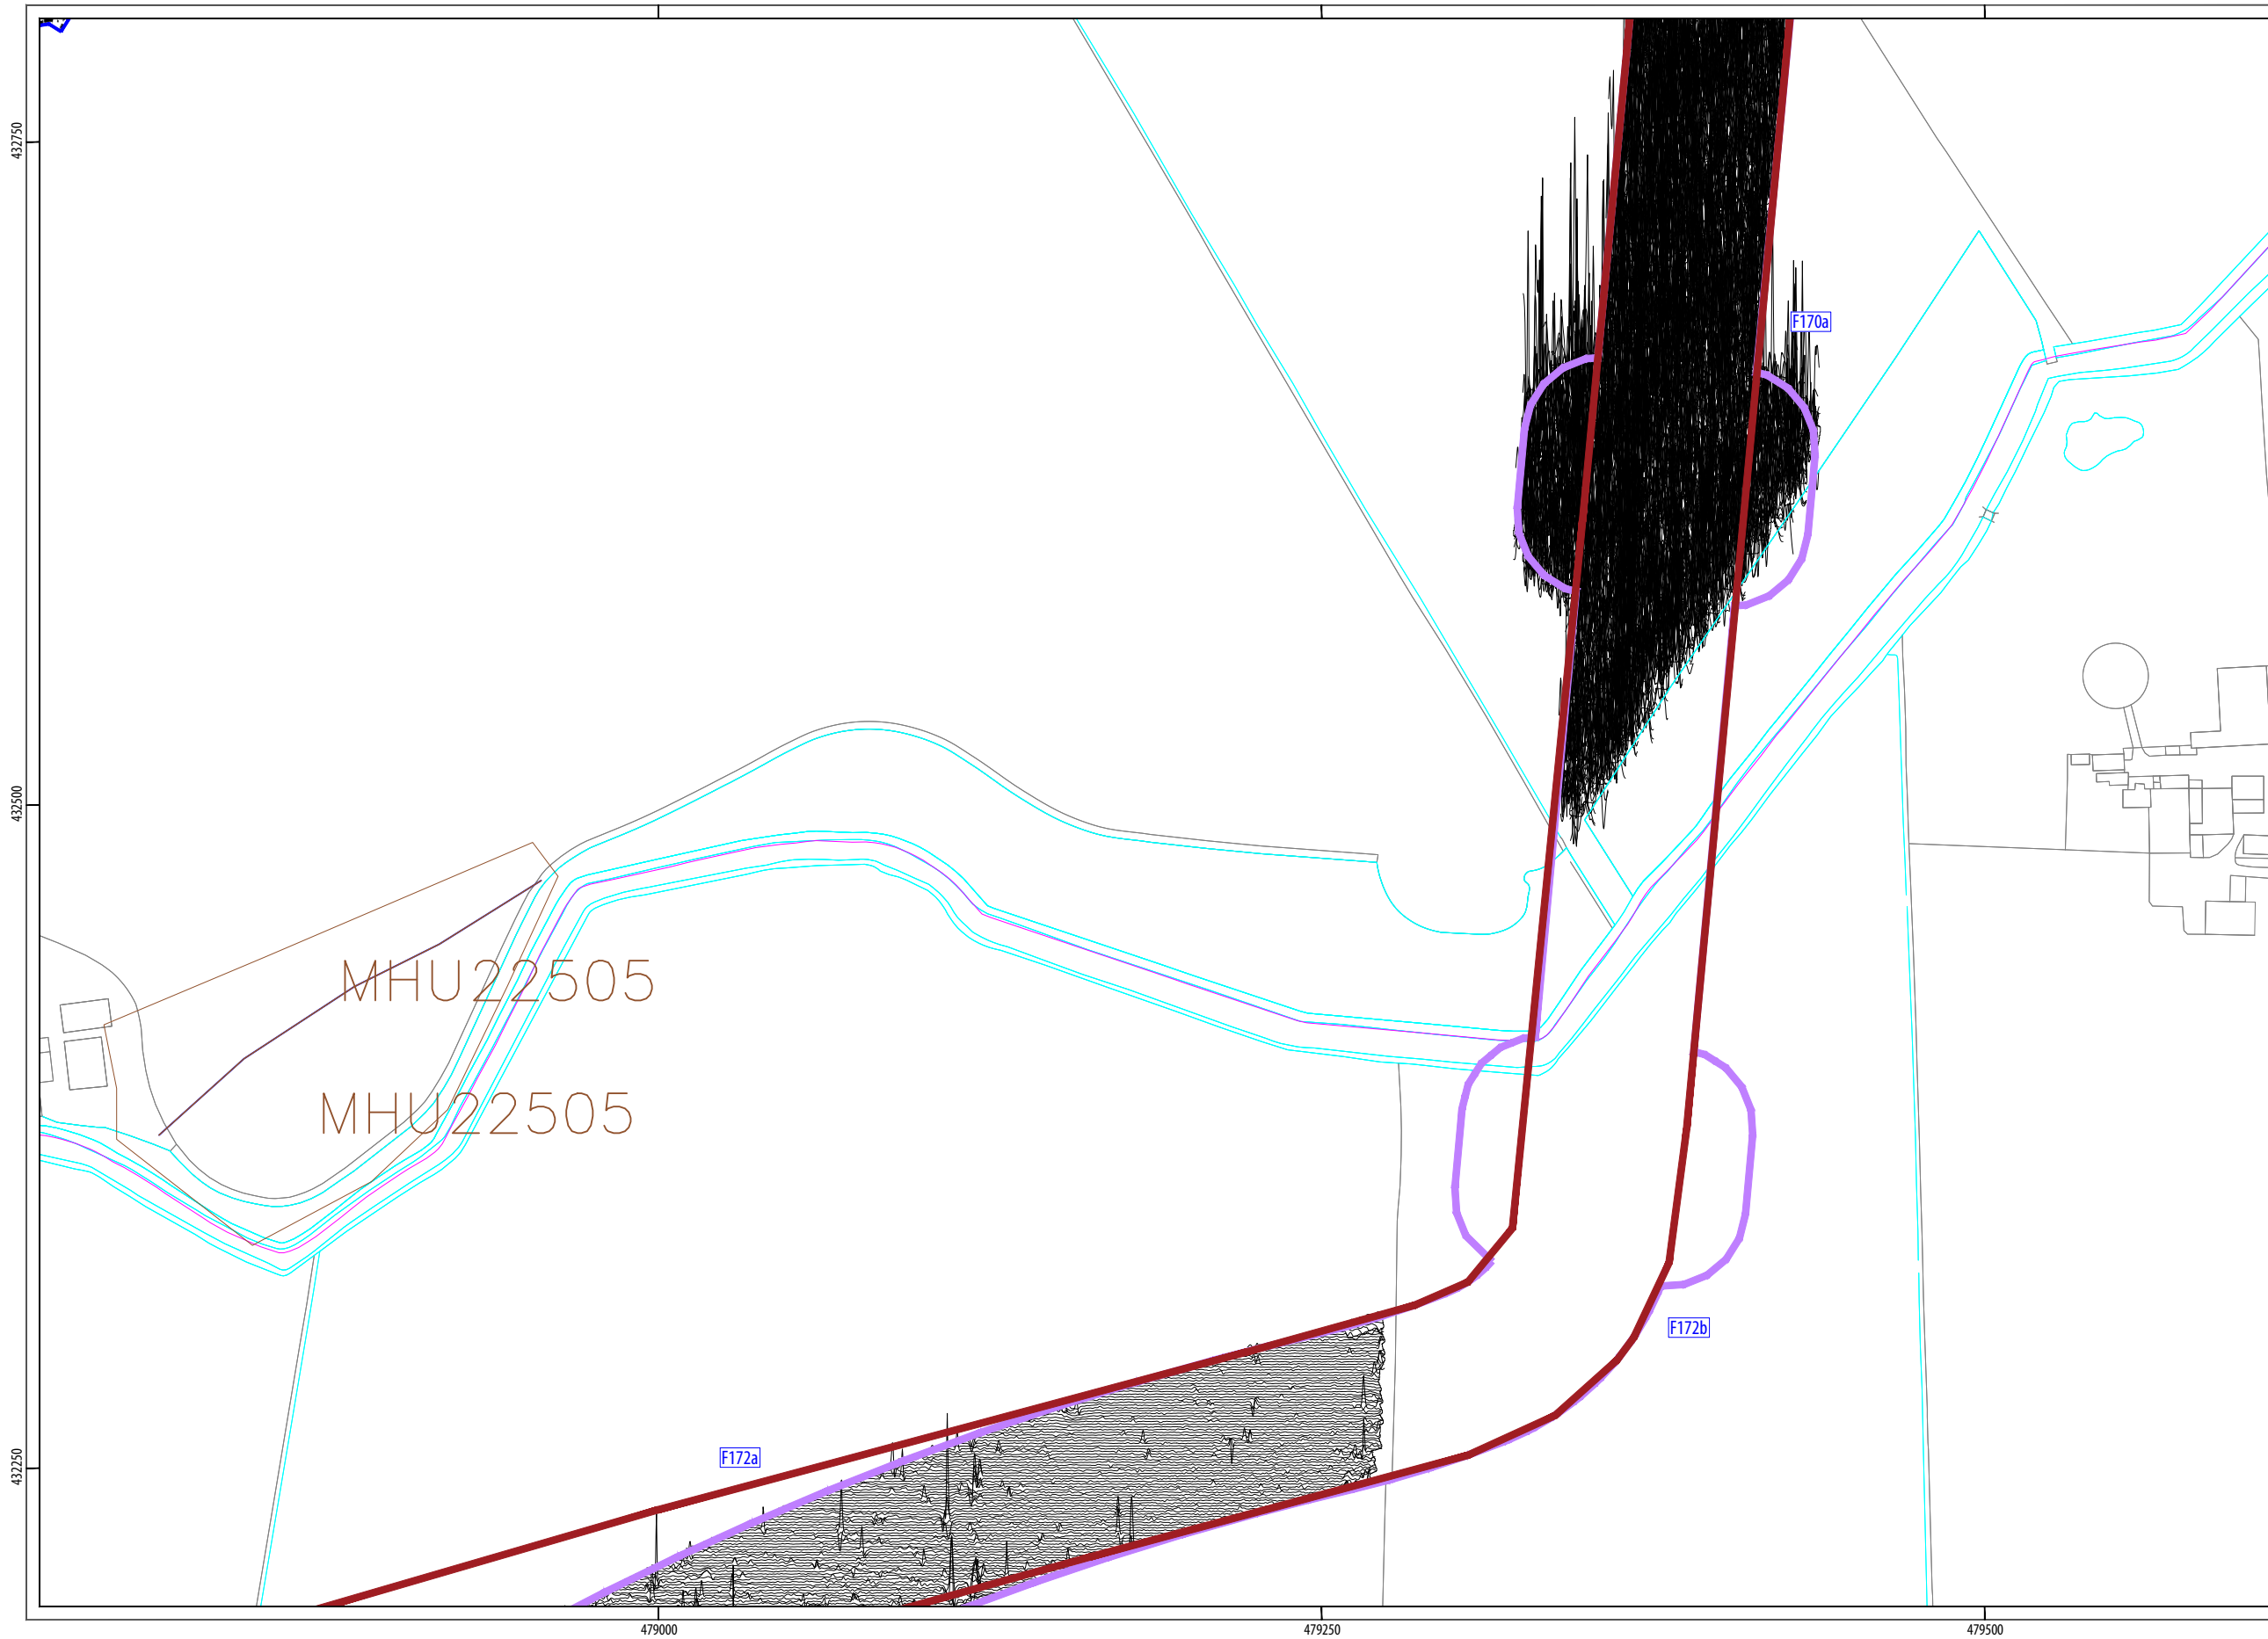
ILLUS 226 XY trace plot of minimally processed magnetometer data; Sector 62

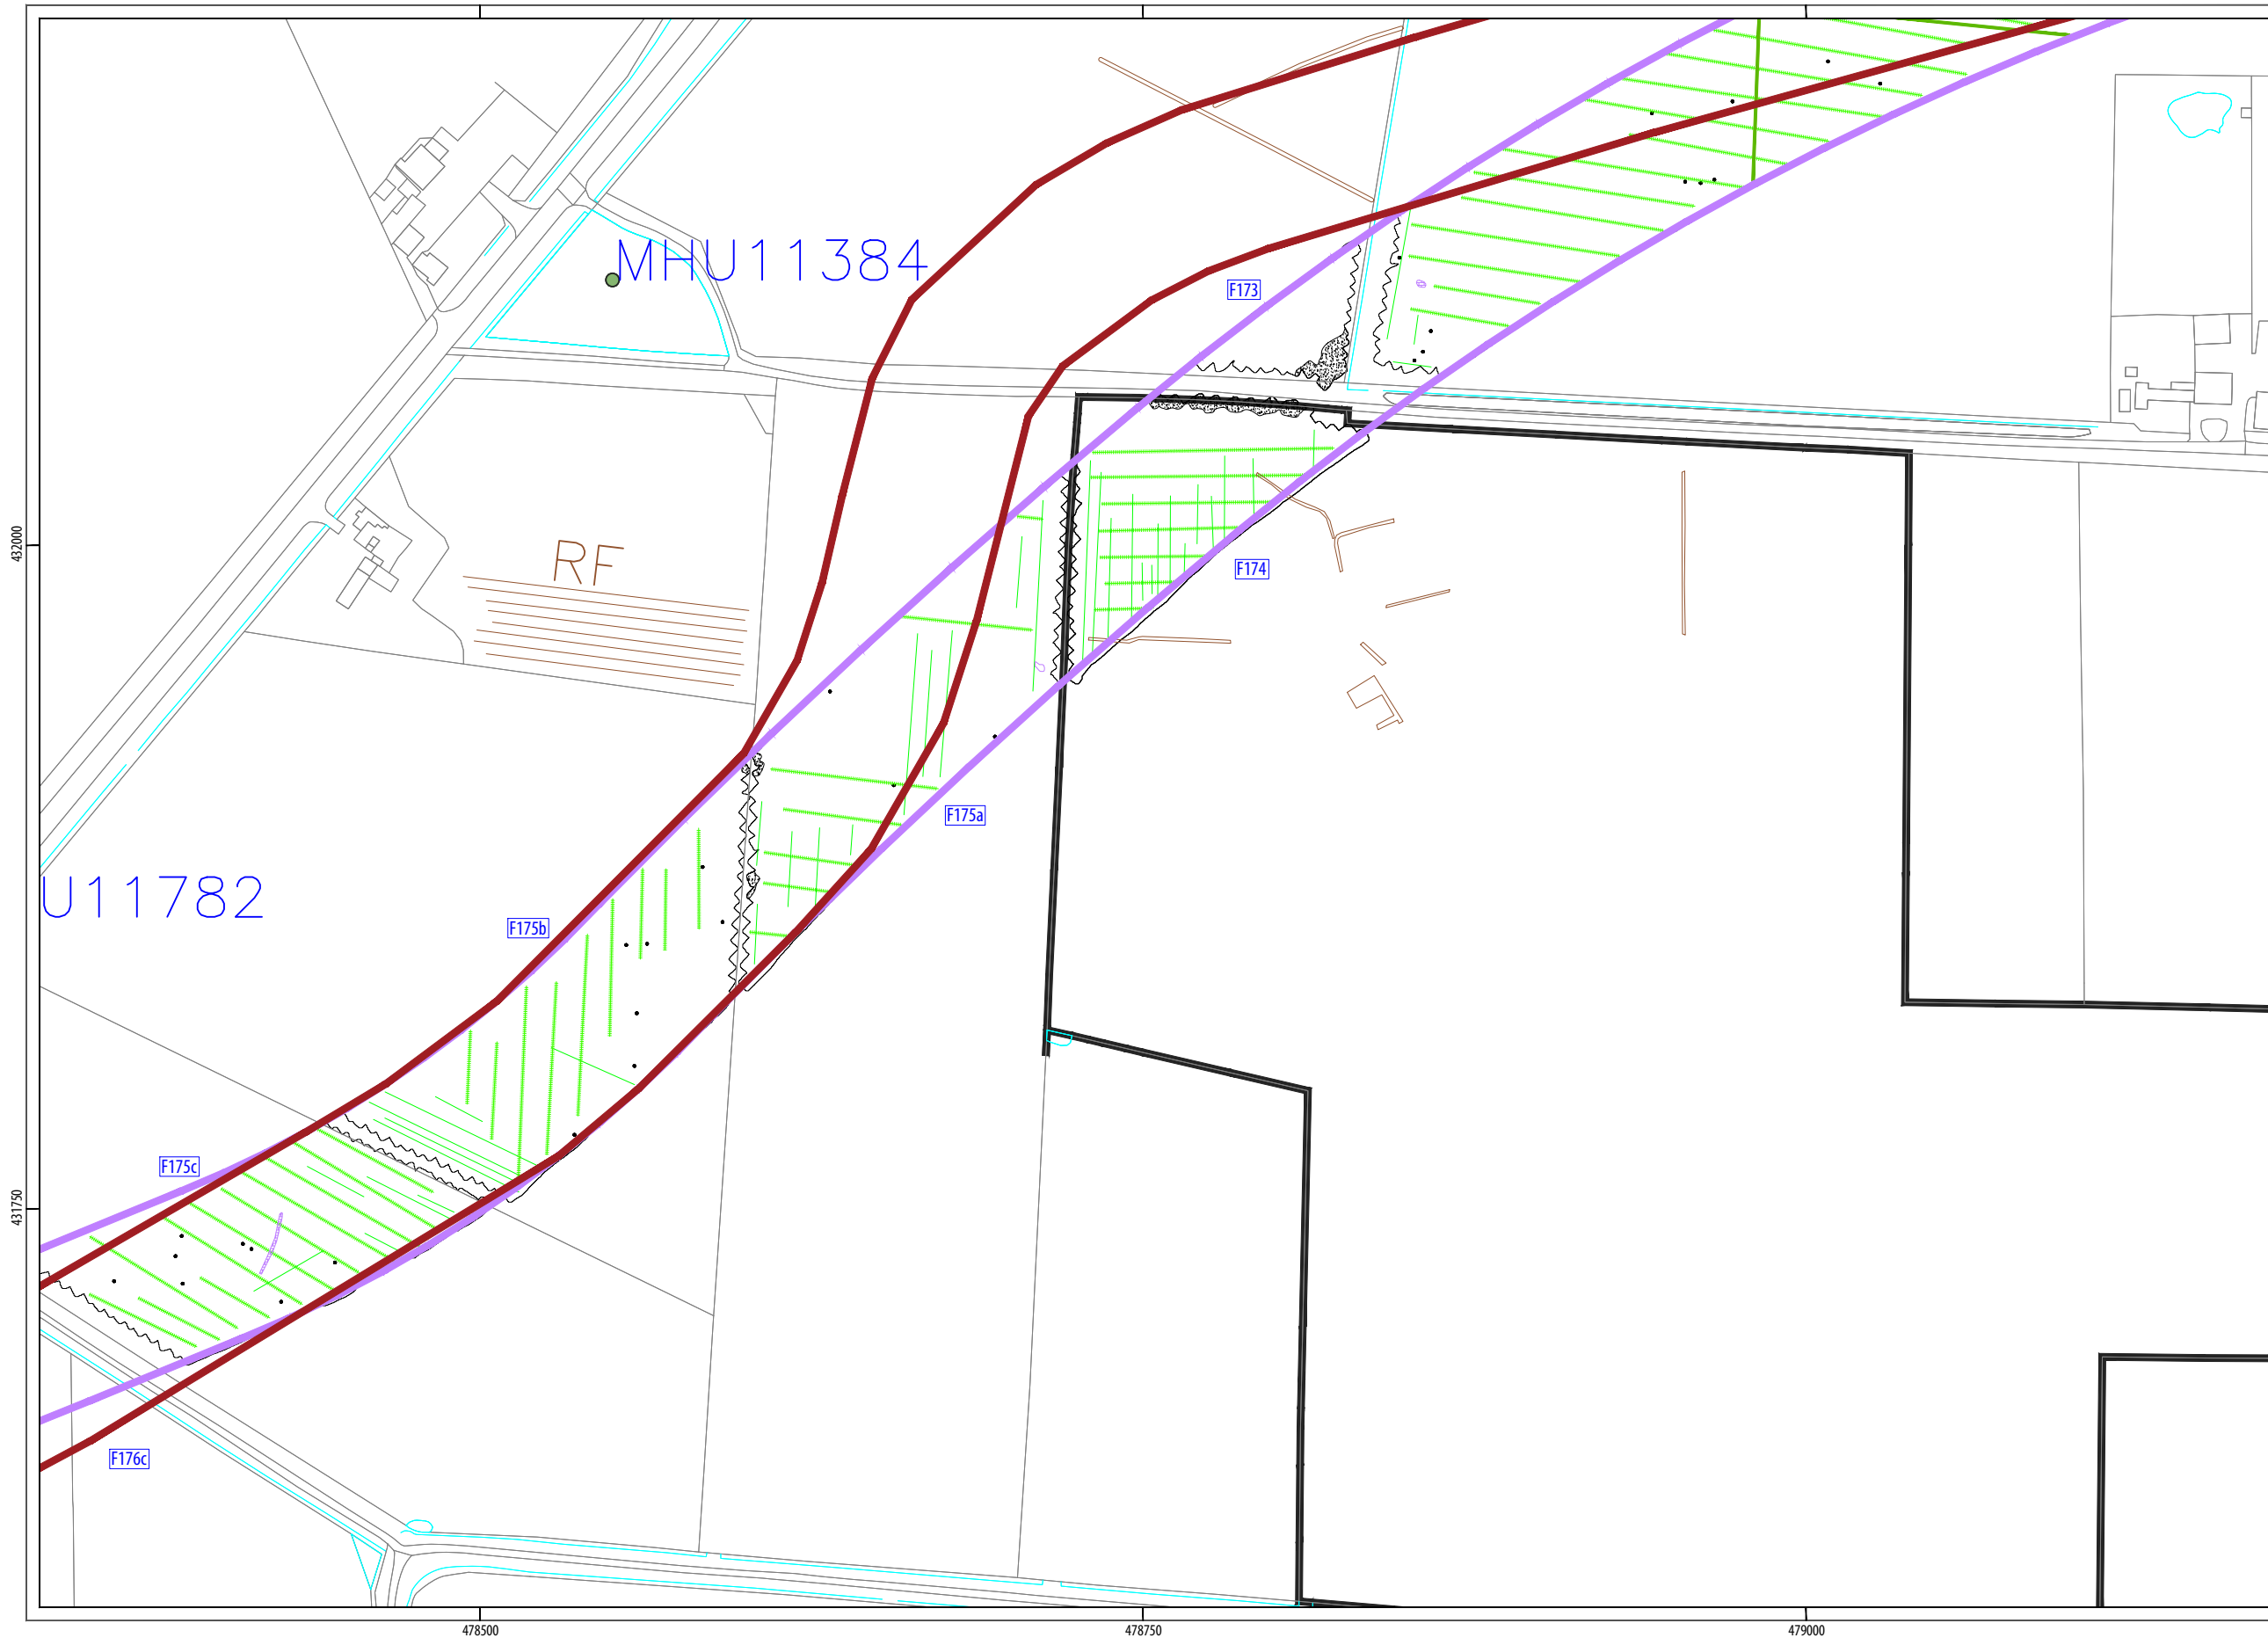
ILLUS 229 XY trace plot of minimally processed magnetometer data; Sector 63

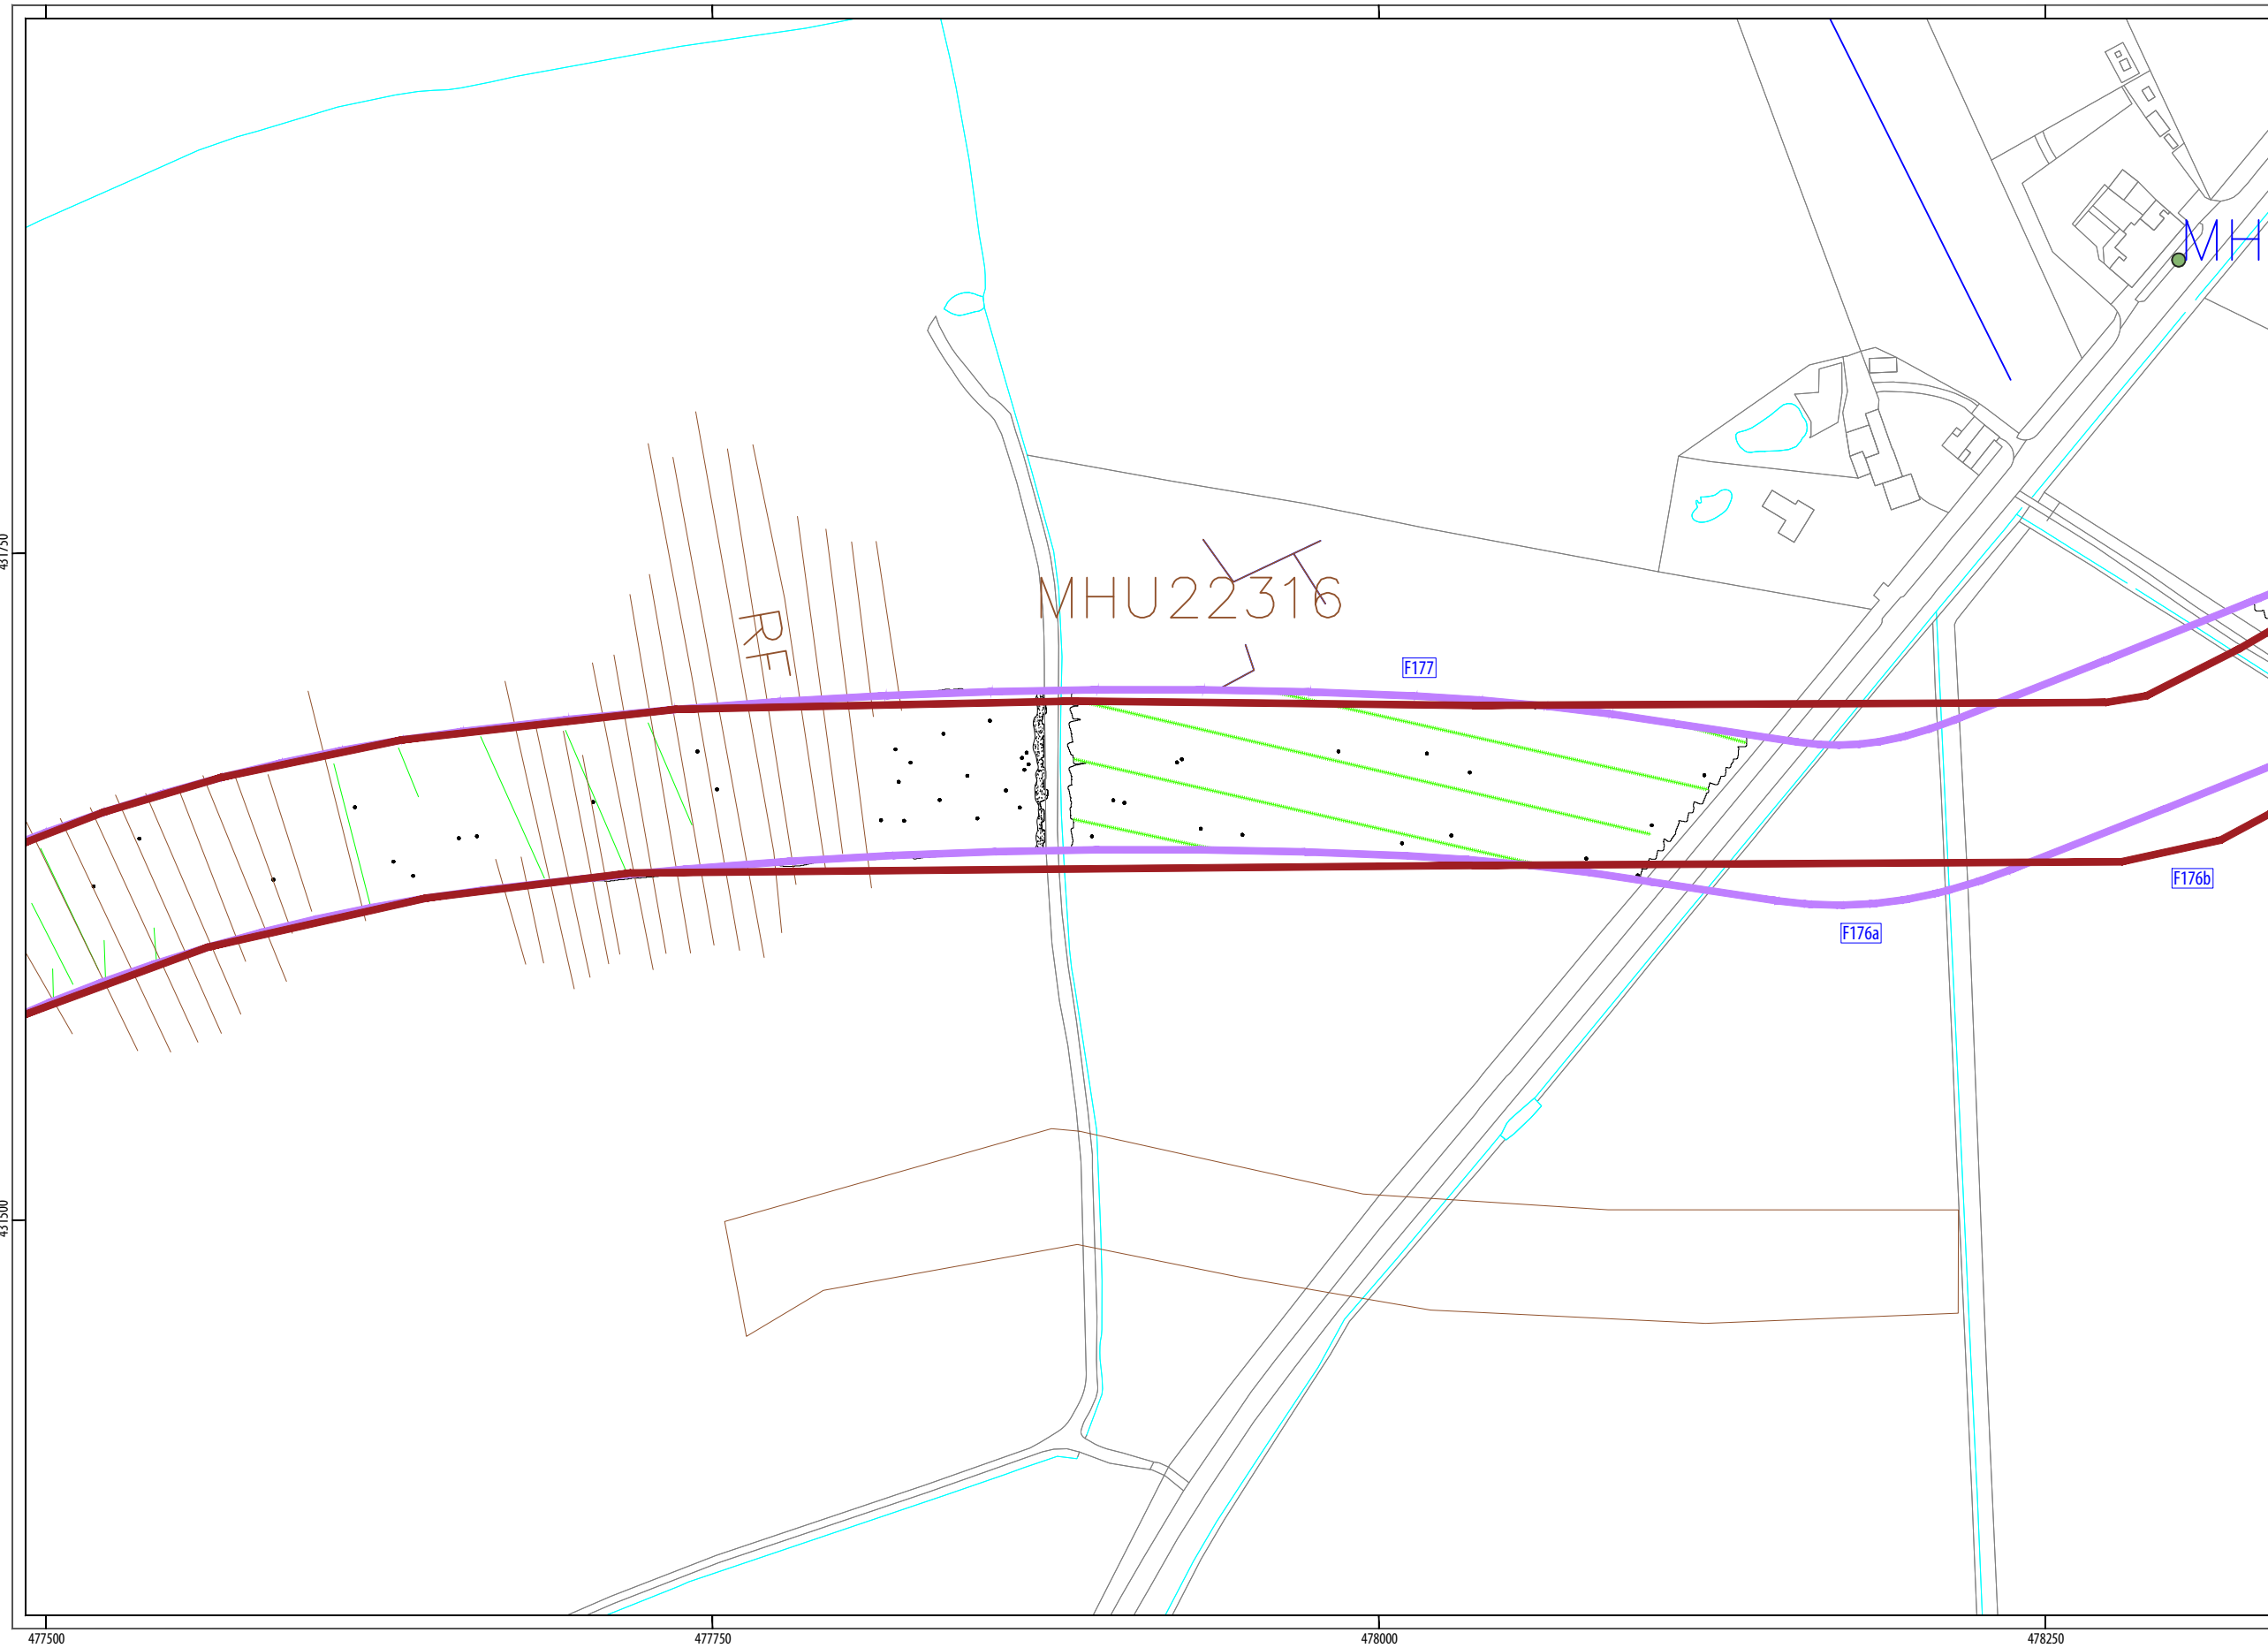
ILLUS 232 XY trace plot of minimally processed magnetometer data; Sector 64

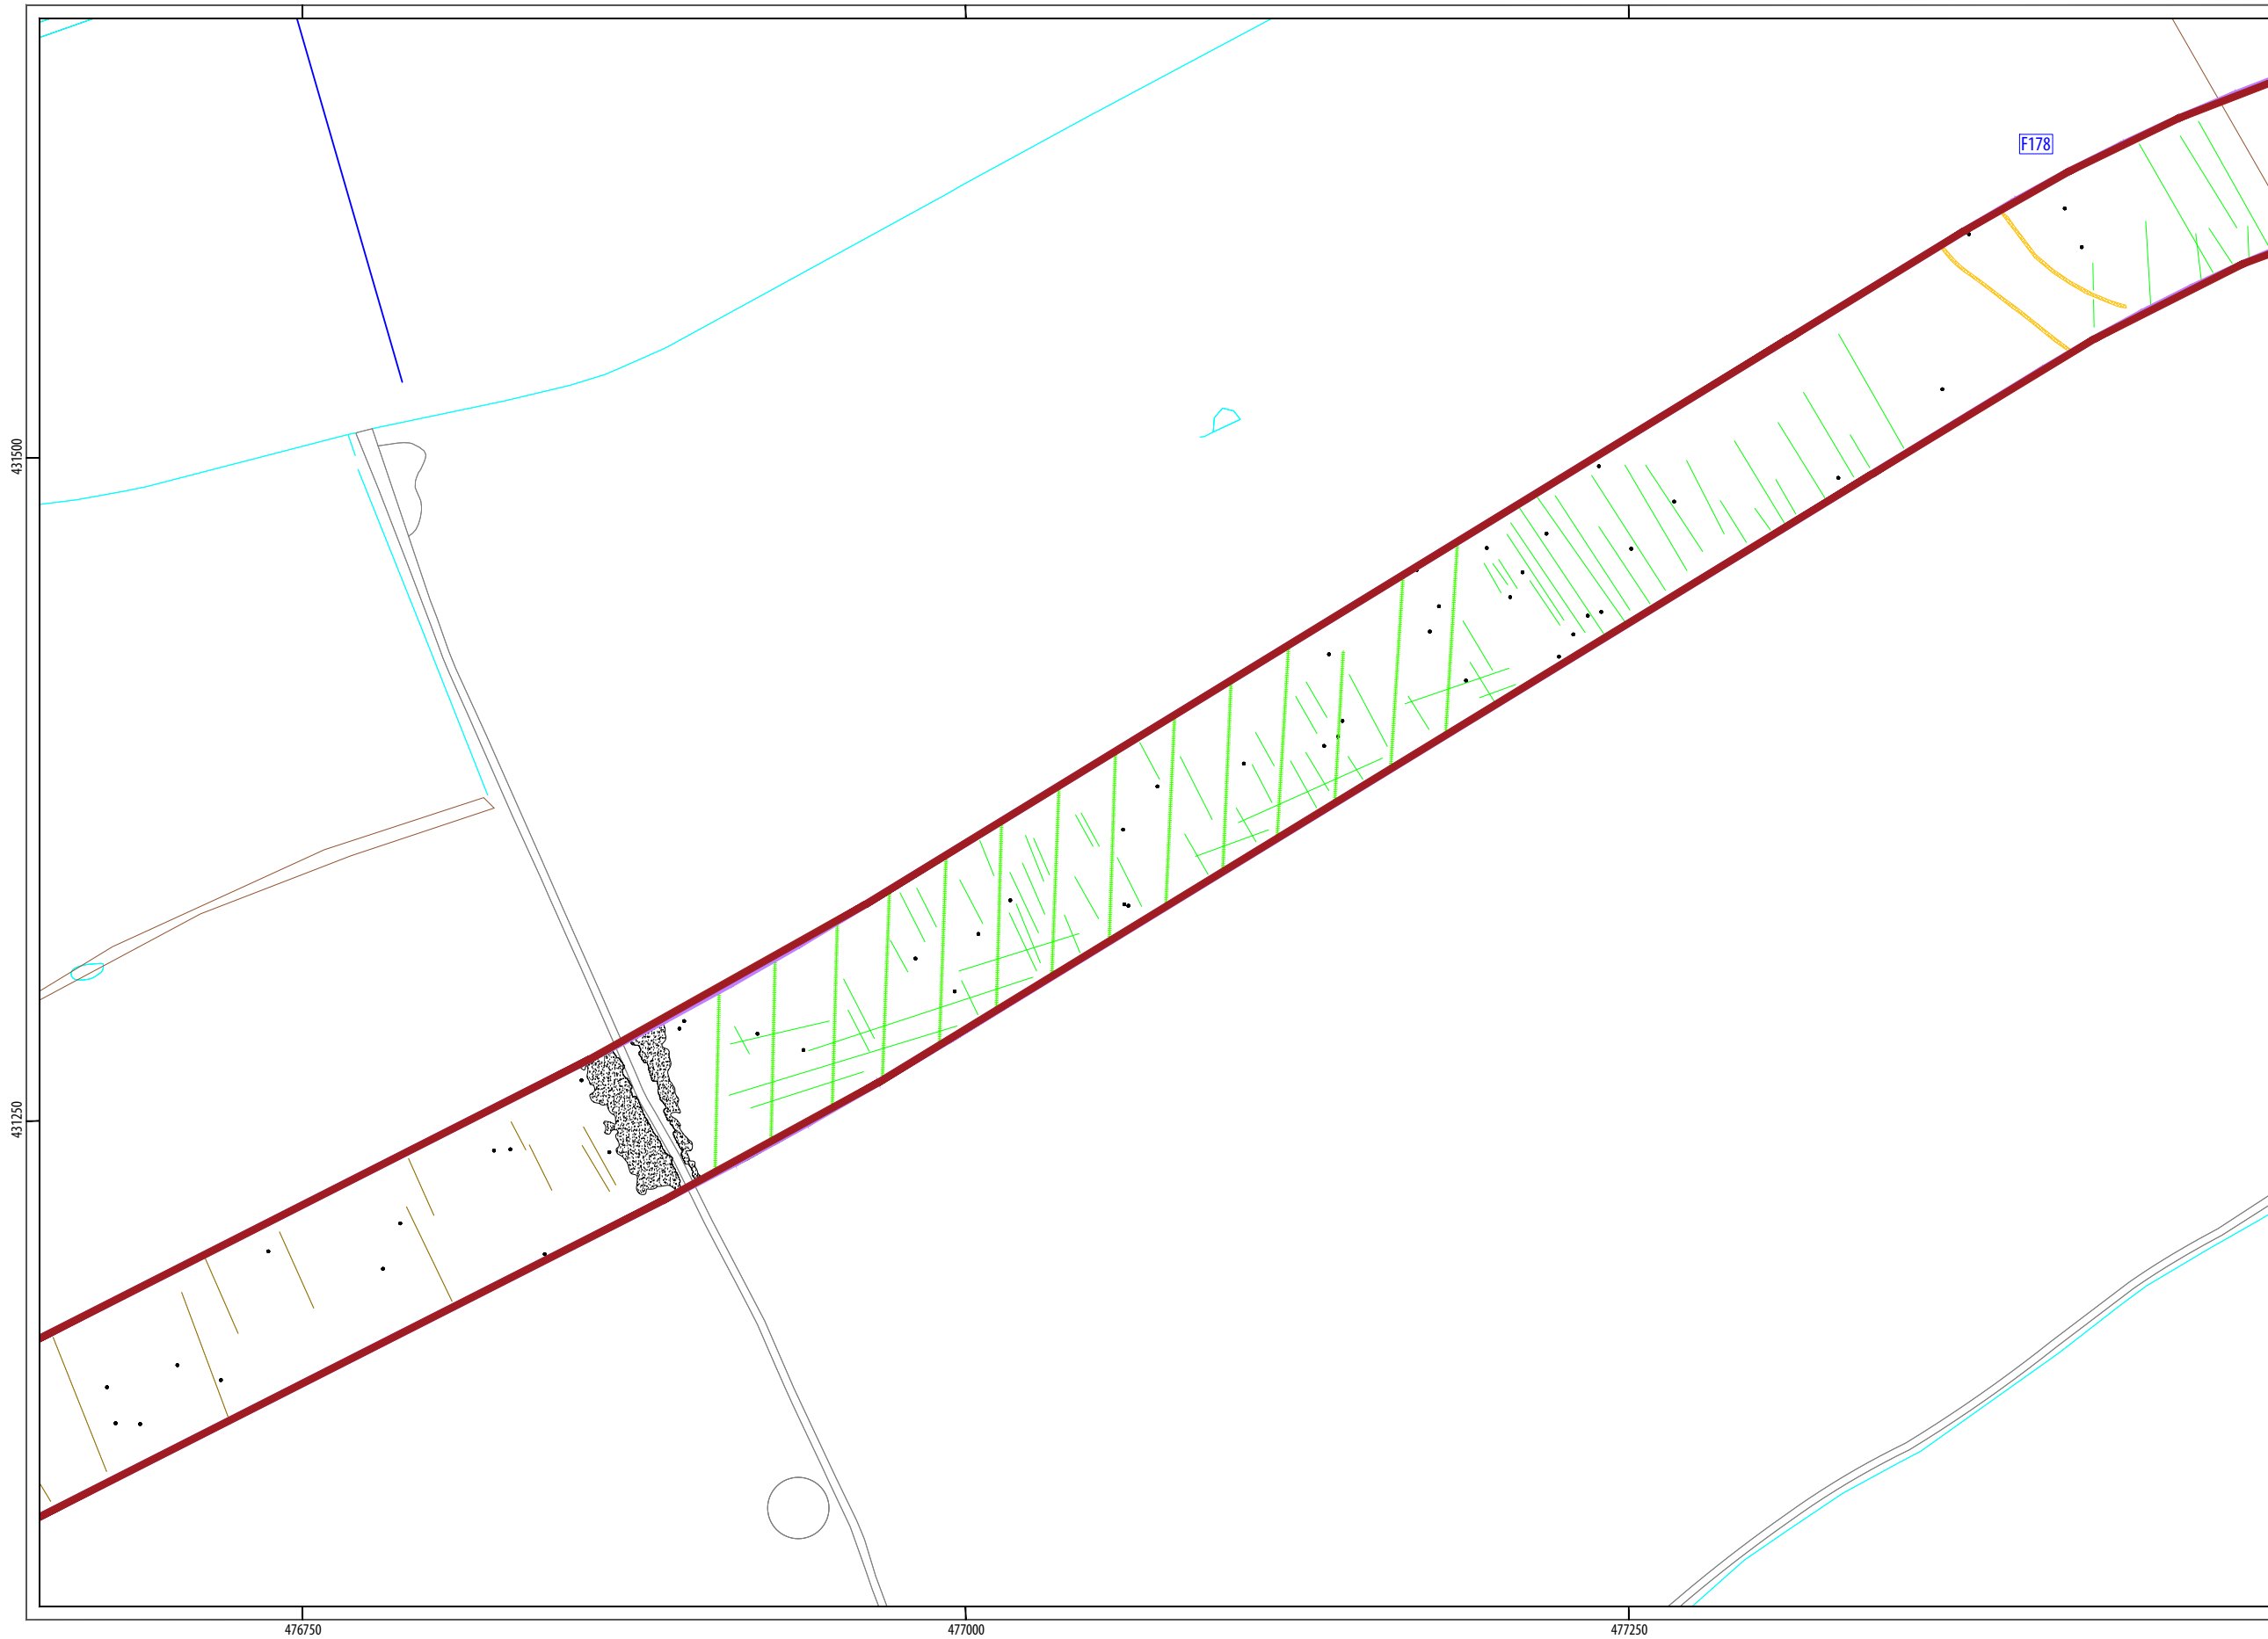
ILLUS 235 XY trace plot of minimally processed magnetometer data; Sector 65
