Scotland England Green Link 2 - English Onshore Scheme

Environmental Statement:
Volume 3 - Appendices

Appendix 10B - Site Walkover
Photographic Information

PHOTOGRAPHIC LOG

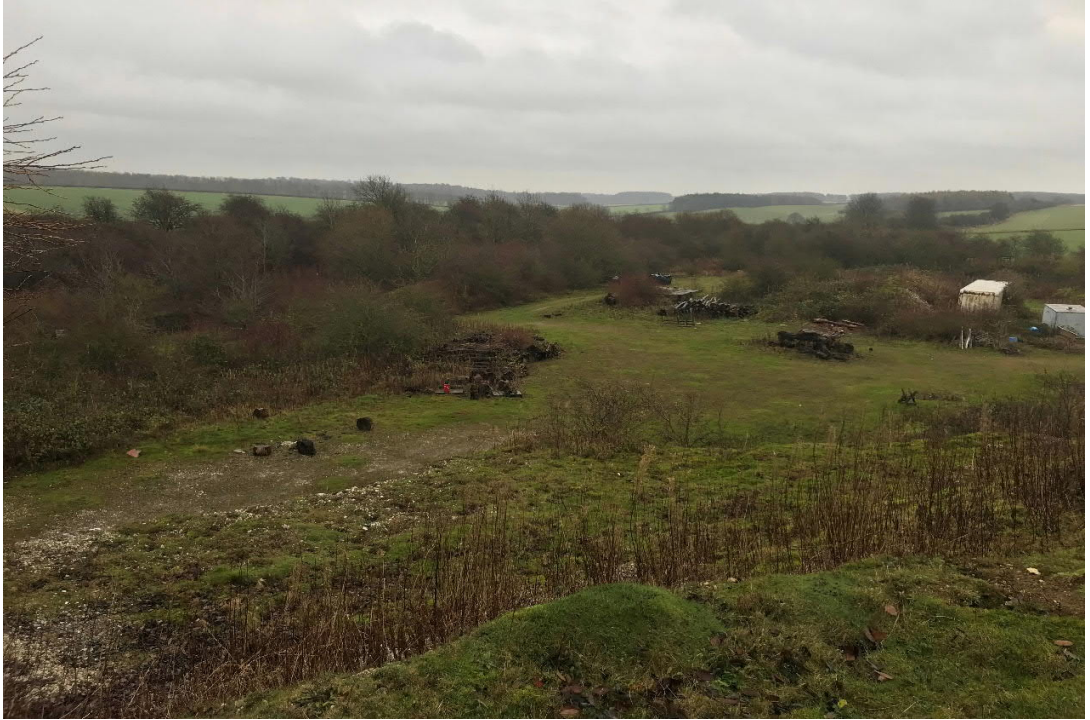
Client Name: NATIONAL GRID		Site Location: SEGL2	Project No. 60641917
Photo No. 1	Date: 09/12/21

Direction Photo Taken: North east			
Description View of Kiplingcotes Nature Reserve. A Regionally Important Geological and Geomorphological Site. Located adjacent to the planning application boundary.

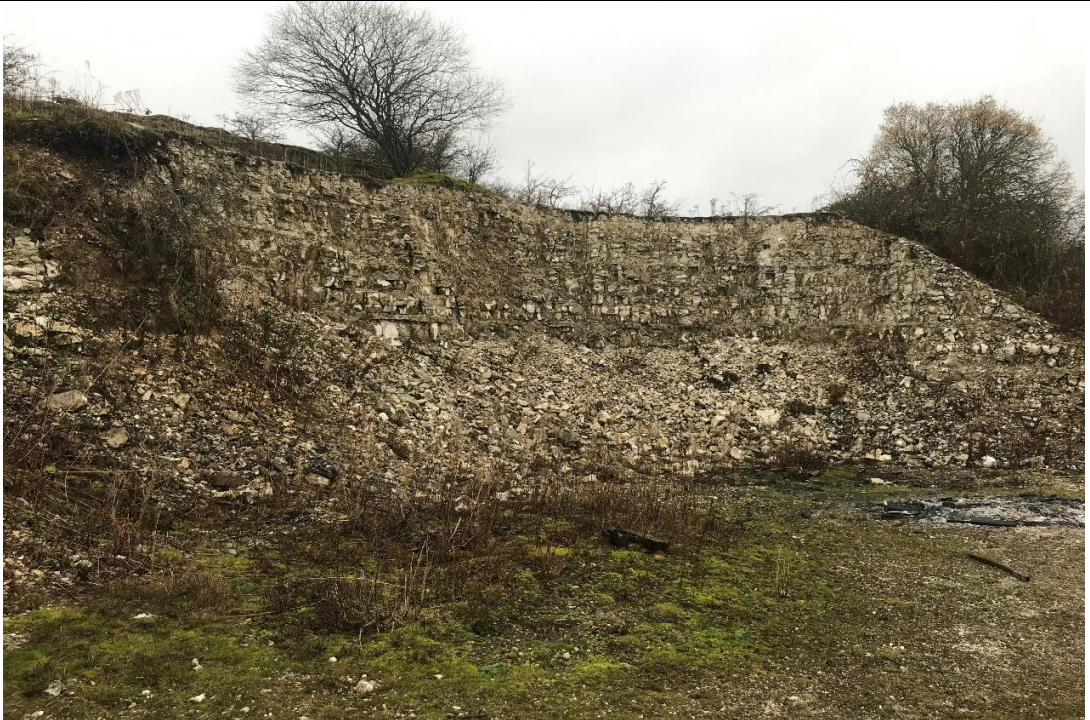
Client Name: NATIONAL GRID		Site Location: SEGL2	Project No. 60641917
Photo No. 2	Date: 9/12/21

Direction Photo Taken: South west			
Description Exposed chalk face of Turonian Chalk located within Kiplingcotes Nature Reserve. No visible evidence of contamination observed. Located approximately 100 m east of the planning application boundary and HDD crossing of the Scheme.

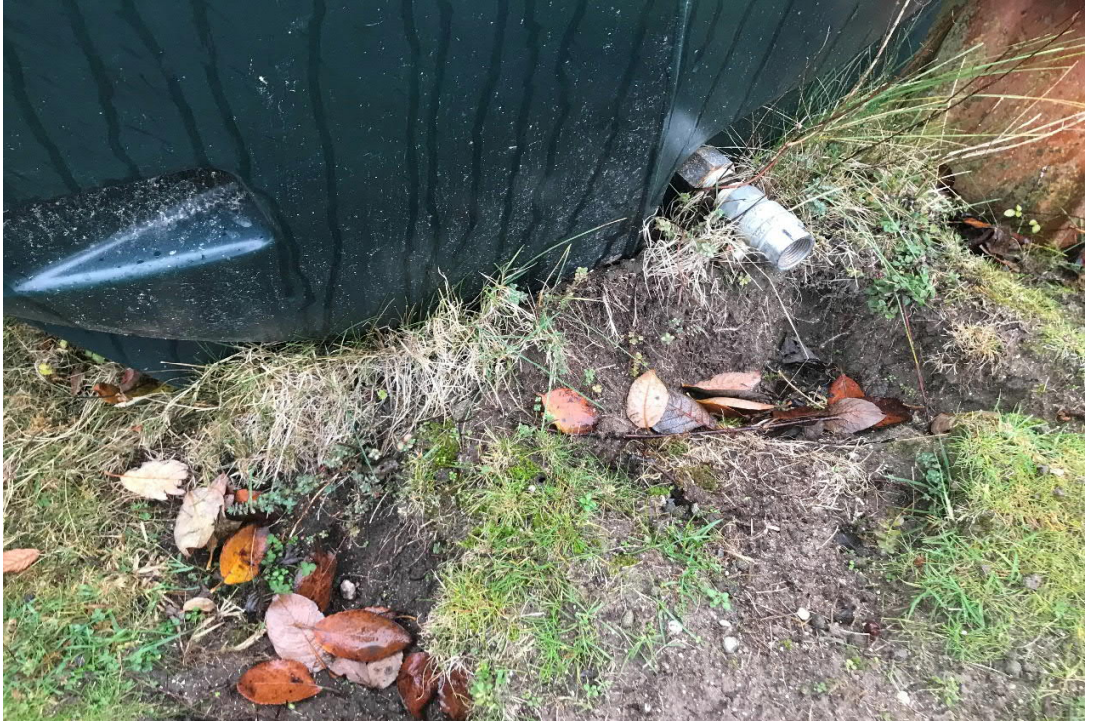
Client Name: NATIONAL GRID		Site Location: SEGL2	Project No. 60641917
Photo No. 4	Date:

Direction Photo Taken: N/A			
Description Exposed ground present at the base of the suspected fuel storage tanks at Kiplingcotes Nature Reserve. No visible signs of contamination observed.

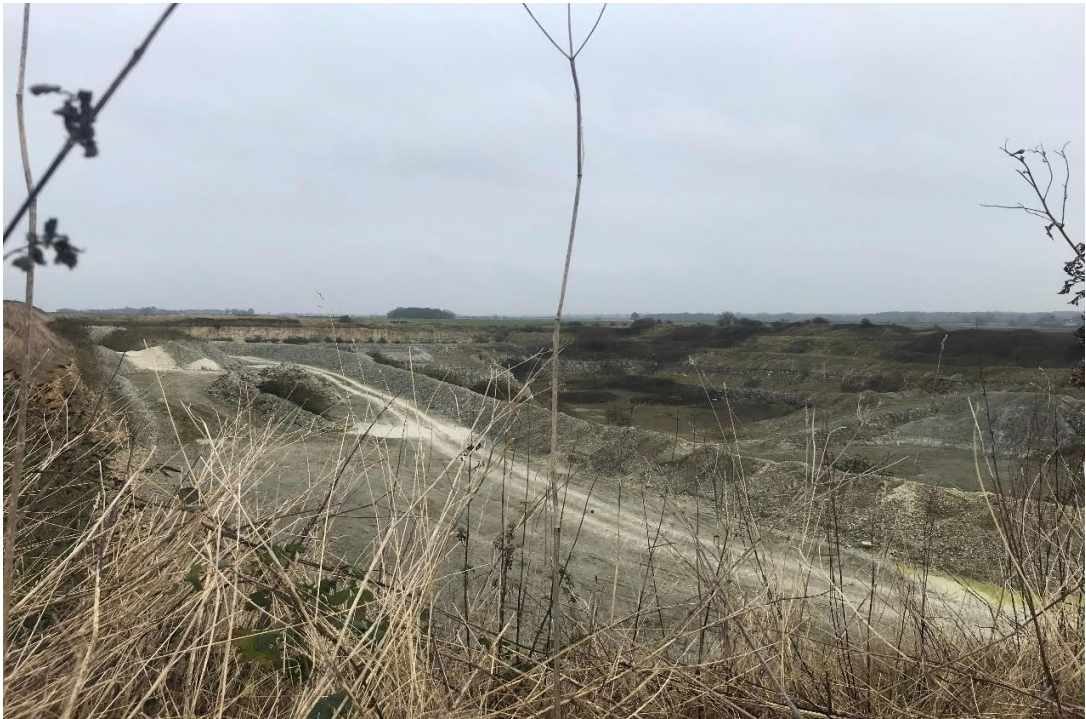
Client Name: NATIONAL GRID		Site Location: SEGL2	Project No. 60641917
Photo No. 6	Date: 09/12/21

Direction Photo Taken: East			
Description Former quarry present to the south east of Bainton and the B1248. Approximately 60 m to the east of the planning application boundary.

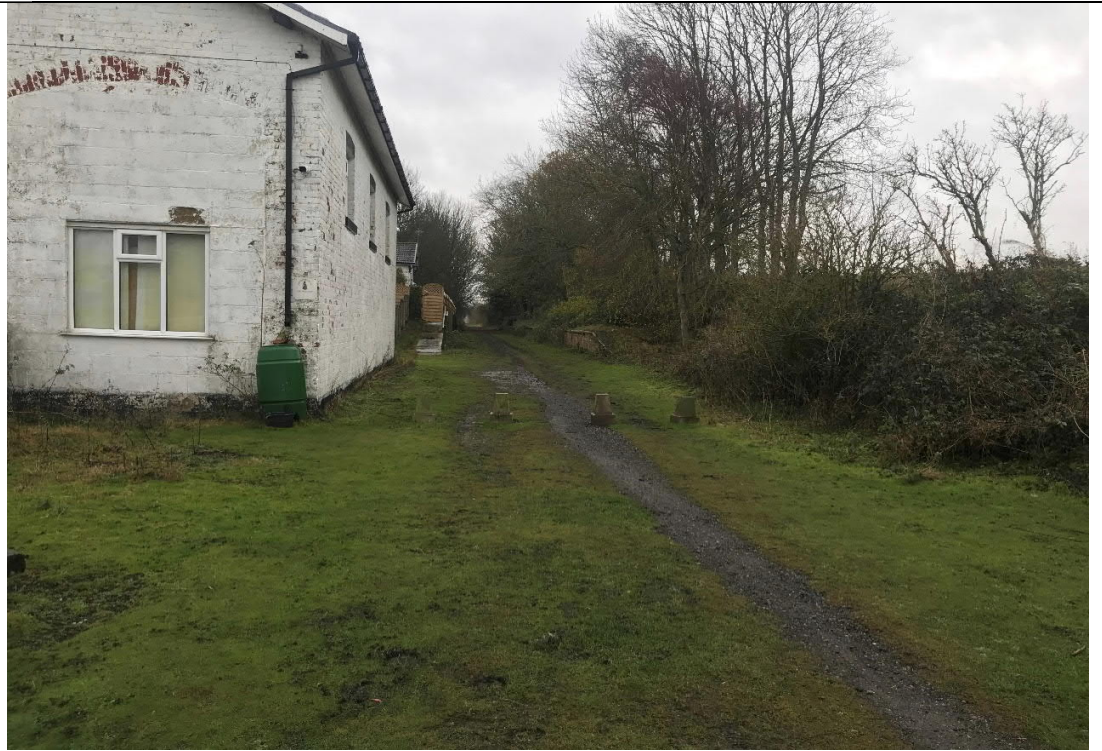
Photo No. 7	Date: 09/12/21
Direction Photo Taken: East	
Description Footprint of former railway tracks at Kiplingcotes where former Kiplingcotes railway station was present. No visible evidence of contamination observed. Transecting a HDD crossing of the Scheme.

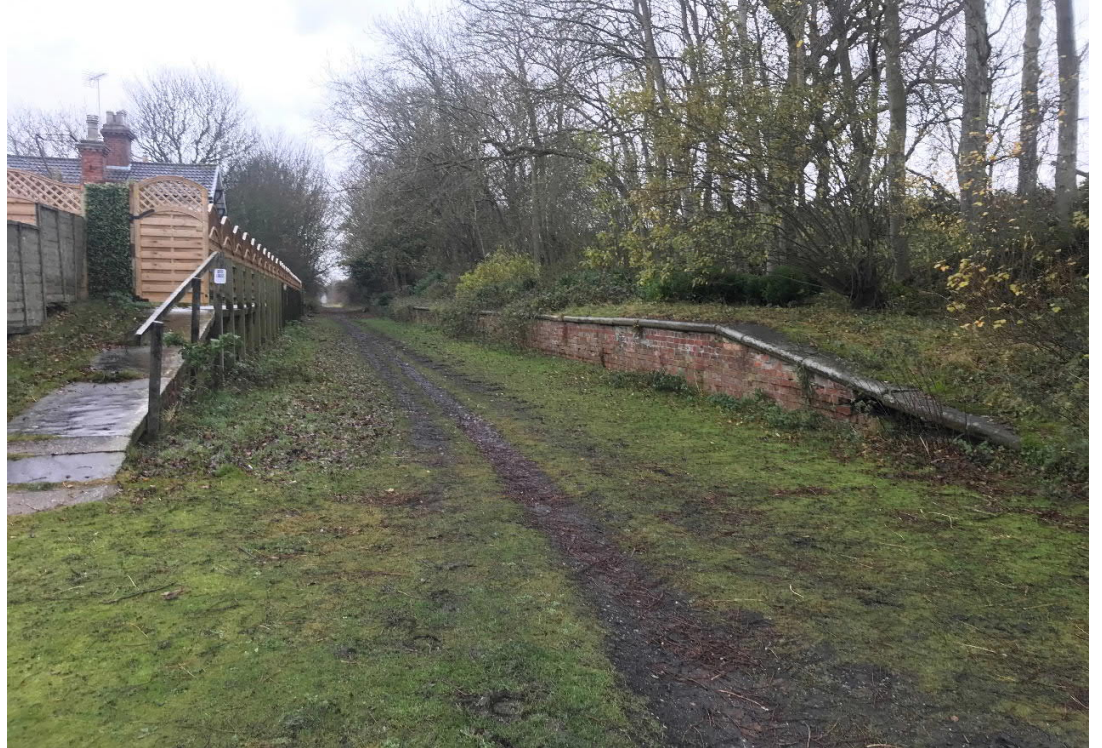
Photo No.
9

Footprint of former railway tracks at Kiplingcotes where former Kiplingcotes railway station was present. Former platform visible. No visible evidence of contamination observed. Transecting a HDD crossing of the Scheme.

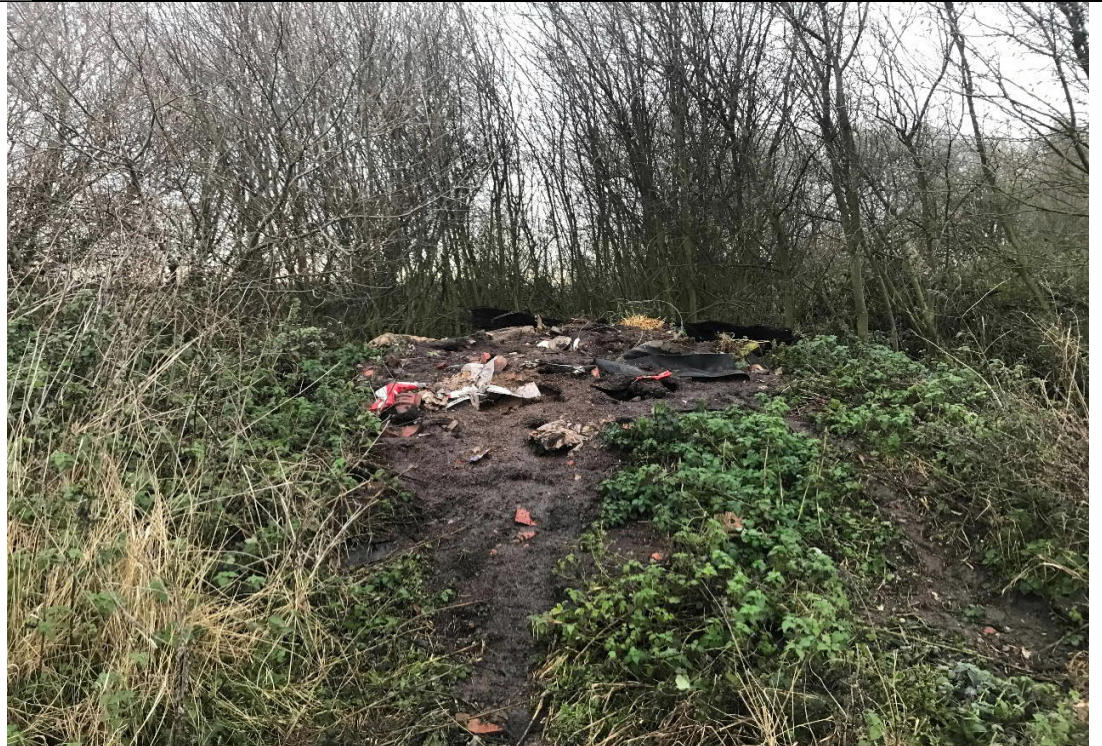
Photo No.
10

Mound of fill material located adjacent to HDD crossing on River Foulness. Fill material consisting of old building material, bricks, concrete, and textiles. Potential asbestos containing material present.
